Exhibit No. \_\_\_\_\_  
Issues: Disposition Agreement and Company  
Background  
Witness: Josiah Cox  
Type of Exhibit: Direct Testimony  
Sponsoring Party: Elm Hills Utility Operating  
Company, Inc  
File Nos.: WR-2020-0275  
Date: October 22, 2020

**Missouri Public Service Commission**

**Direct Testimony**

**Elm Hills Utility Operating Company, Inc**

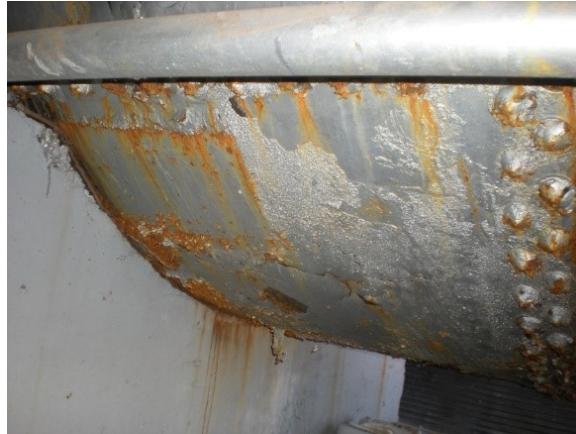
13                As I previously mentioned, hydropneumatic storage was an old rail tanker  
14       car that had been placed on blocks and equipped with a compressor to allow for  
15       hydro-tank functionality. Inspection stamps on the tank show it was originally built  
16       in 1929. Due to its age and lack of maintenance, the tank leaked in several  
17       places and was covered in rust. During initial system renovations, the tank was  
18       cut open and we discovered more than 6 inches of rust sludge in the bottom of  
19       the tank, which routinely was being released with the water provided to  
20       customers. This obviously was detrimental to water quality, was detrimental to  
21       the distribution system's functionality and also posed a potential public health risk  
22       for customers. The rust sludge regularly caused issues for customers ranging

Leaking and rust on hydropneumatic storage tank exterior

7 With the backup connection completed, work could be performed on the  
8 well and tank without interrupting service to the community. After the tank and  
9 well were isolated, the well head was reworked and painted, the pump and pump  
10 motor replaced, and electrical supply and control panels were replaced. To repair  
11 the tank, it first was sand blasted. To complete this phase of the process, the  
12 building surrounding the tank and well had to be partially disassembled and  
13 removed. Sanding also showed the locations of significant leaks that were  
14 targeted for welding repairs. Additionally, a hatch was cut in the end of the tank  
15 and manway installed to allow evaluation of the tank interior.

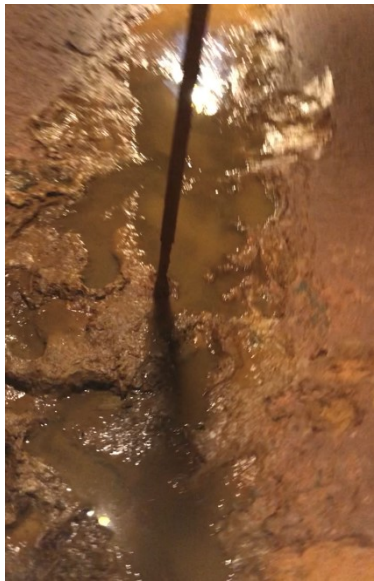
Rust sludge accumulation in tank interior

16 As mentioned previously, it was discovered the entire interior of the tank  
17 was severely corroded, with flaking rust throughout and six inches of rust sludge  
18 accumulated in the bottom of the tank. Interior rust was broken off and shoveled  
19 out as much as possible, and then repeatedly flushed to prep the tank for  
20 sanding. The tank interior was then sanded and leaks, thin spots, and areas  
21 exhibiting significant section loss were identified on the interior and exterior and  
22 welded and patched to extend the tank's useful life. The tank was then coated  
23 inside and out with a new corrosion-resistant coating to prevent further corrosion

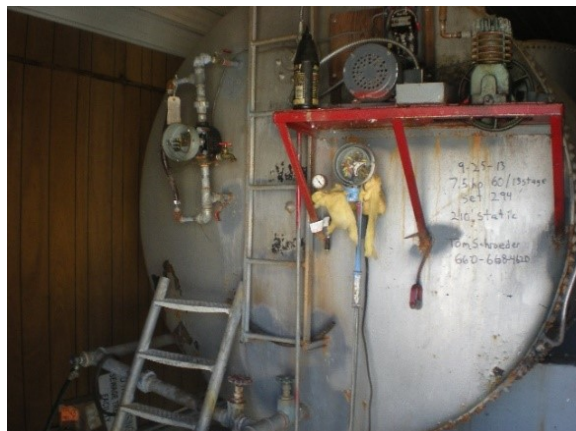
1 Outdated tank gauging and equipment

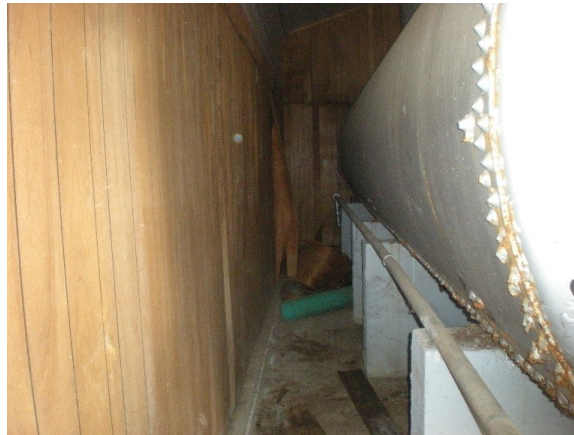
2  
3 Damaged, poorly lit interior of well house

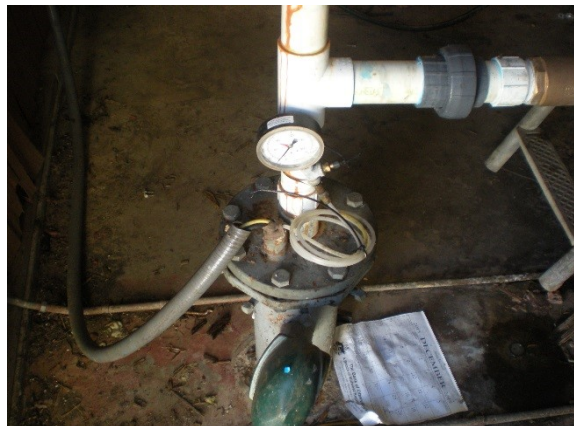
3 The existing well had exposed wiring and showed signs of leaking at the  
4 well head which has the potential to expose consumers to health risks associated  
5 with pathogen contamination. The existing pump and motor were both reaching  
6 the end of their useful lives and needed replacement, with pump testing showing  
7 it was performing 37 percent below published pump curves for the unit. The  
8 exposed wiring was also a concern and should have been properly installed in  
9 conduit. The existing well house, which encloses both the hydropneumatic tank  
10 and the well head, was in poor condition, poorly lit, unpainted on the interior, and  
11 had exposed insulation and debris throughout the structure. Controls in the  
12 structure were out of date and not in compliance with current electrical code  
13 requirements, which represented a safety hazard and also a potential source of  
14 service interruptions. Furthermore, existing electrical service to the structure was

4  
5 Exposed wiring on well head and signs of leaking from well head

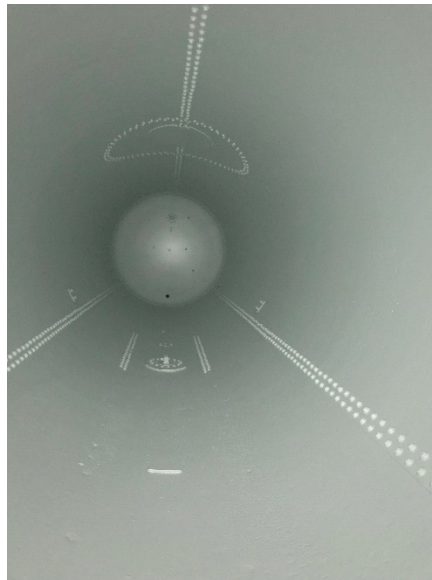
Tank interior sanded, patched, and recoated

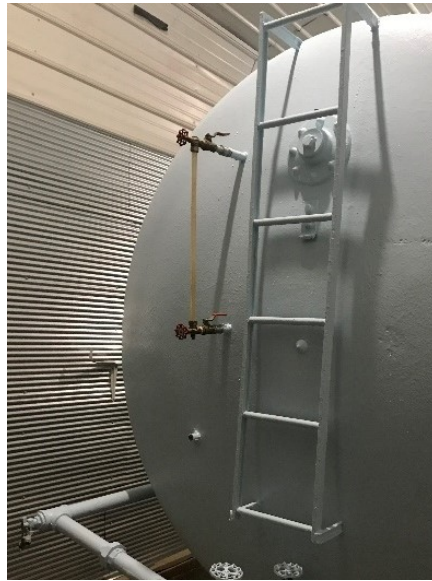
Tank exterior recoated and new tank monitoring equipment installed

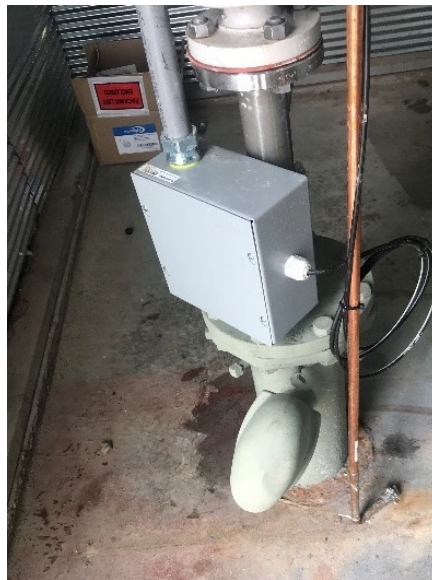
Reworked well head and new monitoring equipment

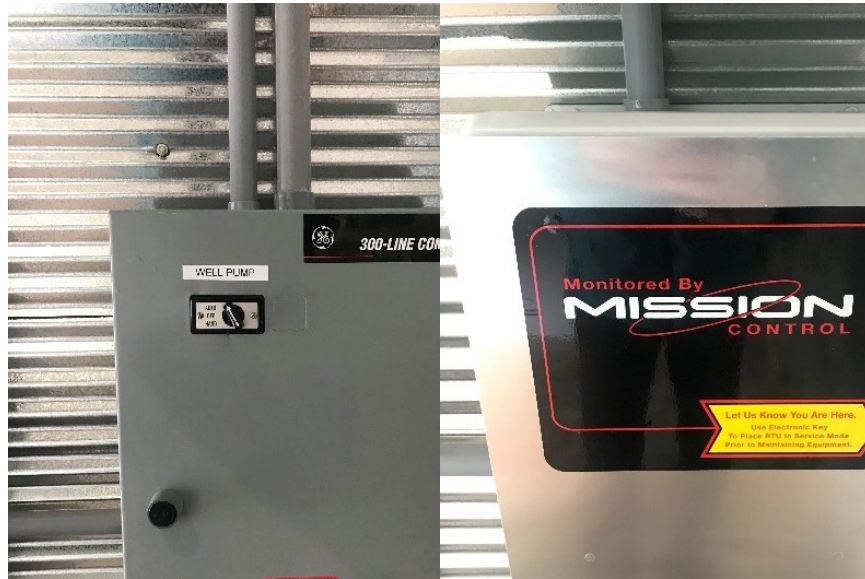
2 New Control panels, power supply, and remote monitoring equipment in well house

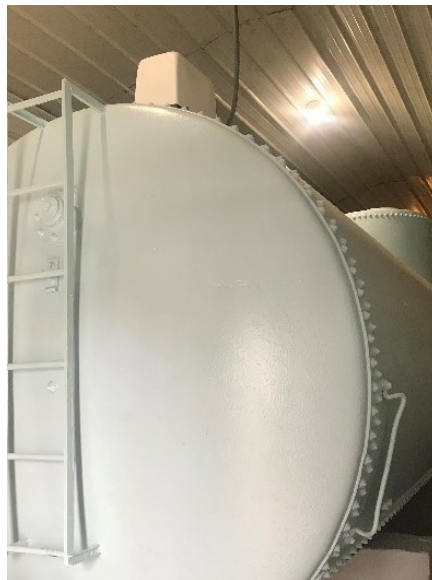
4 Improved well house interior and lighting.

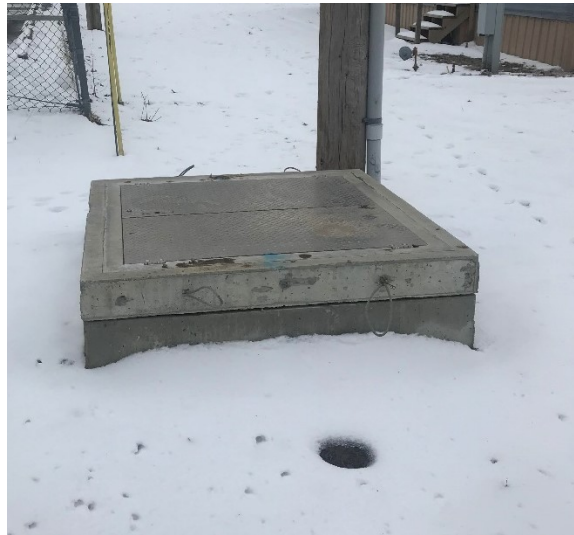
Valve vault with PRV with emergency supply from City of Sedalia

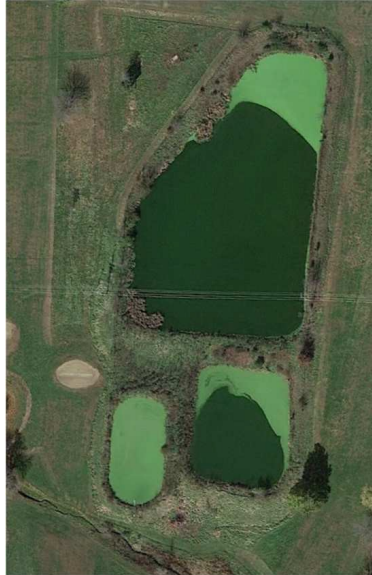
5  
6 Aerial photo of lagoon system with visible overgrowth

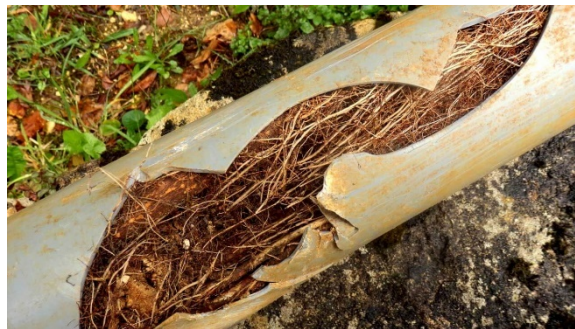
17 One of the largest challenges facing the system is a large amount of inflow  
18 and infiltration (“I&I”) caused by the VCP collection system. VCP can deteriorate  
19 over time and is prone to root infiltration at joints causing cracks and allowing  
20 groundwater to flow into the system. This means during rain events actual flows  
21 routinely exceed design flows and treatment capacity of the system. Between  
22 issues related to I&I flows and stricter effluent limits put into effect just prior to  
23 Elm Hills’ acquisition, the facility requires improvements to meet biochemical

7  
8 Example of vitrified clay pipe damaged by root infiltration allowing I&I flows

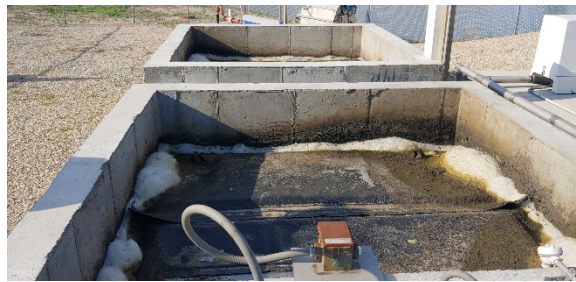
MBBR units with covers in place

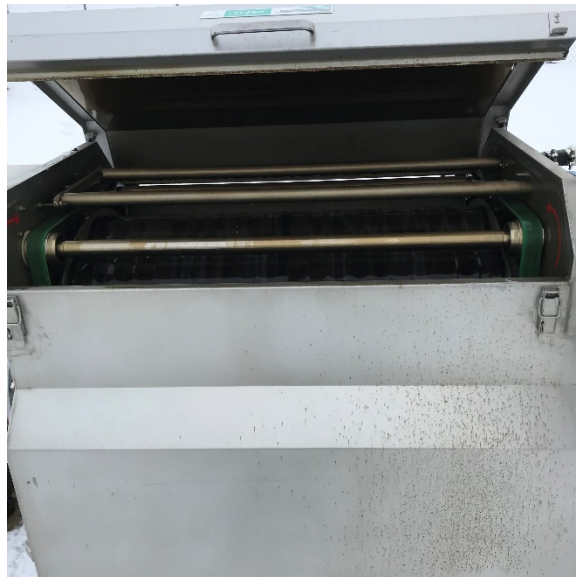
Drum Filter

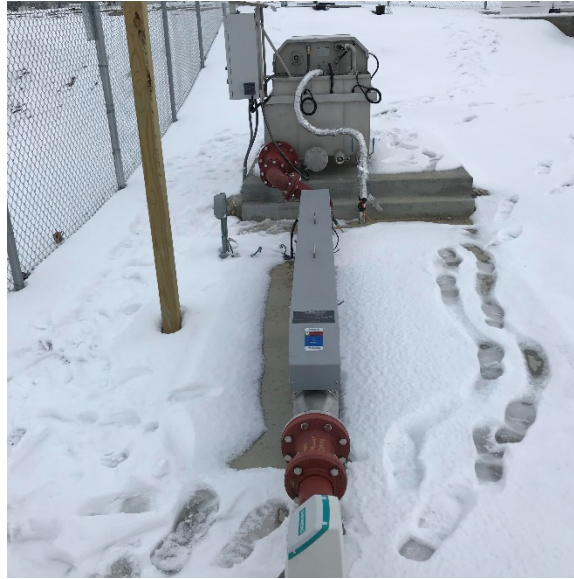
UV Disinfection system

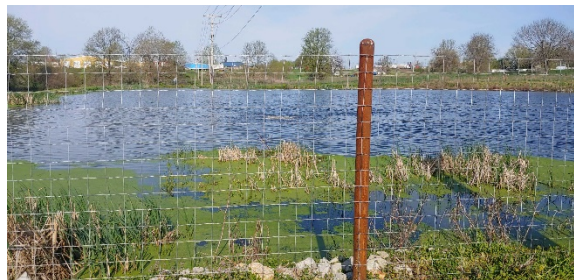
Fencing around lagoon and aeration visible in lagoon

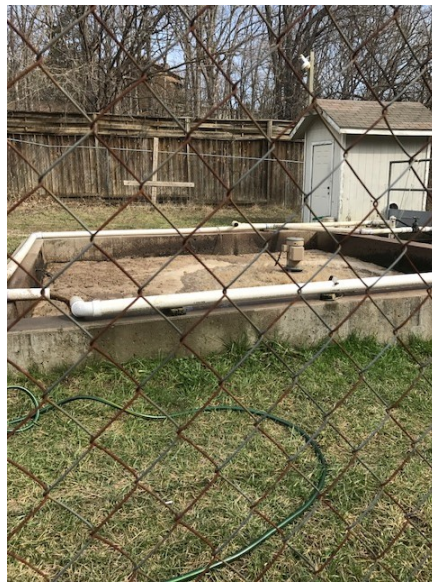
Aeration basin with single surface aerator, also PVC piping visible

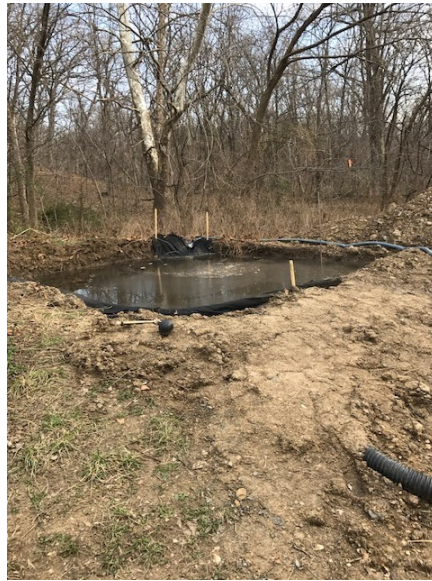
Unpermitted lagoon added to treatment plant by previous operator

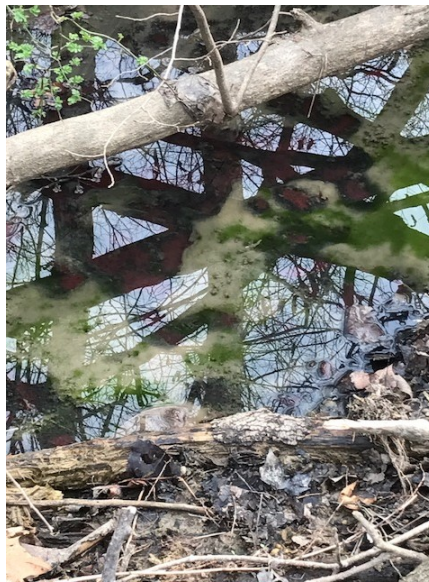
Sludge and blood worm accumulation in receiving waters, continuing for over 1  
mile in stream inside Knob Noster State Park

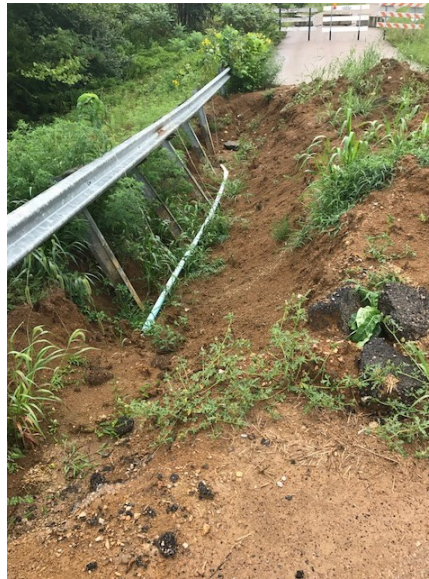
Force main exposed by road washed out from dam

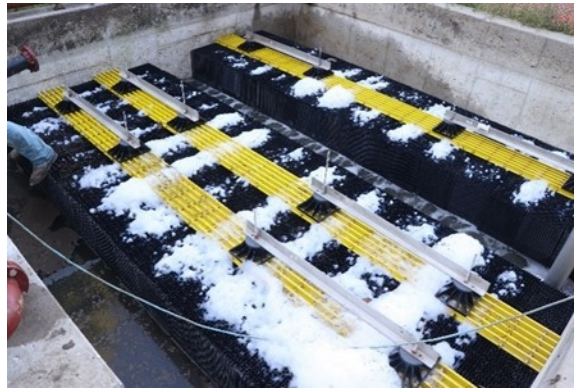
IFAS media visible during construction

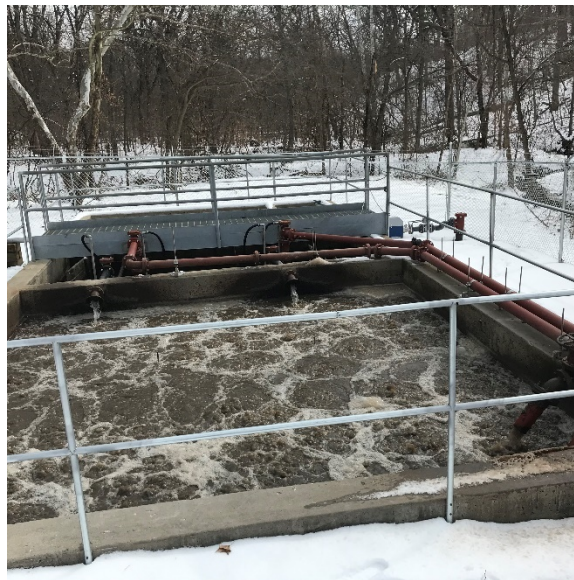
Aeration basin post upgrade

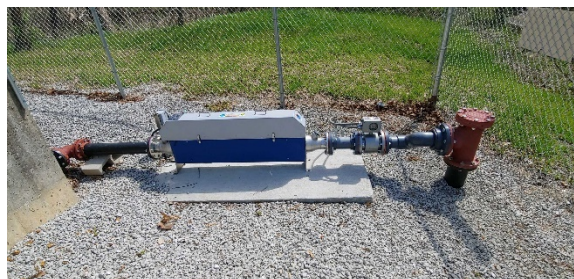
UV disinfection system

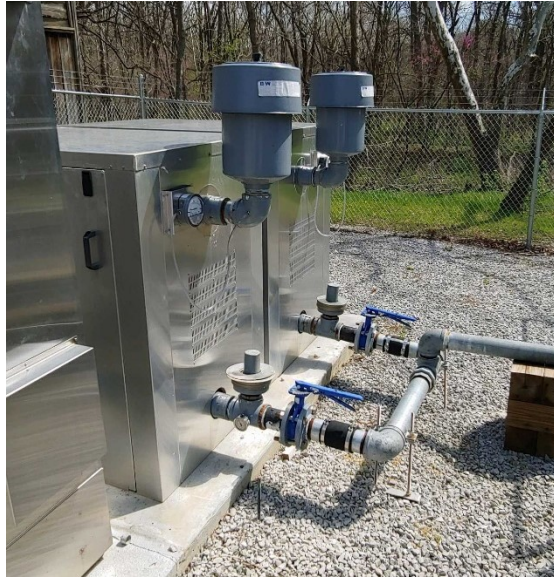
New blowers

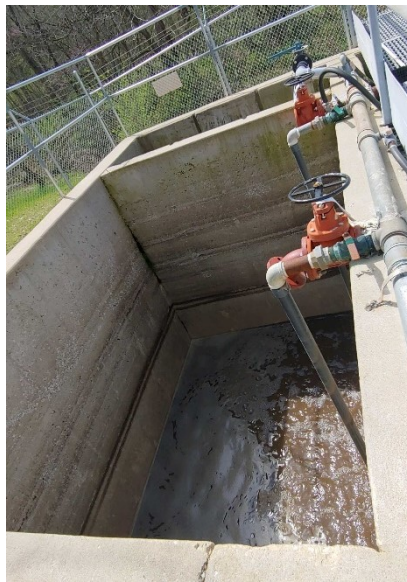
Sludge holding basin

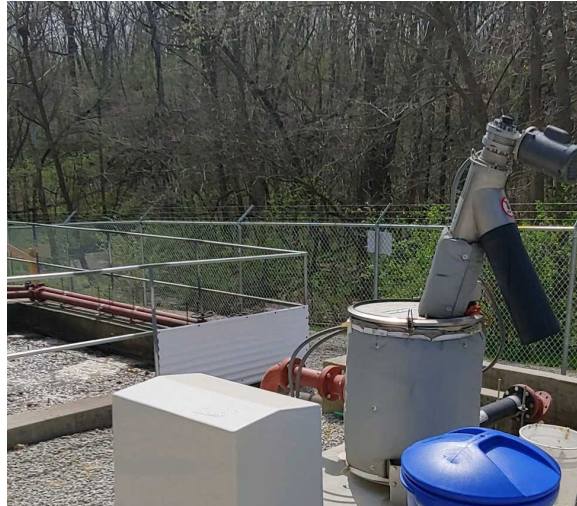
New screw screen and mixing blower

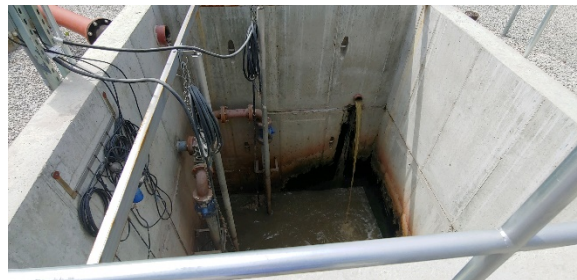
New influent lift station

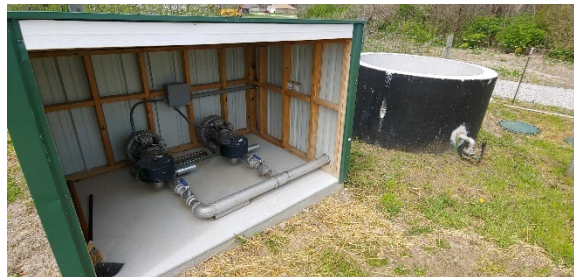
15  
16 New blowers and MBBR unit

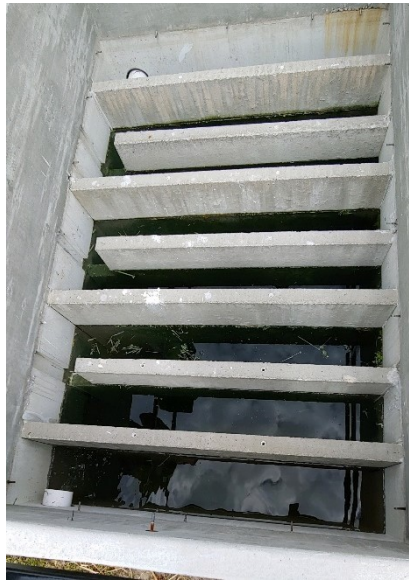
New chlorine contact chamber

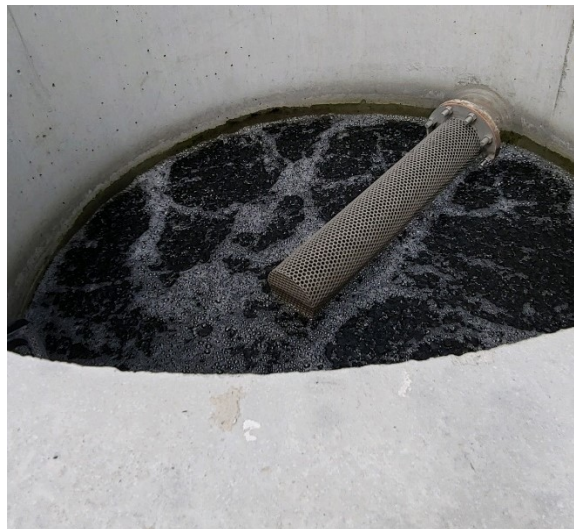
Interior of new MBBR unit

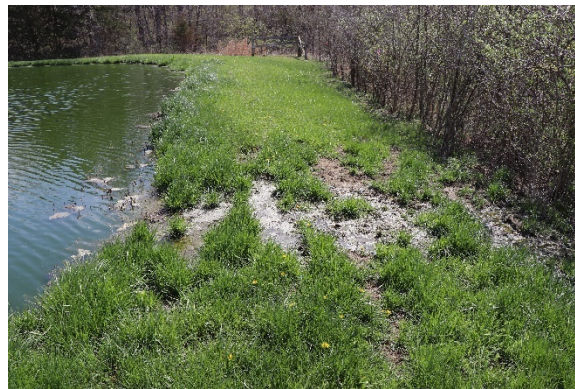
13  
14 Illicit discharge from first cell of lagoon structure with notable sludge accumulation

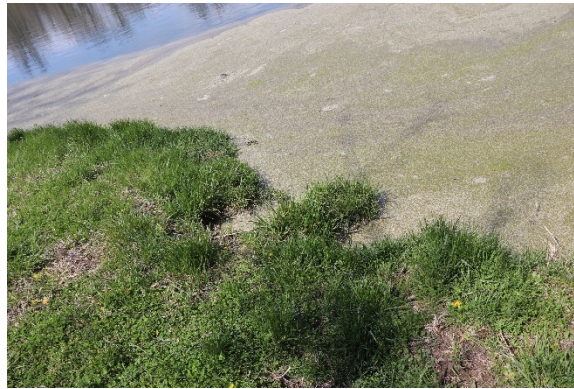
Muskrat damage throughout lagoon berms

all lagoon cells and to repair the structural damage caused by muskrats.

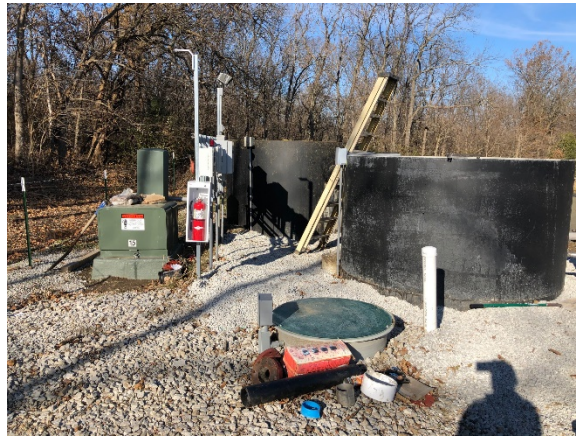
New tankage, power supply and lift station

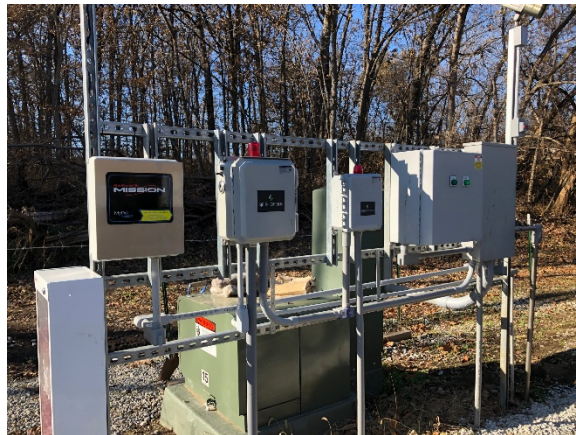
Control panels for new equipment and remote monitoring

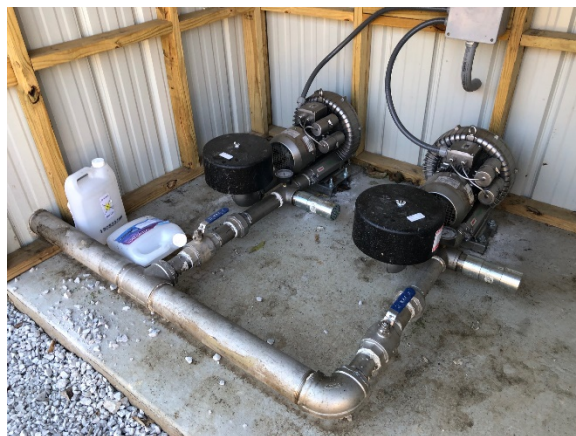
New blowers and blower housing

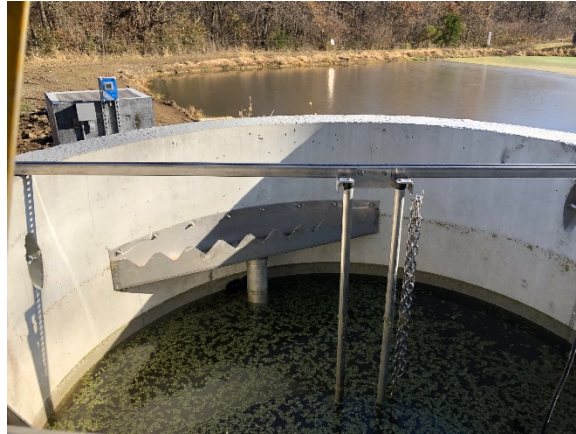
New clarifier

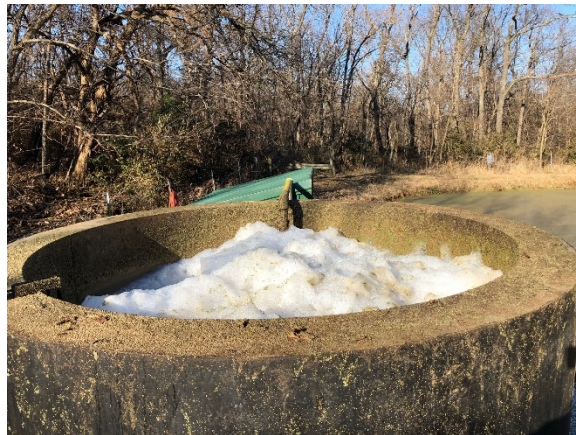
New MBBR at startup (note foaming lasted first few days)

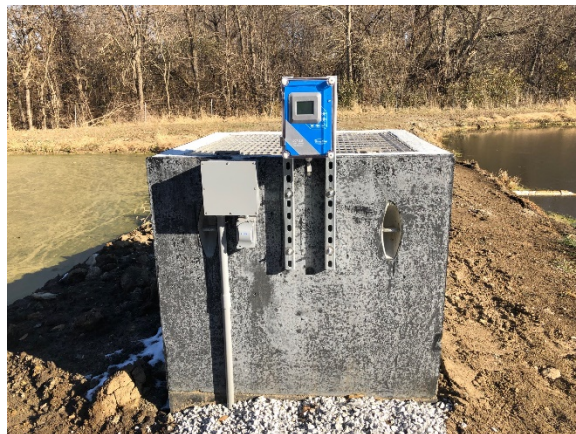
New weir box and flow meter

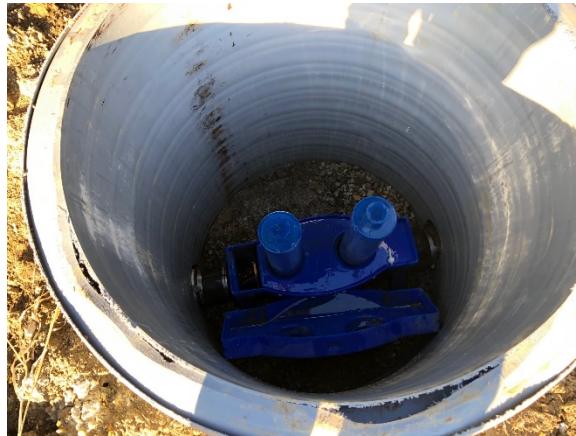
New chlorine disinfection equipment
