STAFF'S CONSTRUCTION AUDIT AND

PRUDENCE REVIEW OF TAUM SAUK

**UNION ELECTRIC COMPANY,
d/b/a Ameren Missouri**

FILE NO. ER-2011-0028

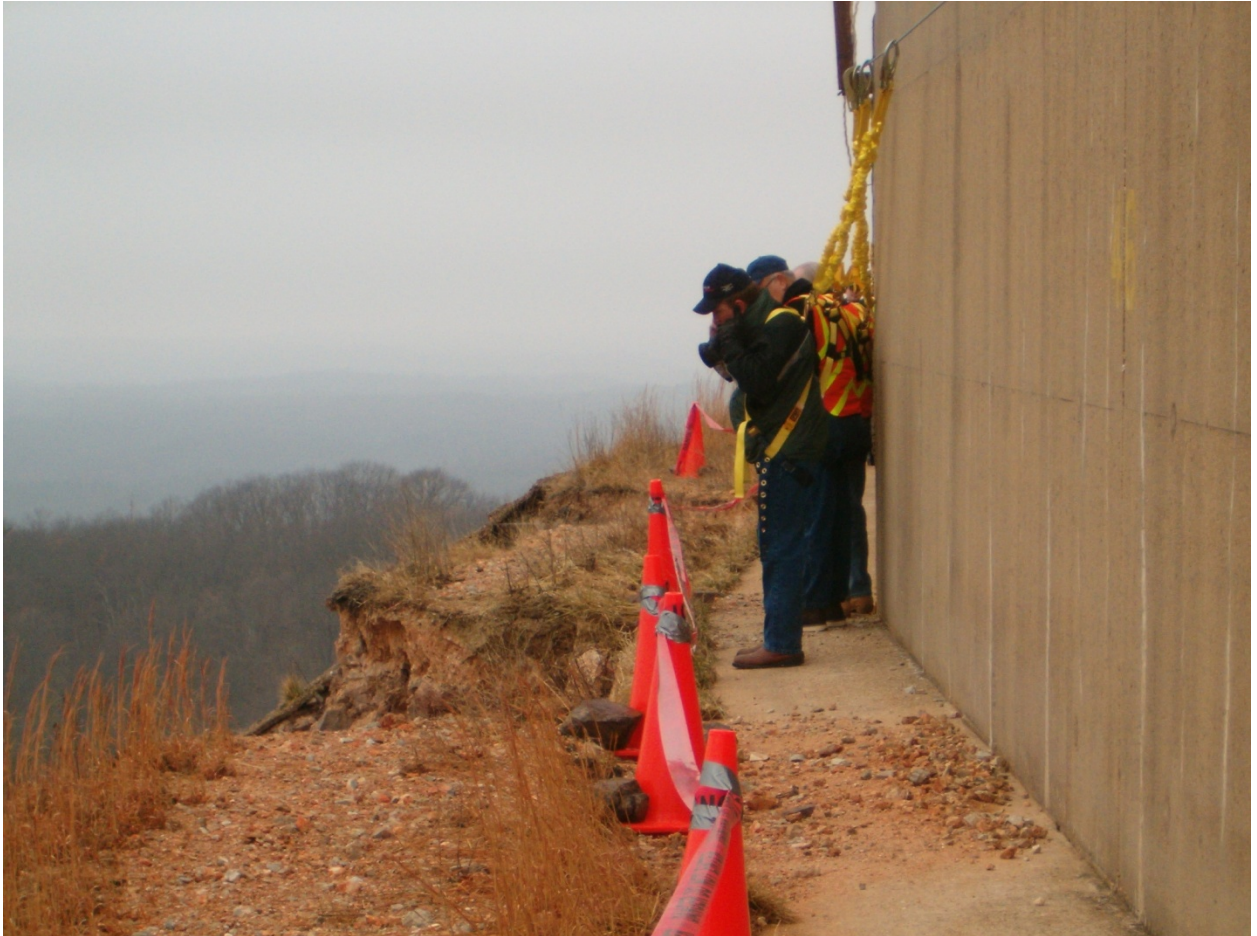
7
8 The photograph above shows a location where the parapet wall was overtopped by water
9 erosion which occurred at several locations around the perimeter of the upper reservoir.

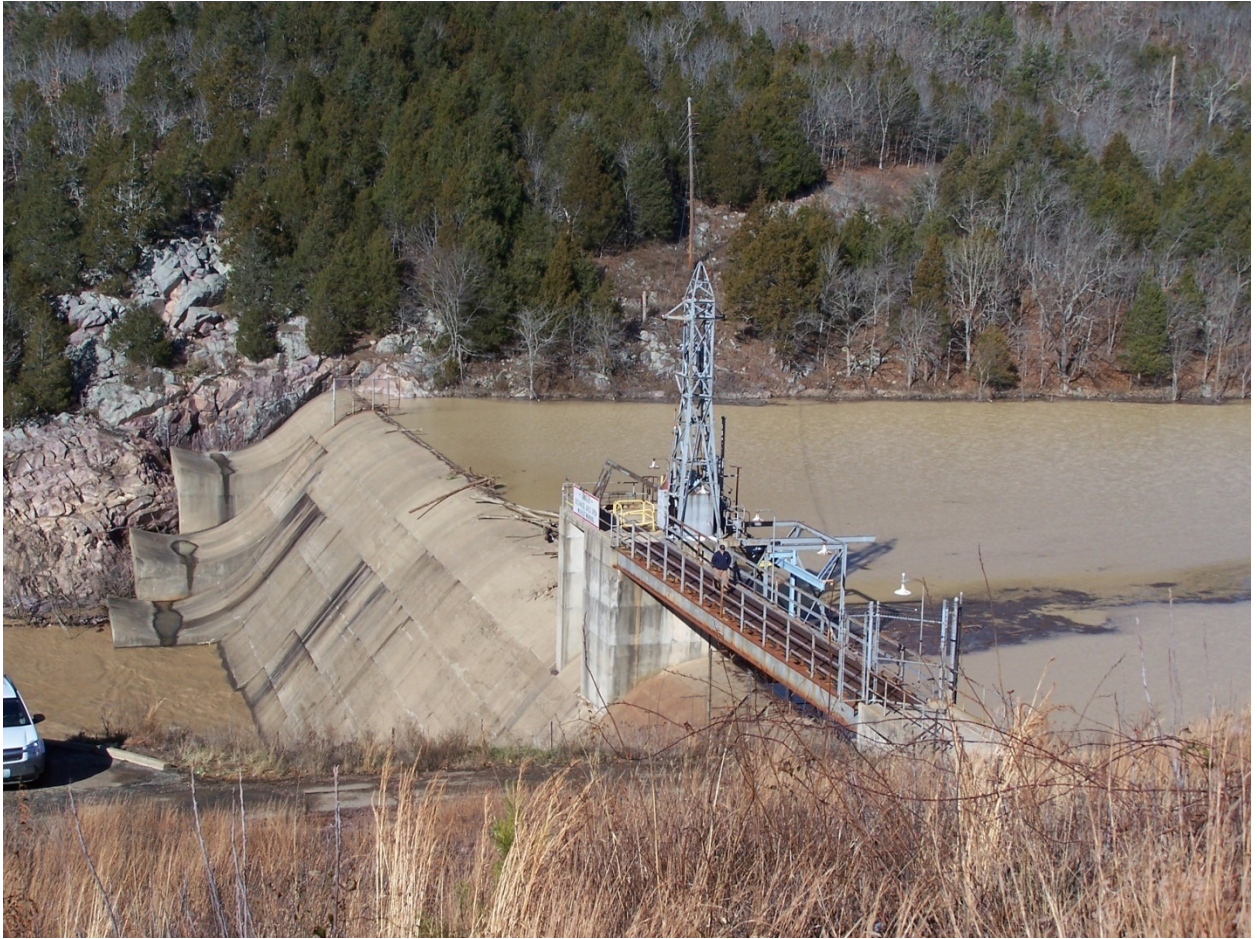
The photograph above shows the lower run of river dam the day after failure of the upper reservoir.

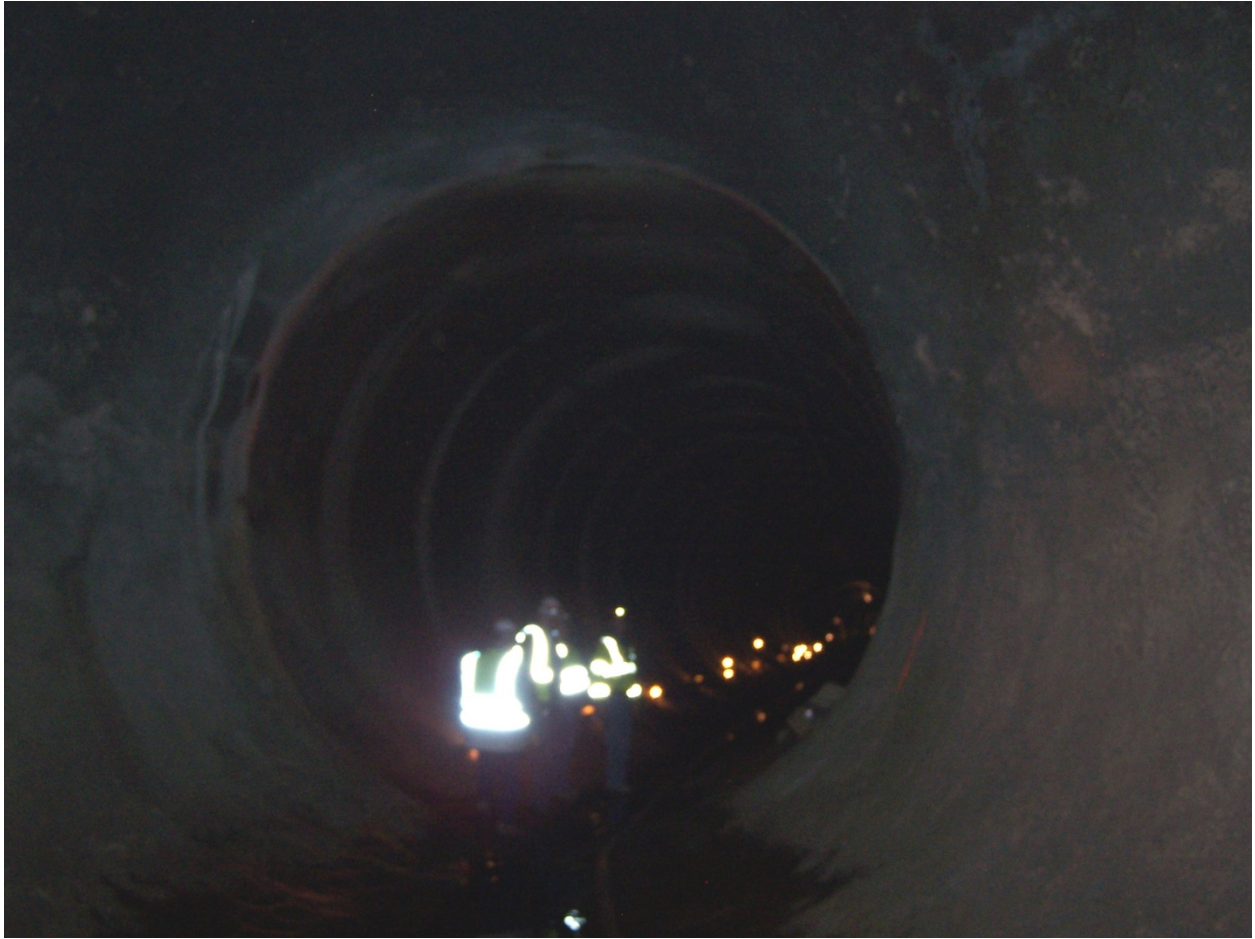
3 The above photograph is in the tunnel that carries water to the power plant at the location
4 where the steel liner within the tunnel begins.
