BLIGHT ANALYSIS

Exhibit B: Photo Log

The following photograph log presents a review of the property tracts within the proposed 25th & Southwest Boulevard PIEA Planning Area. Photos include images of property condition, infrastructure condition, and surrounding adjacent property. All photos were taken June 29th, 2004.

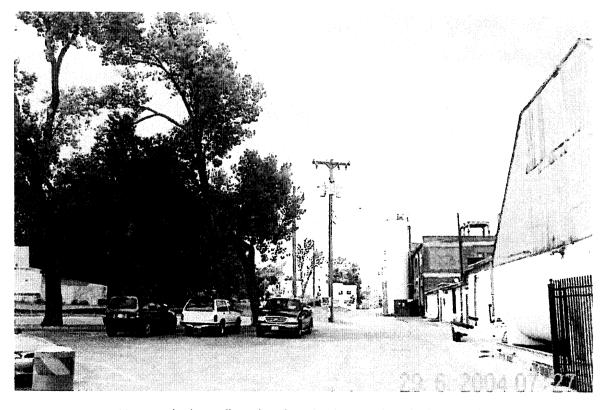
- Deterioration of alley/rail spur located in Planning Area. Presently an abandoned rail spur exists within the Planning area. The spur does not appear to have been utilized in the recent past. In fact portions of the track are exposed and protruding from the alley way in the southern portion of the Planning Area.

View south along alley, abandoned rail spur. Photo looking south.

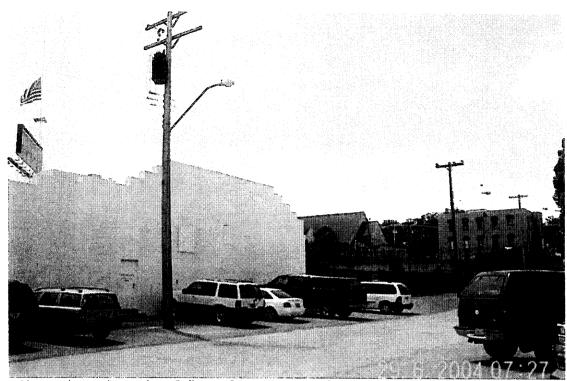
View to the southeast along Belleview Street. Note overhead power lines along eastern edge of Planning Area.

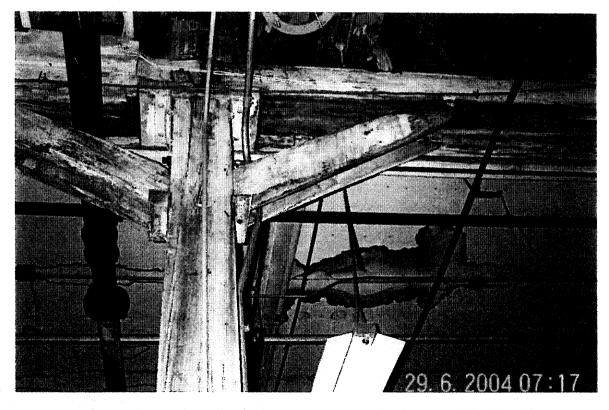
- Other deteriorating roof structure systems. Within the facility located on Tract 12b, significant roof water damage is observable. Actual condition and age of the roofing system is unknown. Due to the age and original construction of the facility, it appears that the roofing system is at its anticipated life expectancy.

View of water damage located in facility on Tracts 12a and 12b. Typical of both buildings.

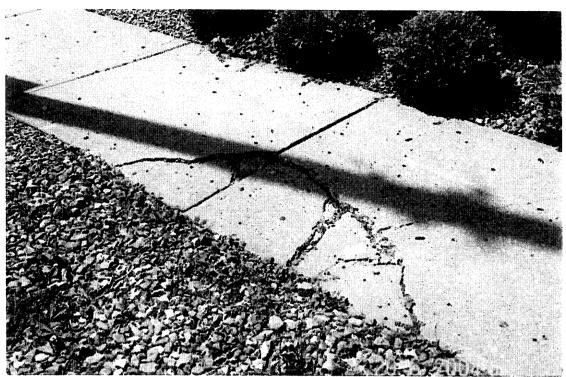
- Inadequate, deteriorated and unsafe sidewalk and curb/gutter systems.
- Deteriorated paving existing throughout the surface parking areas. Typical
 of the surface parking lots and streets and alleys in the Redevelopment
 Area.

Deteriorated sidewalk north of 2501 Southwest Boulevard.

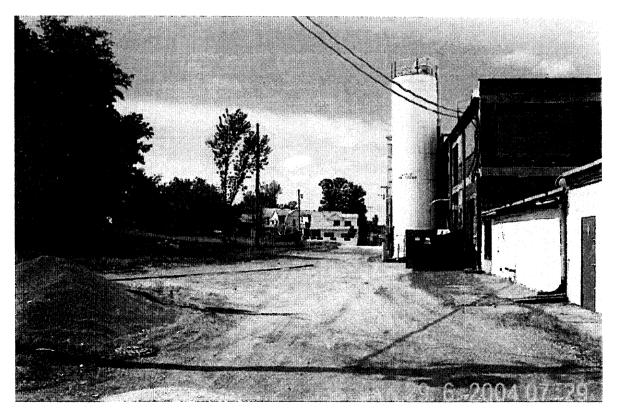
View south along alley, abandoned rail spur. Note rail still present in alleyway.

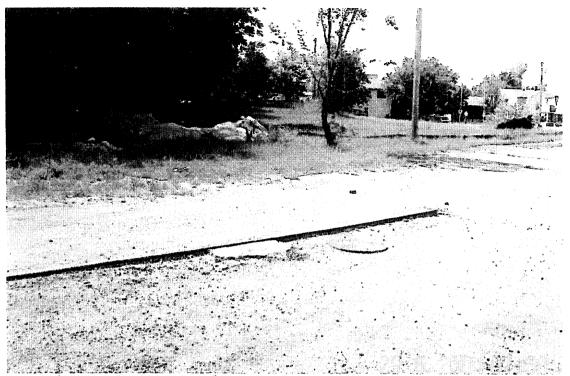
View south at Tract 9 (1012 West 26th Street). Note dumped material to the left and abandoned rail spur in foreground.

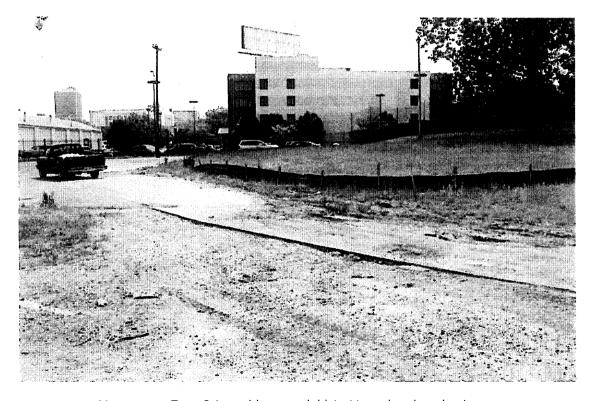
View east at Tract 2 (no address available). Note abandoned rail spur.

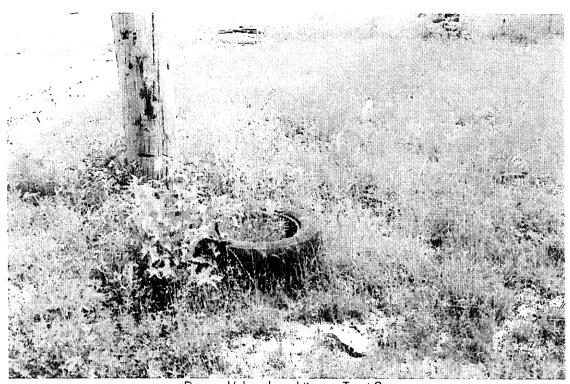
Trash, tires and debris located in scattered areas throughout the area.

Dumped/abandoned tire on Tract 9.

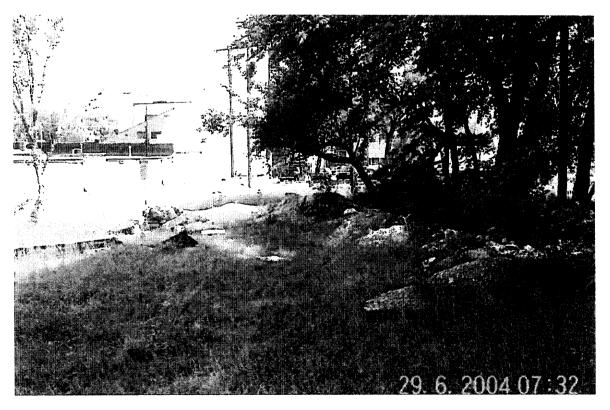
Photo looking north at dumped material on Tract 9.

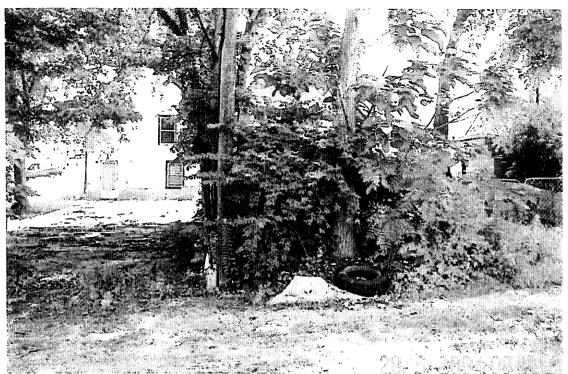
View east at 2536 Belleview. Alleyway in foreground. Note dumped trash and material.

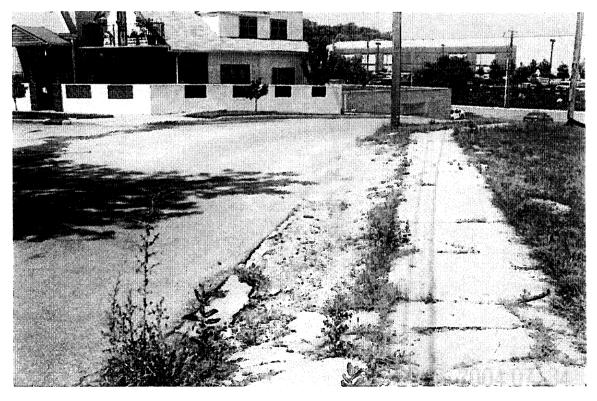
Deteriorated sidewalk and curb system along southern boundary of the Planning Area. Tract 9 to the right.

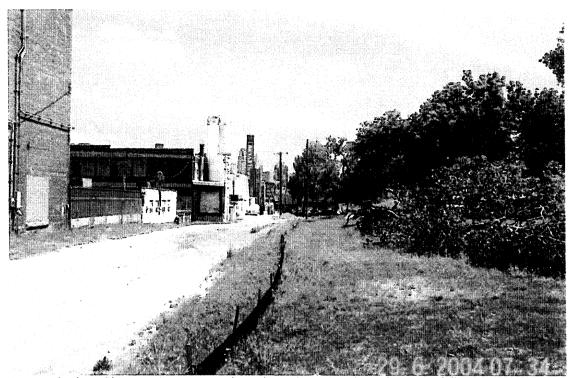
View north along Planning Area western boundary. Tract 9 to the right. Note fallen tree on property.

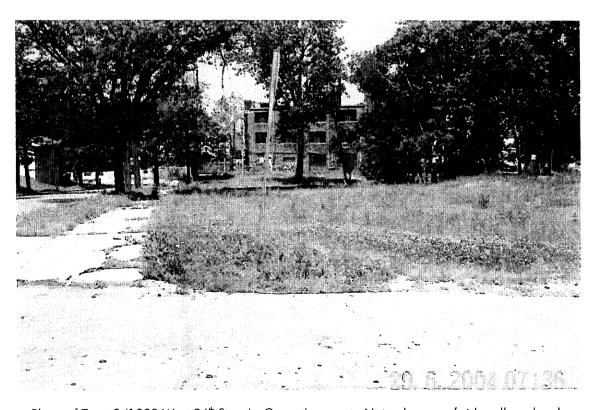
Photo of Tract 8 (1000 West 26th Street). Currently vacant. Note absence of sidewalk and curb.

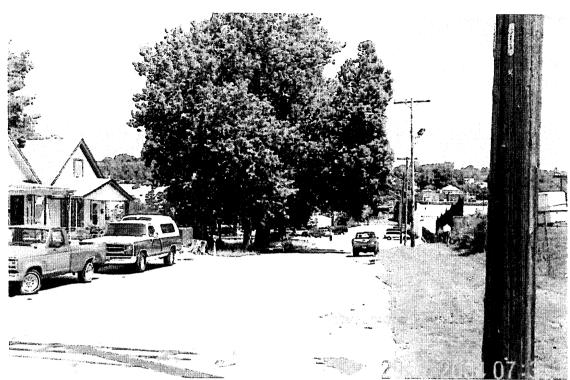
View north along Belleview. Note lack of curbs and gutters.

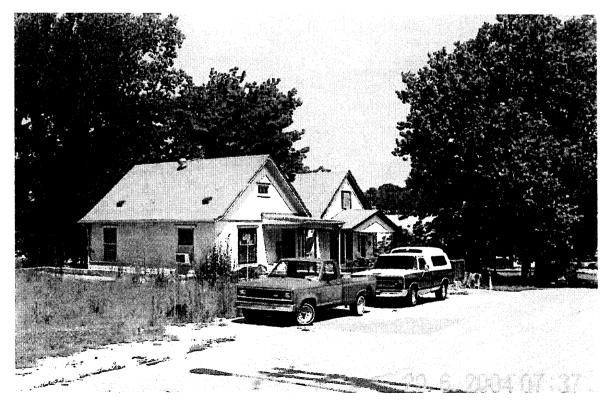
View west at Tracts 6 and 7 (25 42 and 2544 Belleview). Note absence of curbs and gutters.

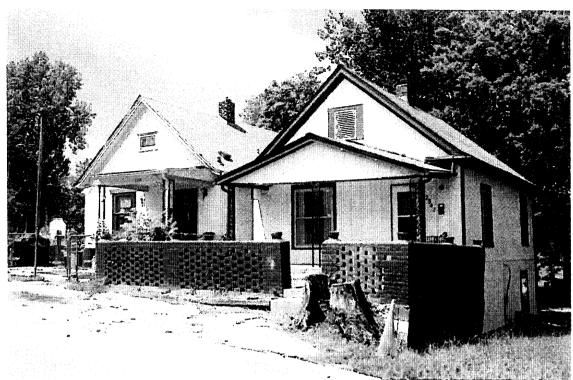
- Environmental Conditions. Due to the age of many facilities, some locations within the redevelopment area exhibit potential environmentally hazardous conditions. These primarily include, but are not limited to; asbestos-containing materials and lead-based paint.

Tracts 6 (left) and 7 (right). Note possible asbestos containing exterior siding material on Tract 7 (2544 Belleview).

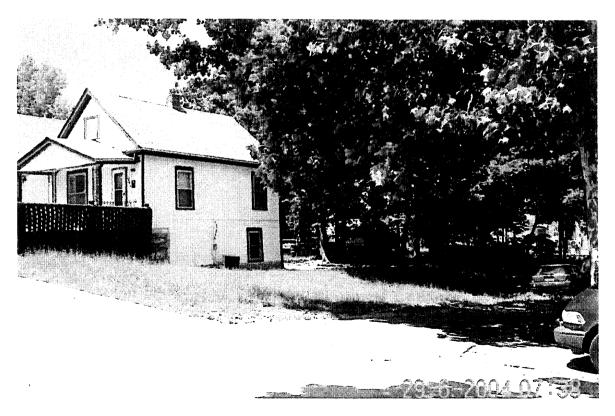
View west at Tracts 5 (vacant lot) and 7 gutters.
