Kuhle H2O, Incorporated, (Smithview):

**SIGNIFICANT DEFICIENCY
RESPONSE REQUIRED**

Attachment #1
Kuhle H20
February 16, 2017
Page 1

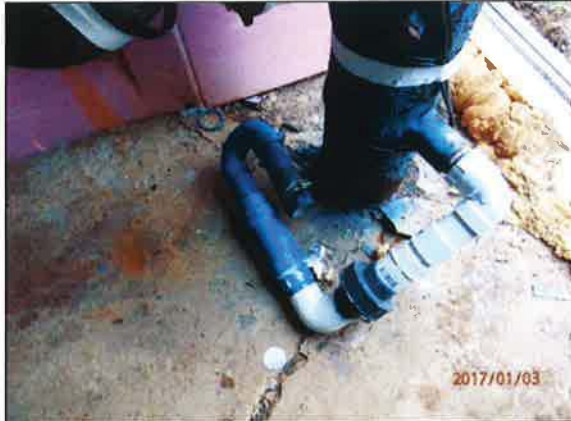
Photo #: 1
Date/Time Taken: 01/03/2017 at approx. 0914 hours
By: Richard Morrow
Program: PDW Unit
File: 3.200
Facility: Kuhle H20
Location: Well House
Description: The well vent installation is improperly constructed. The vent needs to be modified to extend at least 12" above the sanitary seal and away from the discharge piping. It should terminate in an inverted "U" and be properly screened.

11. The current well vent installation is improperly constructed. The well vent needs to be modified or replaced with an adequately sized vent (at least 1.5 inches in diameter) that is screened with 18-mesh screen and turned in the downward position to ensure contamination is not pulled into the well. The current vent needs to be modified to extend at least 12" above the sanitary seal and away from the wellhead and discharge piping. It should terminate in an inverted "U" and be properly screened.

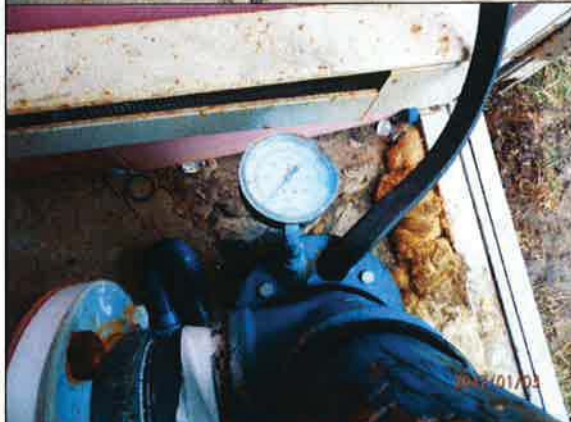
1. There are openings in the wellhead for the airline and electrical service to the pump that are not adequately sealed which could allow contamination into the well. Missouri Public Drinking Water Regulation 10 CSR 60 4.025(4)(A)4.A. states that a significant deficiency effecting the sanitary condition is present for a source if there are any improperly constructed, sealed, or inadequately screened opening in the well head. The use of caulking compound to plug openings in a wellhead is temporary only and is not an acceptable method for a permanent seal in the wellhead. The openings need to be properly sealed with threaded connections or rubber grommet pipe seals. Any opening in the wellhead is considered a significant deficiency.

Photo #: 2
Date/Time Taken: 01/03/2017 at approx. 0915 hours
By: Richard Morrow
Program: PDW Unit
File: 3.200
Facility: Kuhle H20
Location: Wellhead
Description: There are openings in the wellhead for the airline and electrical service to the pump that are not adequately sealed. The openings need to be properly sealed with threaded connections or rubber grommet pipe seals.

The system must consult with the department about a corrective action plan to address these deficiencies within 30 days and has up to 120 days to correct the deficiency or to be on schedule with a department approved corrective action plan.

REQUIRED ACTIONS: The facility shall consult with the Northeast Regional Office **within 30 days**, explaining what actions will be taken to correct the significant deficiencies or be following a department approved corrective action plan.

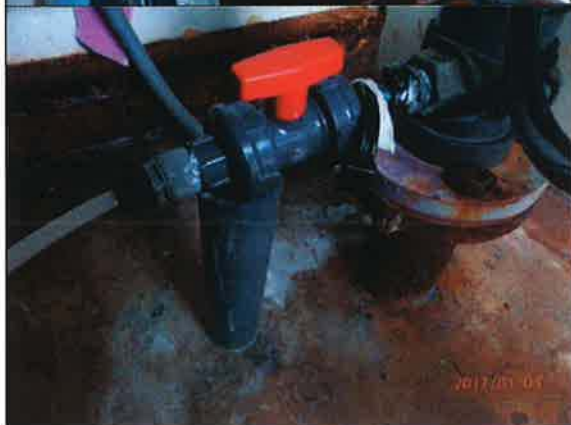
Photo #: 3
Date/Time Taken: 01/03/2017 at approx. 0916 hours
By: Richard Morrow
Program: PDW Unit
File: 3.200
Facility: Kuhle H20
Location: Well House
Description: The well house does not meet the minimum sanitary construction standards. The chlorine injection and ball valve is being braced with a piece of pipe. The system should contract an engineering firm to prepare plans and specifications for a new well house.

9. The well house does not meet the minimum sanitary construction standards. The concrete foundation is cracked and boards and siding are missing on the eastern side of the building. Additionally, the chlorine injection and associated ball valve are being braced with a piece of pipe and some of the wiring is not in conduit and exposed, which is a safety issue. The system should contract an engineering firm to prepare plans and specifications for a new well house.

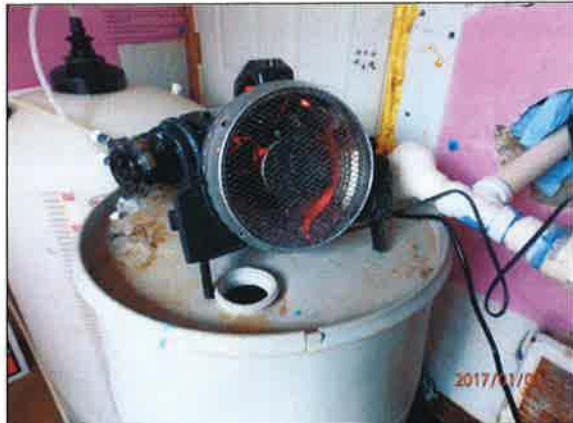
Photo #: 4
 Date/Time Taken: 01/03/2017 at approx. 0916 hours
 By: Richard Morrow
 Program: PDW Unit
 File: 3.200
 Facility: Kuhle H20
 Location: Well House
 Description: The hypochlorite tank is not vented to the outside. The chlorine tank needs to be vented to the outside to prevent further corrosion to the piping and metal works inside the well house.

13. The hypochlorite tank is not vented to the outside. The chlorine tank needs to be vented to the outside to prevent further corrosion to the piping and metal works inside the well house.

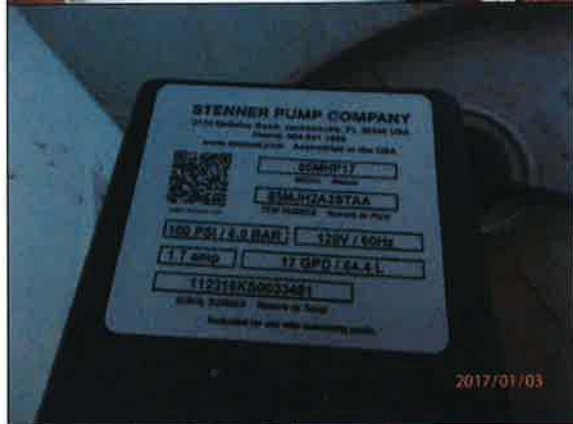
Photo #: 5
 Date/Time Taken: 01/03/2017 at approx. 0916 hours
 By: Richard Morrow
 Program: PDW Unit
 File: 3.200
 Facility: Kuhle H20
 Location: Well House
 Description: There is only one operating chlorination pump. The system should maintain disinfection redundancy by having two pumps available in case the lead pump becomes inoperable.

17. Reportedly, there is a mechanical issue with the spare chlorination pump and there is only one operating pump. The system should maintain disinfection redundancy by having two pumps available in case the lead pump becomes inoperable. This way the system is not pumping untreated or improperly treated water into the distribution system.

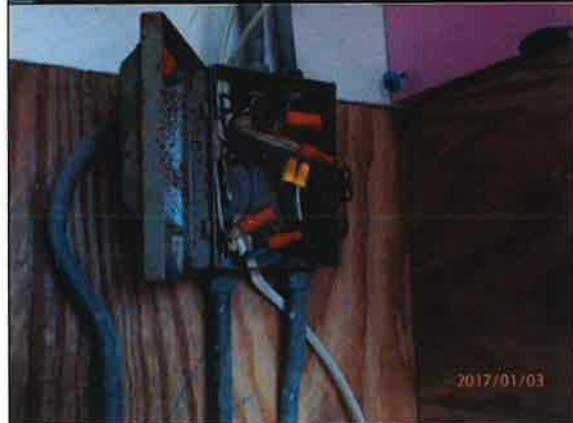
Photo #: 6
 Date/Time Taken: 01/03/2017 at approx. 0918 hours
 By: Richard Morrow
 Program: PDW Unit
 File: 3.200
 Facility: Kuhle H20
 Location: Well House
 Description: The well house does not meet the minimum sanitary construction standards. Some of the wiring is not in conduit and exposed, which is a safety issue.

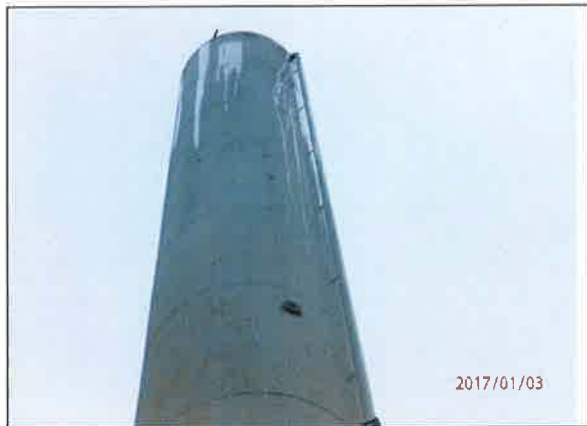
Photo #: 7
Date/Time Taken: 01/03/2017 at approx. 0922 hours
By: Richard Morrow
Program: PDW Unit
File: 3.200
Facility: Kuhle H20
Location: Standpipe
Description: There appears to be a bulge in the eastern side of the standpipe near the top. This may have been caused by ice formation or a plugged overflow or vent. This issue needs to be thoroughly examined the next time the standpipe is inspected.

21. No information was provided to verify that the standpipe had been inspected since its construction. The department recommends that all storage facilities be inspected every (2) to (5) years to determine the structural and sanitary condition and verify water quality to ensure no contamination is present.

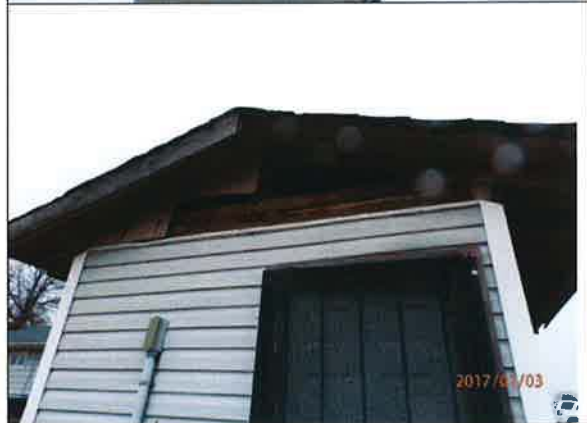
Photo #: 8
Date/Time Taken: 01/03/2017 at approx. 0927 hours
By: Richard Morrow
Program: PDW Unit
File: 3.200
Facility: Kuhle H20
Location: Well House
Description: The well house does not meet the minimum sanitary construction standards. The concrete foundation is cracked and boards and siding are missing on the eastern side of the building.

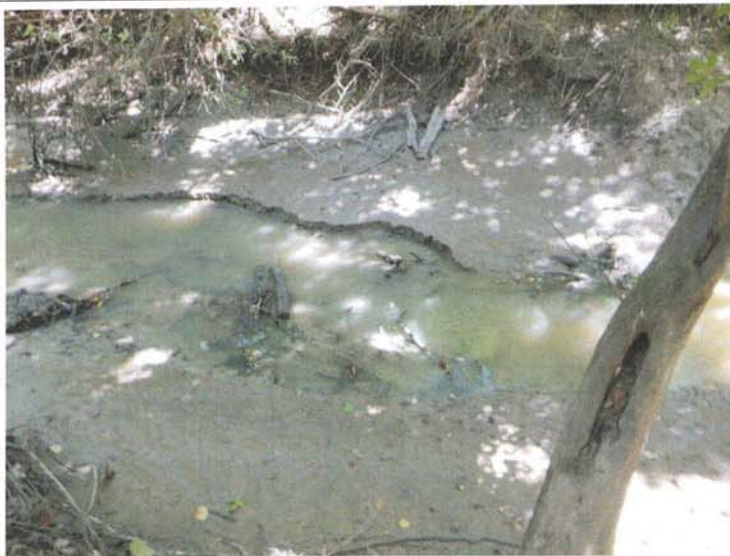
Description: View upstream from outfall pipe; mildly turbid water flowing from south to north; heavy sediment deposits visible; facing east.

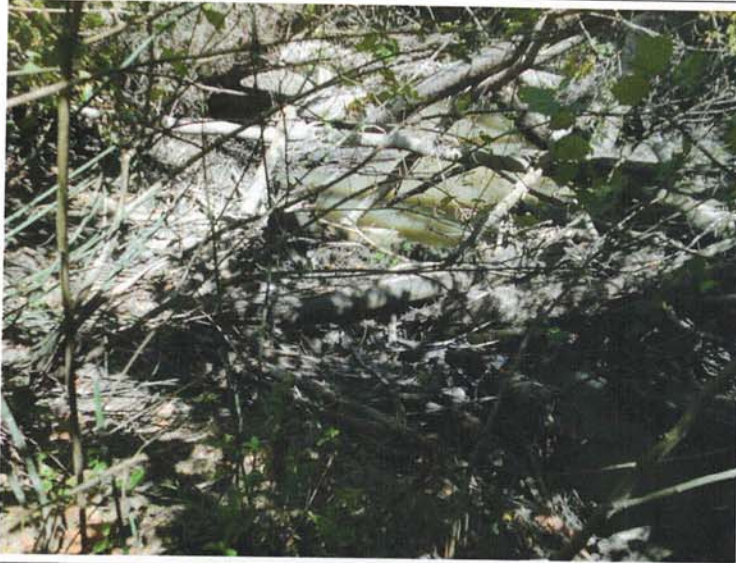
Description: Downstream view of receiving stream, with heavy debris; water appears mildly turbid; facing north.

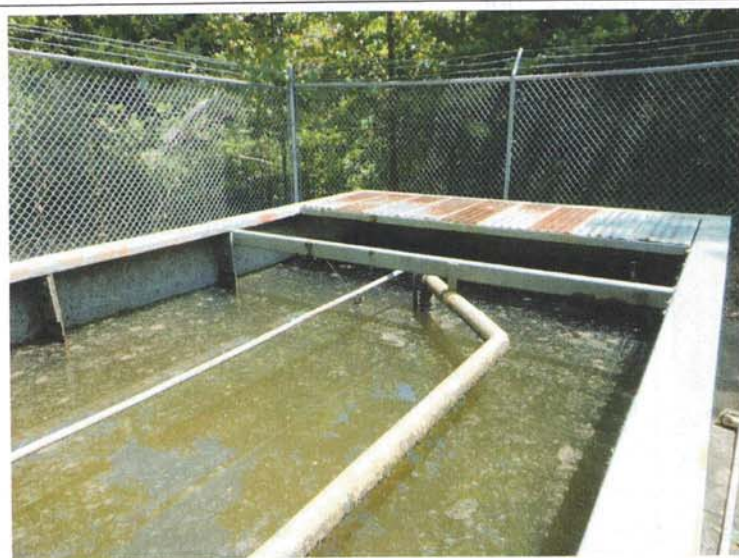
Description: Secondary clarifier; contents are turbid with floating debris; facing northeast.

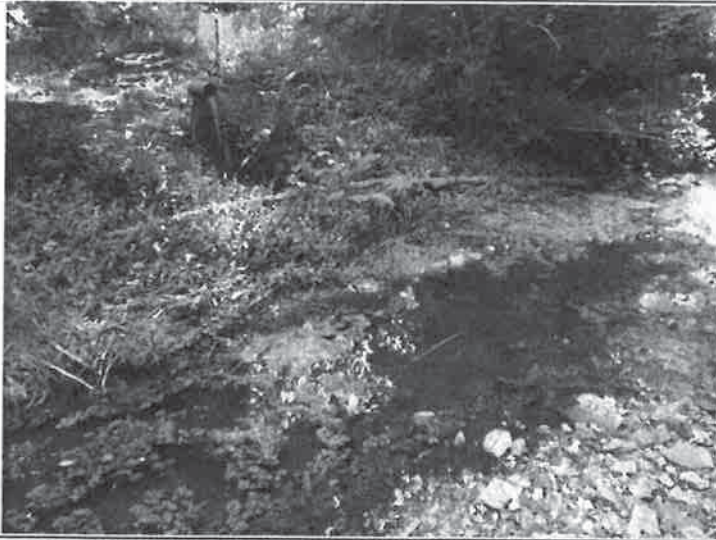
Description: Sludge deposits visible in receiving stream; Outfall #001 visible in background; facing east.

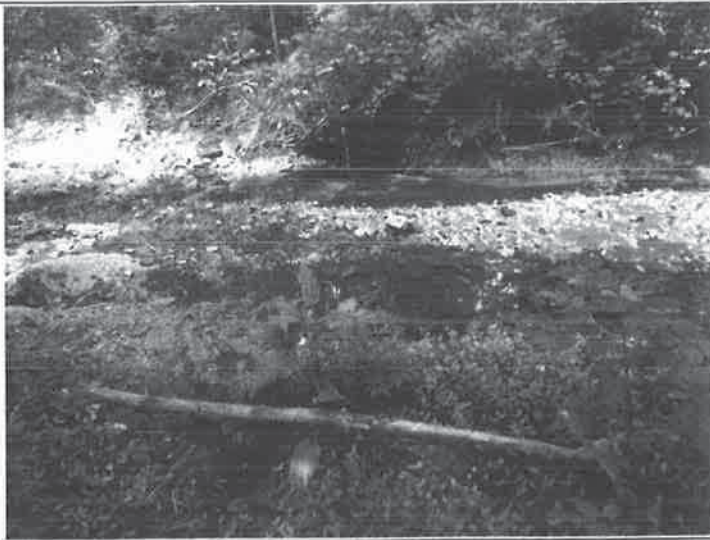
Description: Sludge deposits visible in receiving stream; facing west.

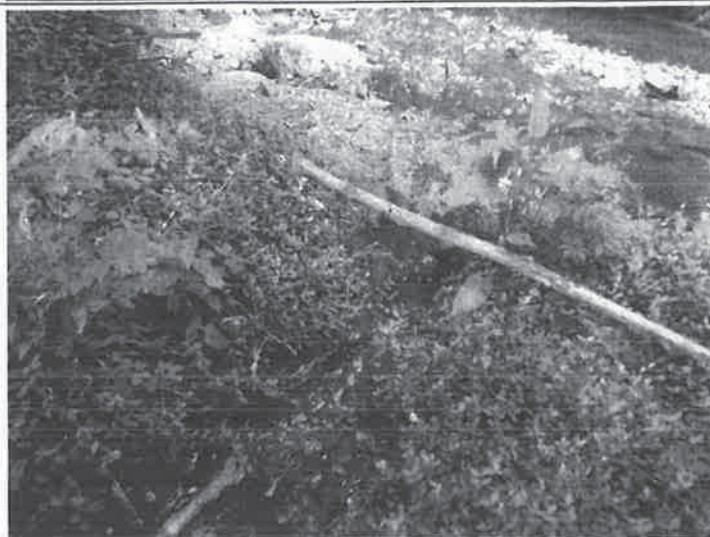
Description: Flow from Outfall #001 to receiving stream, with sludge visible in stream; facing southwest.

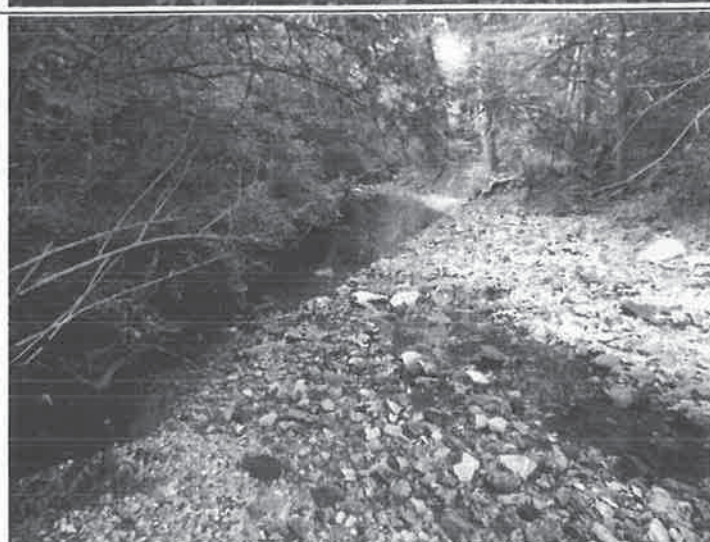
Description: View downstream from where water flow from Outfall #001 meets receiving stream; sludge visible in stream; facing south.

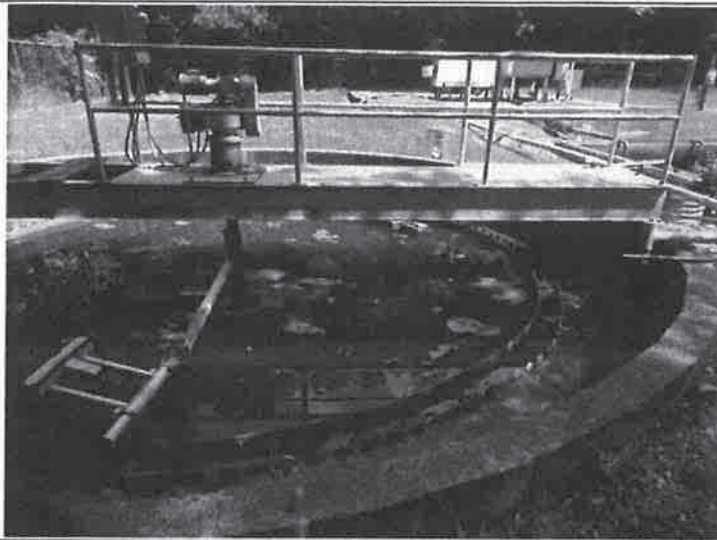
Description: Secondary Clarifier with turbid water and sludge on surface; skimmer arm has missing scum baffle; facing north.

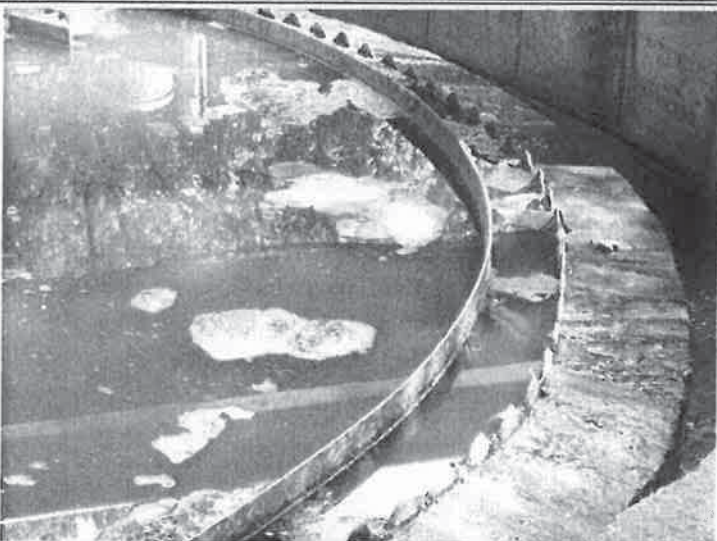
Description: Sludge visible at effluent weirs and in effluent trough; facing northeast.

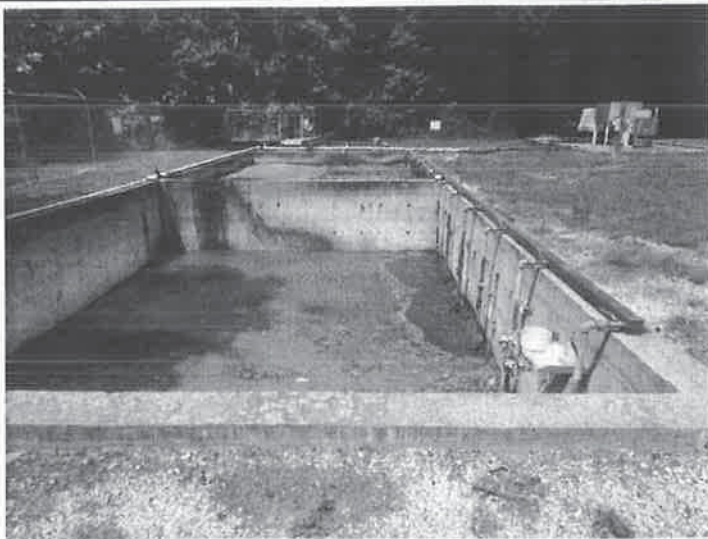
Description: Eastern extended aeration basin with only small area being aerated; facing west.
