**RE: Case No. ES-2001-28 – In the Matter of an Incident at St. Joseph Light & Power Company's Lake Road Power Plant on June 7, 2000.**

## STAFF FINAL ELECTRIC INCIDENT REPORT

St. Joseph Light & Power Company  
Case No. ES-2001-28

Lake Road Power Plant

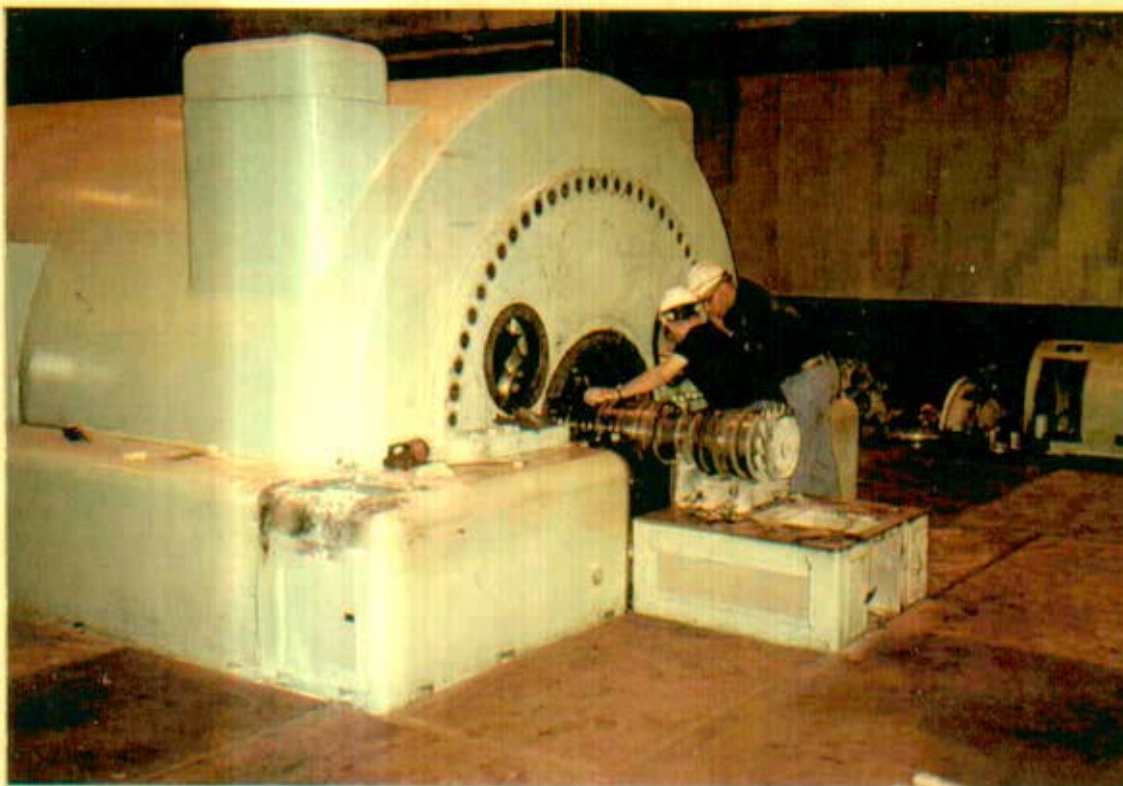
Photograph 1. Scorched paint on generator and No. 5 bearing damage

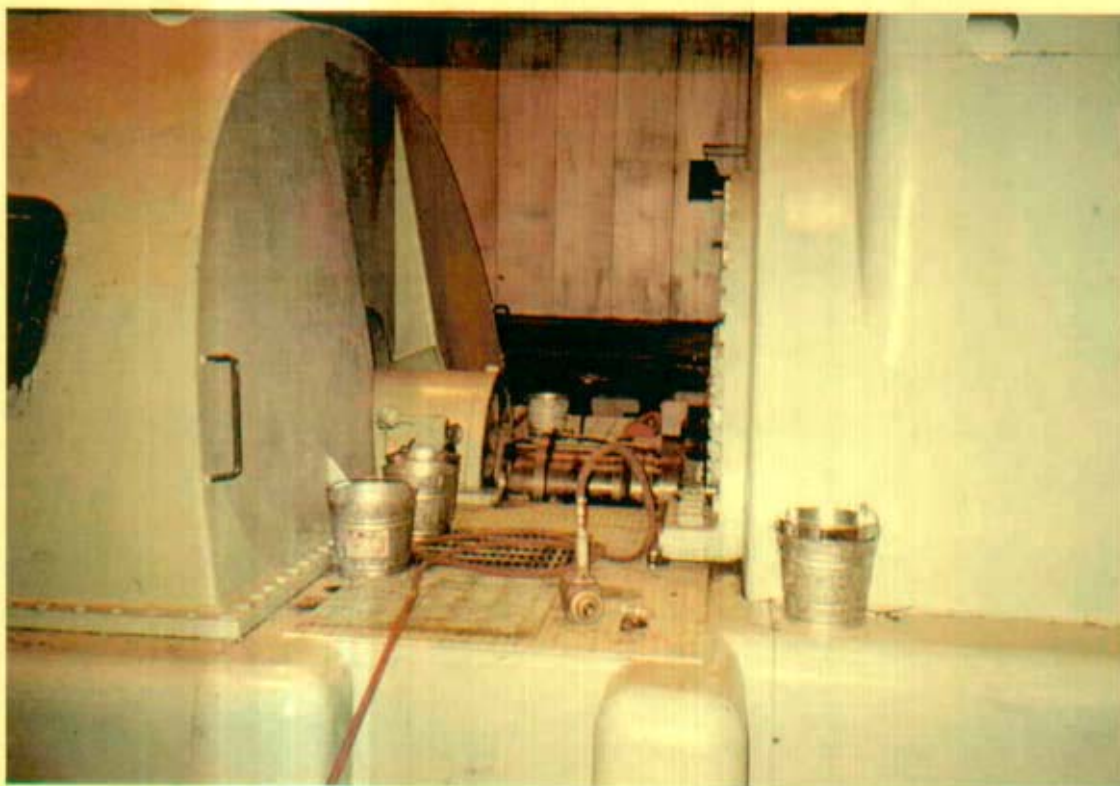
Photograph 2. No. 3 & 4 bearings

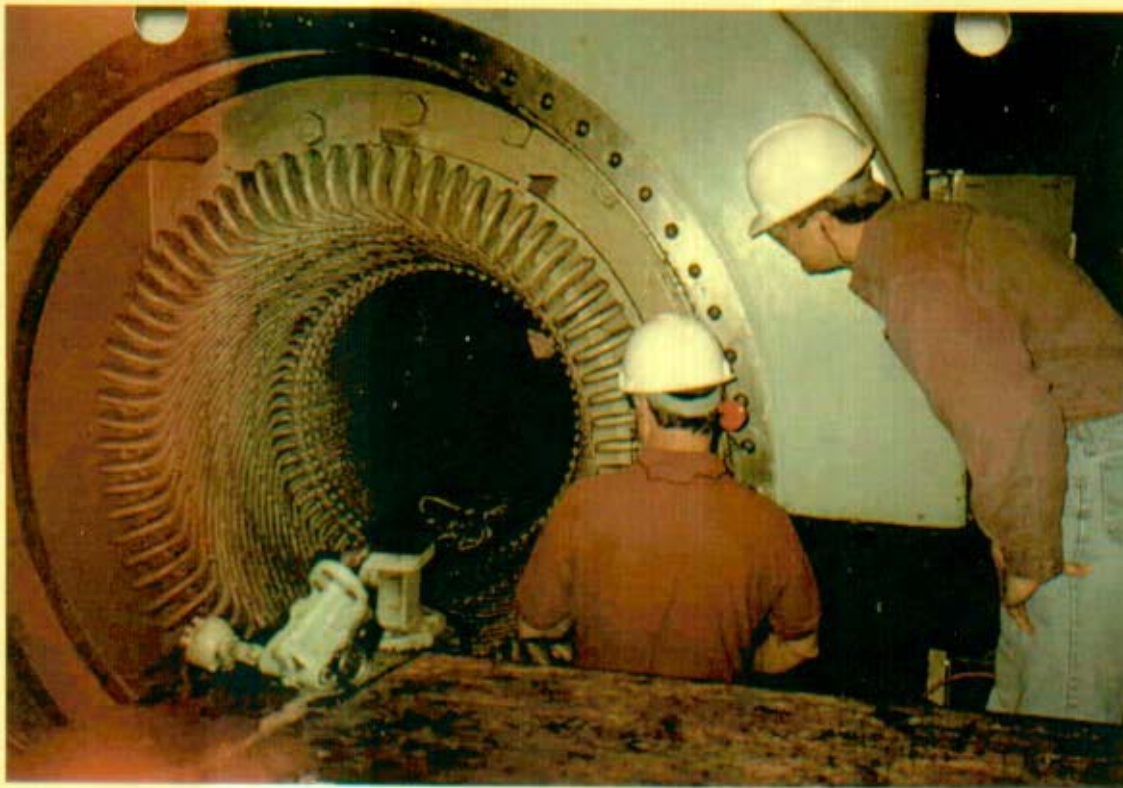
Photograph 3. Generator stator with rotor removed.

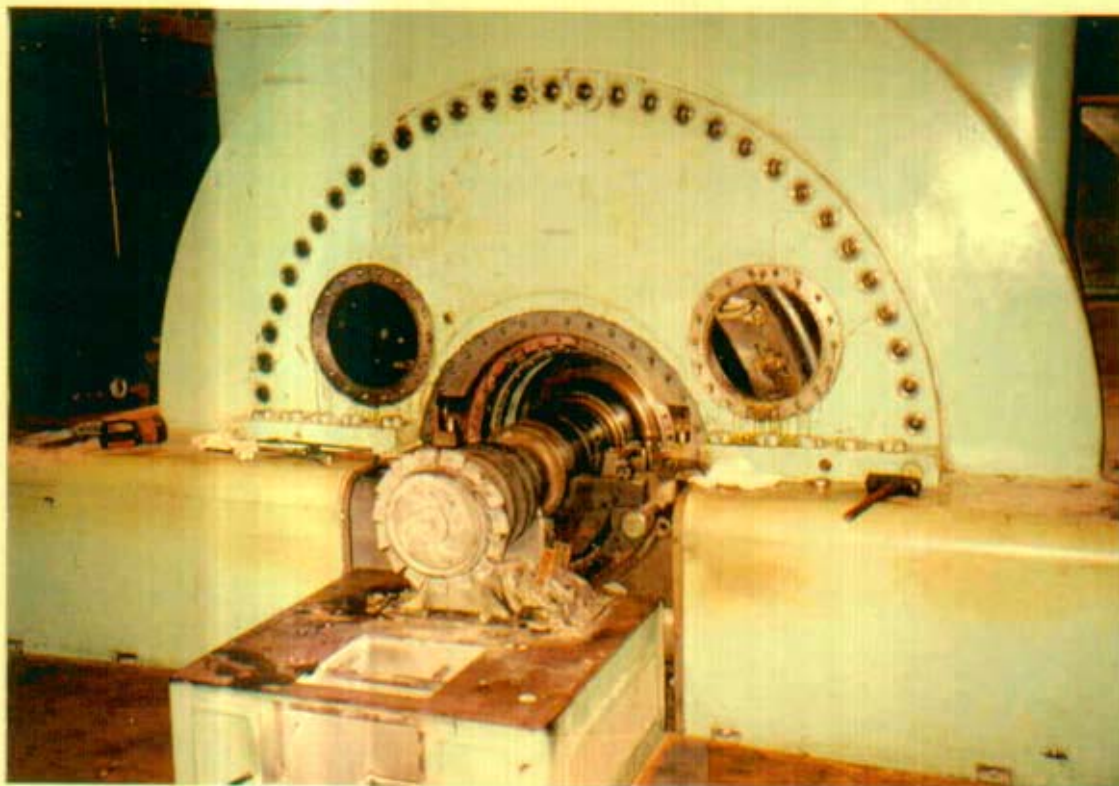
Photograph 4. No. 5 bearing on generator end

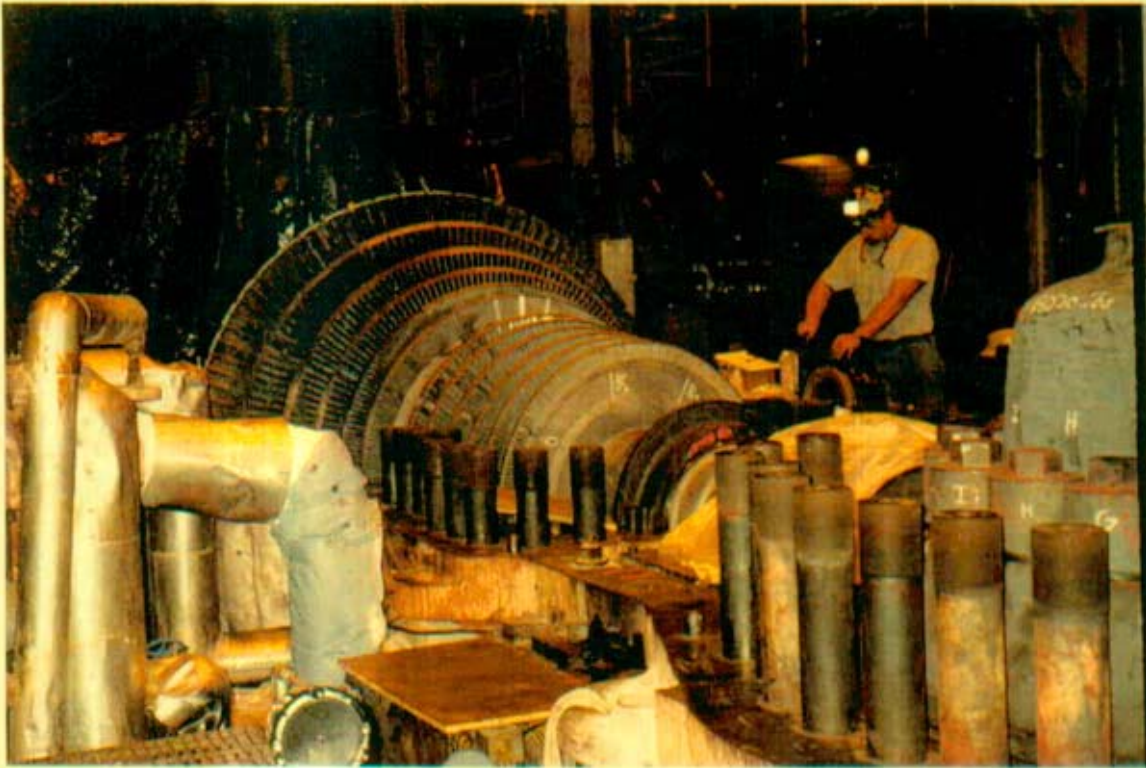
Photograph 5. Turbine rotor and blades with upper casing removed

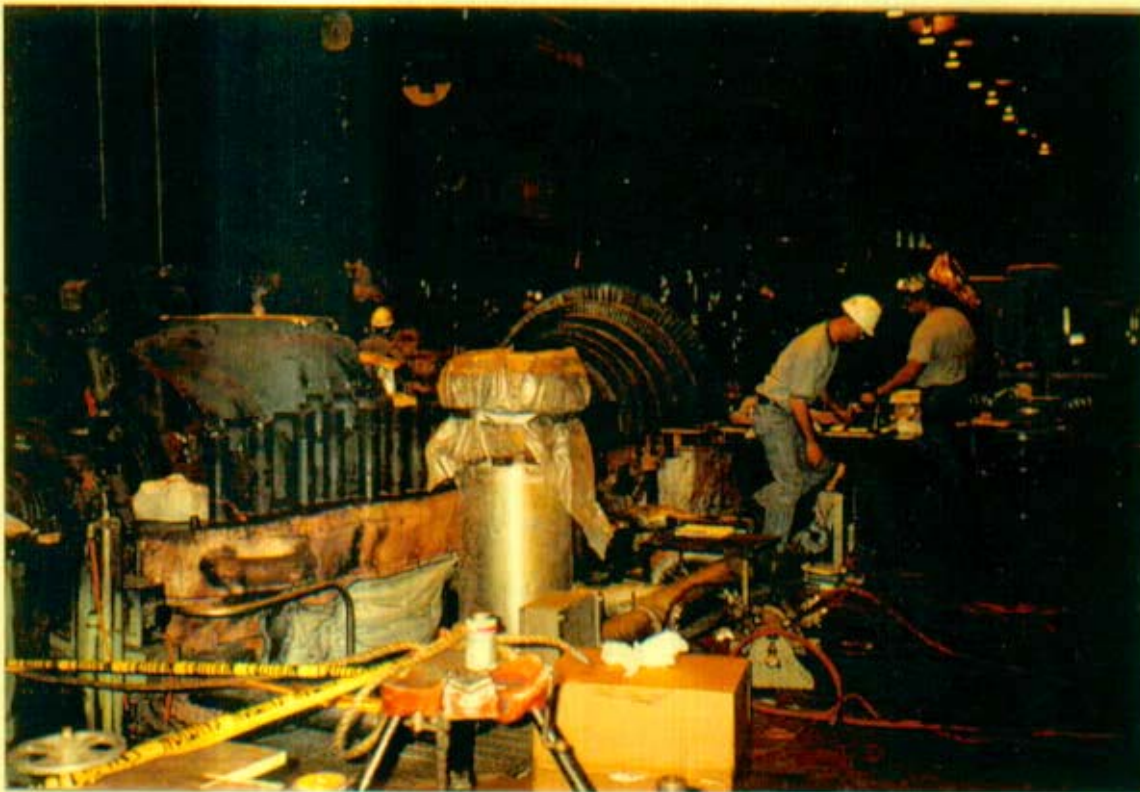
Photograph 6. Turbine rotor with work in progress

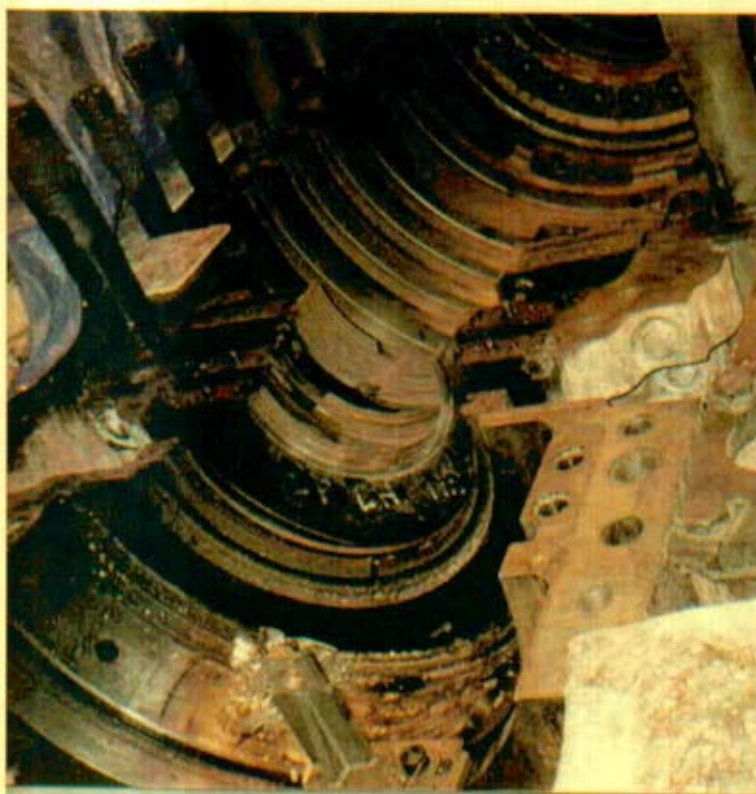
Photograph 7. Turbine lower casing and seals

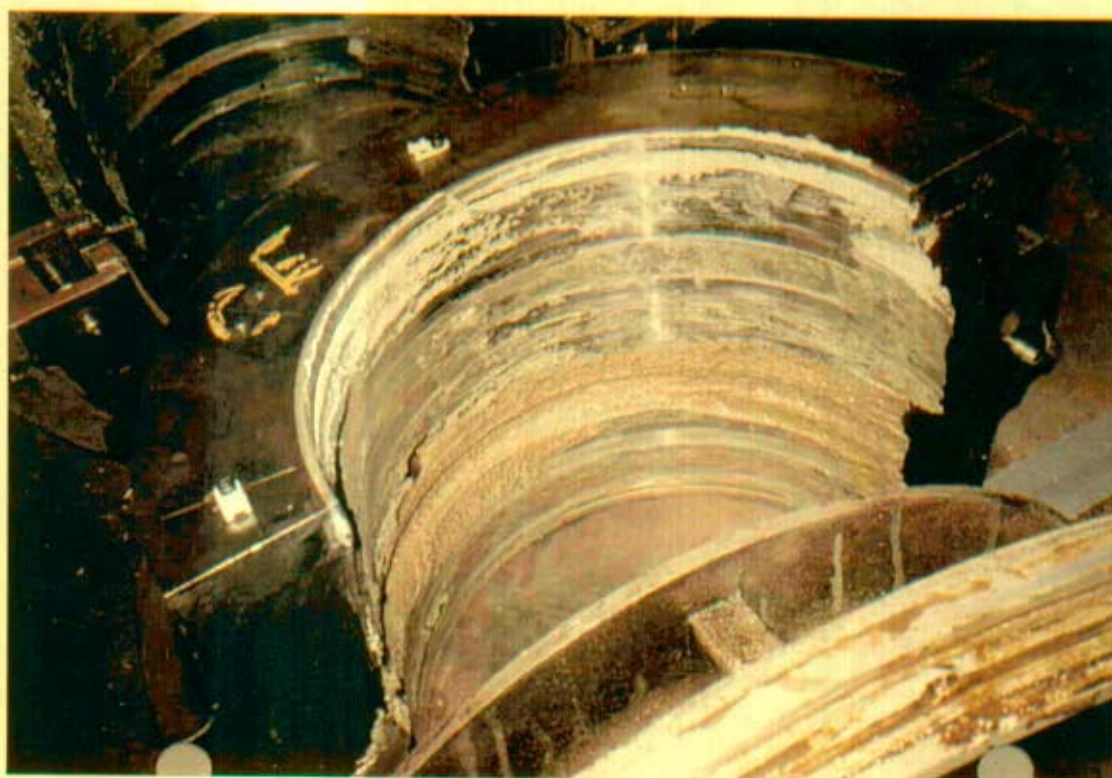
Photograph 8. No. 2 bearing damage

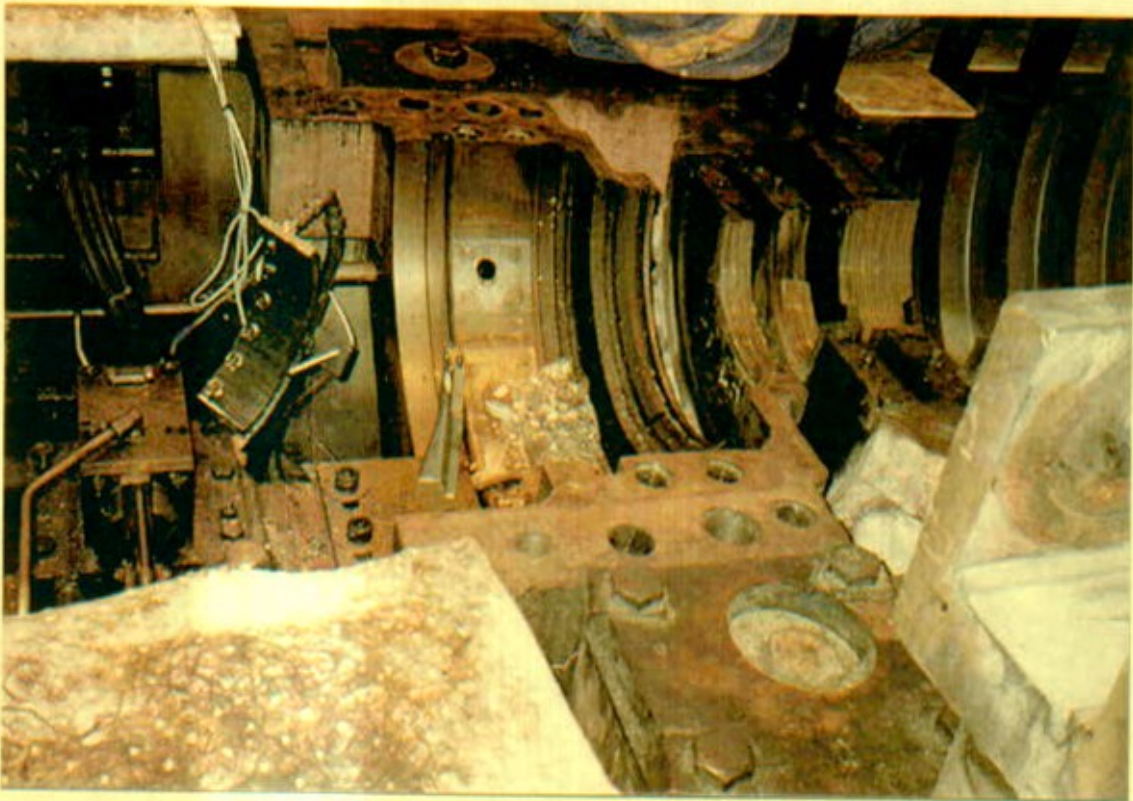
Photograph 9. No. 2 & 3 bearing housing and seal damage

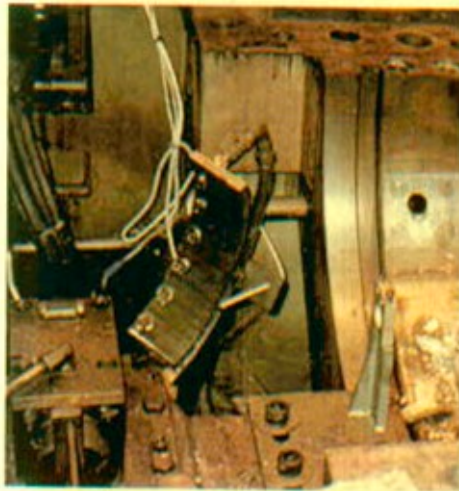
Photograph 10. Instrumentation damage

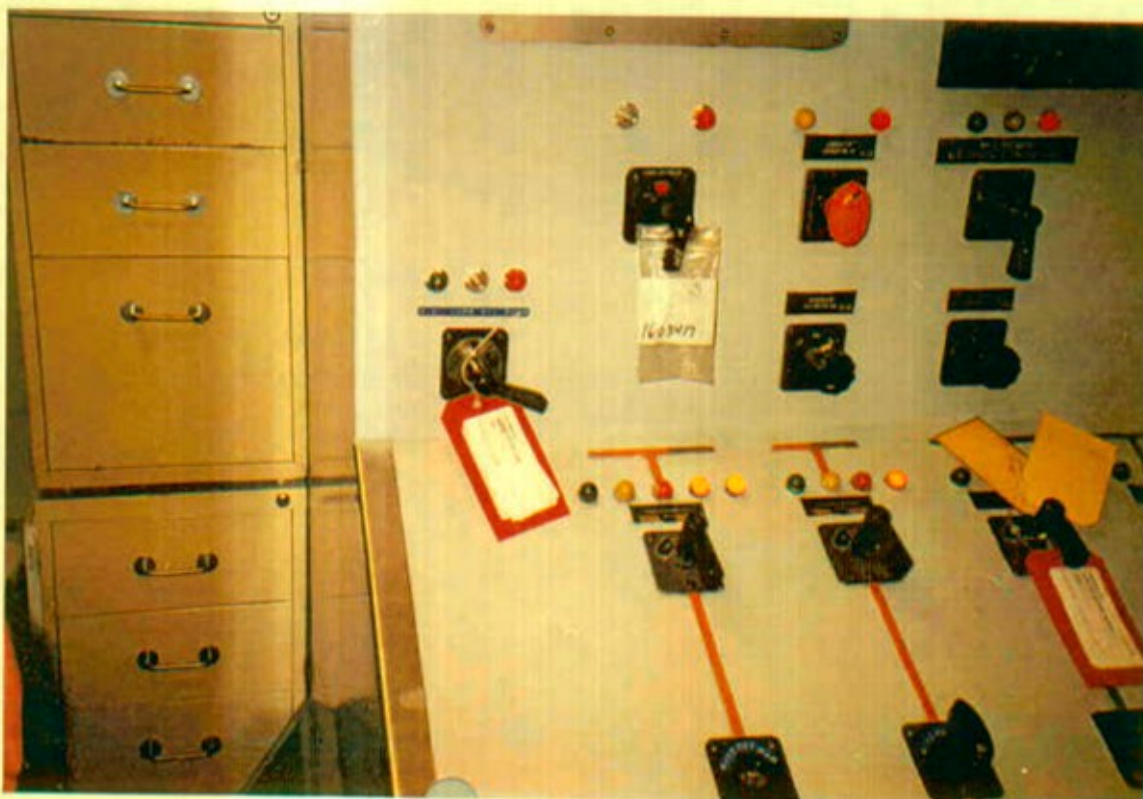
Photograph 12. Newly reinstalled DC oil pump control switch in control room (extreme left with red tag)

SJLP took actions to prevent a recurrence of this type of incident before Unit 4 was restarted on August 8, 2000. SJLP modified the electrical supply for one of the AC bearing and seal oil pumps so that it is supplied power from a source independent of the Unit 4 main auxiliary transformer. This modification allows at least one AC oil pump to run even after a Unit 4 trip. SJLP also reinstalled the manual DC oil pump control switch, which the operators were familiar with. It is hard-wired independent of the DCS. SJLP also provided additional control room alarms for the lube oil system through the DCS. SJLP changed operating procedures to reflect these changes and provided operator training on these changes. SJLP personnel also are provided additional training on the Mark V system.
