Electric Incident Report

**AmerenUE
Case No. ES-2001-359**

**Venice Plant
Turbine #1 Fire
Venice, Illinois
August 10, 2000**

**Jefferson City, Missouri
April 25, 2001**

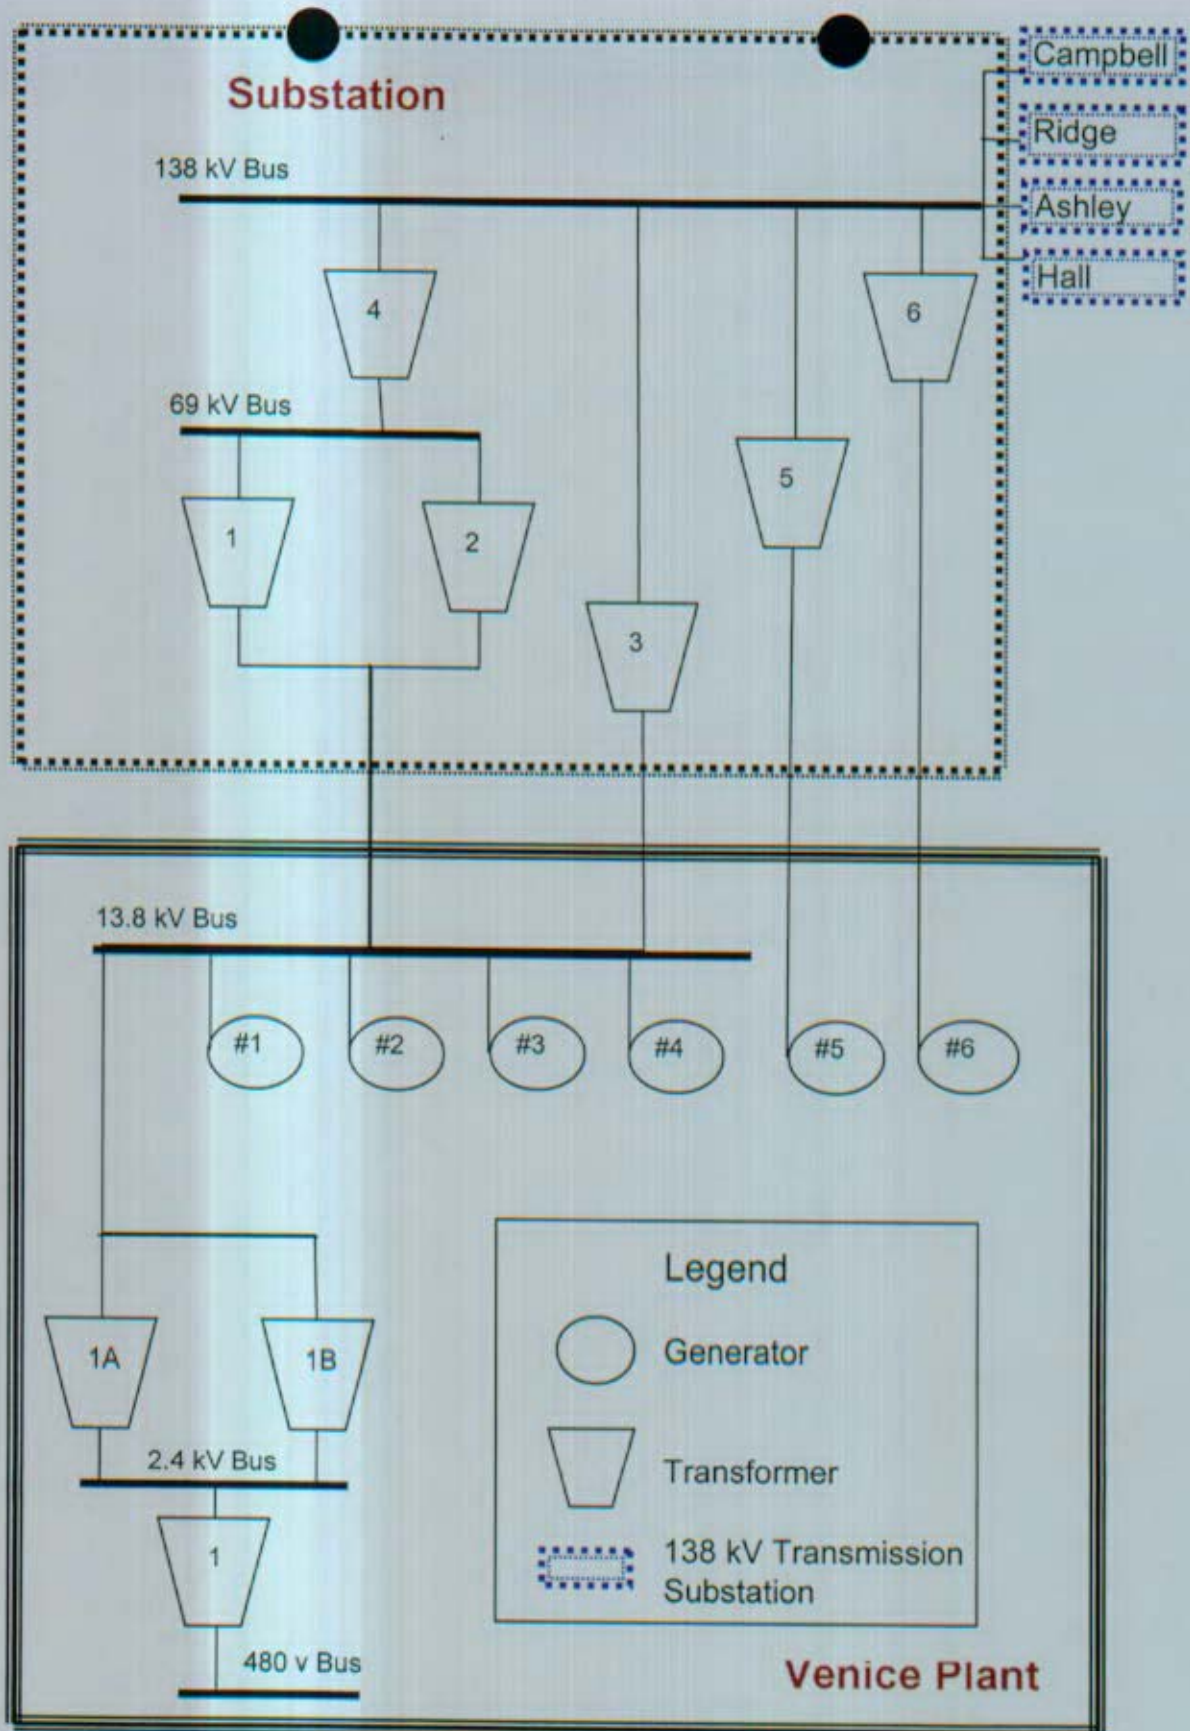
Electrical Diagram

Simple electrical diagram of Venice Plant and Venice Substation.

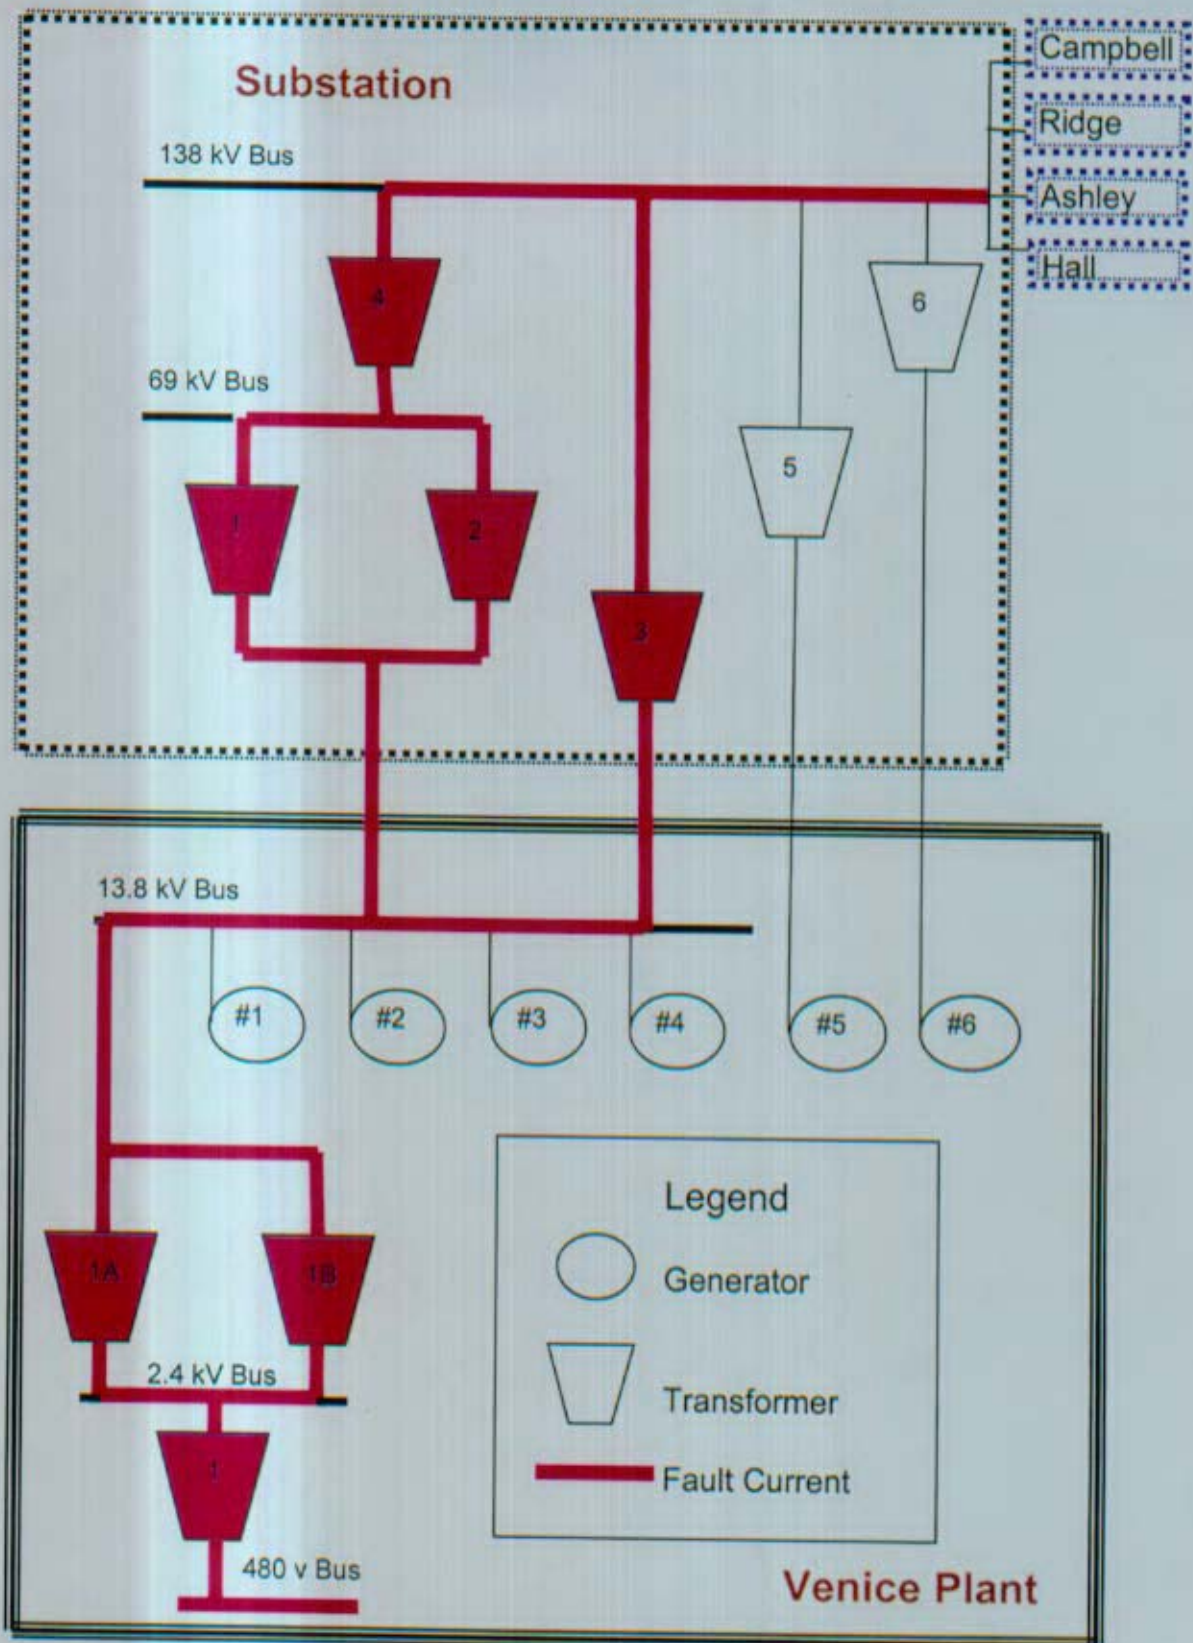
Electrical current available from the 138 kV system sought the ground fault in the plant

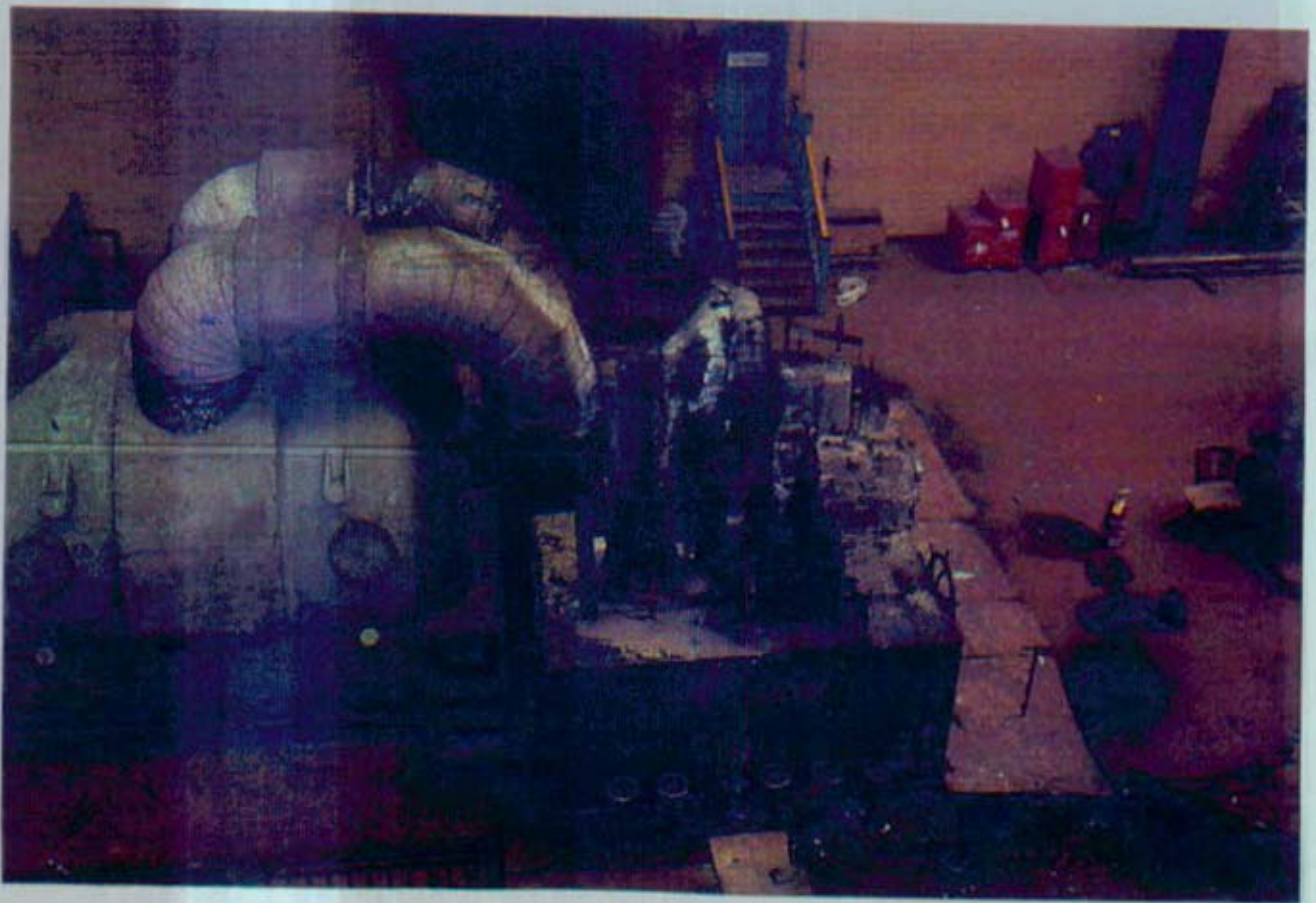
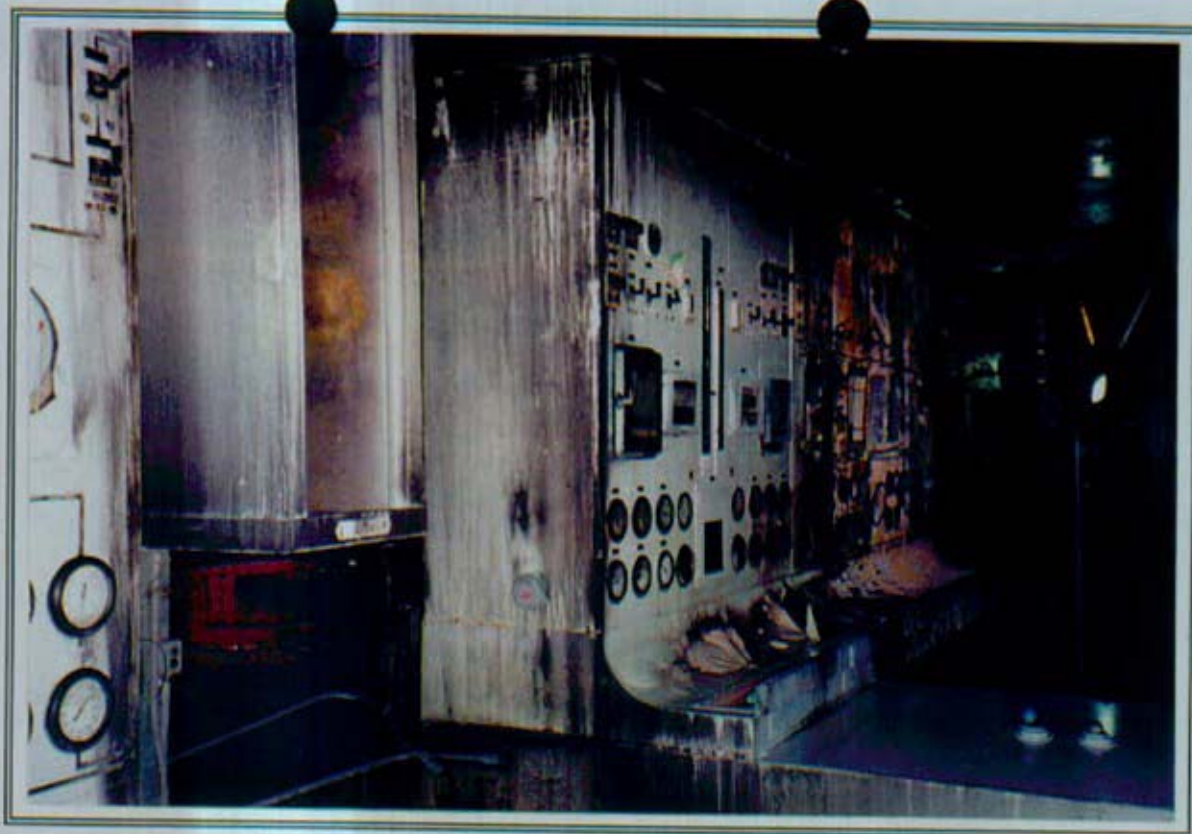
Venice Plant: Unit One Turbine

Unit #1 sustained extensive damage in the area of the fire. Damage to structural steel supporting the turbine floor was evident as the floor dropped approximately ten (10) to twelve (12) inches. The fire caused damage to electrical cables and ensuing electrical faults caused extensive damage to the 480-volt electrical bus² and to the 2400-volt internal station bus. The fire damaged the 125-volt D.C. circuits and the storage batteries quickly discharged, leaving no power to operate the breakers or to activate the fire control systems.

Equipment below Turbine #1 damaged by the fire

Structural repair of the turbine floor has been completed. Damaged cabinets and equipment have been removed. The batteries for the 125-volt D.C. system have been replaced. Installation of new cable to the substation, transformer repair and replacement are underway.

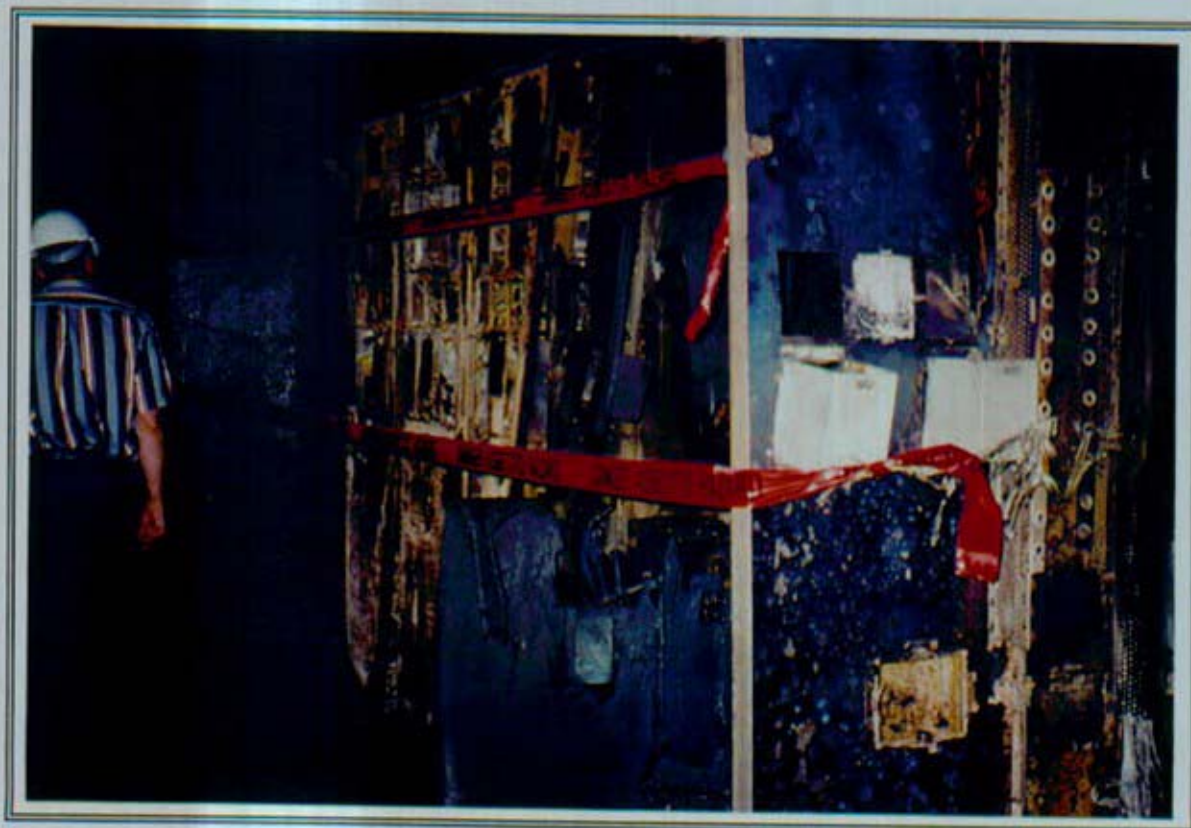
Equipment damaged by electrical ground fault

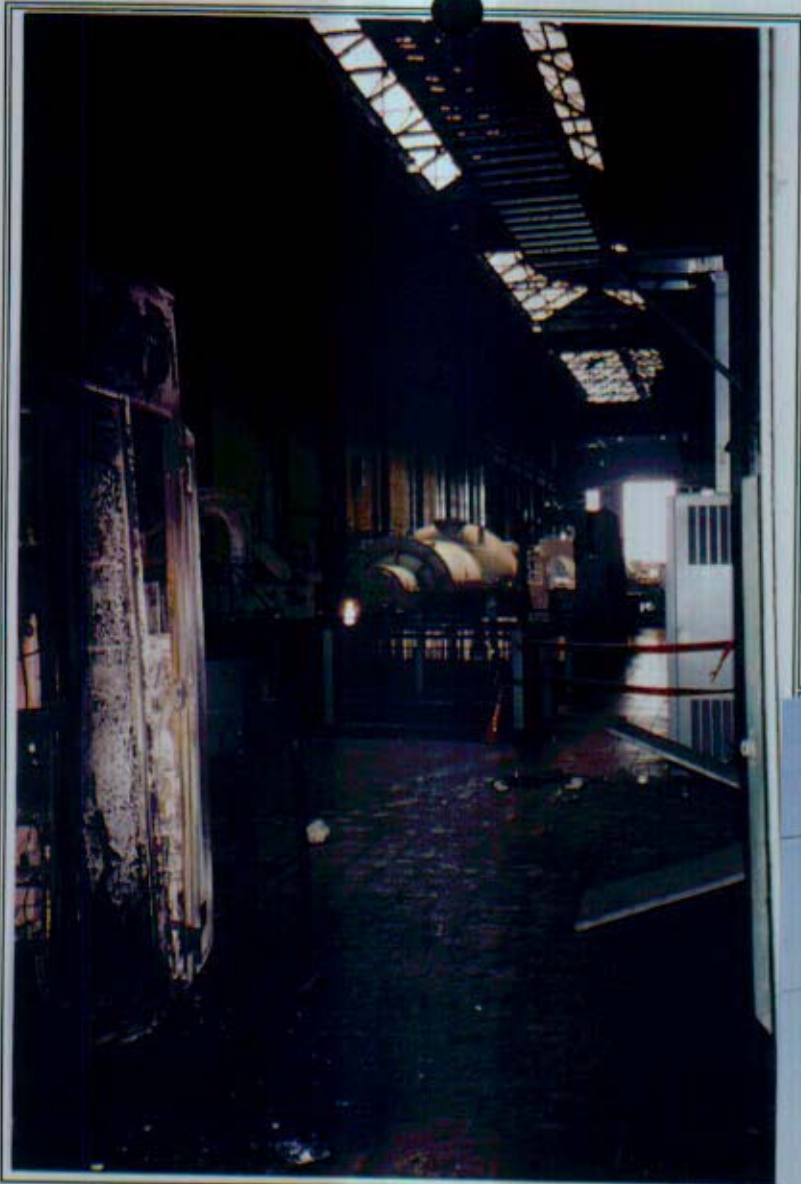
View Of Turbine Floor, Looking South
Unit #1 on Immediate Left

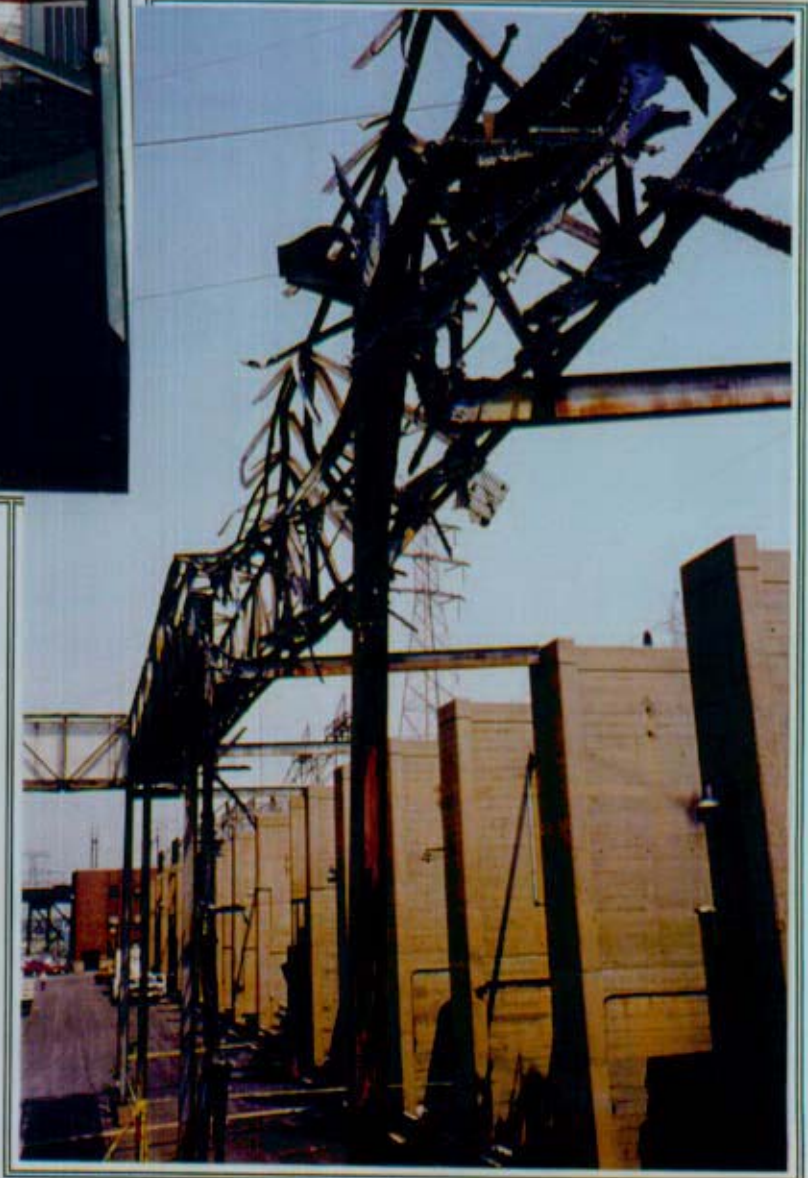
Overhead 13.8 kV Bus Outside
Of Plant That Was Damaged
By The Fault Current

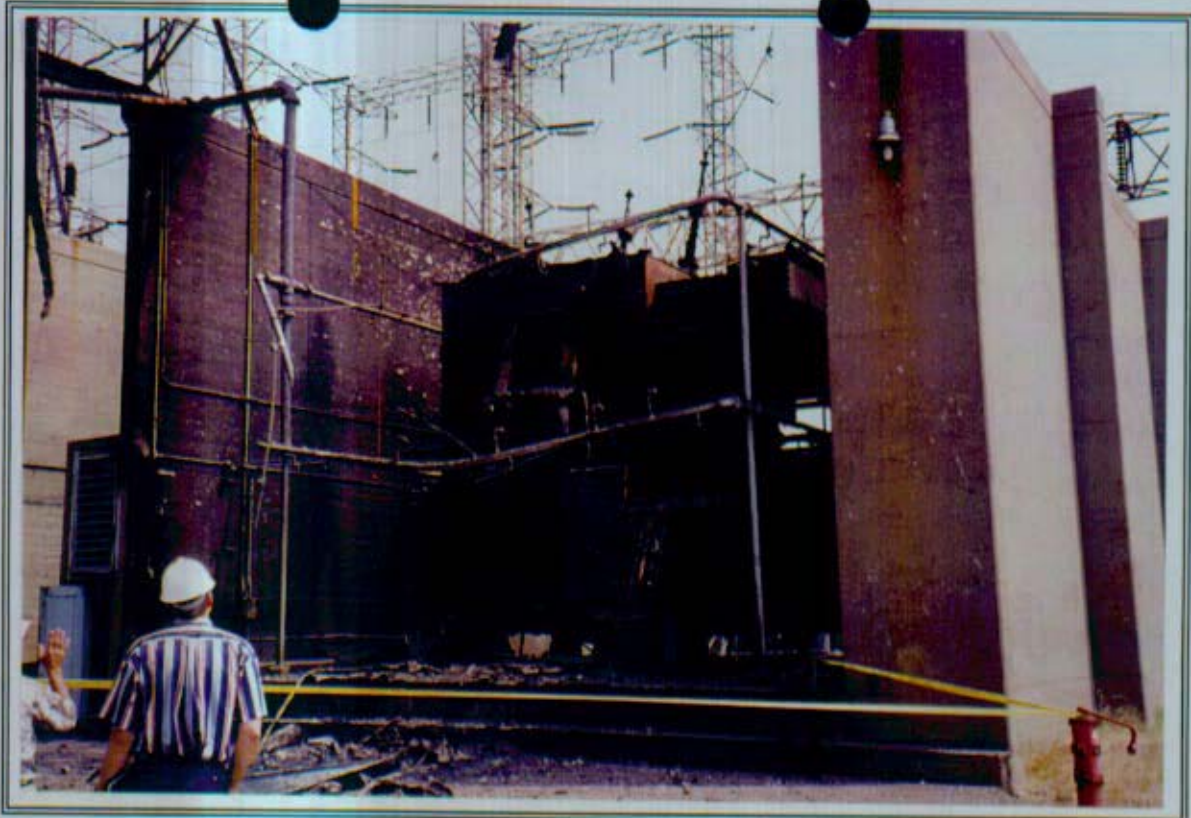
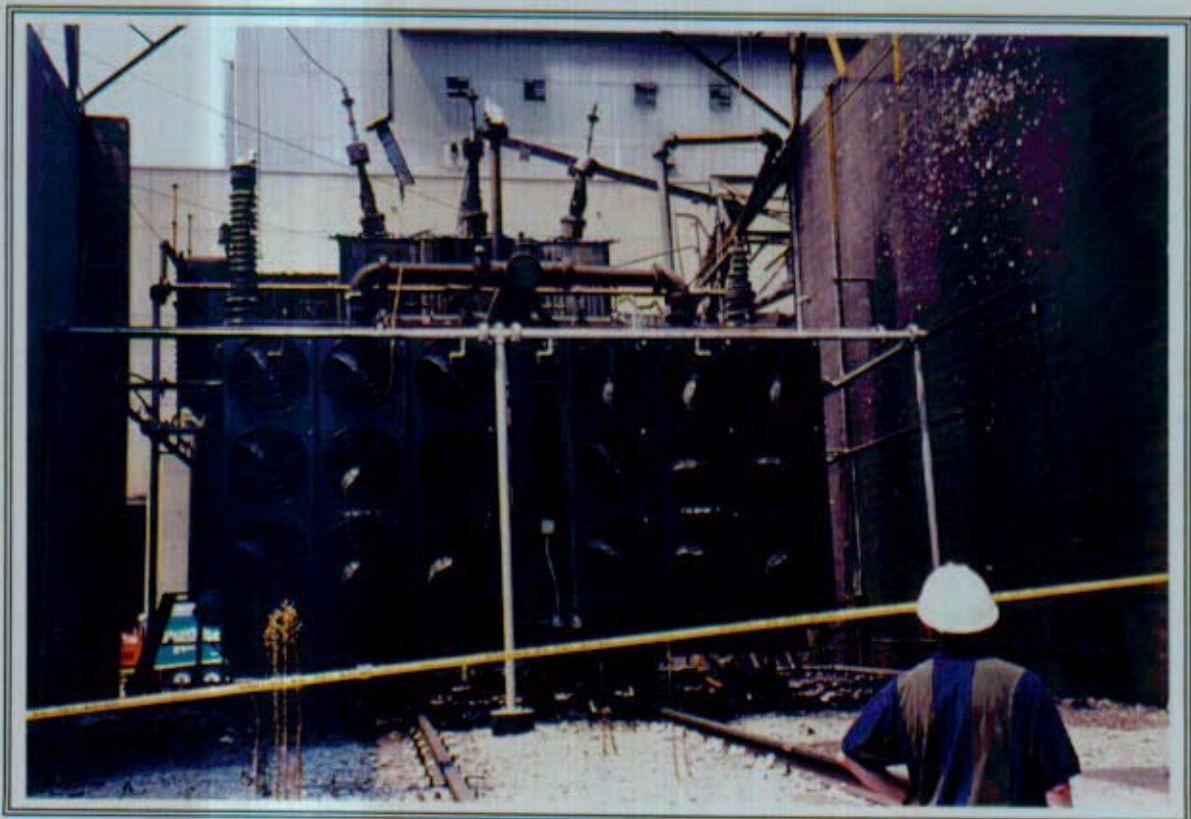
Venice Transformer #3 (13.8 / 138 kV)

Station service transformers (13.8 / 2.4 kV) 1A and 1B plus a 480-volt transformer (2.4 kV / 480 V) were damaged by the electrical fault and fire, as were step-up transformers #1, #2 (13.8 / 69 kV), #3 (13.8 / 138 kV) and #4 (69 / 138 kV). (See diagram in

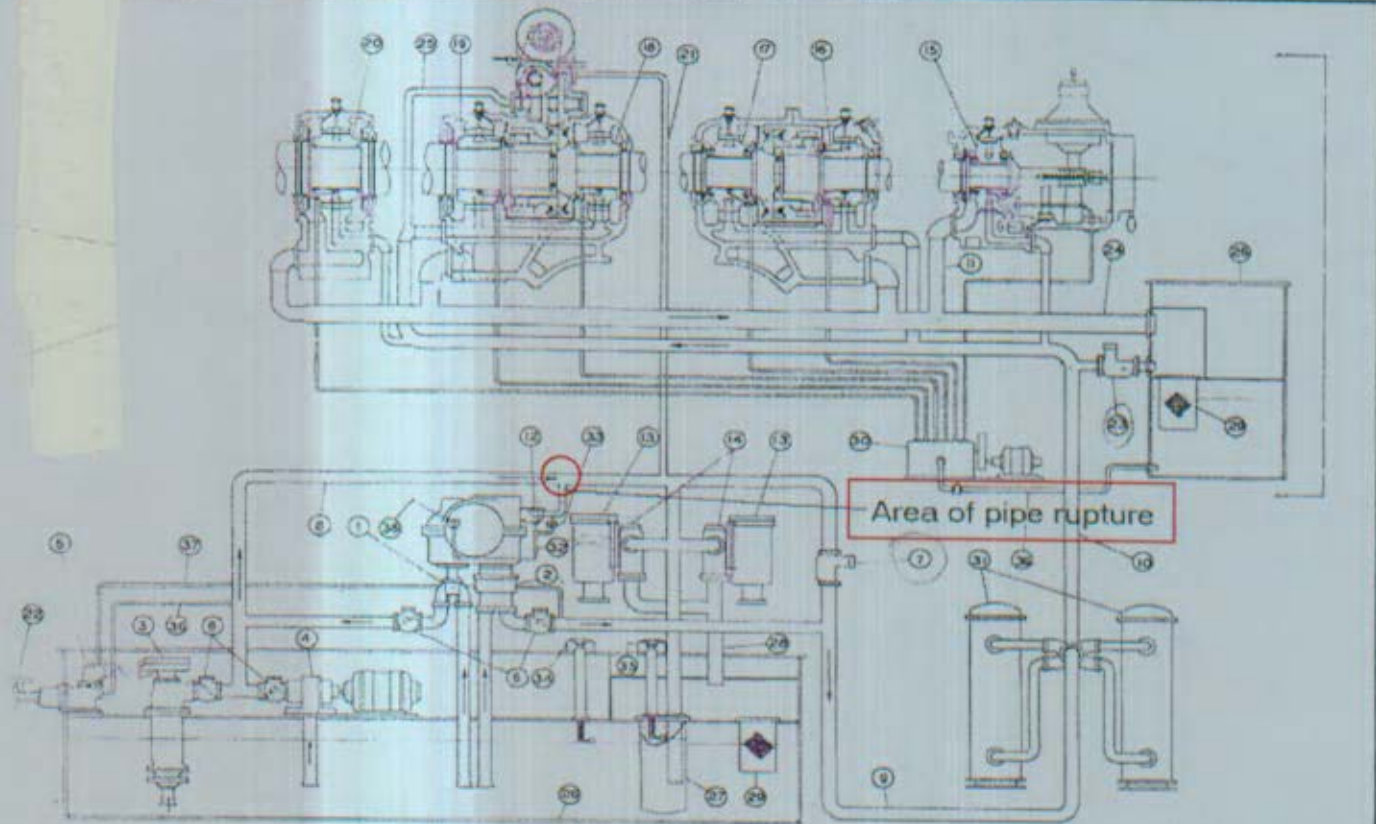
Figure 1 – Schematic showing the Venice turbine oiling system and the location of the failure.

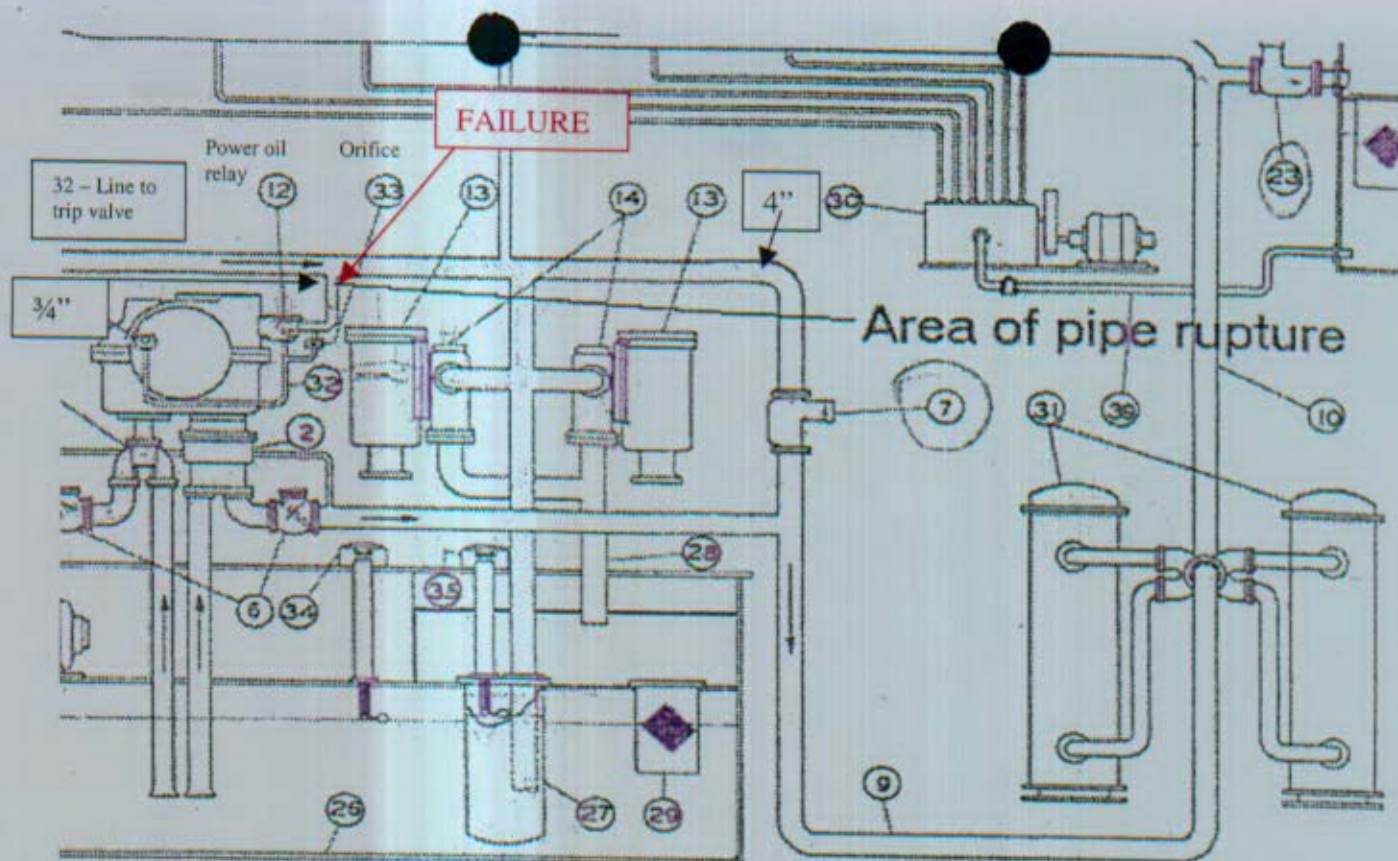
The 60 psi hydraulic system is used in part to control steam valves, and at a reduced pressure the oil is used to lubricate moving parts. The ruptured hydraulic line is a $\frac{3}{4}$ inch pipe of carbon steel and is part of the original piping installed in 1942. The $\frac{3}{4}$ inch pipe tees off a main four (4) inch supply pipe at 45 degrees. Photographs and diagrams are in Appendix C.

Figure 2 – Enlarged section of the turbine oiling system showing the failure location in greater detail. The pipe failed at the location shown by the arrow. The 3/4" line that failed tees off of the main 4" supply line and goes to the power oil relay (12). This line tees off at about a 45° and the pipe failed about 2-1/2" from the socket weld to the 4" line.

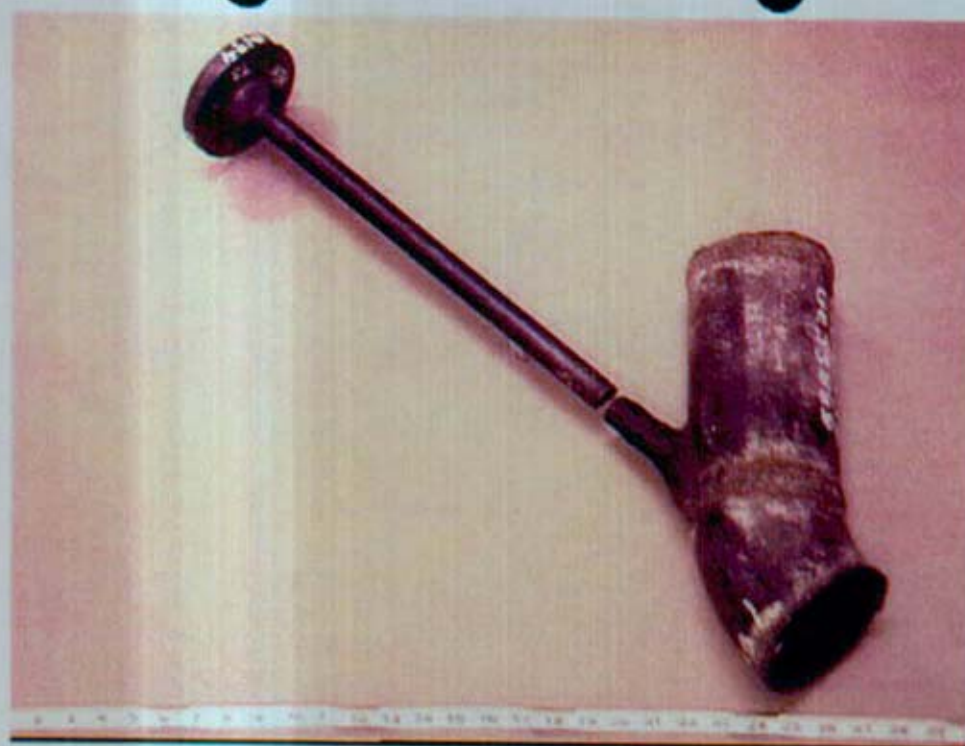
Figure 3 - This photograph shows the $\frac{3}{4}$ " line that failed and the 4" main supply line. The bolted flange at the top of the photograph connects to the power oil relay.

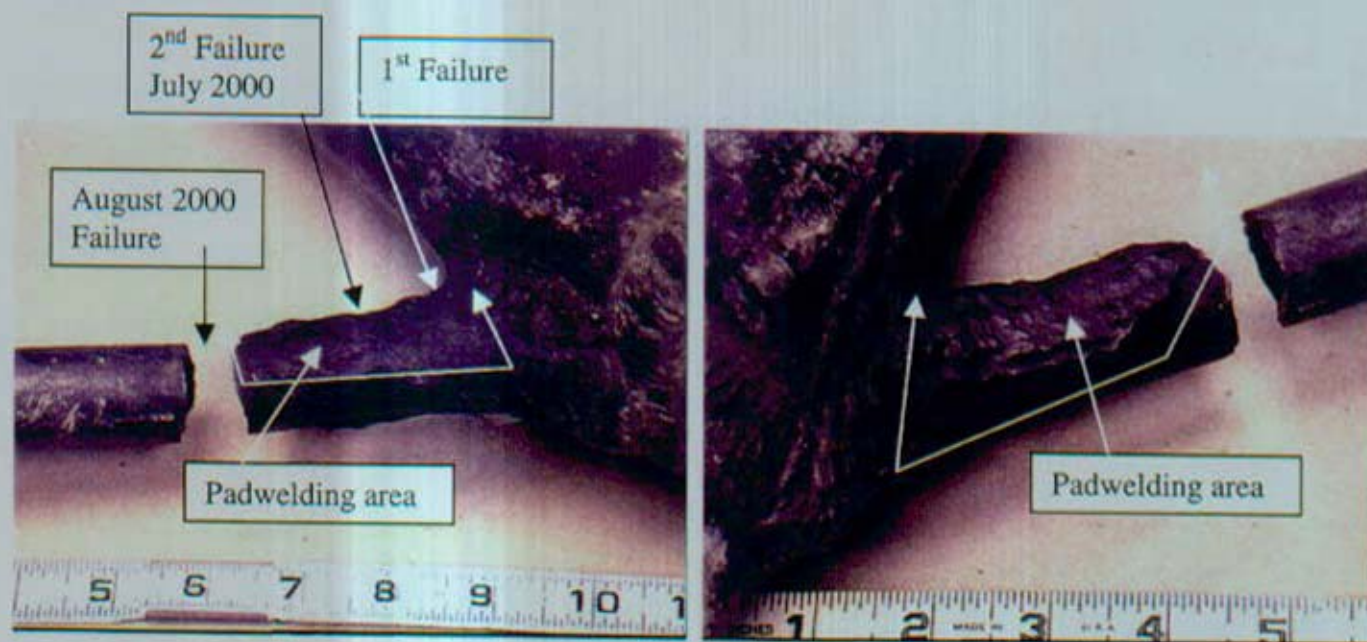
Approximately ten (10) years ago, the same line failed at the weld onto the four (4) inch line. In July 2000, the line failed about one (1) inch from the previous weld failure. The AmerenUE metallurgical report concludes that the pipe failed due to fatigue. Welding over the previous cracks apparently created a stress riser (point) that provided the initiation site for the last failure. These stress risers or points of stress in the pipe are approximately one (1) inch down the pipe from the previous weld. The two previous failures were not repaired, i.e. the crack ground out and re-welded. They were welded over and the cracks continued to grow. The laboratory report found that the original crack grew .003 inches in the ten years since the repair; but the second repair was close to failing again.

1. Welds performed on cracks in the hydraulic line, both ten years ago and in July 2000, proved to be inadequate repairs. Welds served to create a new stress point approximately one inch from the crack that was previously repaired.

Figure 4 - These photographs show the two sides of the failure. Extensive padwelding on the top half of the pipe had been done with the two past failures. The first failure occurred about 10 years ago at the toe of the socket weld on the $\frac{3}{4}$ " side of the weld. The second failure occurred about 1" away from this. All of the padwelding was on the side of the tube between the $\frac{3}{4}$ " line and the 4" line.

As a result of laboratory analysis by Ameren, it was recommended that future repairs should involve pipe replacement, or a defect repair should be made instead of only welding over the crack. The welding provided a point of initiation one (1) inch down the pipe that could lead to failure. It appears from laboratory analysis that several individual cracks connected together, resulting in the failure on August 10, 2000. Photographs in Appendix C show results from the metallurgical report.

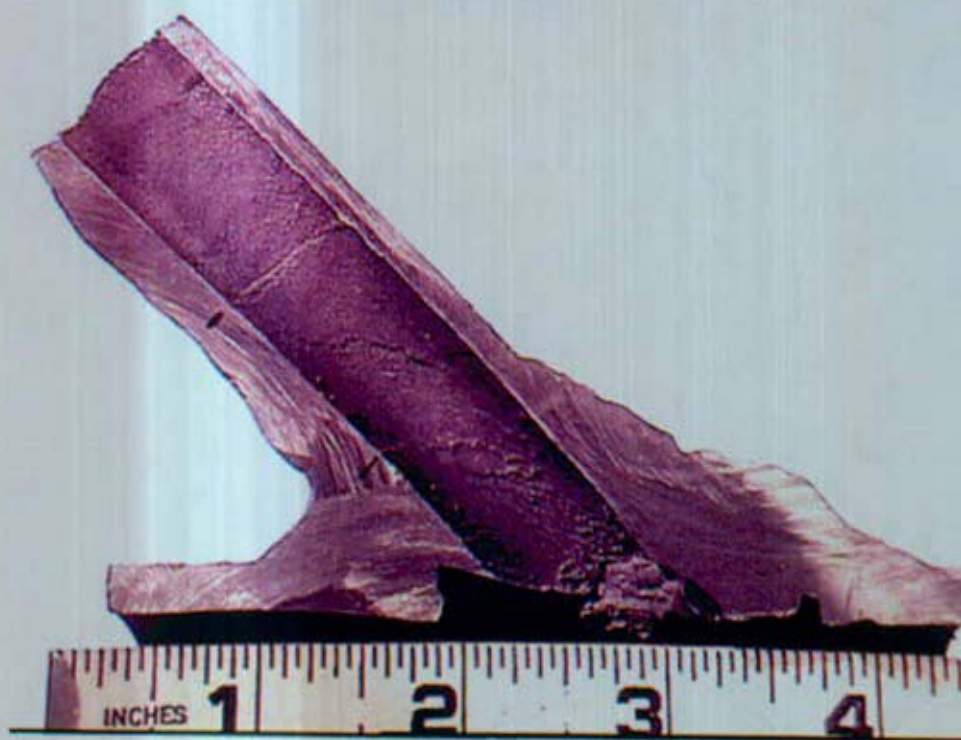
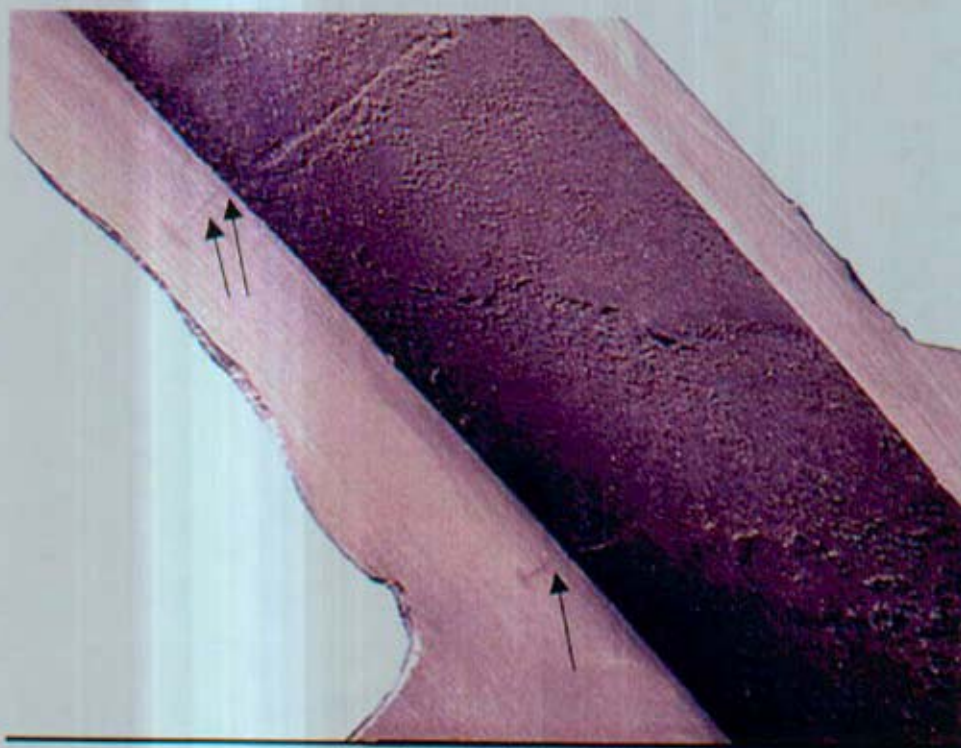
Figure 7 – These photographs show the 3/4" line split in half. The lower photograph shows the original crack (arrow) and the July 2000 crack (double arrow).
