Gas Incident Report

**Missouri Gas Energy
Case No. GS-2001-216**

205 East Oak Street
Warrensburg, Missouri
July 24, 2000

Safety/Engineering Section ... Gas Department ... Utility Operations Division
February 2001 Jefferson City, Missouri

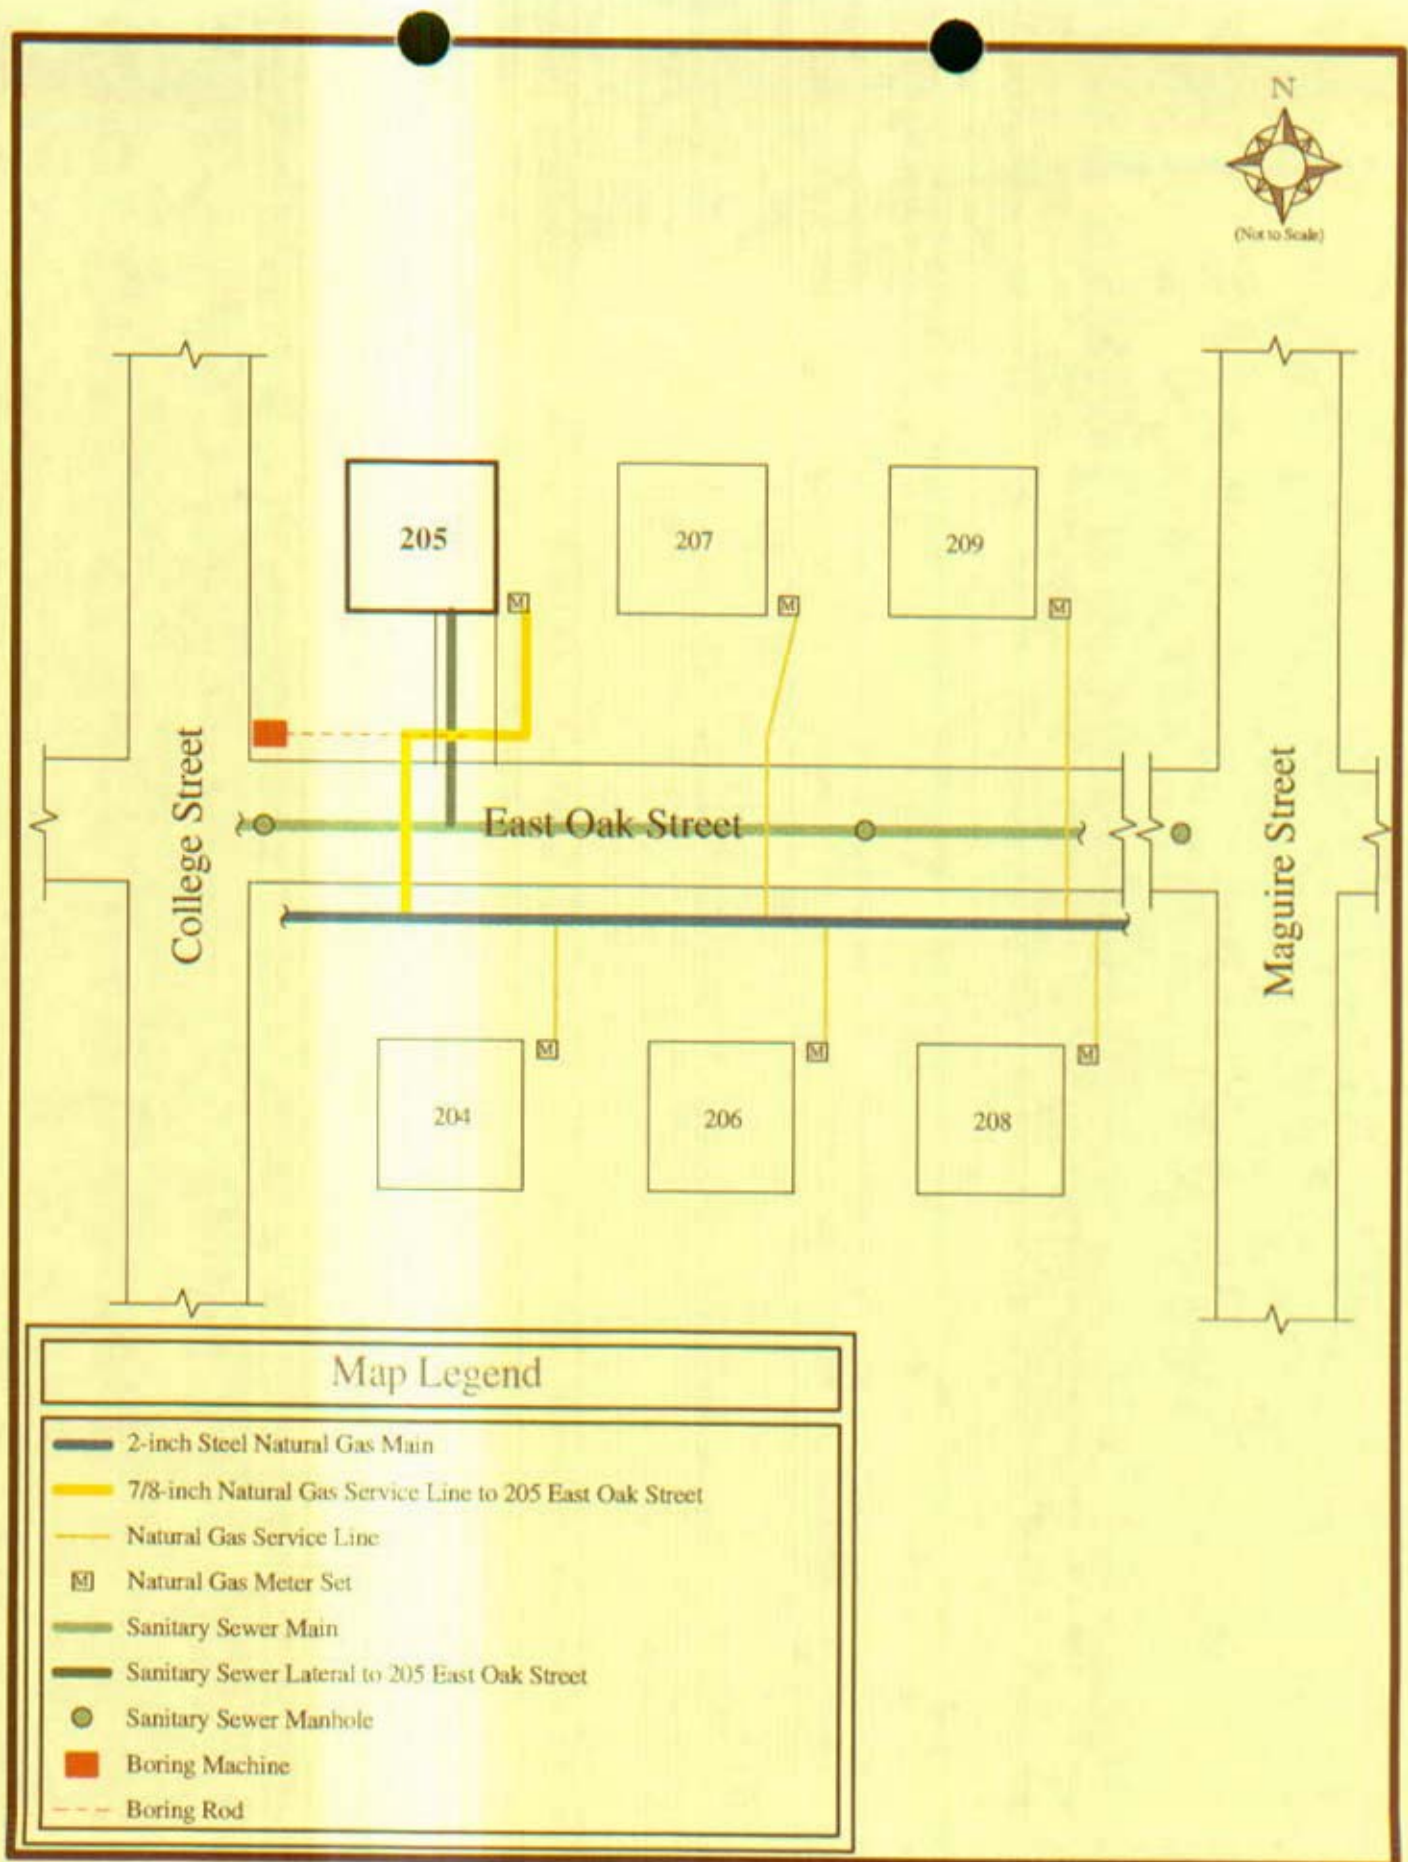
Figure 1
Plan View of the 200 Block of East Oak Street
Appendix A-1

The 200 block of East Oak Street generally runs in a west/east direction between College Street to the west and Maguire Street to the east. For purposes of this report, all geographic locations will be referenced as if East Oak Street was oriented in a west/east direction. The house at 205 East Oak Street is located approximately 40 feet north of the north curb of East Oak Street (Appendix A-1, Figure 1).

natural gas service line then turns to the north and travels parallel to the driveway, to the service riser approximately 57 feet north of the north curb (Appendix A-1, Figure 1).

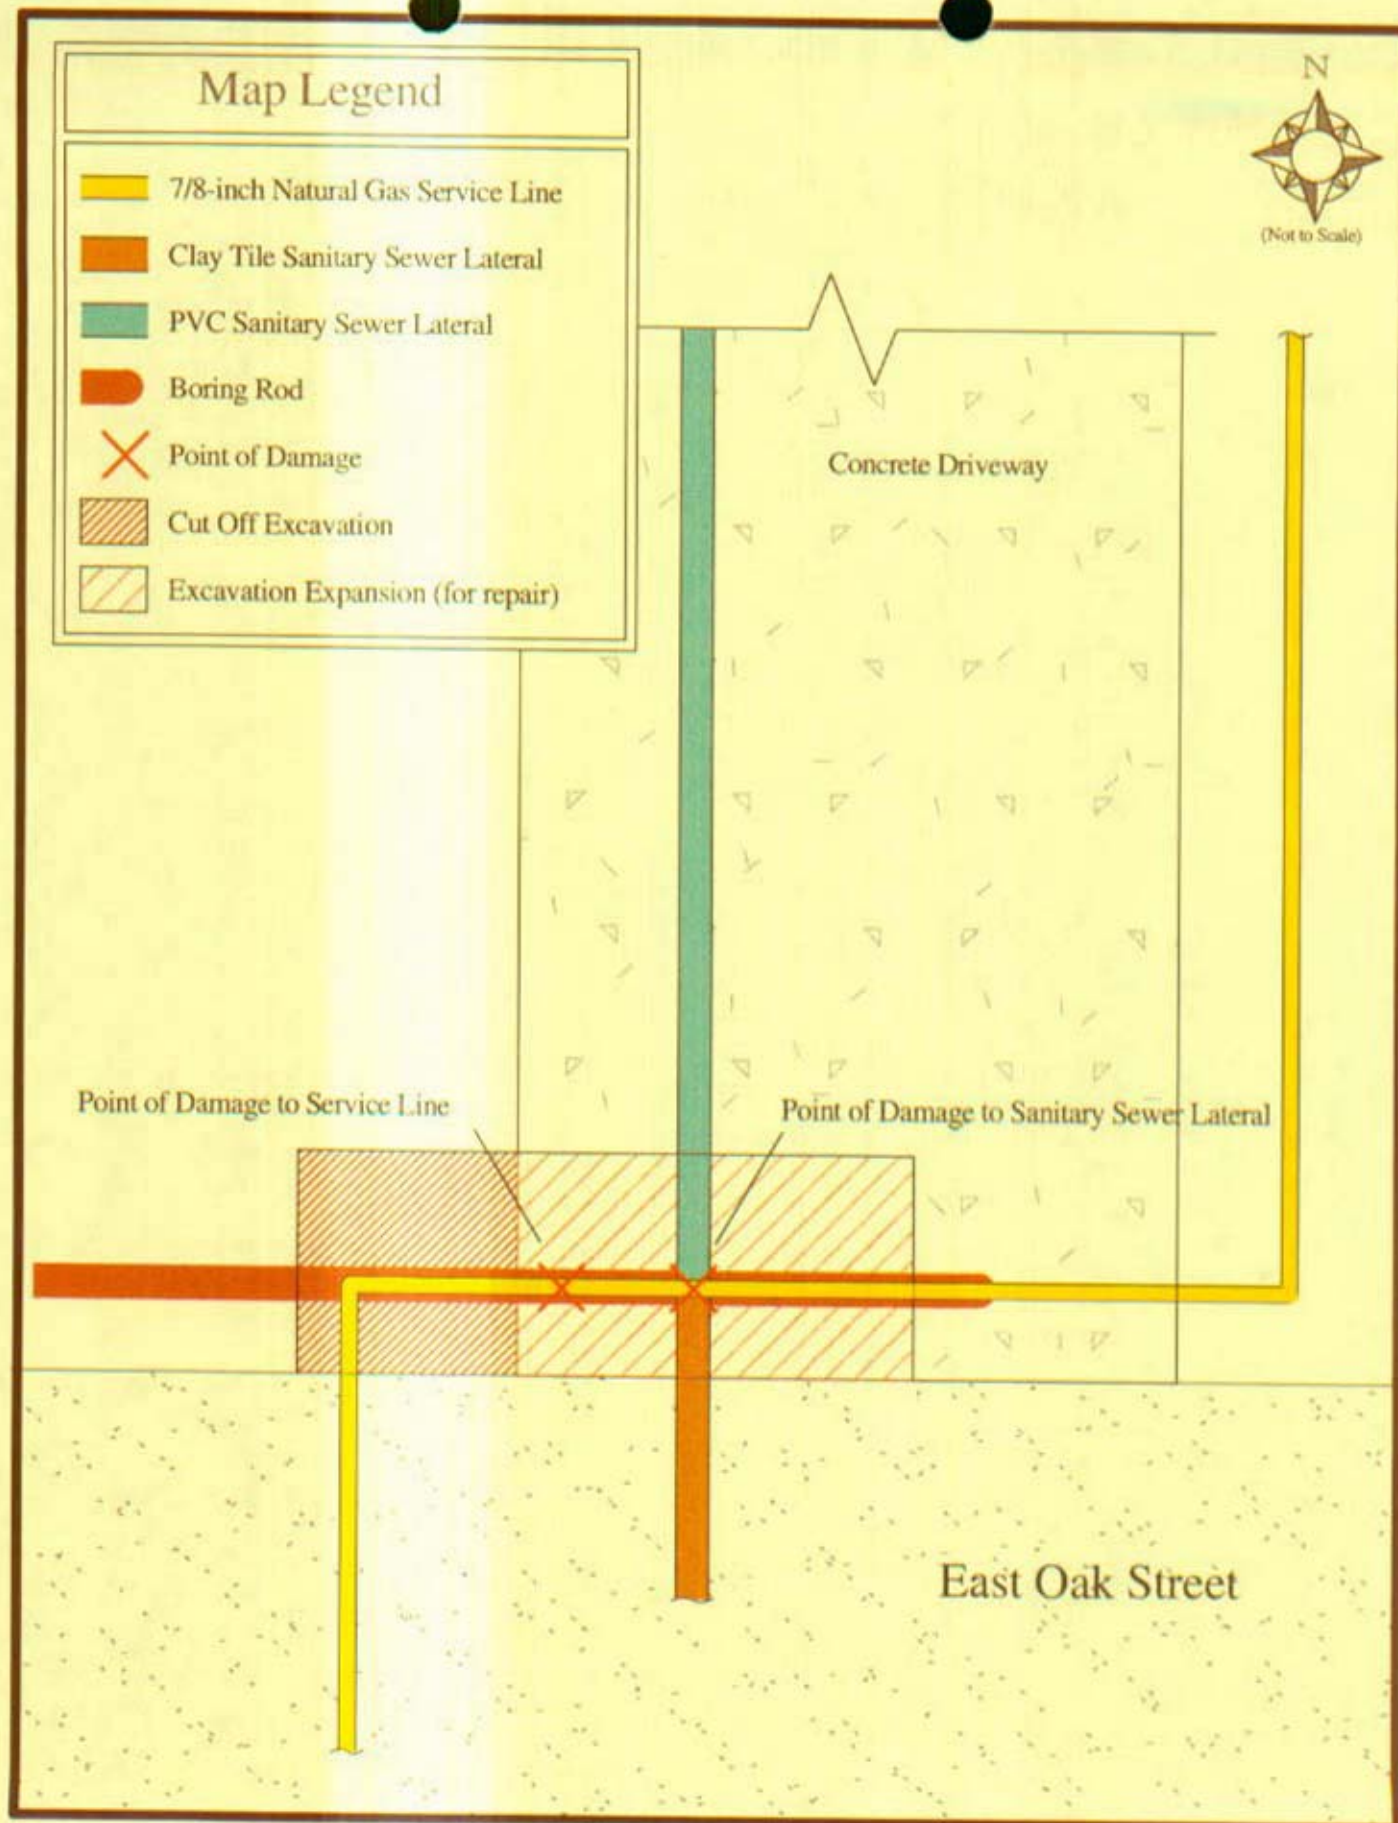
Figure 2
Plan View of the Excavation at 205 East Oak Street
Appendix A-2

The Staff observed three excavations north of the north curb line of 205 East Oak Street. MGE personnel explained that the east excavation was made first to cut off the flow of natural gas to the service line serving 207 East Oak Street, as that location initially had the highest concentration of natural gas in the subsurface atmosphere. The second, middle, excavation was made to vent natural gas from the subsurface atmosphere in between 207 and 205 East Oak Street. The west excavation was made to cut off the flow of natural gas to the service line serving 205 East Oak Street. This excavation was later expanded to reveal and remove the damaged section of the service line (Appendix A-2, Figure 2).

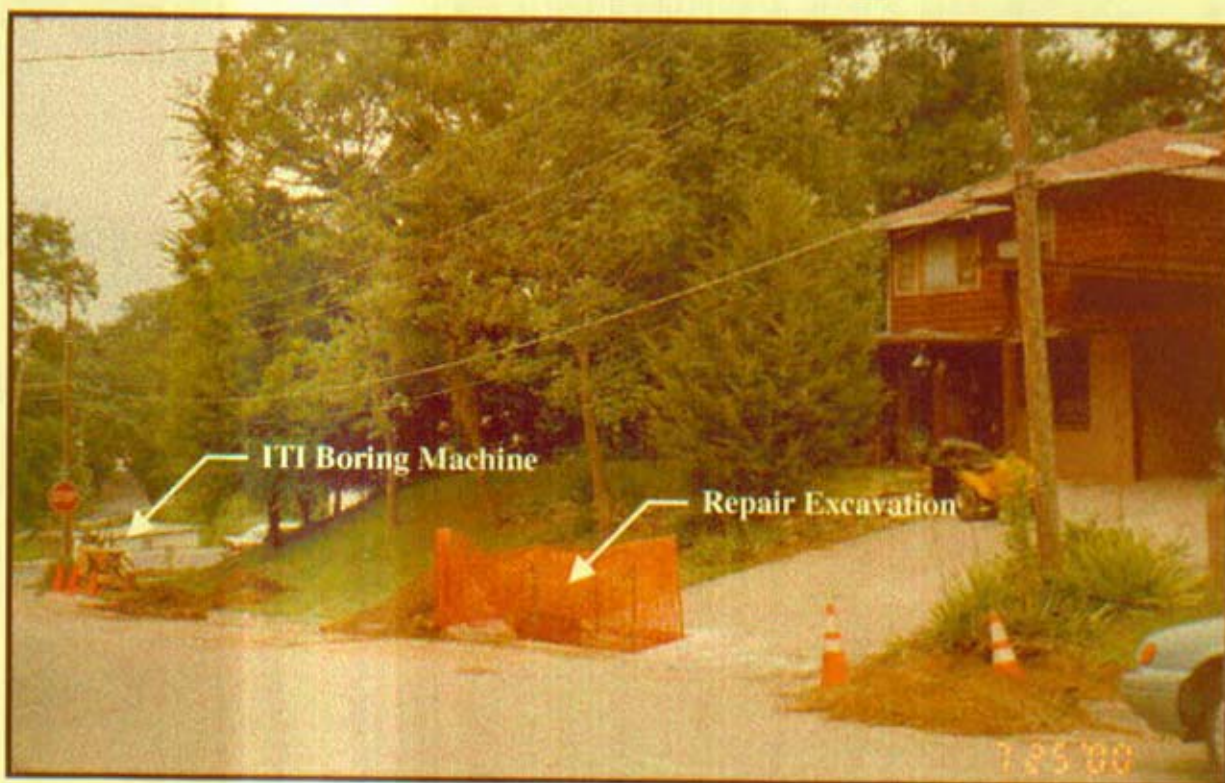
Photograph 1: 205 East Oak Street, incident site. Excavation in center of photograph was made to expose and repair the natural gas service line to 205 East Oak Street.

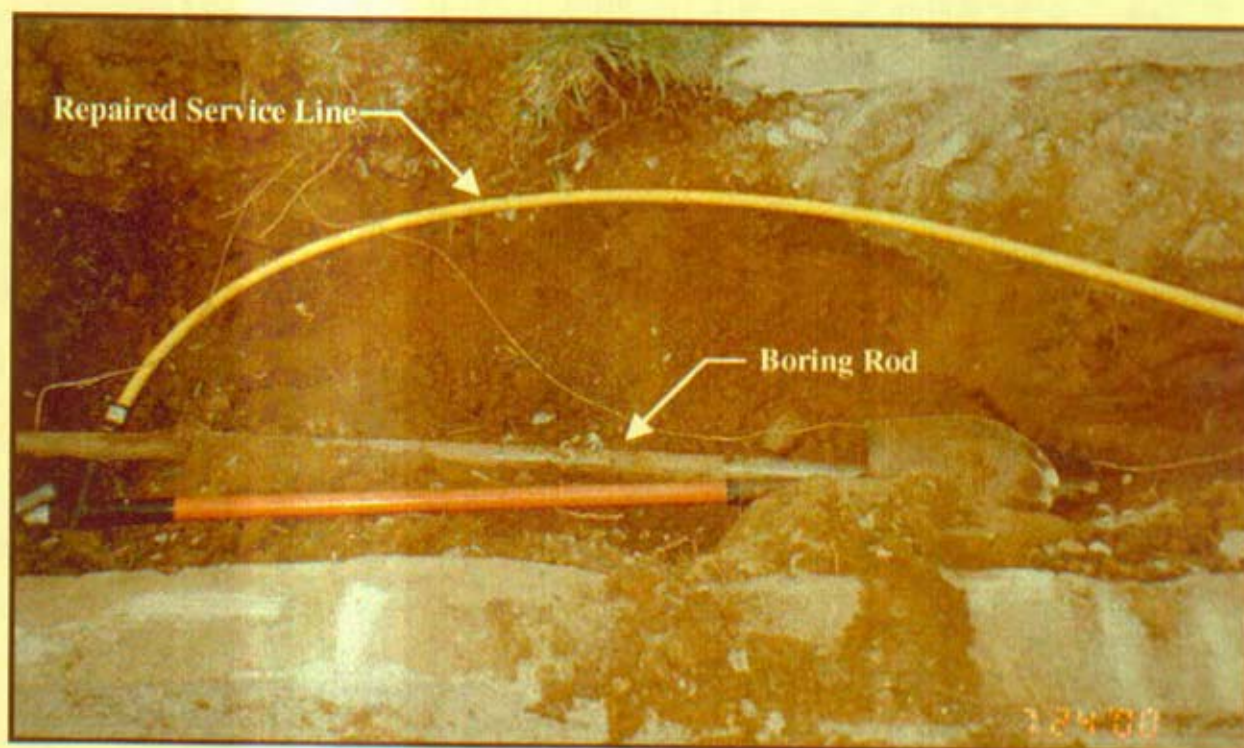
Photograph 2: View from the south, looking down at the repair excavation in front of 205 East Oak Street. This is the excavation identified in Photograph 1.

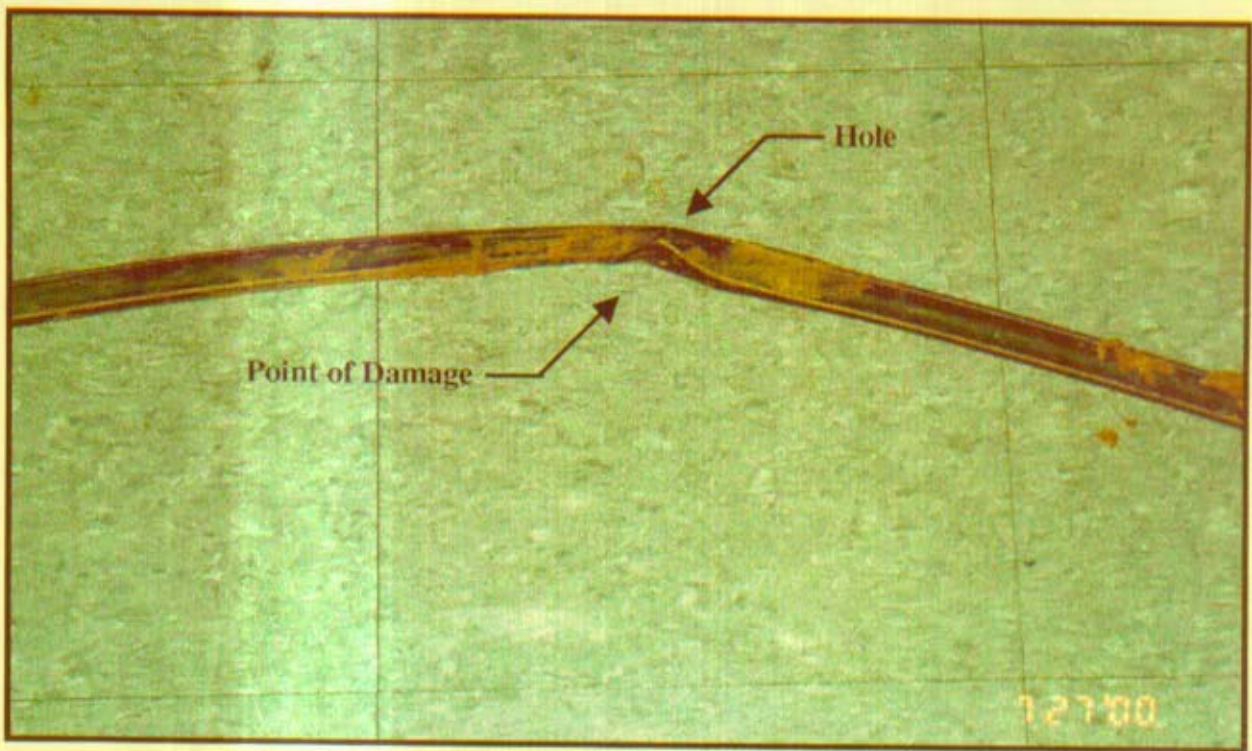
In the excavation made over the natural gas service line to 205 East Oak Street, the Staff could clearly see the repair made to the service line, consisting of approximately 17 feet of 7/8-inch CTS polyethylene pipe and two Lyco® fittings (couplings) for connecting into the existing service line, and the boring rod (Appendix B-1, Photograph 2). MGE personnel told the Staff that the approximate location of damage to the natural gas service line was 10 inches east of the west edge of the driveway and 15 inches north of the north curb line of East Oak Street. The damaged segment of the natural gas service line had been retained by MGE and taken to their Lee's Summit office. The Staff was able to view and photograph the service line at a later date (Appendix B-2, Photograph 3).

The hole in the natural gas service line was apparently the result of stresses imposed by the boring rod bit hitting and pulling the polyethylene pipe. The force exerted on the outside wall of the service line by the boring rod bit exceeded the strength of the polyethylene pipe, creating a tear in the pipe wall

Photograph 3: Area of damage to the 7/8-inch diameter CTS polyethylene natural gas service line to 205 East Oak Street.

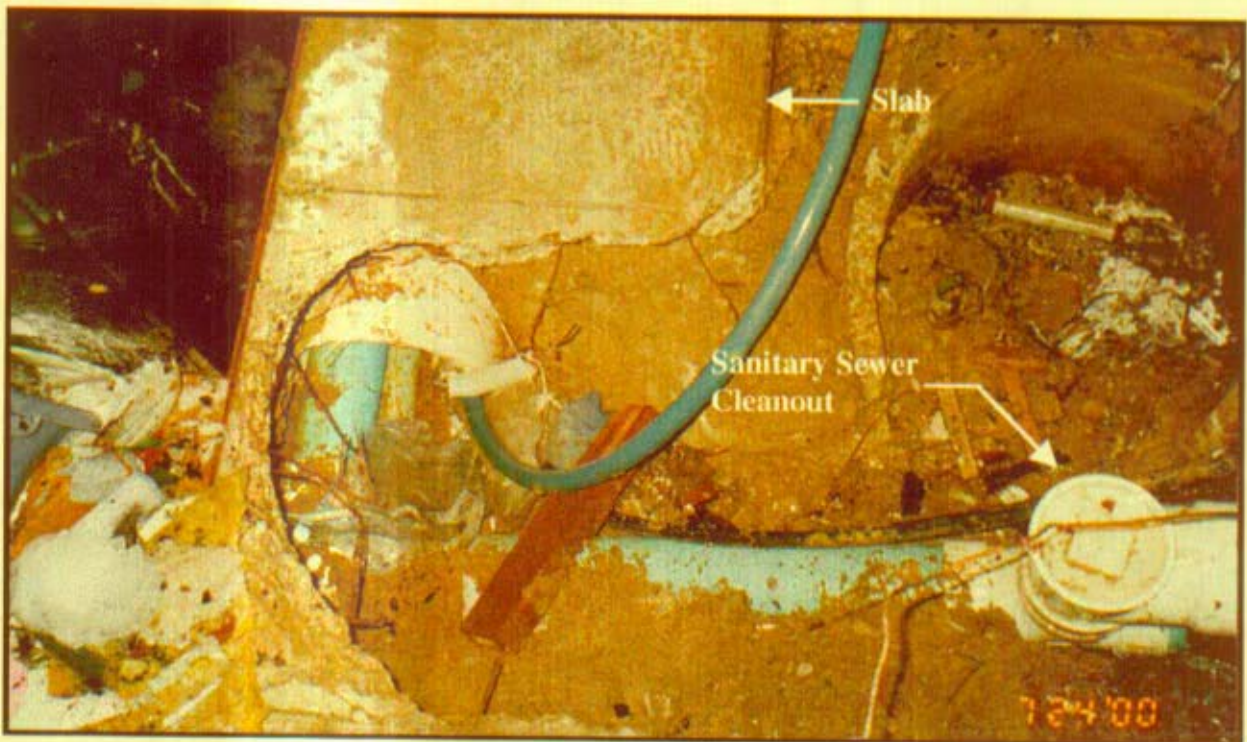
Natural gas from the sewer lateral could have accumulated in the laundry room of 205 East Oak Street, possibly entering through the loose-fitting sanitary sewer lateral cleanout lid located below the slab level. While the source of ignition could not be positively identified, a likely source was the standing pilot on the natural gas clothes dryer.

Photograph 4: View of the utility corridor beneath the floor of the laundry room of 205 East Oak Street.

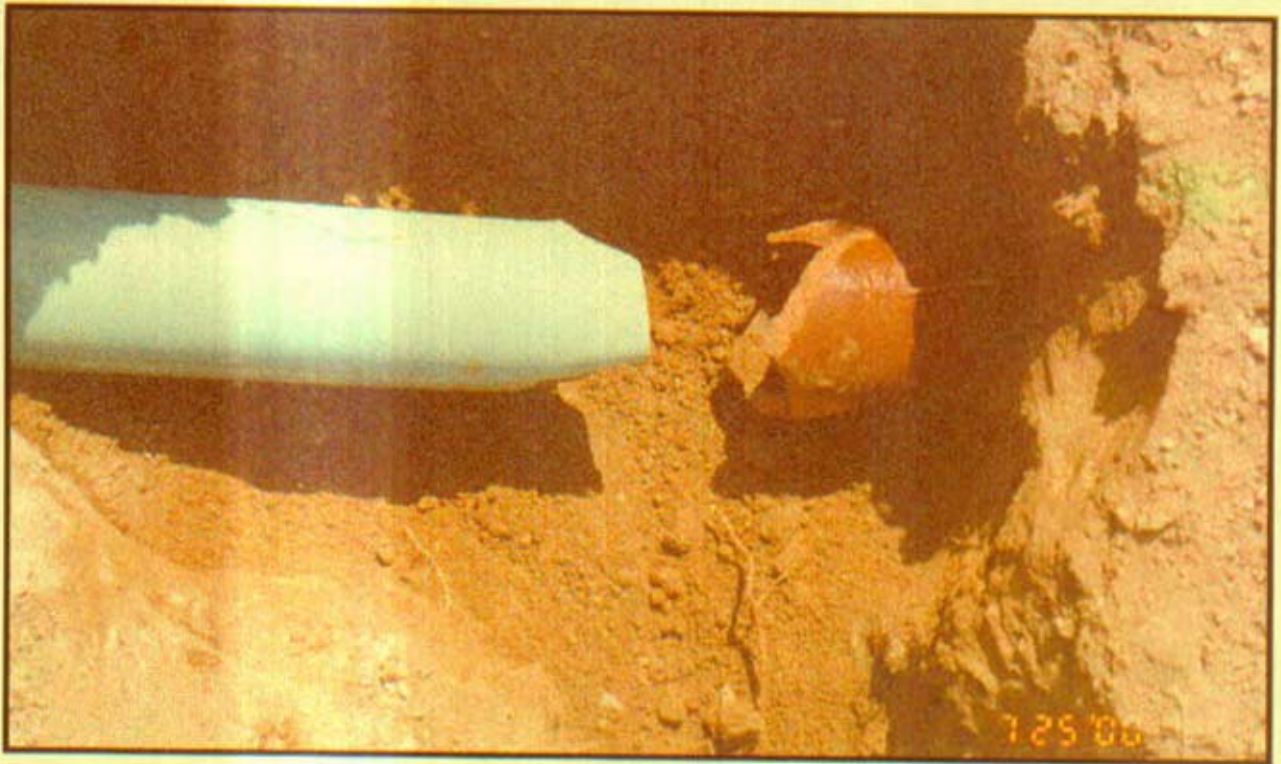
After tearing a hole in the polyethylene natural gas service line, the boring rod continued on its path and hit the sanitary sewer lateral to 205 East Oak Street approximately 30 inches east of the natural gas service line damage. Natural gas escaping at a pressure of approximately 17 psig from the service line would have had a direct path through loose soil along the boring rod, from the damaged natural gas service line to the damaged sanitary sewer lateral. Natural gas could have entered the sanitary sewer lateral, and then traveled through the sewer lateral to the laundry room of 205 East Oak Street and the sanitary sewer main under East Oak Street. Natural gas, being lighter than air, also migrated upward through the soil, and being confined by the concrete slab driveway, followed the least resistive paths to vent to atmosphere, as evidenced by the 100% gas-in-air indications found by MGE along the curb line between 205 and 207 East Oak Street.

Photograph 5: View of the damaged sanitary sewer lateral to 205 East Oak Street (the rubber boot had been removed).
