Staff from the Missouri Department of Natural Resources (Department) conducted an inspection on December 1, 2017, of the Makalu Estates public water system (system). The system operates under the public water system identification number MO3031208.

**Missouri Department of Natural Resources
Southwest Regional Office/Public Drinking Water Branch
Report of Inspection
Makalu Estates
Camden County, Missouri
Public Water System ID Number MO3031208
January 4, 2018**

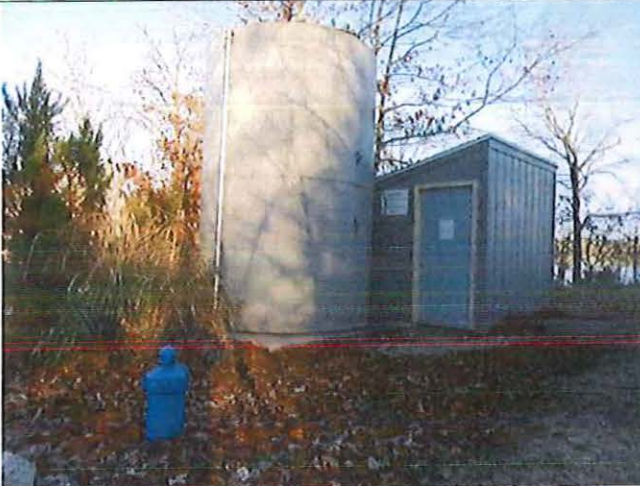
PHOTOGRAPH# 1
TAKEN BY: Darrell Barber
ENTITY: Makalu Estates
PERMIT: MO3031208
LOCATION: Next to well #2 facing Northwest
DESCRIPTION: Well #2, 3,500-gallon ground storage tank and well house.
DATE TAKEN: December 1, 2017
PROGRAM: Public Drinking Water Branch

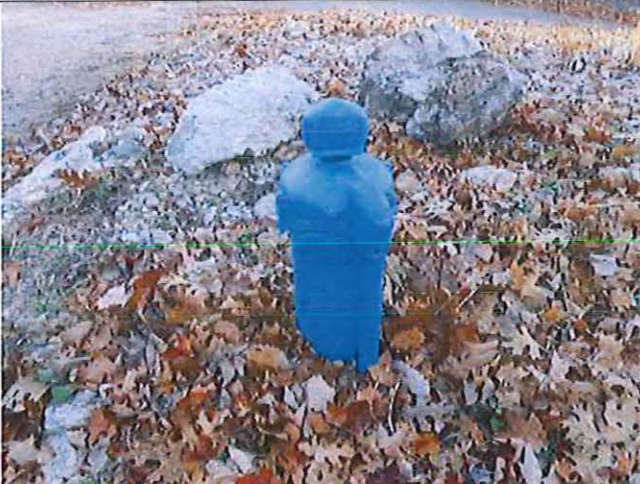
1. The pump discharge piping is not equipped with an aboveground check valve.

A well pump discharge check valve is needed to prevent water from the storage tank and distribution system from entering the well. Even wells with submersible pumps that have a check valve in the piping in the well need an above ground pump discharge piping check valve as a safety precaution. The only exception is a pump that discharges directly into the top of an unpressurized storage tank. The Department recommends a check valve should be installed between the well and storage tank.

PHOTOGRAPH# 2
TAKEN BY: Darrell Barber
ENTITY: Makalu Estates
PERMIT: MO3031208
LOCATION: Next to Well #2 facing South
DESCRIPTION: Well #2
DATE TAKEN: December 1, 2017
PROGRAM: Public Drinking Water Branch

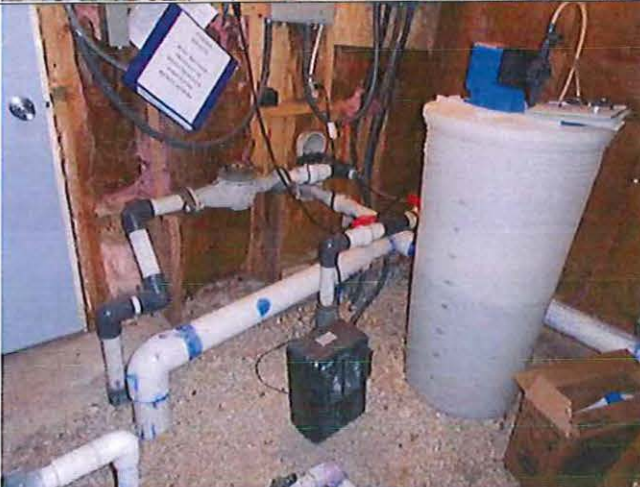
1. The public water system failed to obtain written authorization from the Department prior to construction, alteration, or extension of the water system in violation of Safe Drinking Water Regulation 10 CSR 60-3.010(1). A chlorination system was installed since the last inspection.

PHOTOGRAPH# 3
TAKEN BY: Darrell Barber
ENTITY: Makalu Estates
PERMIT: MO3031208
LOCATION: Inside well house
DESCRIPTION: Chlorination system and related piping.
DATE TAKEN: December 1, 2017
PROGRAM: Public Drinking Water Branch

REQUIRED ACTION: Within 180 calendar days of the date of this report, the public water system shall submit two copies each of an as-built engineering report, plans, and specifications prepared by a professional engineer registered in Missouri along with an application for a construction permit and a letter from the public water system authorizing the construction (unless the system is applying for the permit) to the Public Drinking Water Branch, P.O. Box 176, Jefferson City, MO 65102, 573-751-5331.

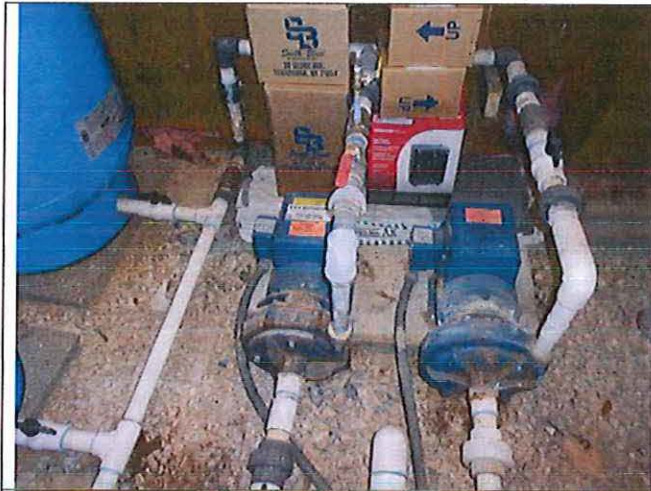
PHOTOGRAPH# 4
TAKEN BY: Darrell Barber
ENTITY: Makalu Estates
PERMIT: MO3031208
LOCATION: Inside well house
DESCRIPTION: Two 5-hp booster pumps and related piping.
DATE TAKEN: December 1, 2017
PROGRAM: Public Drinking Water Branch

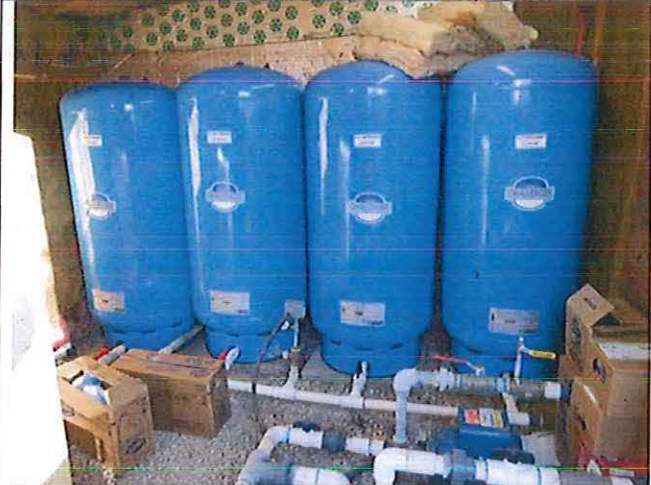
As noted in the last Report of Inspection dated June 18, 2015, the pre-charge air pressure in some of the bladder tanks needs to be adjusted. The pressure appears to be set too high and isn't allowing much water to enter some of the tanks. The water system needs to adjust the pre-charge pressure in the tanks so that all of the tanks are operating at similar levels.

PHOTOGRAPH# 5
TAKEN BY: Darrell Barber
ENTITY: Makalu Estates
PERMIT: MO3031208
LOCATION: Inside well house
DESCRIPTION: Four 119-gallon bladder tanks and related piping.
DATE TAKEN: December 1, 2017
PROGRAM: Public Drinking Water Branch
