Exhibit No.:
Issues: Water Storage Tank Rehabilitation,
Risks of Providing Water & Sewer
Service
Witness: Matthew A. Lueders
Exhibit Type: Direct
Sponsoring Party: Missouri-American Water Company
Case No.: WR-2024-0320
SR-2024-0321
Date: July 1, 2024

DIRECT TESTIMONY

MATTHEW A. LUEDERS

3 Schedule MAL-2 – Sample water storage tank inspection reports

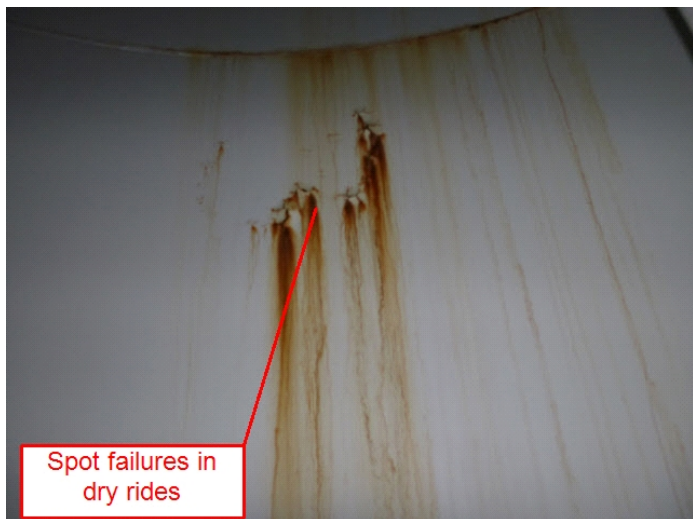
Dry Riser: Multiple spot failures with moderate rusting on condensation plates and inside dry riser tube.

Spot failures in dry rides

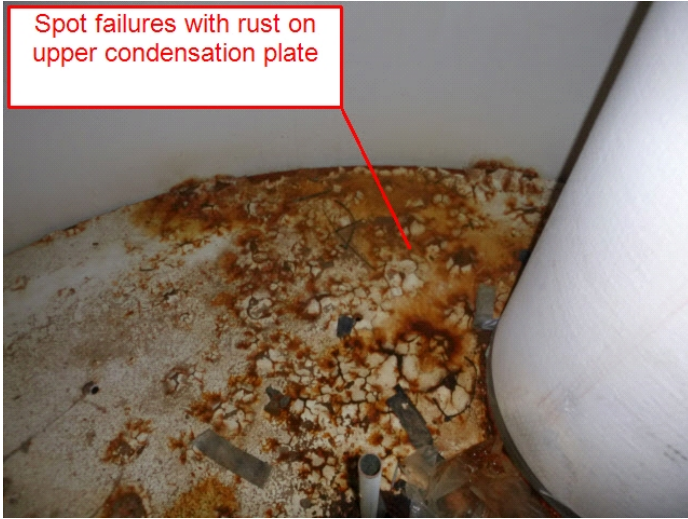
Spot failures with rust on upper condensation plate

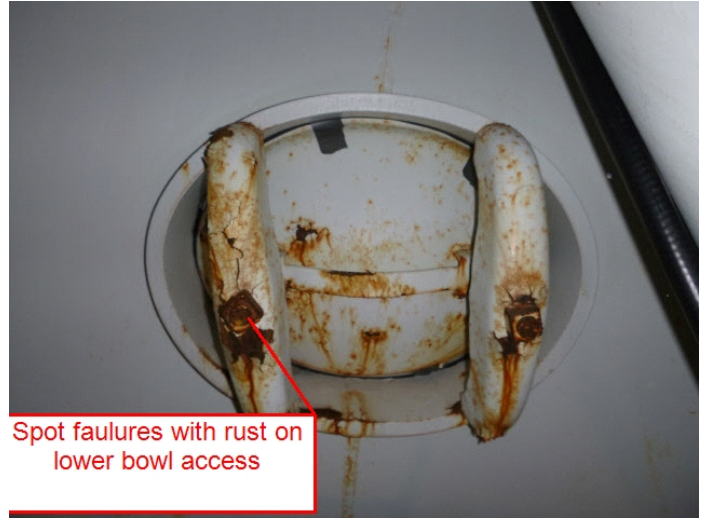
Spot failures with rust on lower bowl access

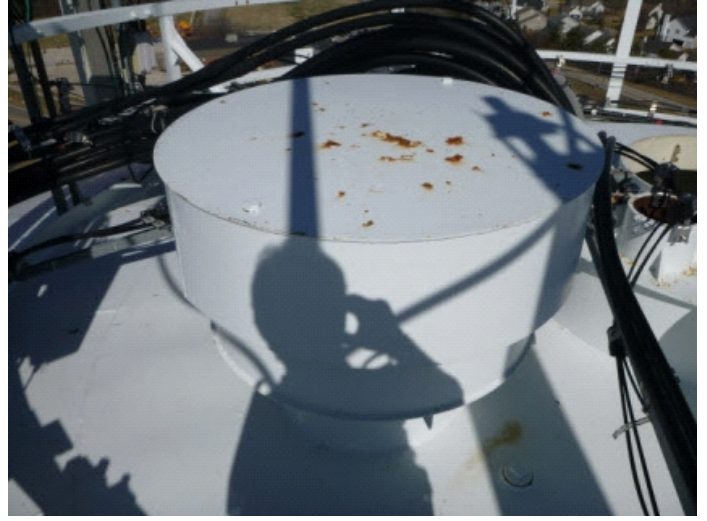
Pipe chase access for cellular cables needs foam sealant

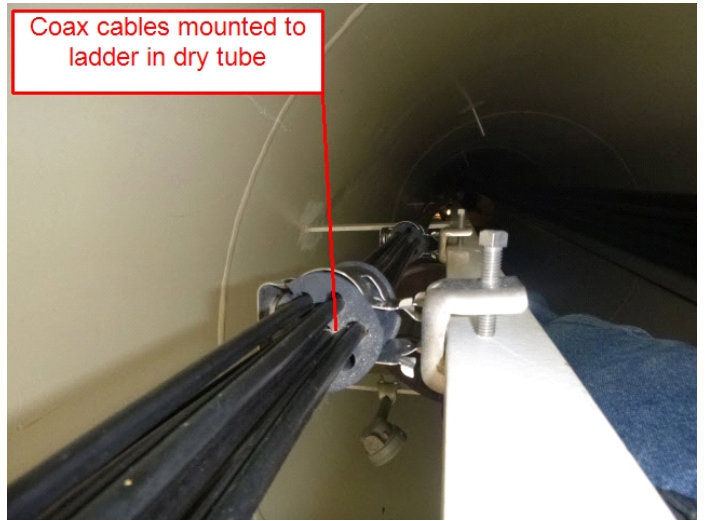
Coax cables mounted to ladder in dry tube

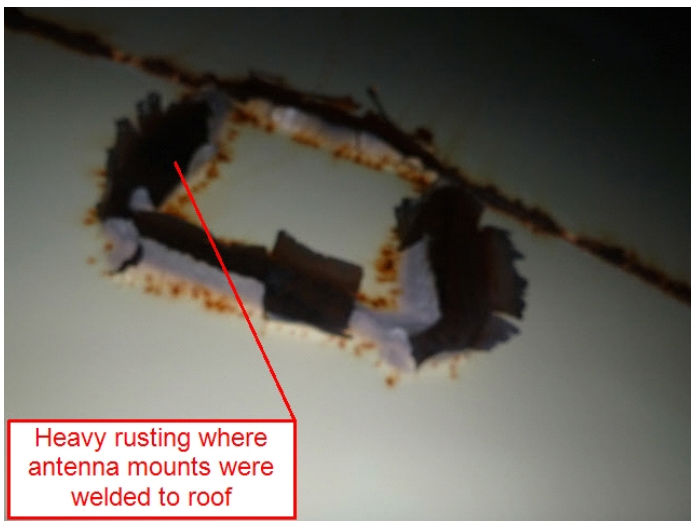
Heavy rusting where antenna mounts were welded to roof

| Component | Score | Comments |
|---|---|---|
| Interior Roof | 4 | Heavy rusting on roof seams and spot failures from welding antenna mounts |

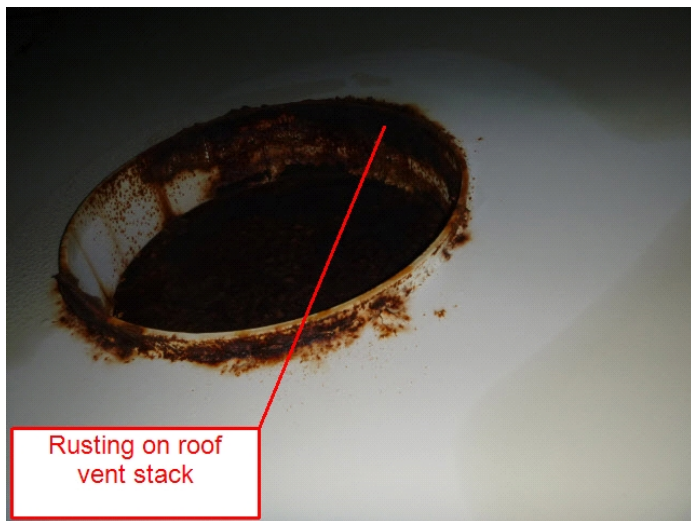
Rusting on roof vent stack

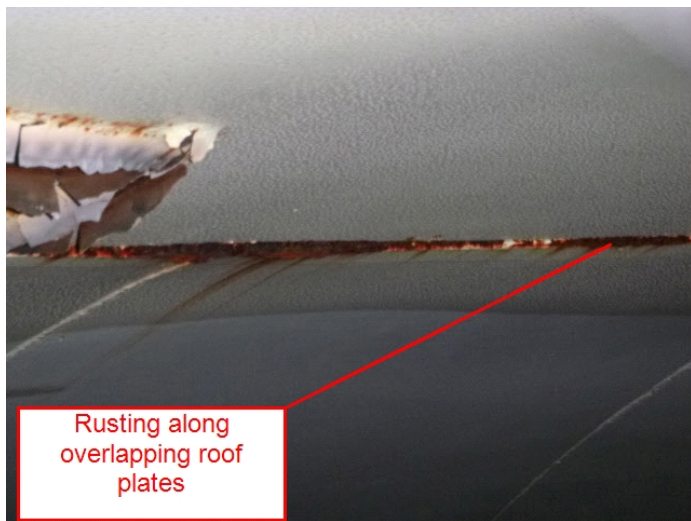
Rusting along overlapping roof plates

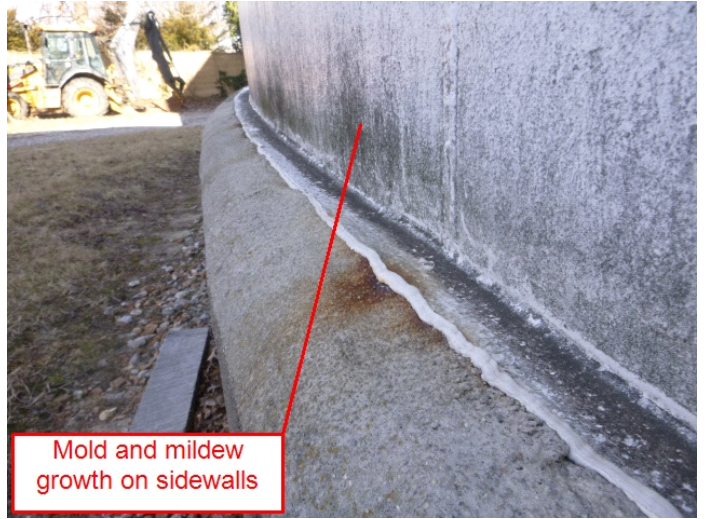
Exterior coating condition: Coatings are in fair condition with an average of 15.0-17.0 mils DFT. Isolated spots of top coat delamination where sidewalls meet lower flange. Spot failures with rust on top of wind girder.

Peeling paint where lower sidewall meets lower flange

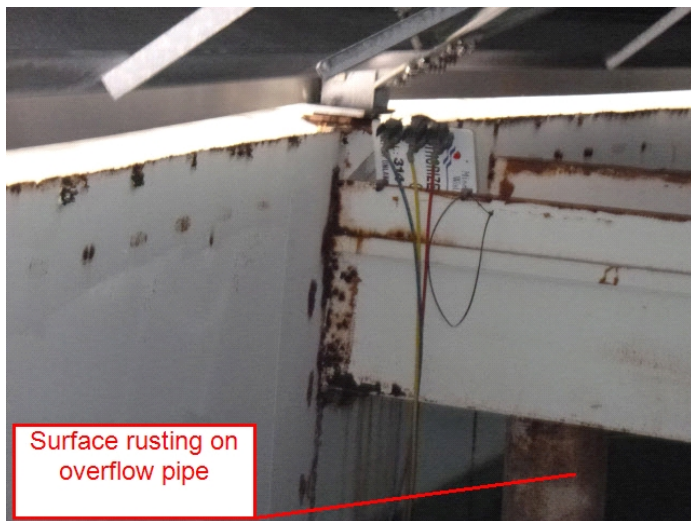
Surface rusting on overflow pipe
