Attachment #4 – ESP Report and Sample Results
 Eureka WWTF
 August 20, 2019
 Page 1 of 1

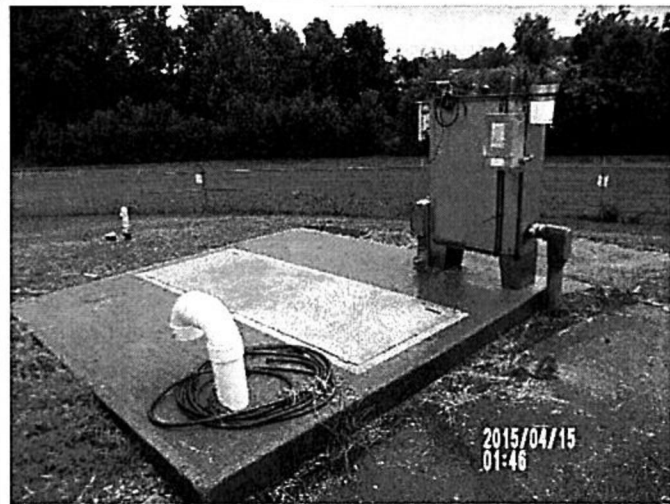
Photograph: # 1.
Taken By: Oscar Vazquez
Date Taken: July 29, 2019
Program: ECA Unit

Entity: Eureka WWTF
Permit: MO-0039569
Location: Influent Lift Station
Description: Wet well and pump control panel.

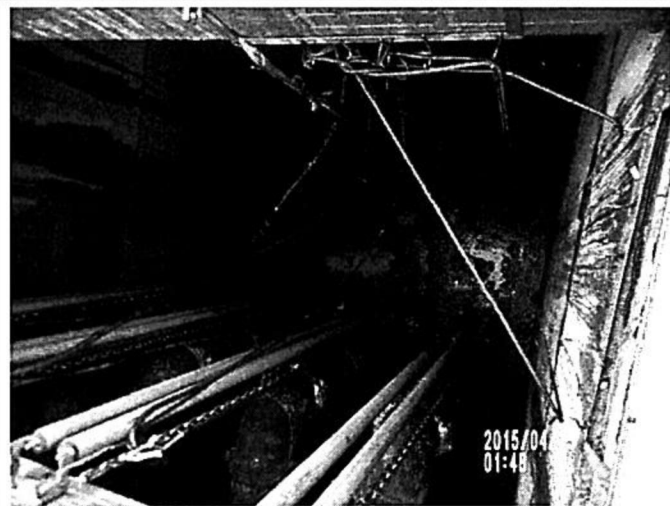
Photograph: # 2.
Taken By: Oscar Vazquez
Date Taken: July 29, 2019
Program: ECA Unit

Entity: Eureka WWTF
Permit: MO-0039569
Location: Influent Lift Station
Description: Wet well with four pump discharge lines.

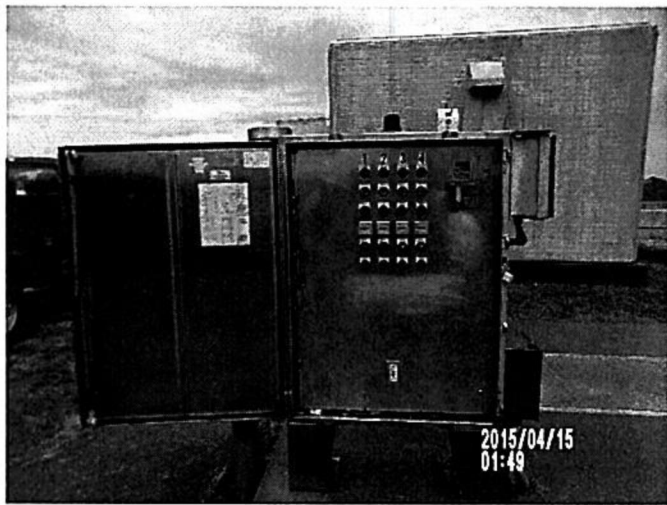
Photograph: # 3.
Taken By: Oscar Vazquez
Date Taken: July 29, 2019
Program: ECA Unit

Entity: Eureka WWTF
Permit: MO-0039569
Location: Influent Lift Station
Description: LS control panel features include pump run indicator lights, hand-off-auto selector switches, and elapse time meters.

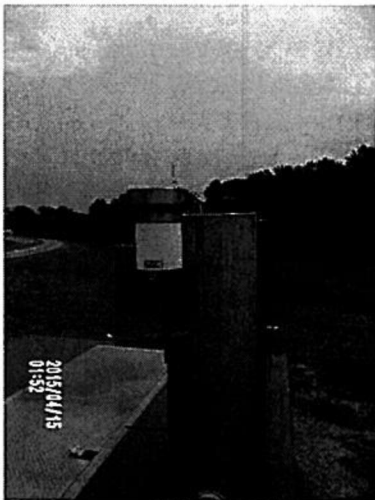
Photograph: # 4.
Taken By: Oscar Vazquez
Date Taken: July 29, 2019
Program: ECA Unit

Entity: Eureka WWTF
Permit: MO-0039569
Location: Influent Lift Station
Description: Rain gauge attached to LS control panel is integrated into a SCADA system.

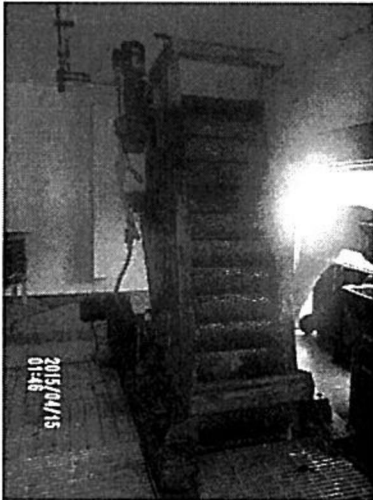
Photograph: # 5.
Taken By: Oscar Vazquez
Date Taken: July 29, 2019
Program: ECA Unit

Entity: Eureka WWTF
Permit: MO-0039569
Location: Fine Screen Building
Description: Fine Screen.

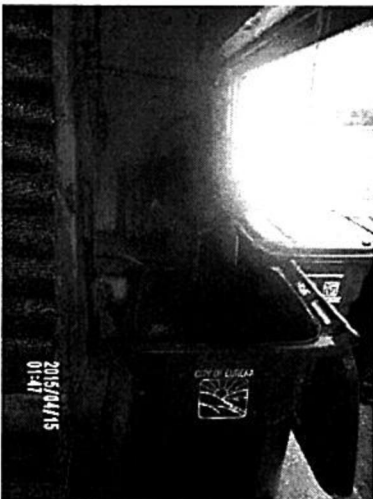
Photograph: # 6.
Taken By: Oscar Vazquez
Date Taken: July 29, 2019
Program: ECA Unit

Entity: Eureka WWTF
Permit: MO-0039569
Location: Fine Screen Building
Description: Compacted and dewatered screenings are dumped into 300-pound trash containers.

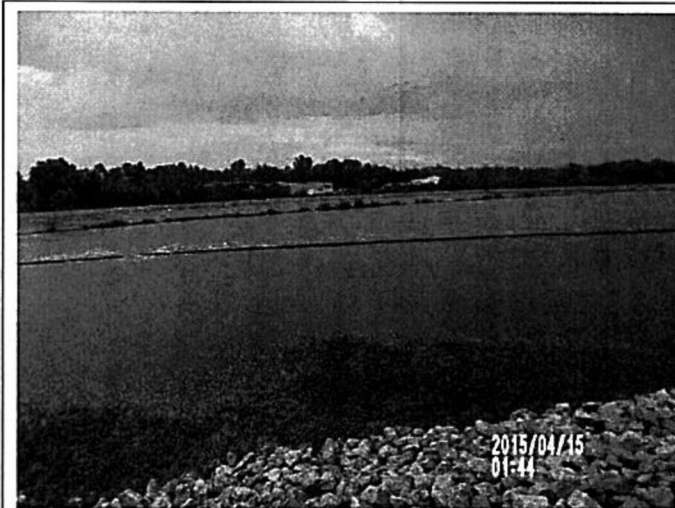
Photograph: # 7.
Taken By: Oscar Vazquez
Date Taken: July 29, 2019
Program: ECA Unit

Entity: Eureka WWTF
Permit: MO-0039569
Location: Three-Cell Aerated Lagoon
Description: Looking northeast from the southern shore of lagoon cell #1, near the bar screen building.

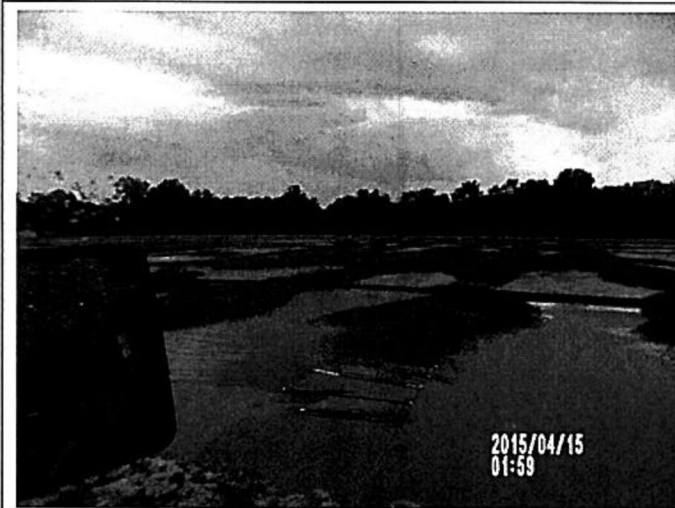
Photograph: # 8.
Taken By: Oscar Vazquez
Date Taken: July 29, 2019
Program: ECA Unit

Entity: Eureka WWTF
Permit: MO-0039569
Location: Three-Cell Aerated Lagoon
Description: Looking south from the northern shore of lagoon. A line of Aquamats® is shown here.

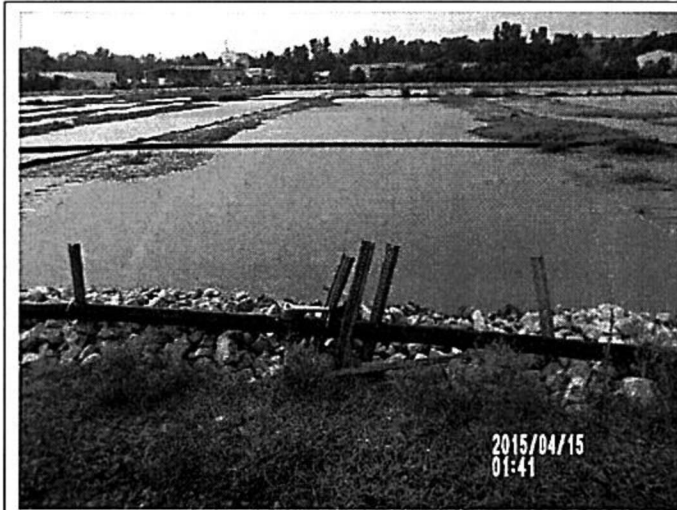
Photograph: # 9.
Taken By: Oscar Vazquez
Date Taken: July 29, 2019
Program: ECA Unit

Entity: Eureka WWTF
Permit: MO-0039569
Location: Three-Cell Aerated Lagoon
Description: Looking north from the southern shore of lagoon cell #2. The photo shows the valve operated to control the discharge of return wastewater into cell #2.

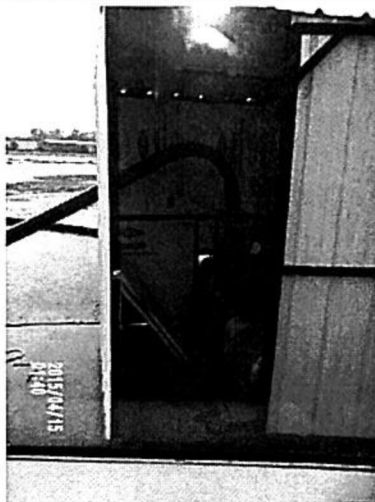
Photograph: # 10.
Taken By: Oscar Vazquez
Date Taken: July 29, 2019
Program: ECA Unit

Entity: Eureka WWTF
Permit: MO-0039569
Location: Recirculation Pump Shed
Description: The recirculation pump shown here is operated manually to recirculate approximately 6.5 MGD of wastewater from lagoon cell #3 back to lagoon cell #s 1 and 2.

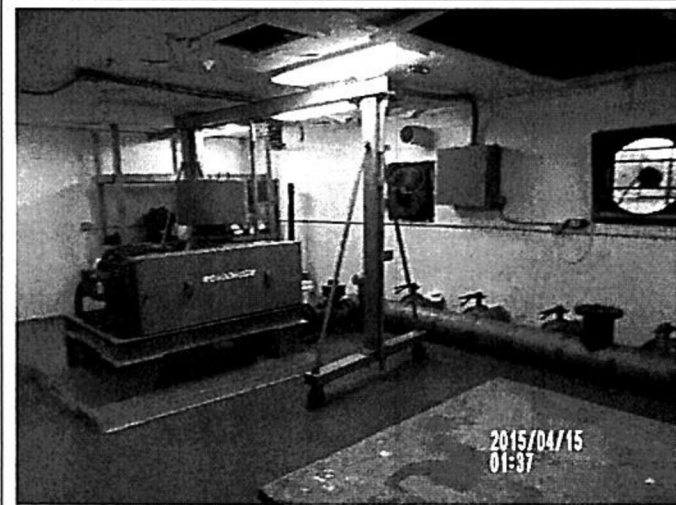
Photograph: # 11.
Taken By: Oscar Vazquez
Date Taken: July 29, 2019
Program: ECA Unit

Entity: Eureka WWTF
Permit: MO-0039569
Location: Blowers Building
Description: Old aeration pump used as backup.

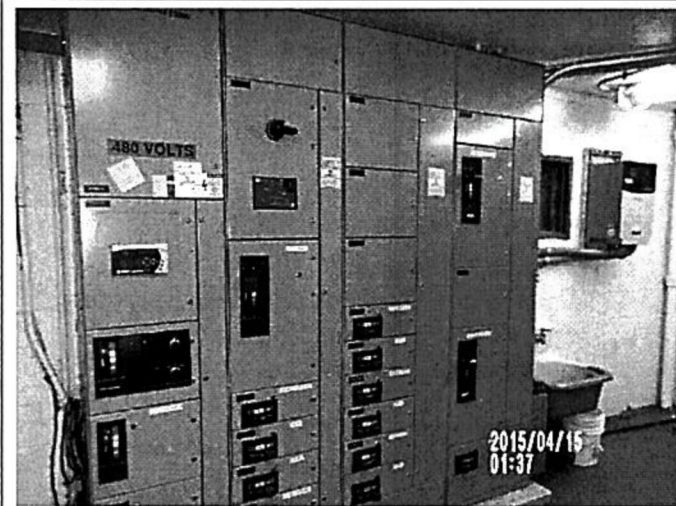
Photograph: # 12.
Taken By: Oscar Vazquez
Date Taken: July 29, 2019
Program: ECA Unit

Entity: Eureka WWTF
Permit: MO-0039569
Location: Blowers Building
Description: Aeration pump panels.

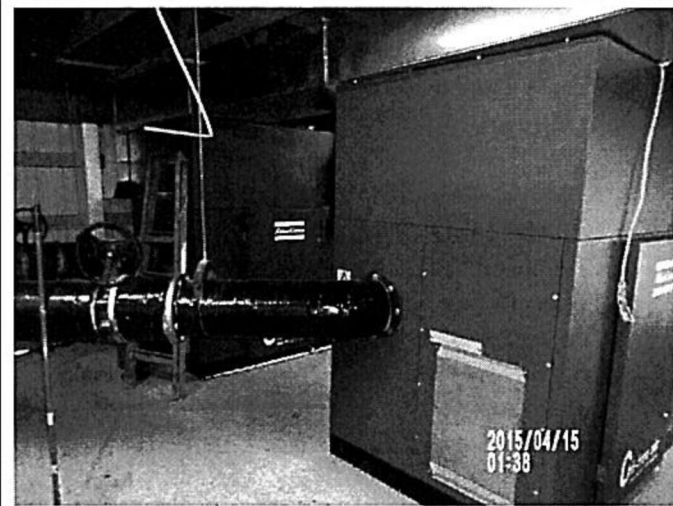
Photograph: # 13.
Taken By: Oscar Vazquez
Date Taken: July 29, 2019
Program: ECA Unit

Entity: Eureka WWTF
Permit: MO-0039569
Location: Blowers Building
Description: Turbo blowers.

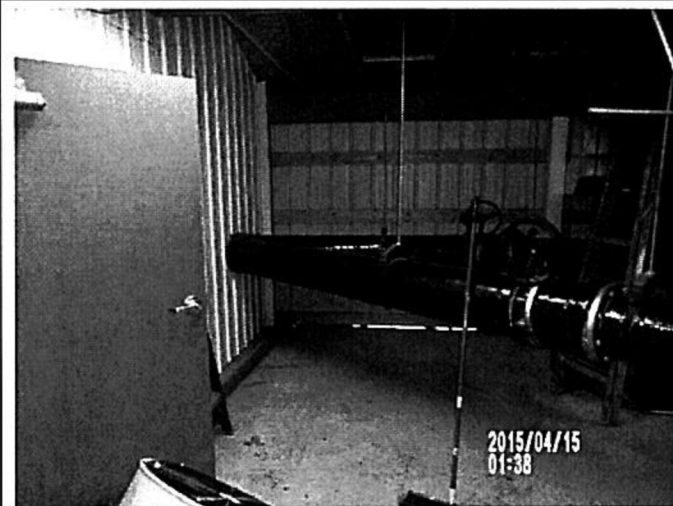
Photograph: # 14.
Taken By: Oscar Vazquez
Date Taken: July 29, 2019
Program: ECA Unit

Entity: Eureka WWTF
Permit: MO-0039569
Location: Blowers Building
Description: Turbo blower ducts system.

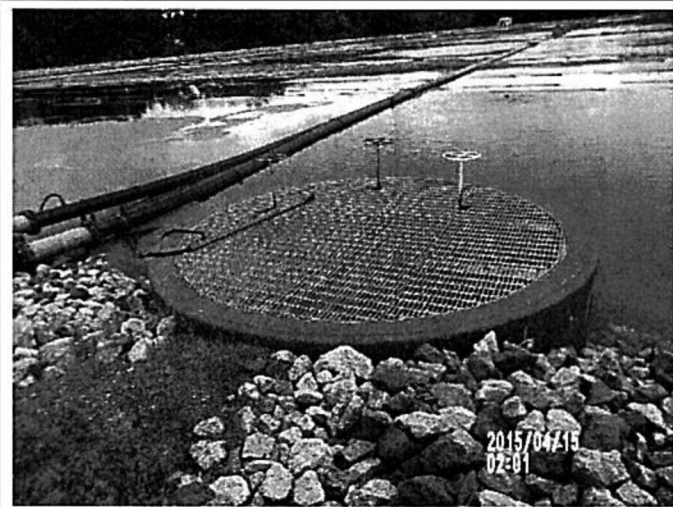
Photograph: # 15.
Taken By: Oscar Vazquez
Date Taken: July 29, 2019
Program: ECA Unit

Entity: Eureka WWTF
Permit: MO-0039569
Location: Effluent Structure
Description: The three valves are manually operated to draw and control lagoon cell #3 outflows at three different depths. To some extent, the effluent structure design allows the operator to control the lagoon effluent blend.

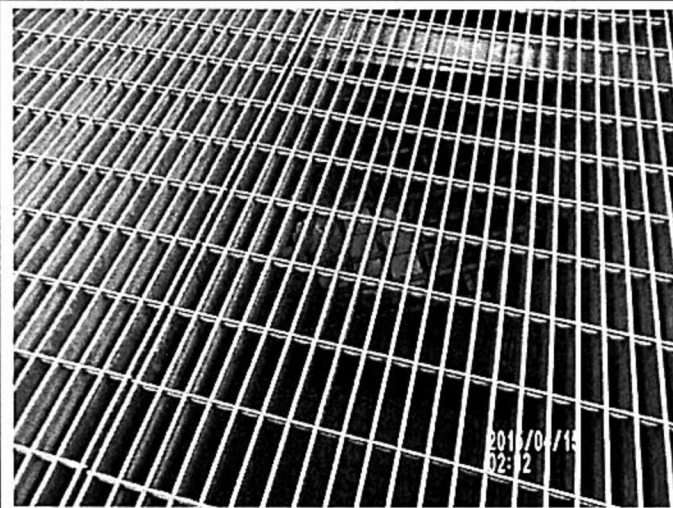
Photograph: # 16.
Taken By: Oscar Vazquez
Date Taken: July 29, 2019
Program: ECA Unit

Entity: Eureka WWTF
Permit: MO-0039569
Location: Effluent Structure
Description: The effluent blend overflows and is conveyed by gravity to the UV disinfection unit.

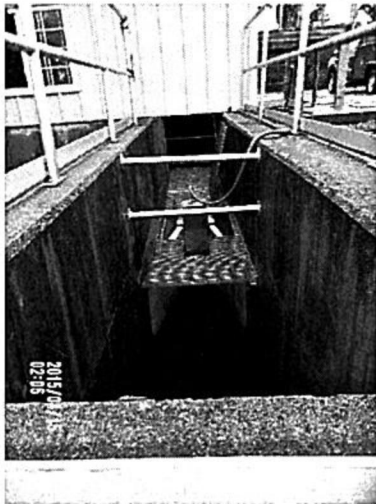
Photograph: # 17.
Taken By: Oscar Vazquez
Date Taken: July 29, 2019
Program: ECA Unit

Entity: Eureka WWTF
Permit: MO-0039569
Location: UV Disinfection System Building
Description: Looking downstream: Parshall channel with mounted ultrasonic flow meter.

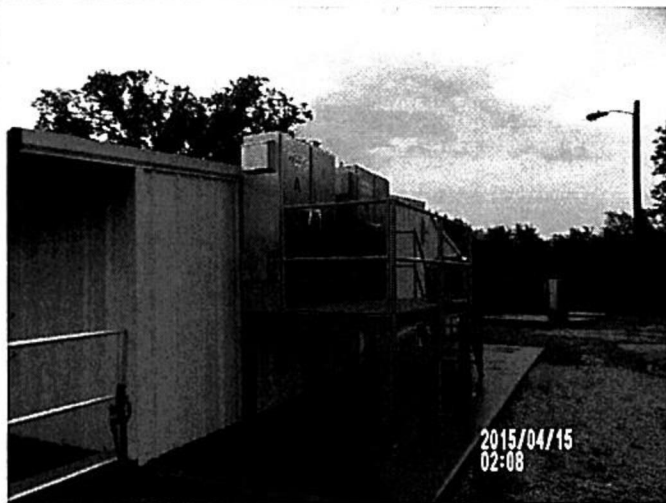
Photograph: # 18.
Taken By: Oscar Vazquez
Date Taken: July 29, 2019
Program: ECA Unit

Entity: Eureka WWTF
Permit: MO-0039569
Location: UV Disinfection System Building
Description: UV Disinfection Unit Control Panels are raised to the 100-year floodplain.

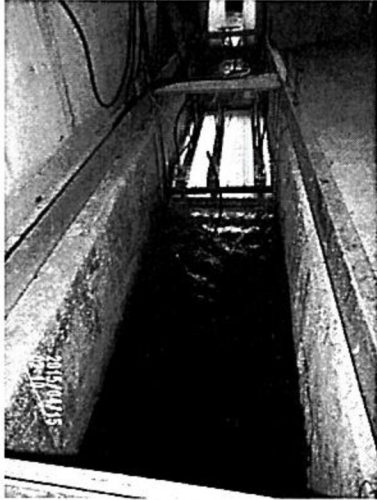
Photograph: # 19.
Taken By: Oscar Vazquez
Date Taken: July 29, 2019
Program: ECA Unit

Entity: Eureka WWTF
Permit: MO-0039569
Location: UV Disinfection System Building
Description: Looking upstream, after the Parshall channel, it can be observed that one of the UV disinfection banks and some modules were out of service at the time of inspection.

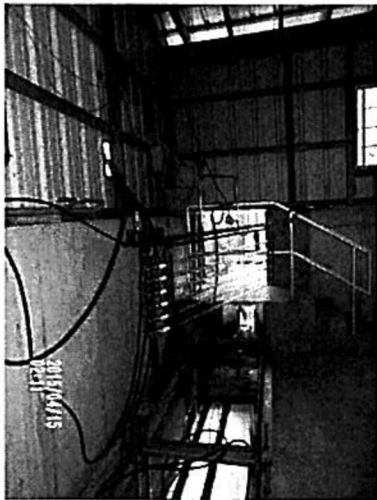
Photograph: # 20.
Taken By: Oscar Vazquez
Date Taken: July 29, 2019
Program: ECA Unit

Entity: Eureka WWTF
Permit: MO-0039569
Location: UV Disinfection System Building
Description: Out-of-service bulb module is shown in the photo.

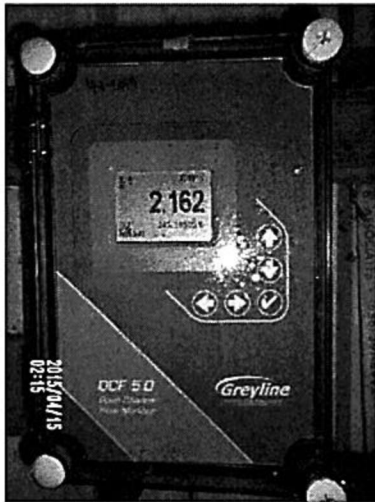
Photograph: # 21.
Taken By: Oscar Vazquez
Date Taken: July 29, 2019
Program: ECA Unit

Entity: Eureka WWTF
Permit: MO-0039569
Location: UV Disinfection System Building
Description: Flow meter controller.

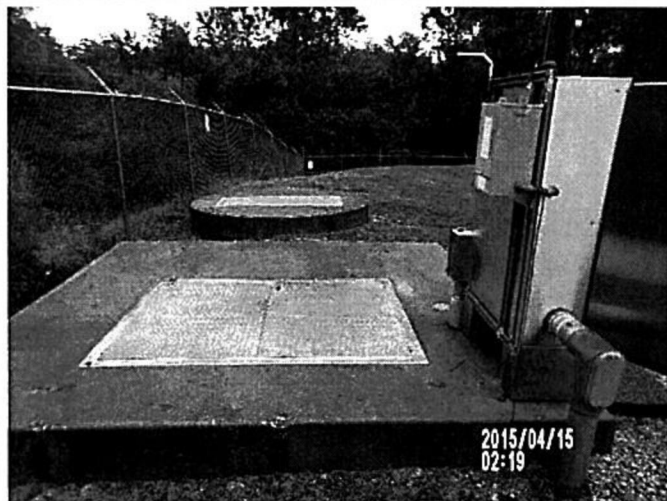
Photograph: # 22.
Taken By: Oscar Vazquez
Date Taken: July 29, 2019
Program: ECA Unit

Entity: Eureka WWTF
Permit: MO-0039569
Location: Effluent Lift Station (LS)
Description: In the foreground, the effluent LS and LS control panel. In the background, effluent check valves vault.

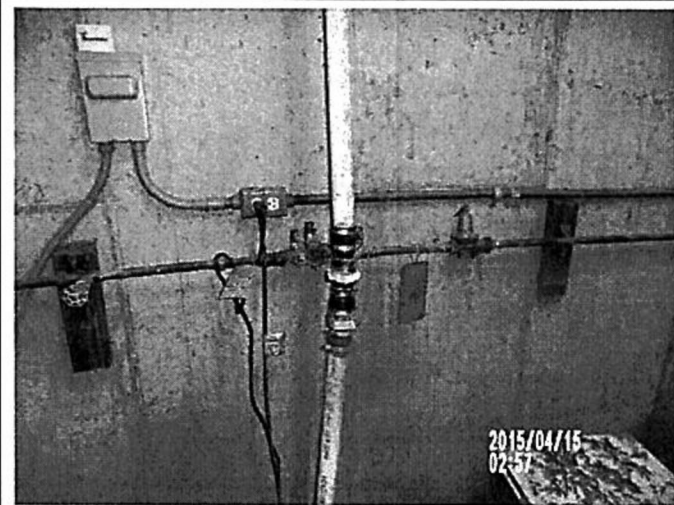
Photograph: # 23.
Taken By: Oscar Vazquez
Date Taken: July 29, 2019
Program: ECA Unit

Entity: Eureka WWTF
Permit: MO-0039569
Location: WWTF Office/Lab Building
Description: Backflow preventer.

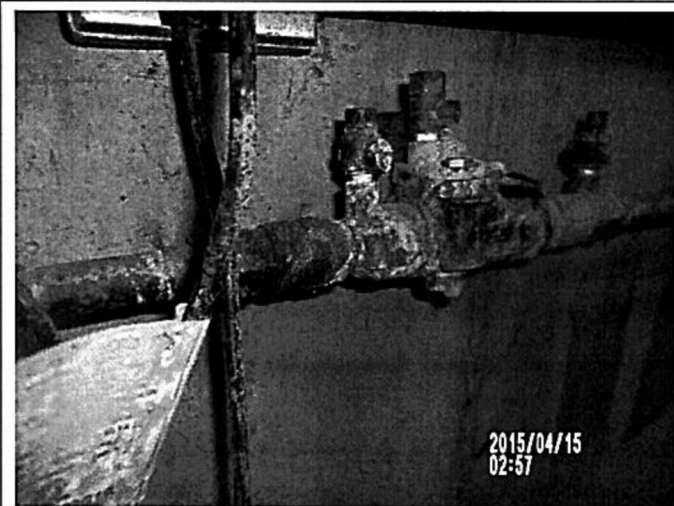
Photograph: # 24.
Taken By: Oscar Vazquez
Date Taken: July 29, 2019
Program: ECA Unit

Entity: Eureka WWTF
Permit: MO-0039569
Location: WWTF Office/Lab Building
Description: Backflow preventer.
