MISSOURI PUBLIC SERVICE COMMISSION

STAFF'S GAS INCIDENT REPORT

**South Charleston Avenue and East Republic Road
Springfield, Missouri
July 17, 2023**

**City Utilities of Springfield
Case No. GS-2024-0024**

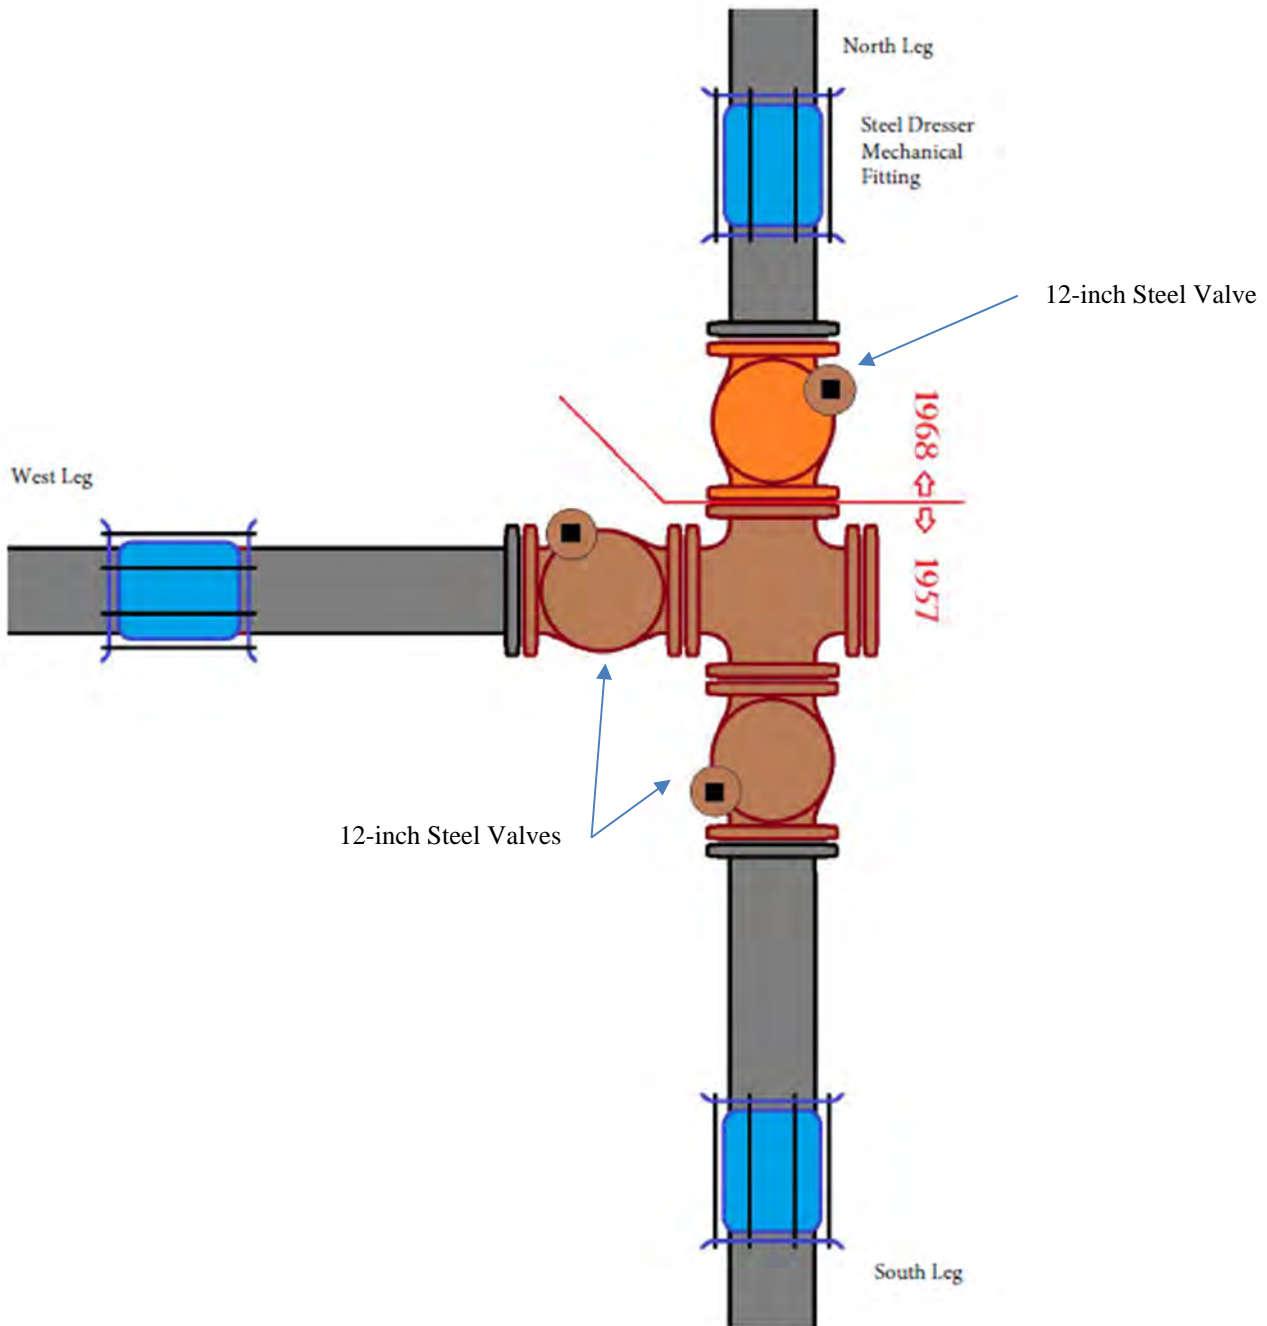
Figure 3: Schematic of Valve Cluster at Location of the July 17, 2023 Natural Gas Incident, Springfield Missouri (Source City Utilities of Springfield)

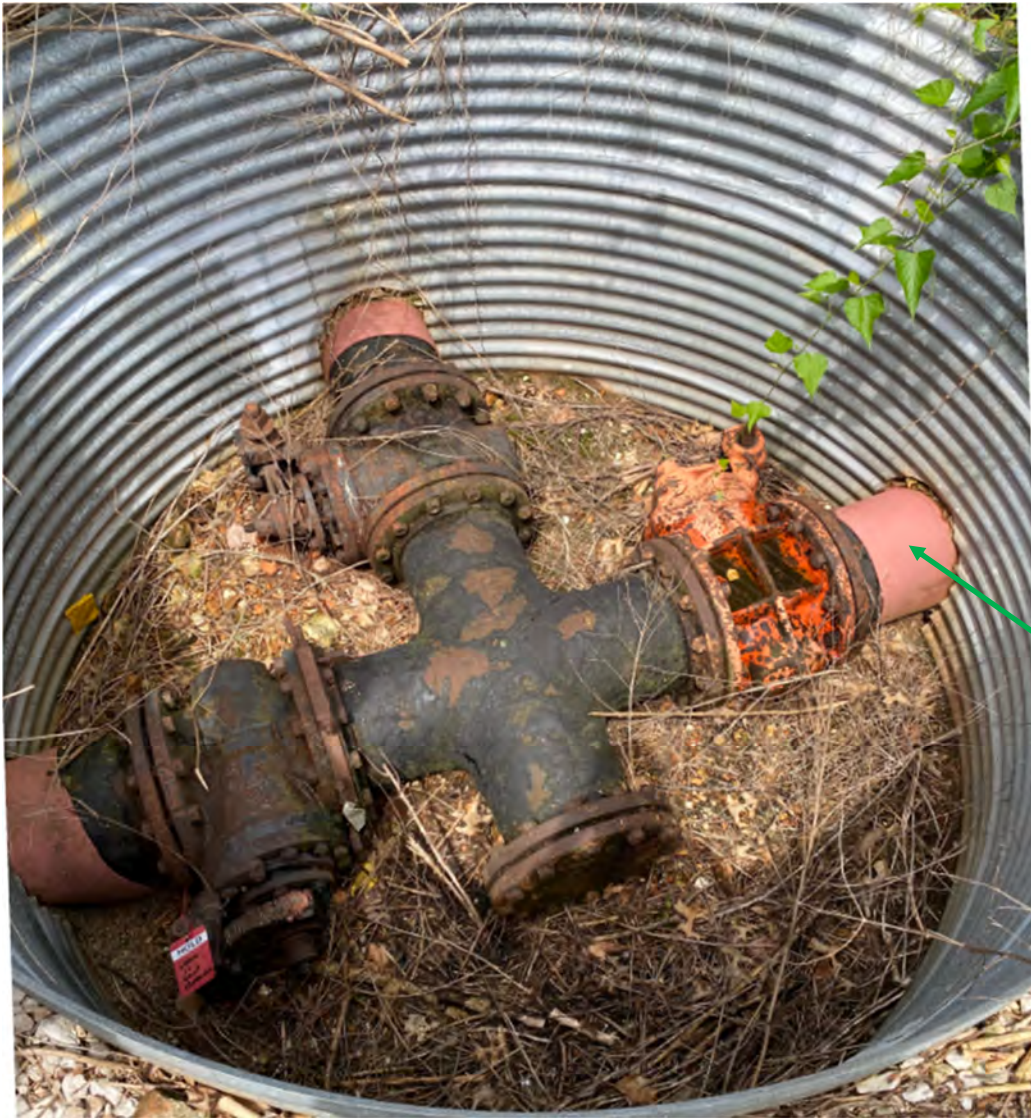
However, Staff notes that during the time that CU employees were performing work to loosen bolts on the flanges connecting valves to the cross-fitting within the valve pit (See Appendix B, Figure 4 of this Report), CU did not monitor the atmosphere within the valve pit for the presence of combustible gas. Ideally, the gas would have been entirely isolated from the valve pit by the closed valves on the north and west legs of the feeder line. However, there is a possibility that gas can leak past a closed valve. The valve pit is a semi-enclosed area, which could have delayed employee egress and allowed for concentration of gas in the vicinity of the flange.

Figure 4: Photograph of the Valve Cluster Pit that contains the cross-tee fitting. Taken by City Utilities Prior to the July 17, 2023 Natural Gas Incident, Springfield Missouri (Source City Utilities of Springfield in response to Staff Data Request 0006)

Staff recommends that CU revise its procedures to require monitoring of combustible gas concentrations in the atmosphere whenever its employees are performing work on facilities containing natural gas, and at a minimum when such work is being performed in enclosed or semi-confining locations such as valve pits where gas can concentrate or employee egress could be delayed.

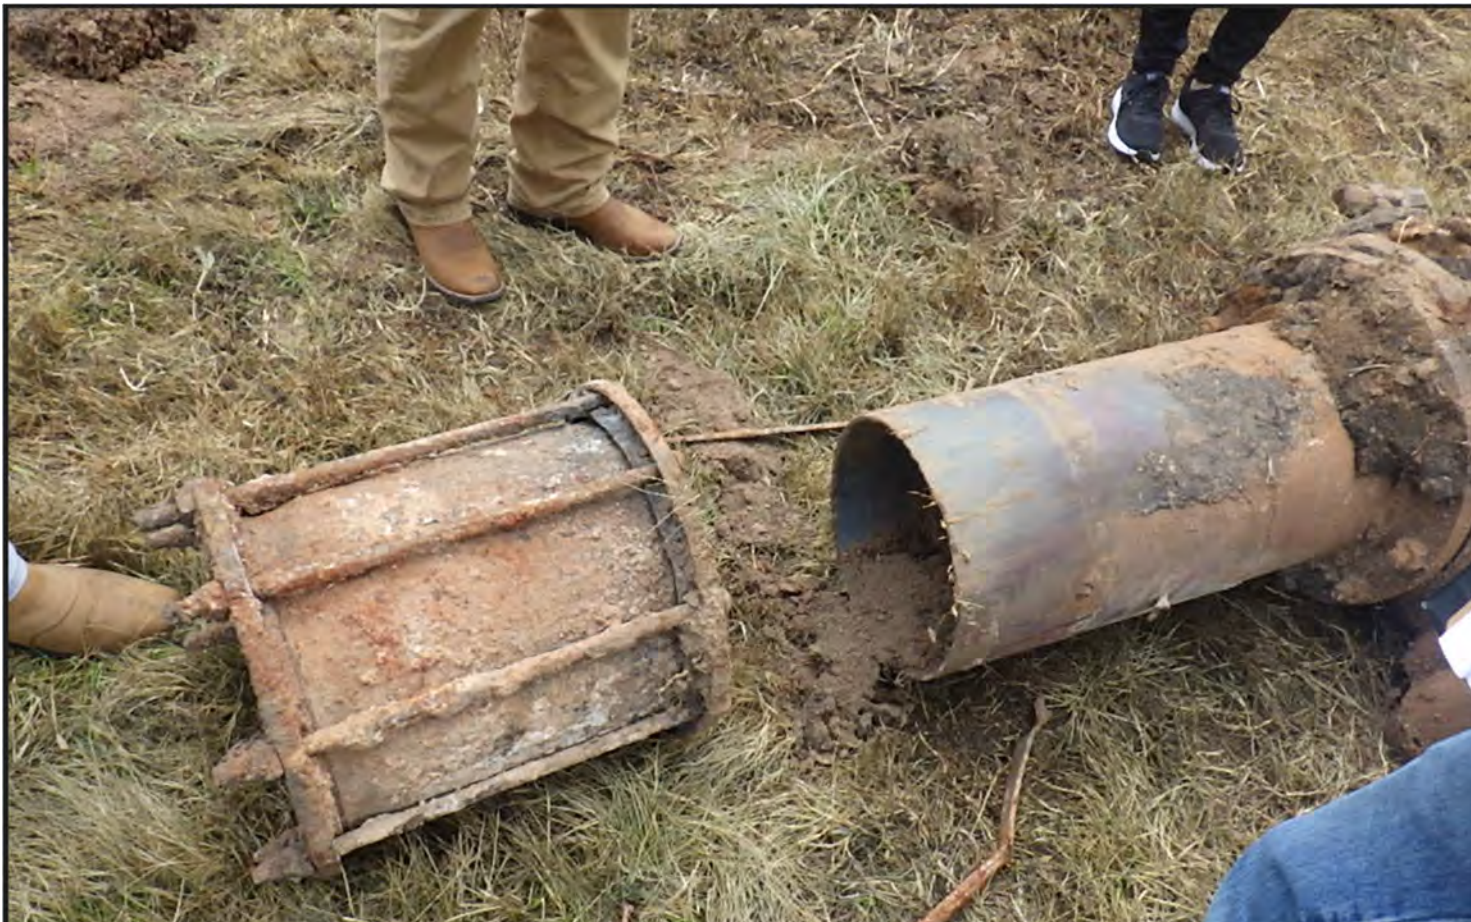
leak as a Dresser fitting located on the North leg of the feeder line upstream of the north valve (See Figure 6 of Appendix B of this report).

CU's investigation of this incident determined that the gas was released when a pipe segment separated from a Dresser mechanical fitting installed on the North Leg of the feeder line upstream of the closed valve as shown on Figure 6 in Appendix B of this Report. CU provided a copy of its confidential investigation report,⁷⁹ which is included as Confidential Appendix C to this Report. CU's investigation report identified the root cause of the incident to be **

Figure 6: Photograph showing Dresser fitting previously installed on the North Leg of the Feeder line separated from the North Leg piping following the incident (Source: Staff Photograph July 19, 2023).

1. Staff recommends that CU update its procedure for investigation of incidents to address the currently effective requirements of 20 CSR 4240-40.030(12)(L). This should include provisions that apply to both distribution and transmission pipelines.

2. Staff recommends that CU develop a procedure to formally evaluate potential hazards and abnormal conditions that may occur prior to performing non-routine activities on its pipelines. This should include a review of the pipeline design, construction and maintenance history, as well as the environment in which the pipe is installed.
