Appendix A - Facts

Spire Missouri Inc. d/b/a Spire

Case No. GS-2024-0137

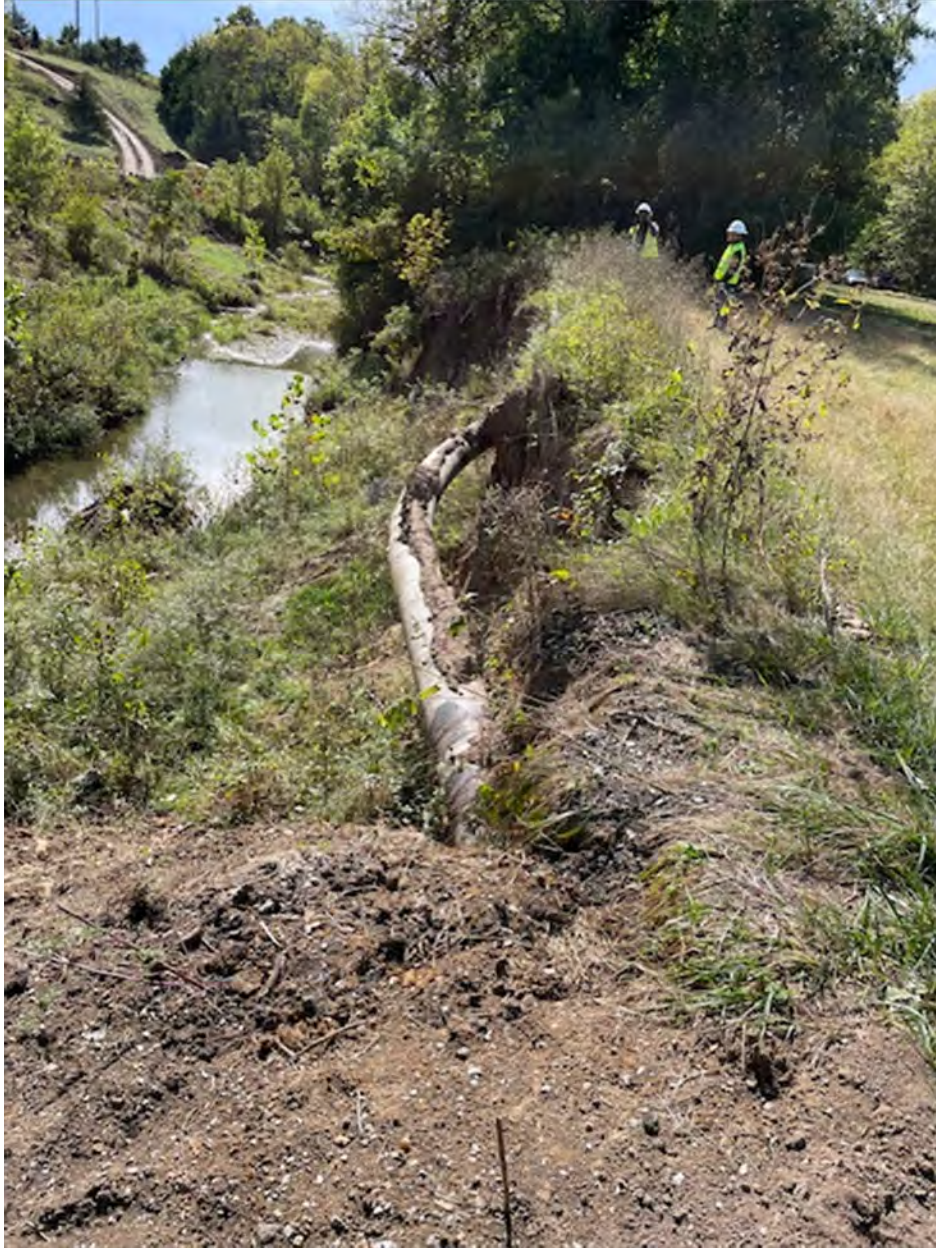
A segment of a natural gas feeder line¹ in Holt, Missouri had become exposed in a creek bank due to soil erosion. Employees of Spire Missouri, Inc. (“Spire”) and of a Spire contractor, ** [REDACTED] ** (“Pipeline Contractor”) were installing a new 12-inch steel pipe segment to replace the exposed segment, and retiring the exposed section of feeder line.

bank due to soil erosion. Figure 1 of *Appendix B- Figures and Photographs* of this Report shows the approximate location of the feeder line and Figure 2 shows the exposed segment and creek. Spire’s intended scope of work for October 5, 2023, included the replacement of the exposed segment with newly installed pipe⁸. This was to be accomplished by installation of stopple fittings⁹ and vent stacks, purging¹⁰ of new and replaced pipe segments, blow down (venting) of feeder line segment that was being replaced, and cutting and capping of the abandoned segment of feeder line. The work was being performed by Spire employees and employees of a Spire contractor, ** [REDACTED] ** (“Pipeline Contractor”). Additionally, an employee of ** [REDACTED] [REDACTED] ** (“Inspection Contractor”) was on site to observe and inspect the work on behalf of Spire.

Figure 2 – Photograph showing Segment of Pipeline Exposed in Creek Bank (Source: Staff Photograph)

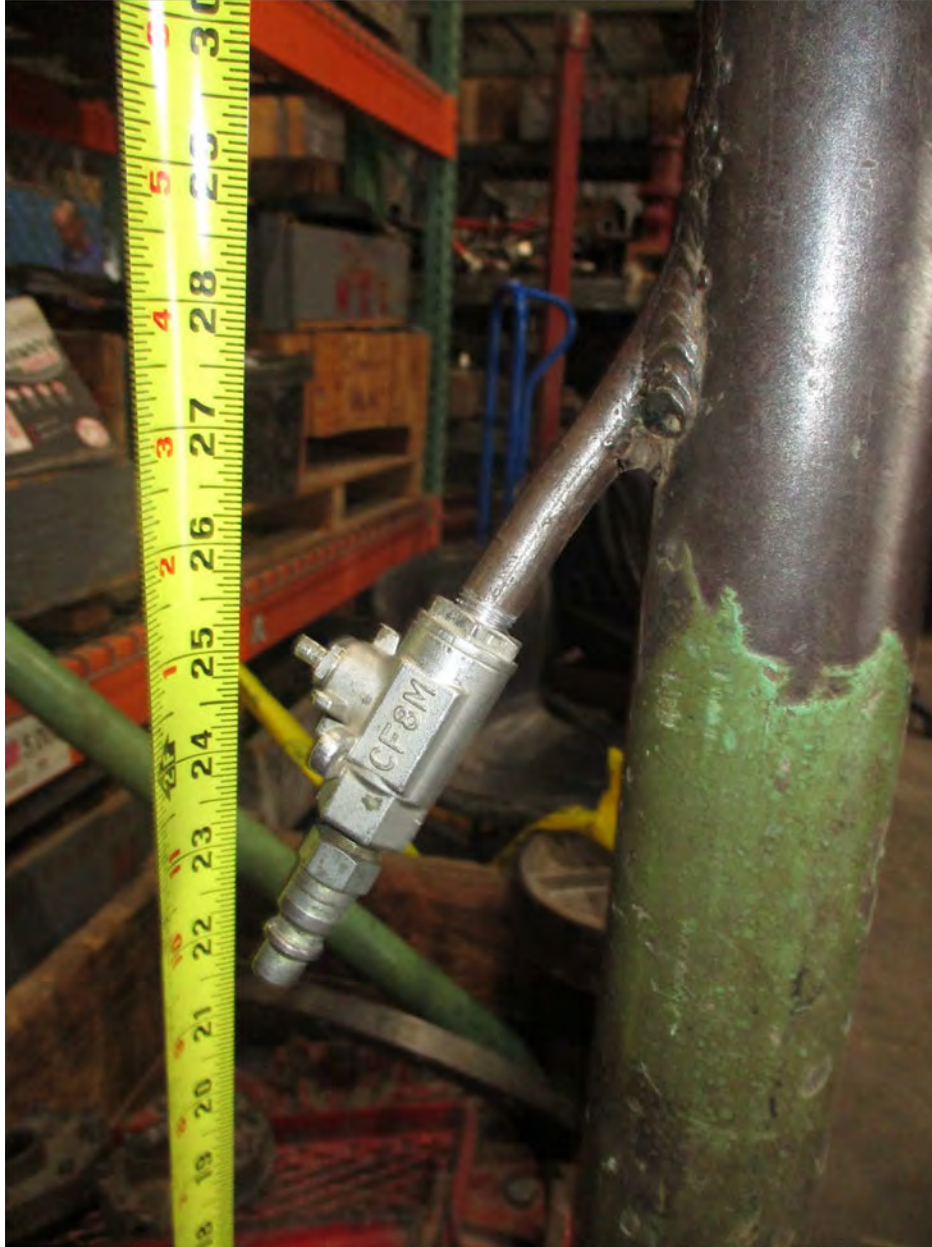
Gas was seeping past the stopple fitting to the pipe that was to be cut and capped. Two vent stacks were installed near the stopple fitting, and the closest vent stack used what Spire calls

an “air handler”⁴³ to create a vacuum from the 12-inch pipe and vent the natural gas out of the excavation and to the atmosphere. A fire extinguisher was provided near the location of the vent stacks.

Figure 3 – Photograph of vent stack that was used at the incident location showing air hose connection for air handler, pipe extending diagonally into the vent stack with open end inside the vent stack, and valve used to allow the flow of air from a compressor into the vent stack. The venturi-effect of the air flowing upward and out of the vent stack to the atmosphere creates a vacuum from the vent stack below this location and from the pipe segment connected to the bottom of the vent stack. (Source: Staff Photograph)
