Missouri-American Water Company – Exhibit 16  
Testimony of Matthew A. Lueders  
Direct  
File No. WR-2024-0320

Exhibit No.:	
Issues:	Water Storage Tank Rehabilitation, Risks of Providing Water & Sewer Service
Witness:	Matthew A. Lueders
Exhibit Type:	Direct
Sponsoring Party:	Missouri-American Water Company
Case No.:	WR-2024-0320 SR-2024-0321
Date:	July 1, 2024

**DIRECT TESTIMONY**

**MATTHEW A. LUEDERS**

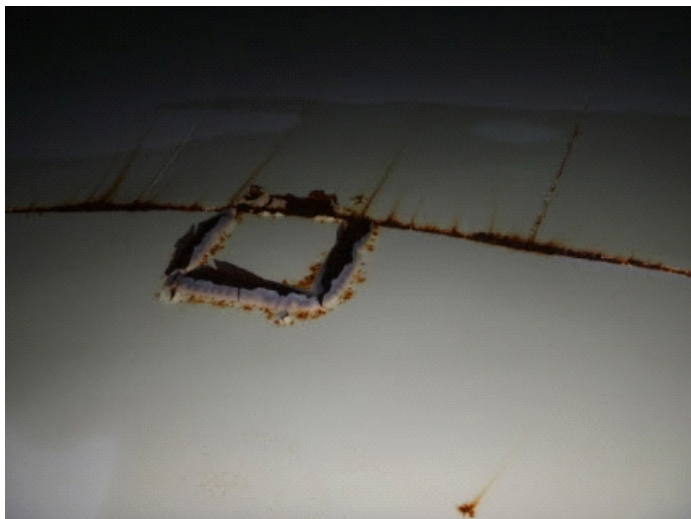
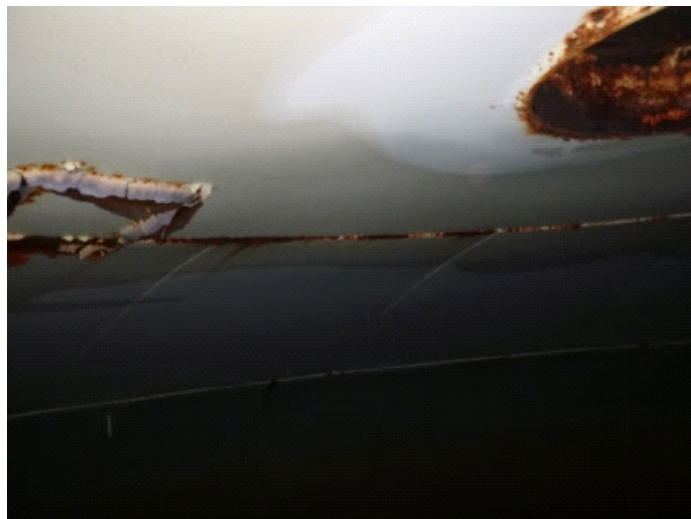
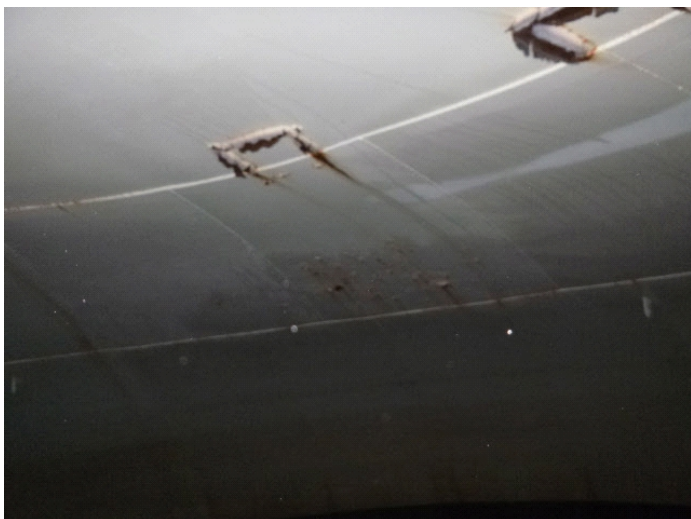
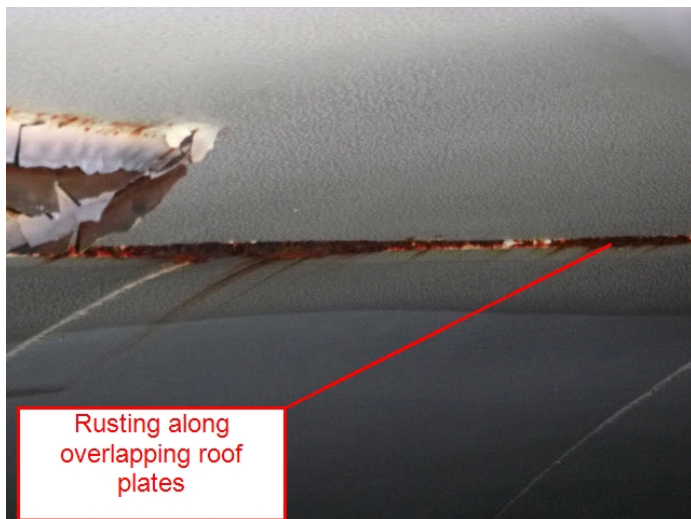
Rusting along  
overlapping roof  
plates
