## Gas Incident Report

**Missouri Gas Energy  
Case No. GS-2001-224**

1426 W. 50<sup>th</sup> Terrace  
Kansas City, Missouri  
August 8, 2000

Gas Safety Section ... Gas Department ... Utility Operations Division  
February 2001 Jefferson City, Missouri

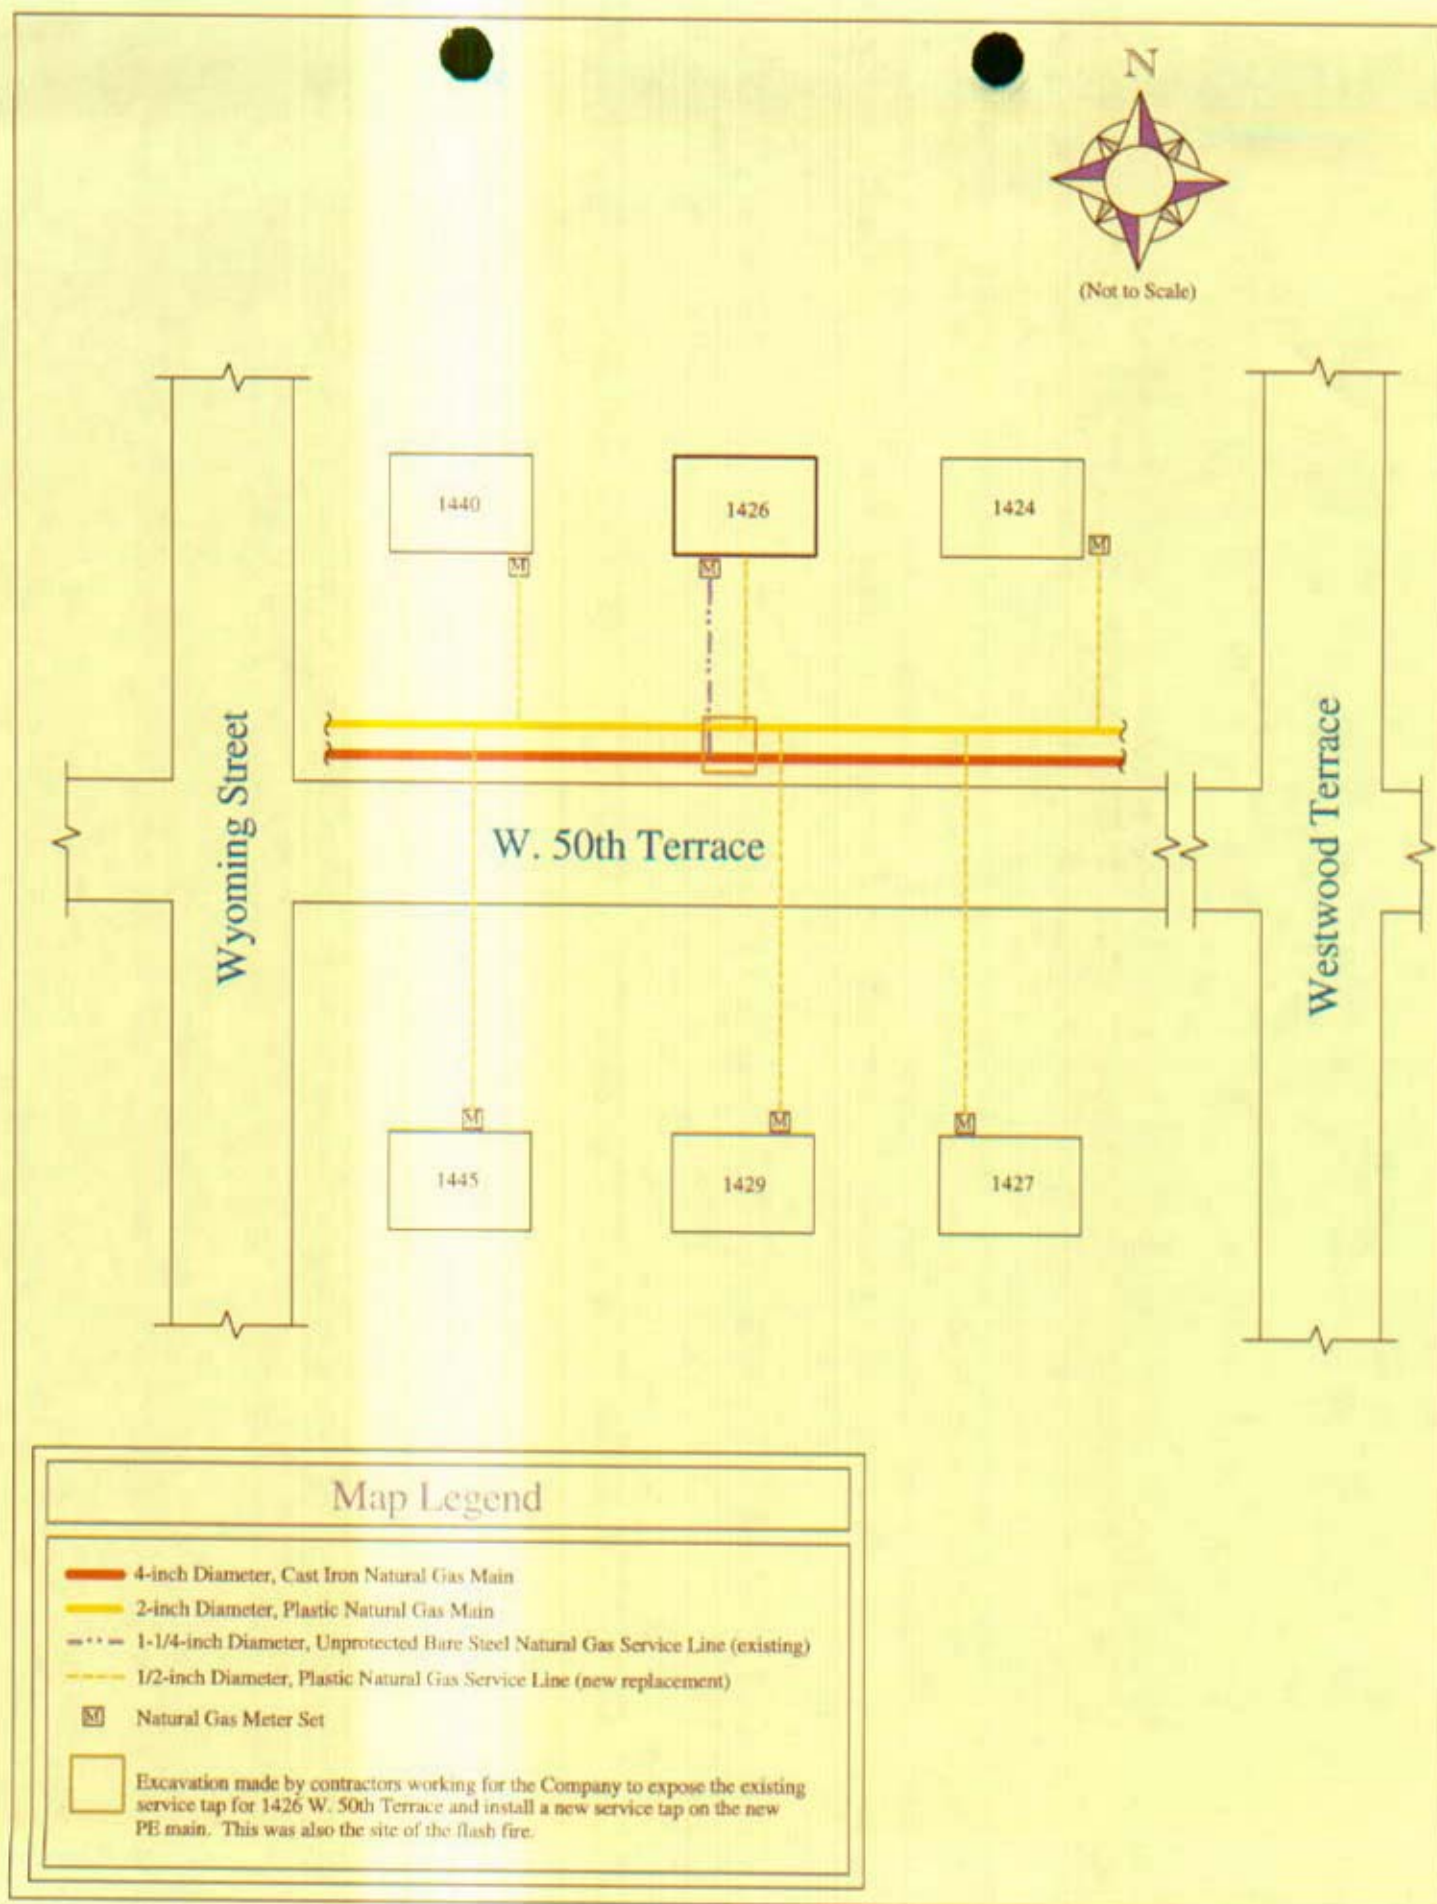
Figure 2  
Plan View of 1426 W. 50th Terrace Incident Area  
Appendix A-2

The excavation itself was located immediately north of the north curb of W. 50<sup>th</sup> Terrace (See Appendix A-2, Figure 2). The excavation was approximately five feet long and five feet wide and was approximately 36 to 40 inches in depth. The excavation contained the following: an exposed section of 4-inch diameter, cast iron natural gas main; an exposed section of 2-inch diameter, PE natural gas main; the existing tapping tee and exposed section of 1¼-inch diameter, bare-steel service line to 1426 W. 50<sup>th</sup> Terrace; and, a new PE tapping saddle and exposed section of new ½-inch diameter, PE service line to 1426 W. 50<sup>th</sup> Terrace.

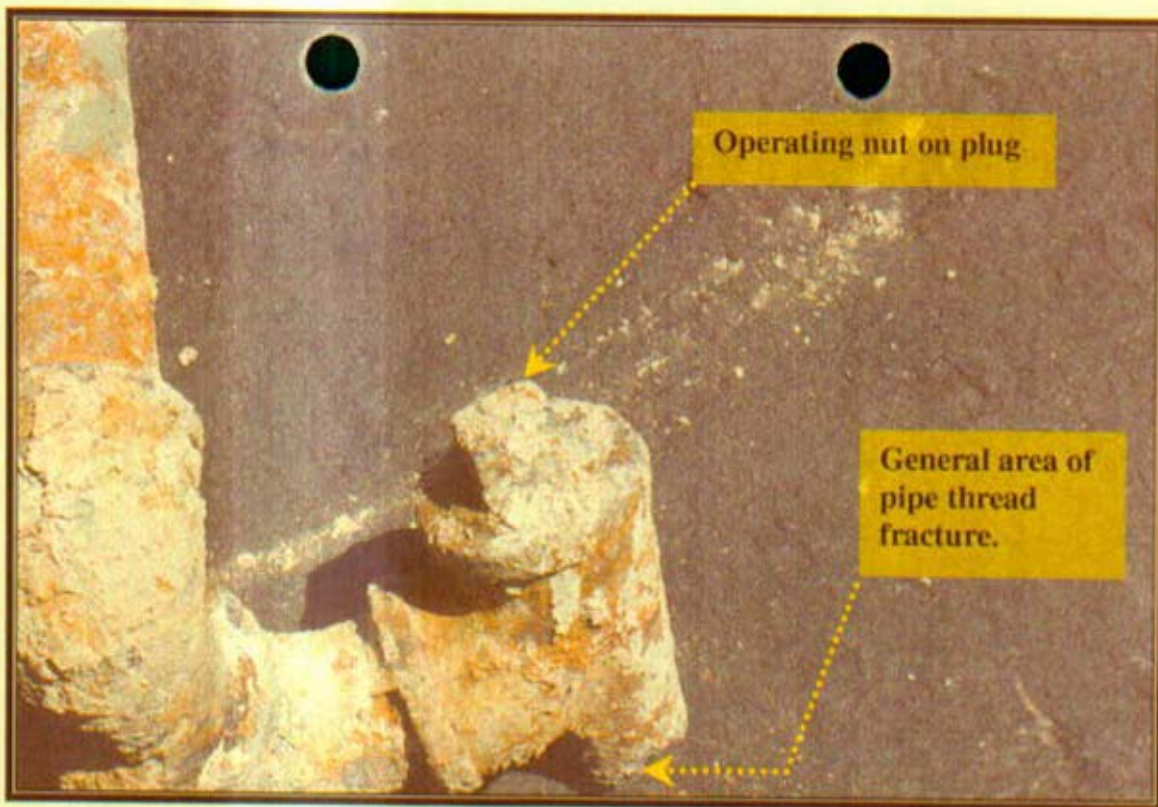
Upon initial examination, the Staff noted that the fittings and piping exhibited general corrosion<sup>15</sup> and pitting of the base metal. The pipe and fittings were covered with hardened clay and corrosion scale (See Appendix B-1, Photographs 1 and 2, and Appendix B-2, Photograph 4). The fracture in the tapping tee was located at the first non-engaged thread in the threaded portion of the base of the tee (See Appendix B-1, Photograph 1 and Appendix B-2, Photograph 4). The Staff also observed that at the point of fracture at the base of the tee, heavy corrosion had thinned the pipe wall appreciably (See Appendix B-1, Photograph 2). An observation of the broken-off pipe threads from the tapping tee also revealed an appreciable amount of pipe wall thinning at the point of fracture due to corrosion (See Appendix B-2, Photograph 3).

The Staff also observed marks and gouges on the operating nut on the top of the plug. This could have resulted from applying torque to the plug with a wrench (See Appendix B-1, Photograph 1).

**Photograph 1** View of the top side of the tapping tee and attached piping.

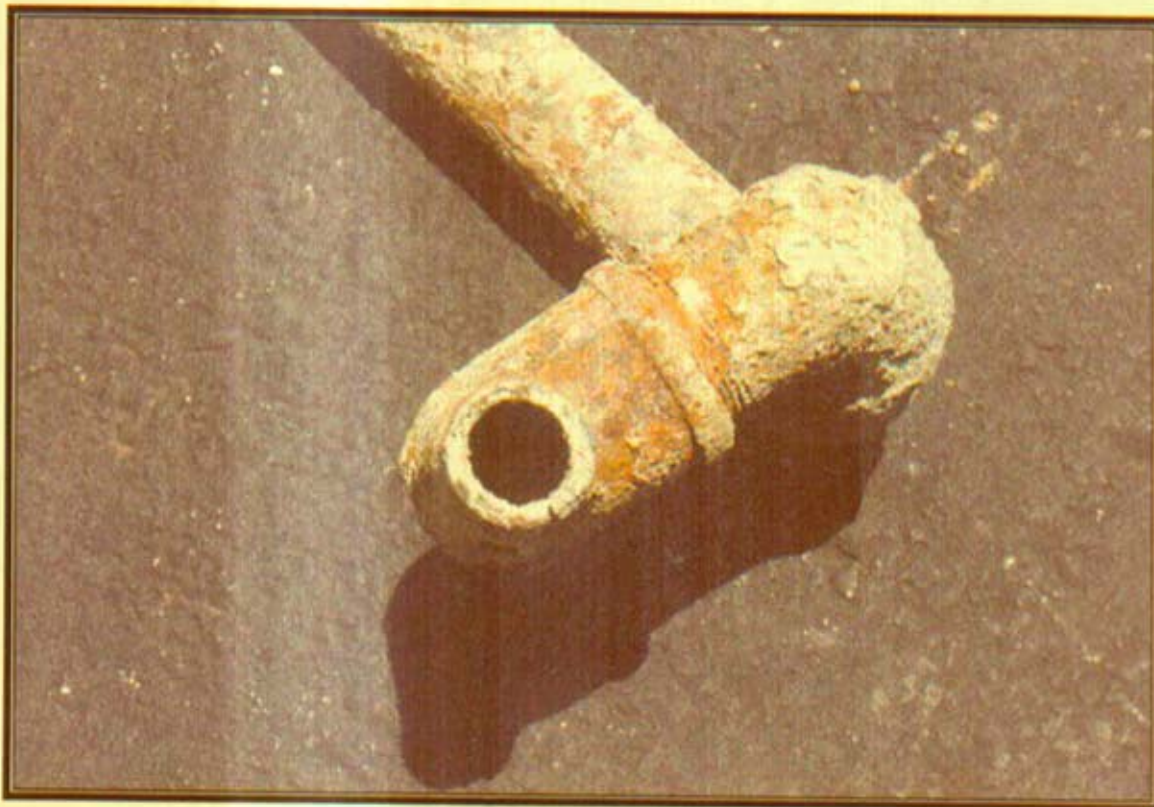
The fracture of the tapping tee occurred as a result of forces exerted on the plug in the top of the tee. These forces were imposed on the tapping tee when a GDC employee applied torque to the operating nut on the plug with an adjustable-wrench. This external force induced stresses beyond the strength of the remaining steel at the fracture location. The fracture initiated at the first non-engaged pipe thread of the base of the tapping tee.

The nominal wall thickness of the tapping tee base was reduced at the fracture initiation point (first non-engaged pipe thread) due to the depth of the threads in the pipe. The nominal pipe wall thickness of the tapping tee base was reduced even more because of the loss of metal due to the effects of corrosion.

**Photograph 2** View of the underneath side of the tapping tee base where the pipe threads fractured.

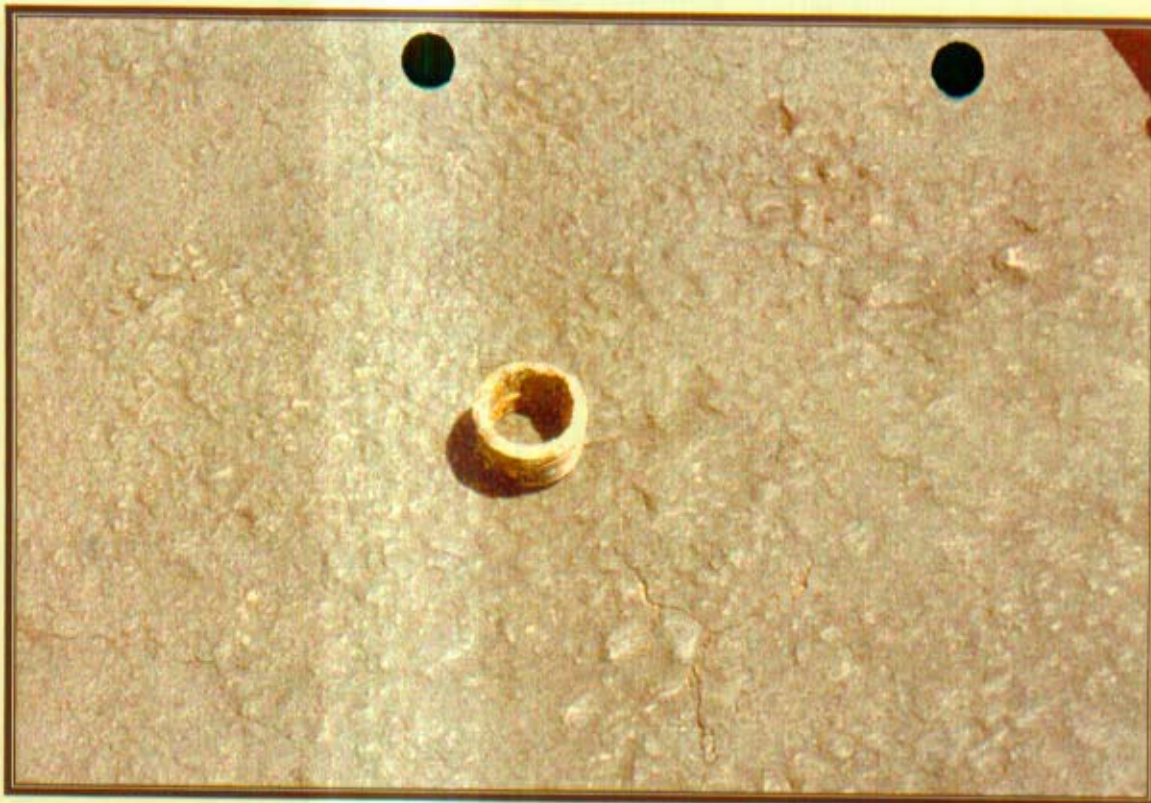
Over a period of years, the normal process of corrosion resulted in general corrosion of the tapping tee, fittings, and service line piping. The corrosion caused thinning of the pipe wall at the location of the threaded portion of the tapping tee base. The corrosion process would have occurred over a long period of time. No evidence was discovered to determine that exact length of time that the corrosion existed prior to the fracture of the tapping tee. The amount of metal loss at the point of fracture indicates that the corrosion process was active for an extended period of time.

Because steel is a less noble metal (i.e., lower on the galvanic series) than cast iron, the steel tapping tee would have tended to corrode to "protect" the cast iron main. Since the threaded portion of the tapping tee was in direct contact with the cast iron main, the corrosion would tend to concentrate in this location.

**Photograph 3**  
View of the fractured pipe threads that separated from the bottom of the tapping tee. Note the corrosion on top of the threads.

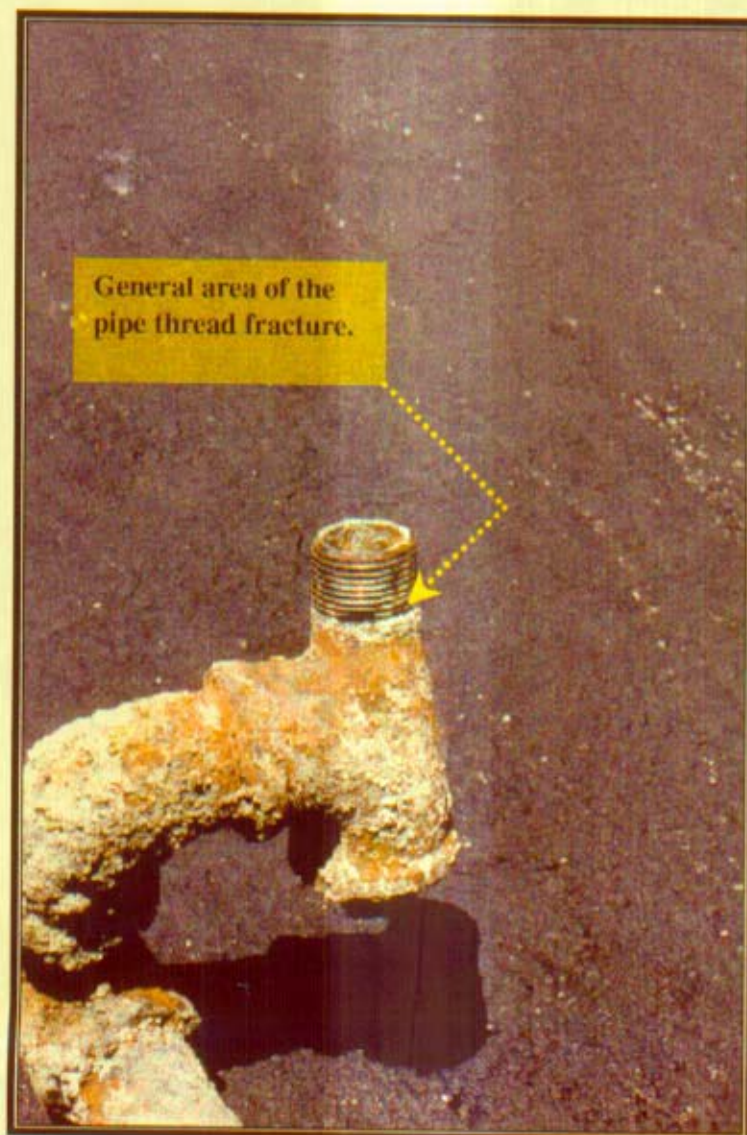
The force exerted by the application of the wrench on the operating nut of the plug in the tapping tee created a twisting moment in which the shear stress exceeded the shear strength of the remaining metal in the corroded pipe threads, causing the failure at the weakest point.

**Photograph 4** View of the tapping tee with the section of fractured pipe threads placed on top of the tapping tee. NOTE: The tapping tee and attached pipe components were actually oriented 180° from the position shown.
