Exhibit No.:
Issues: Capital Investment Program,
Description of Plant Additions, Water
Storage Tank Rehabilitation, Risk
Associated with Providing Public
Water and Wastewater Services
Witness: Rebecca B. Losli
Exhibit Type: Direct
Sponsoring Party: Missouri-American Water Company
Case No.: WR-2022-0303
SR-2022-0304
Date: July 1, 2022

DIRECT TESTIMONY

REBECCA B. LOSLI

MISSOURI-AMERICAN WATER COMPANY

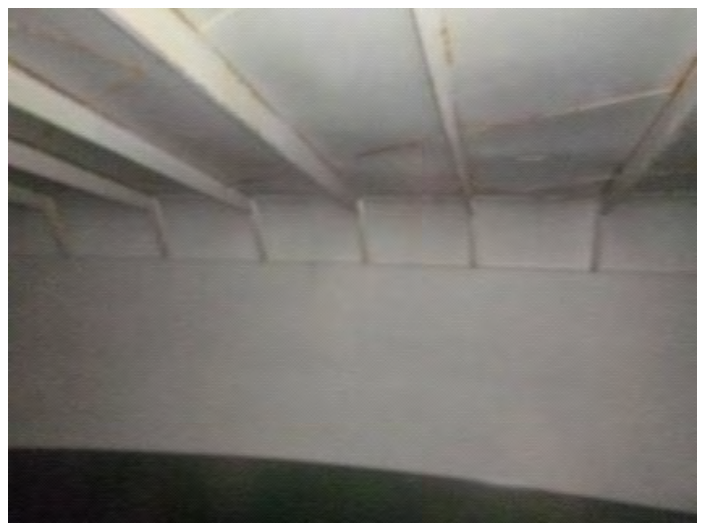
Rusting on tops of roof beams
due to roof plates contacting
tops of roof plates

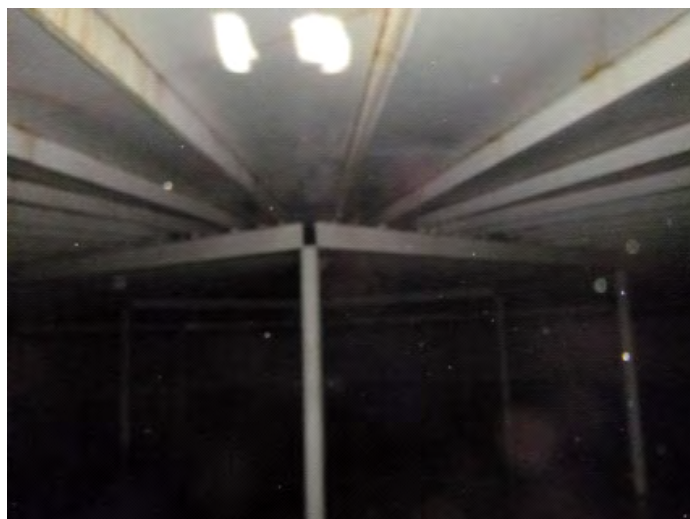
Spot rusting on beams

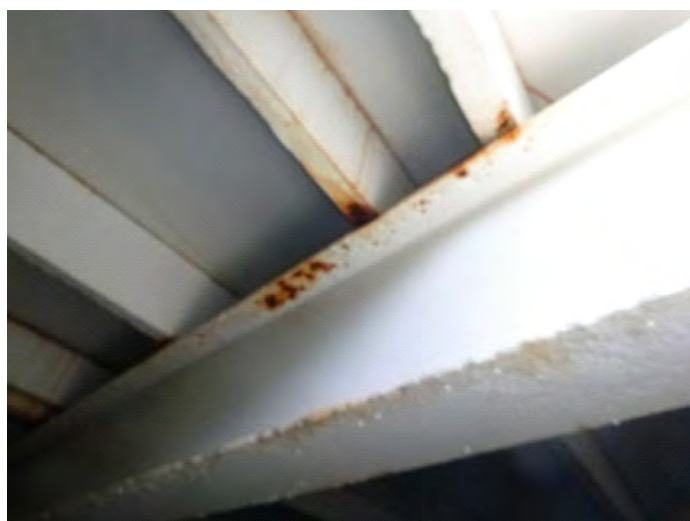
Rust streaking from top of beams
