**MISSOURI PUBLIC SERVICE COMMISSION**  
**STAFF'S GAS INCIDENT REPORT**

**426 E Fair Street  
Independence, MO  
August 26, 2024**

**Spire Missouri, Inc.  
Case No. GS-2025-0068**

**STAFF’S GAS INCIDENT REPORT**  
**SPIRE MISSOURI, INC.**  
**CASE NO. GS-2025-0068**

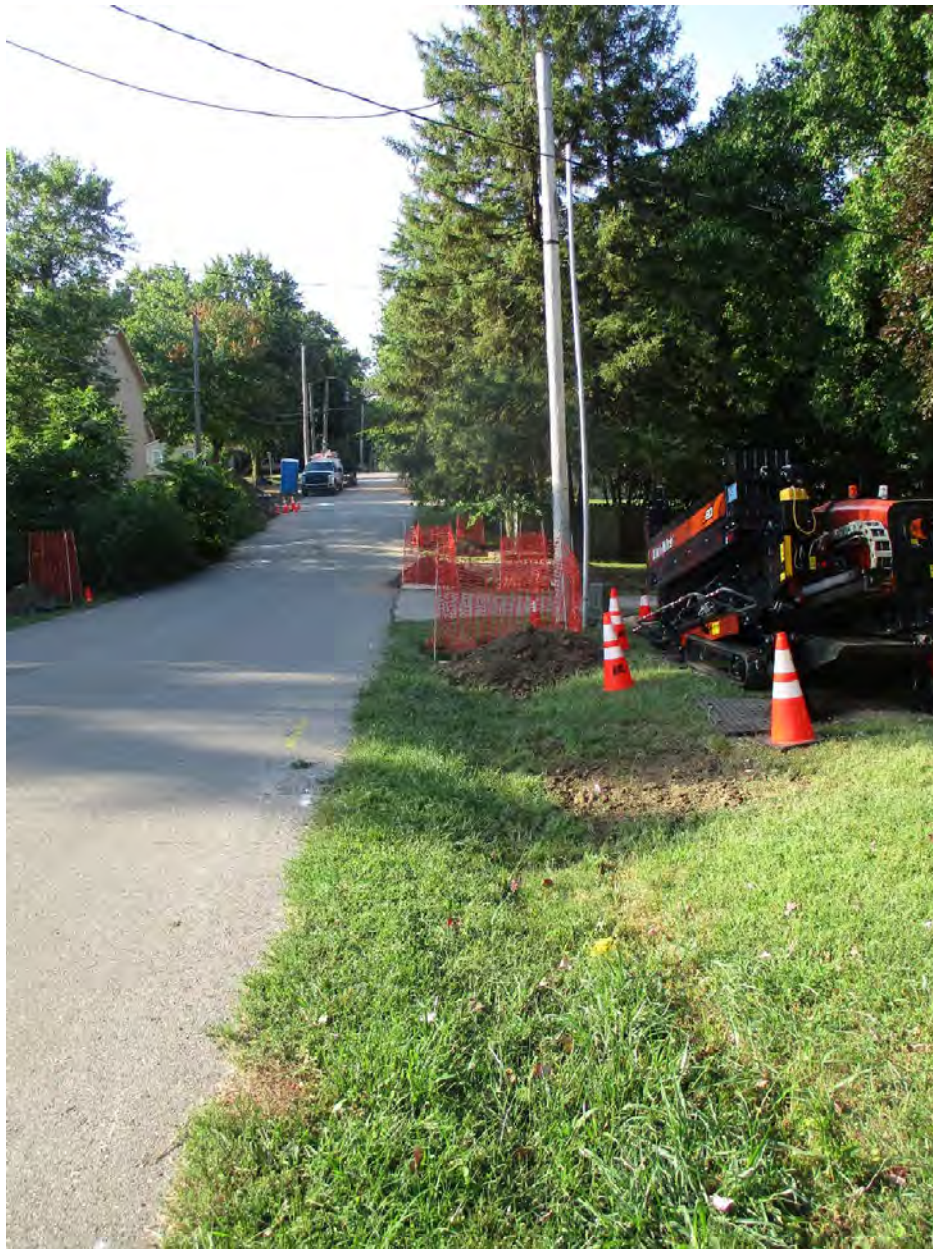
Figure 4 – Photograph looking south along South Hocker Ave. The horizontal directional drilling machine is set up on right side of image in order to install telecommunications line heading south alongside South Hocker Ave. (Staff photograph)
