STAFF'S GAS INCIDENT REPORT

**Grandview Road
Kansas City, MO
April 22, 2025**

Failure Investigation Report (FIR)

Principal Investigators Missouri PSC – ** [REDACTED] **
responded to incident site on April 22 and 23, 2025.
Date of Report 04/28/2026
Subject Failure Investigation Report – Spire Missouri West – Third Party Damage

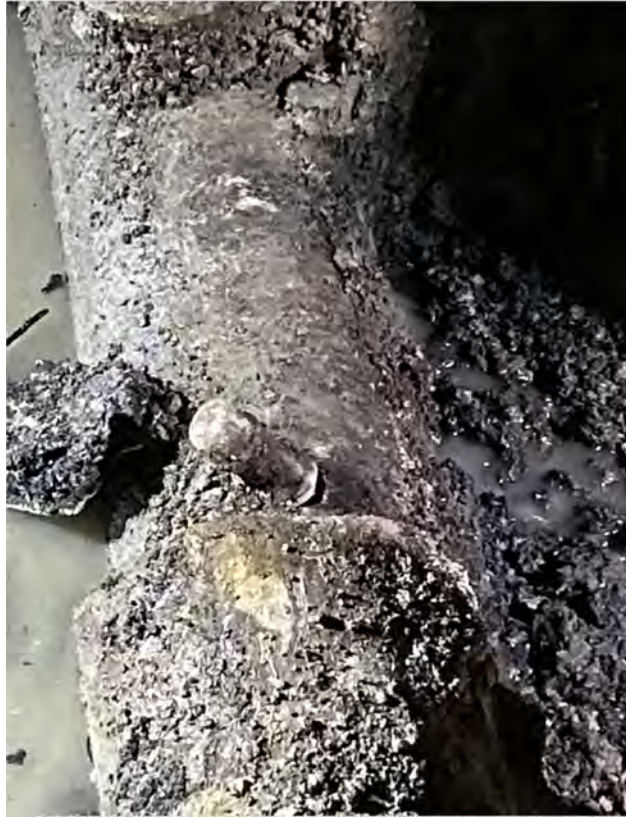
[REDACTED] **. A Spire employee was on-site on April 22, 2025, to observe excavations during the water main repair, but departed prior to the backfilling work. A 1-inch fitting at the 12:00 position on the 10-inch steel natural gas pipeline was damaged by a backhoe bucket during backfilling at approximately 5:10 pm.

The 3rd-party damage to the pipeline was caused by the excavator hitting a fitting on top of the natural gas main with a backhoe bucket while backfilling with gravel. The excavator did not follow safe digging practices during backfilling when moving gravel with mechanized equipment in immediate proximity to the natural gas main and fittings. A contributing factor was the absence of the Spire inspector who had been present earlier that day during excavation activities to remove soil for a water main repair, but left the site prior to the excavation activities to backfill the repair hole with gravel that were occurring at the time of the 3rd-party excavation damage. In response to Staff Data Request 0018 about whether Spire should have had a qualified representative on-site to observe the specific excavation activity of backfilling, Spire stated:

Figure 2: Damaged Fitting on Main (Source: Spire Response to Staff Data Request 0001.3A)

Repair was completed by removing the damaged 1-inch fitting and welding on a permanent repair sleeve.

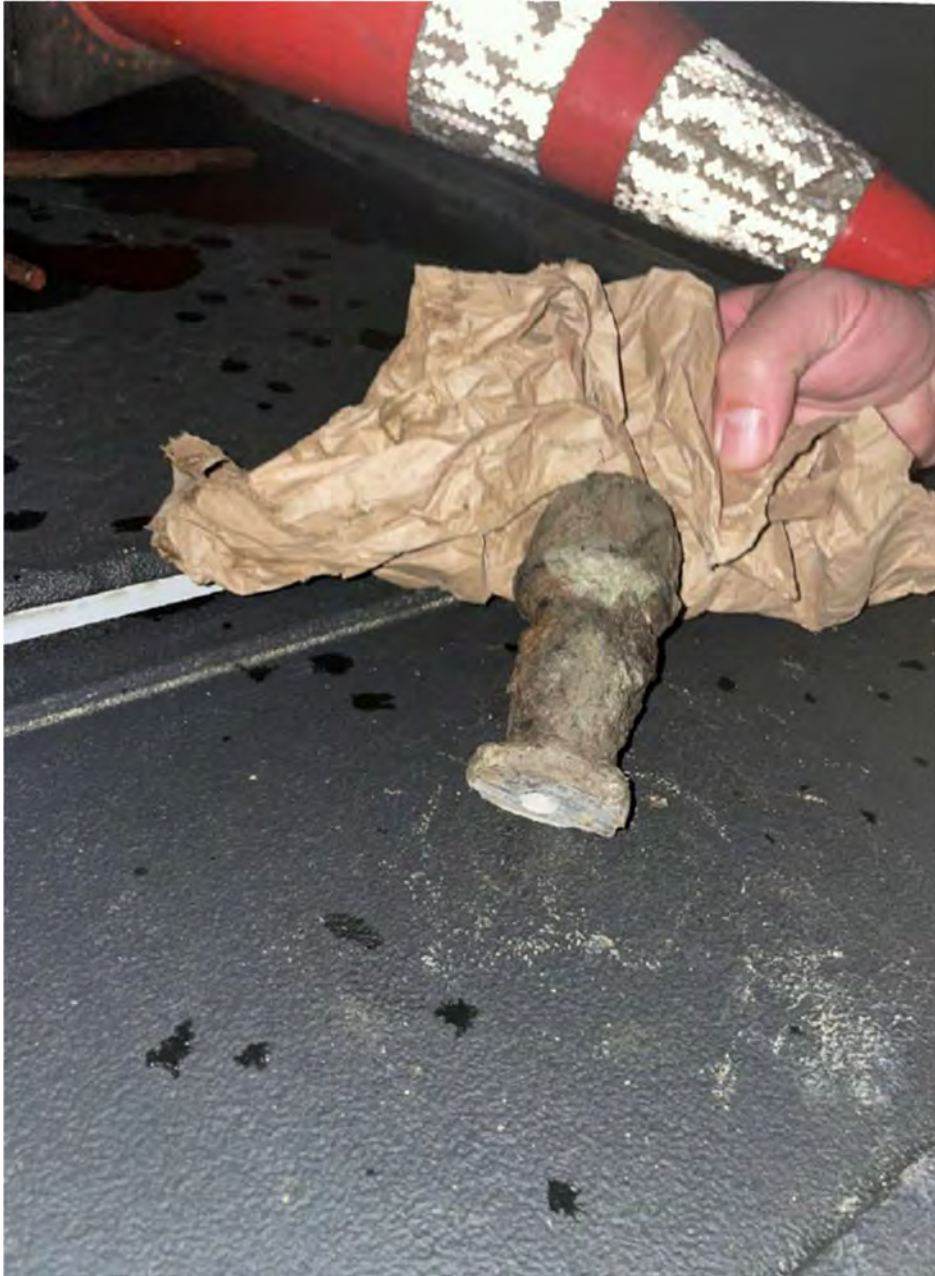
Figure 3: Damaged Fitting After Removal (Source: Spire Response to Staff Data Request 0001.3B)

- If Leak - Select Type:	Other
- If Other, Describe:	.5" hole from 1-inch nipple
- If Rupture - Select Orientation:	
- If Other, Describe:	
Approx. size: (widest opening):	
(length circumferentially or axially):

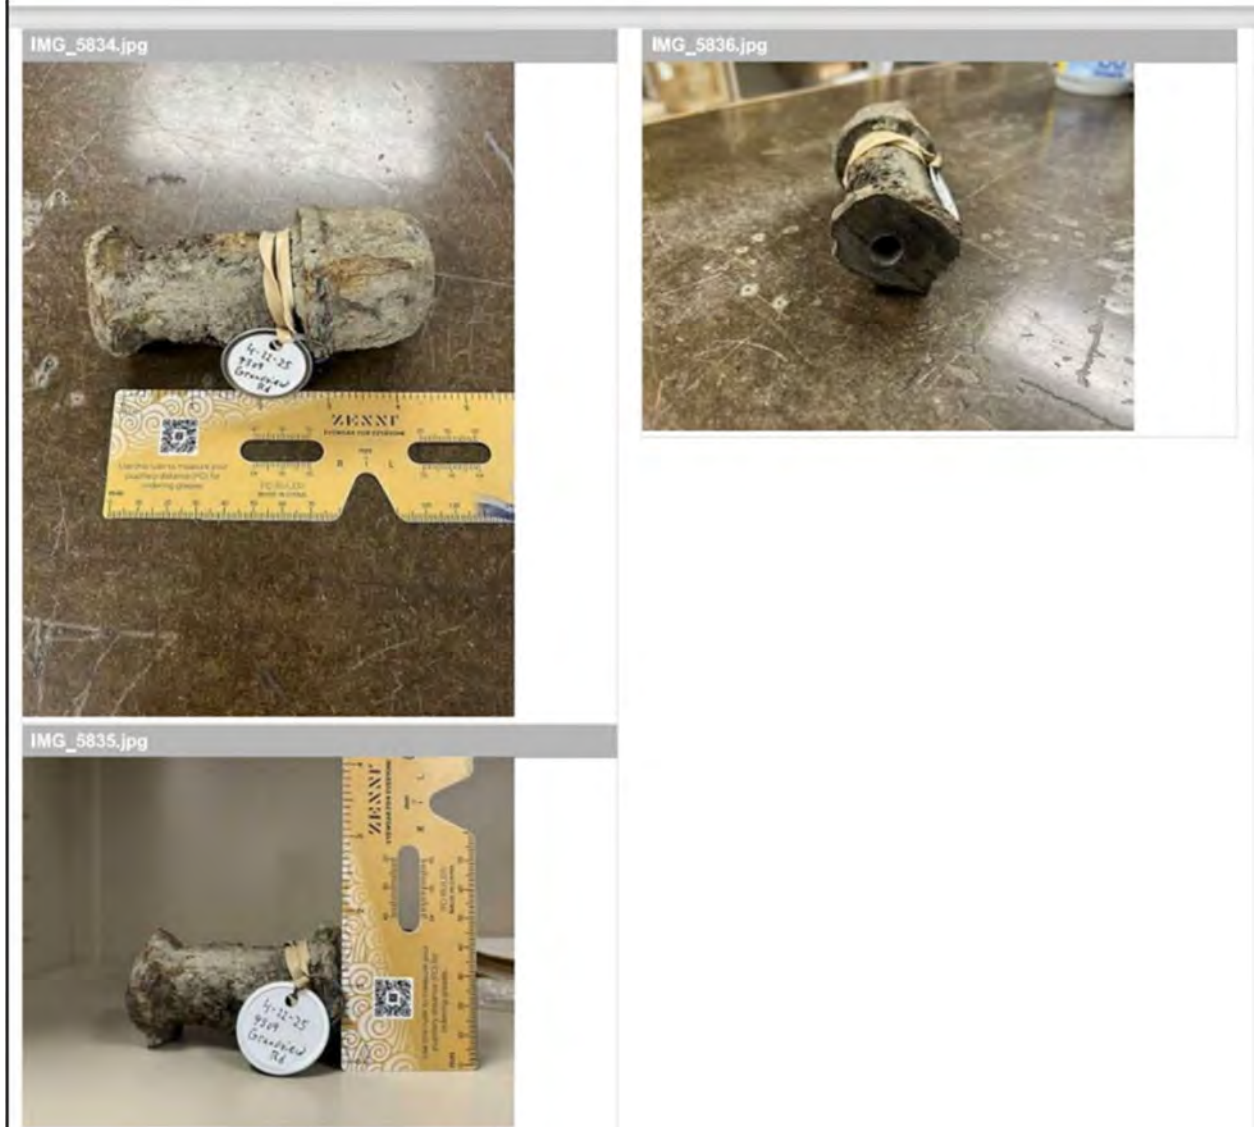
Figure 4: Fitting Measurements (Source Spire Response to Staff Data Request 0001.2)

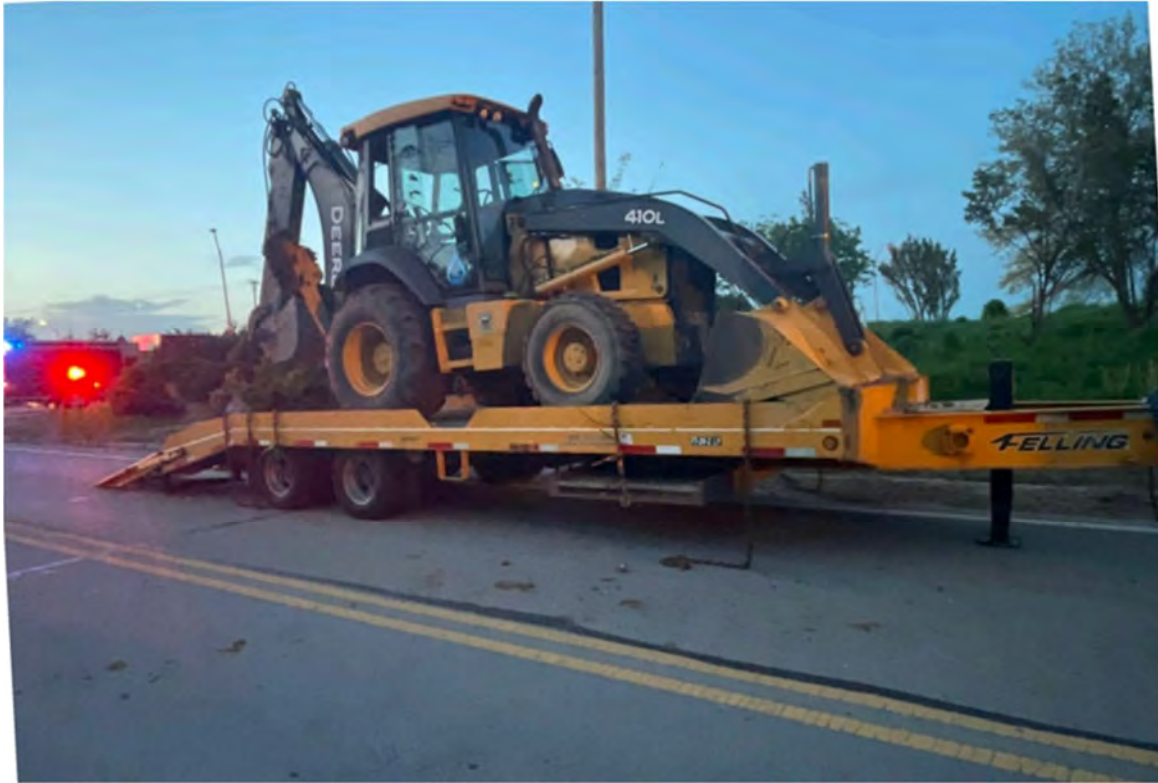
Figure 7: Kansas City Water Department Backhoe (Source: Spire Response to Staff Data Request 0001.3B)

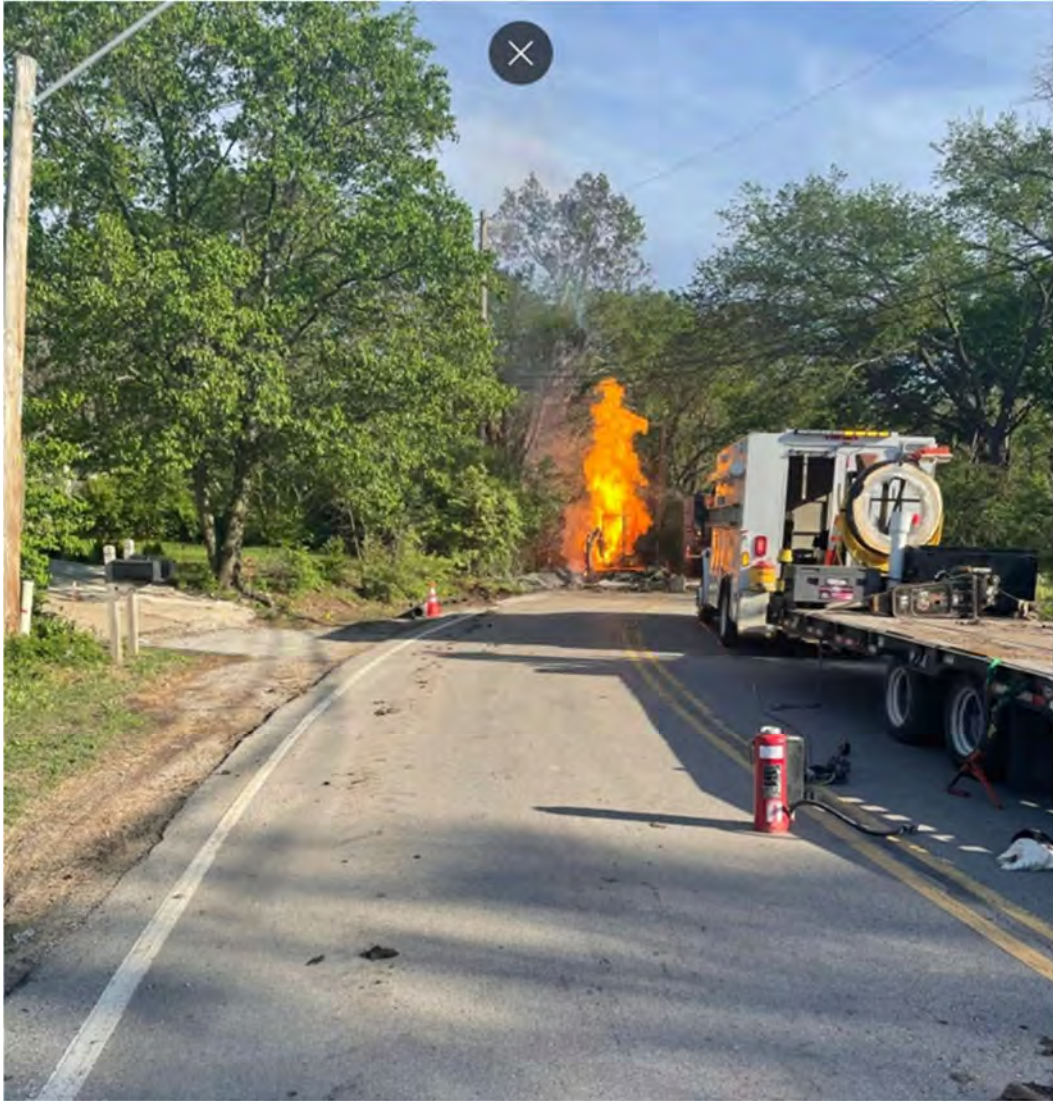
Figure 8: View Looking South at Gas Fire (Source: Spire Response to Staff Data Request 0001.3B)
