## STAFF'S GAS INCIDENT REPORT

Grandview Road  
Kansas City, MO  
April 22, 2025

**Spire Missouri, Inc.**

**Case No. GS-2025-0295**

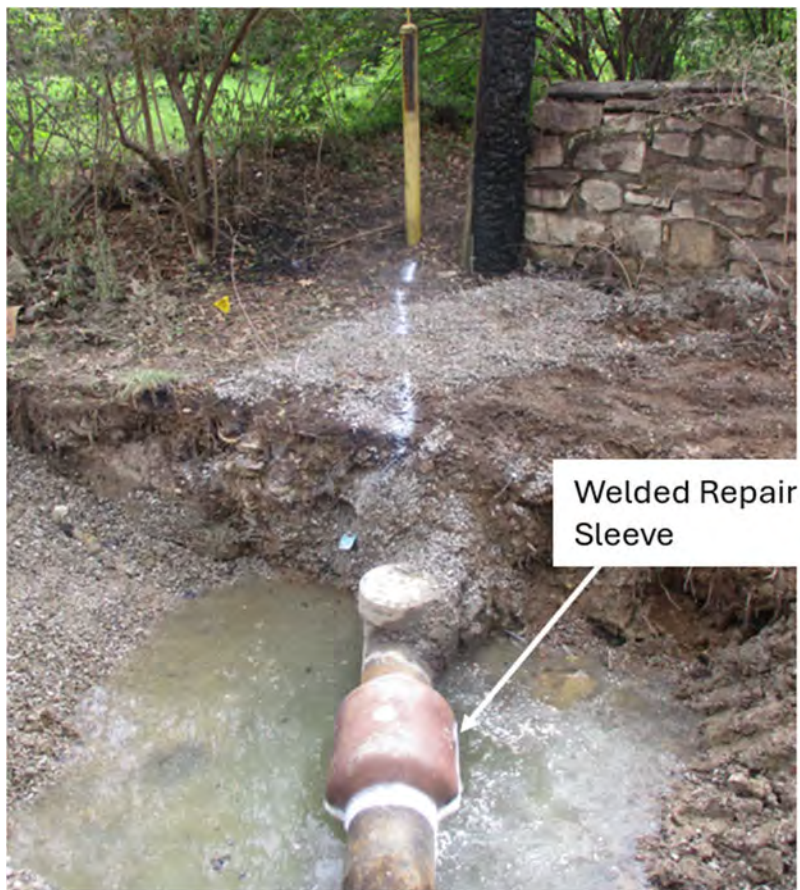
**Figure 2: Pipeline Following Repair (Source: Staff Photograph)**

to move their excavation equipment away from the blowing gas, then Spire began excavating the backfill using a mini-excavator. The natural gas ignited during Spire's excavation activities, resulting in severe burns to the Spire Machine Operator. The location of the pipeline damage was then made safe by closing two nearby valves. Temporary repair was made on the pipeline by removing the 1-inch pipe nipple from the pipeline installing a band clamp. Permanent repair was completed by welding on a permanent repair sleeve around the 10-inch pipeline. Figure 2 shows the pipeline following repair.

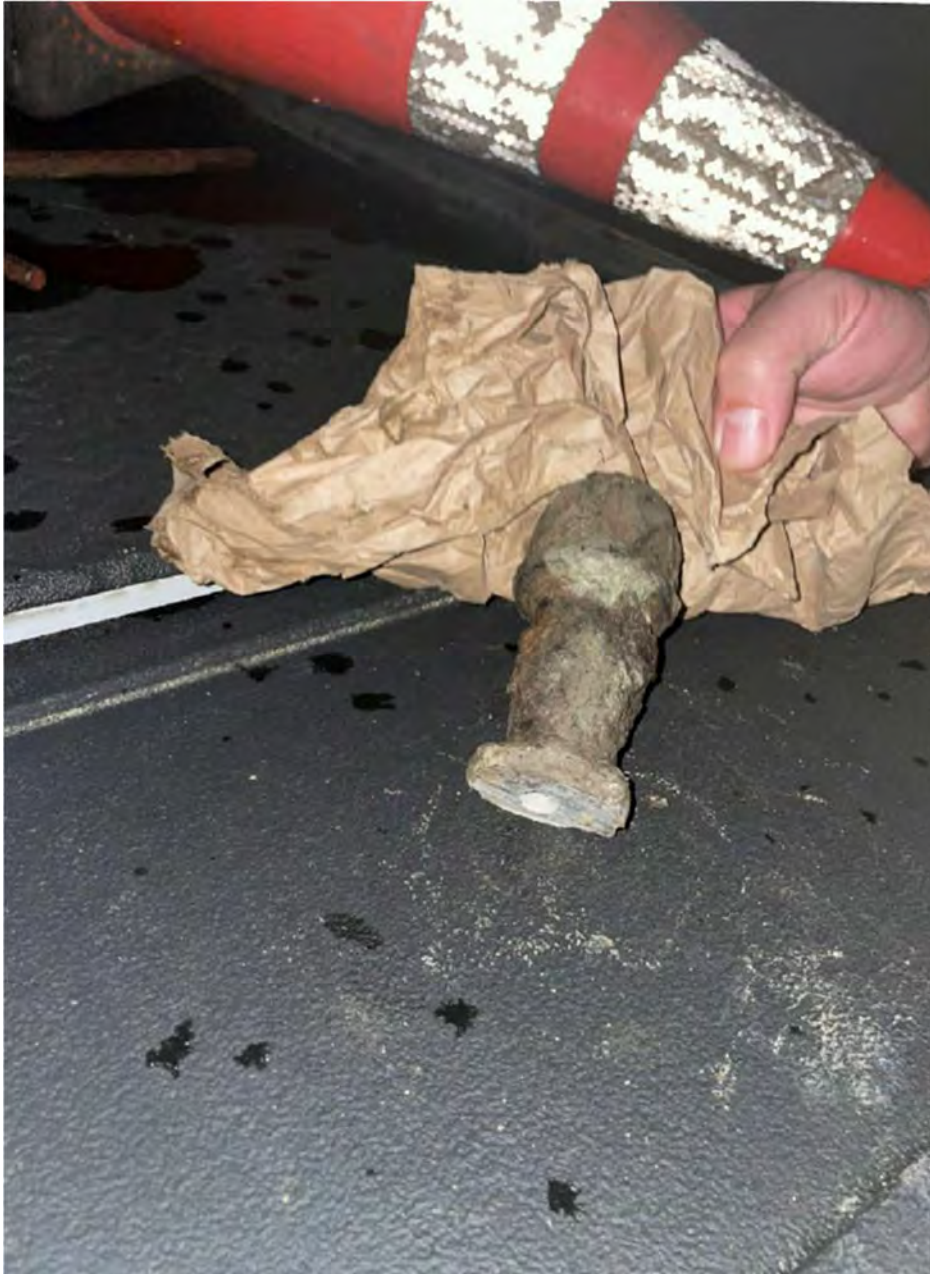
*Figure 3: Damaged Fitting After Removal (Source: Spire Response to Staff Data Request 0001.3B)*

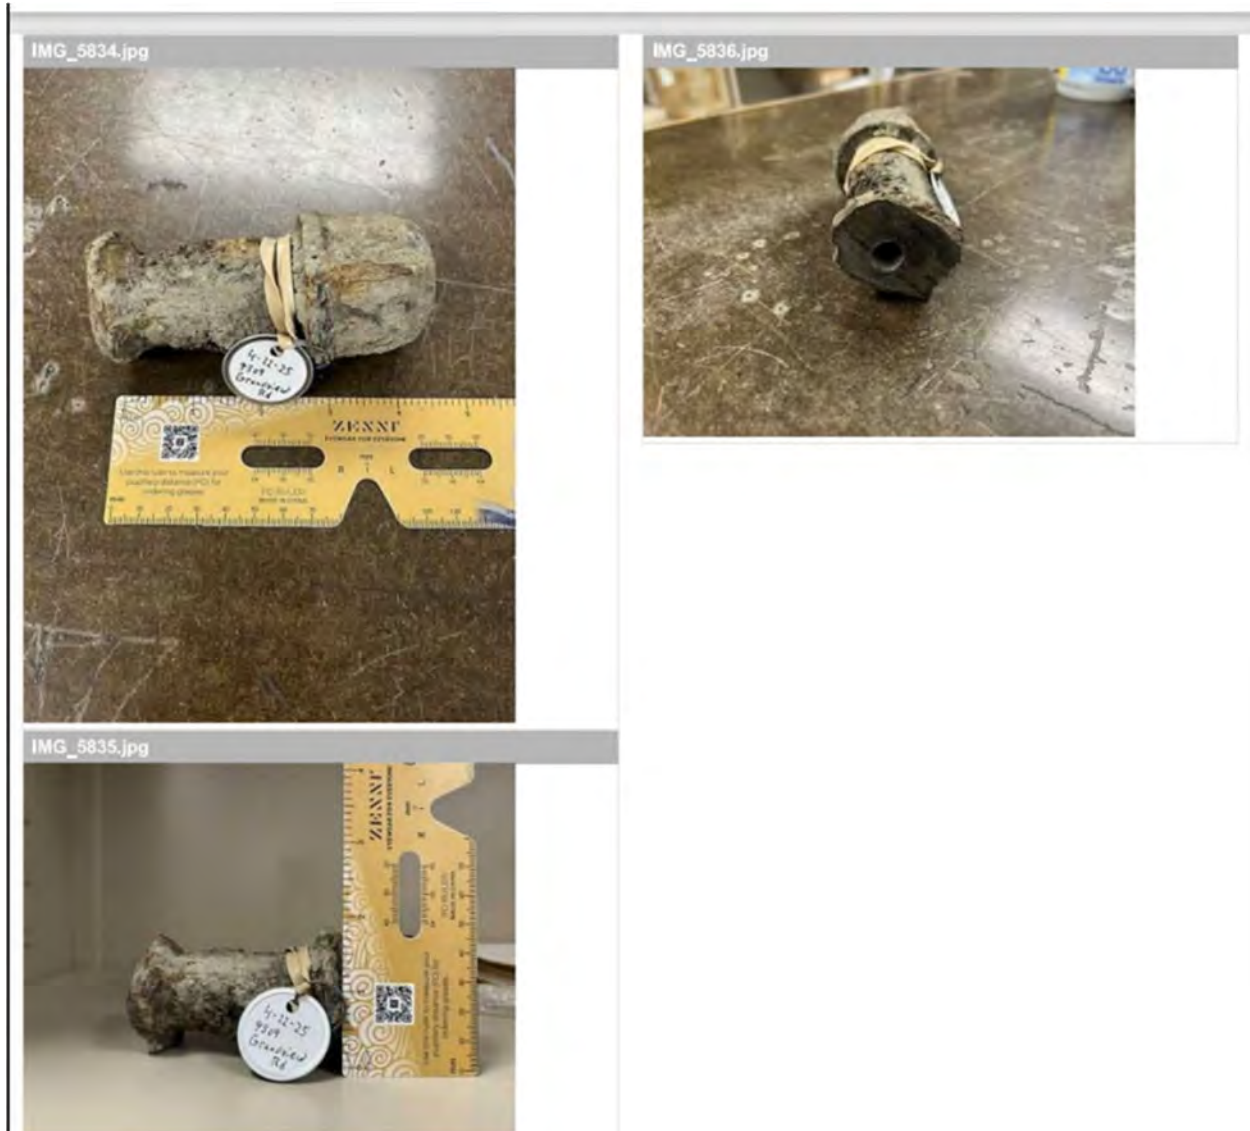
Figure 4: Fitting Measurements (Source Spire Response to Staff Data Request 0001.2)

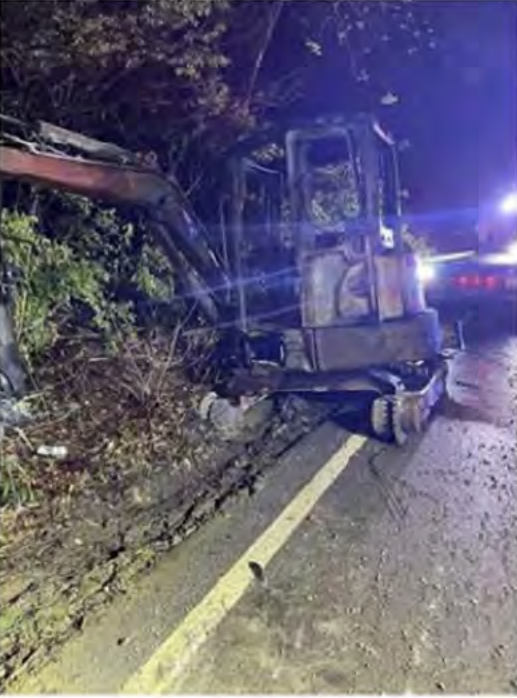
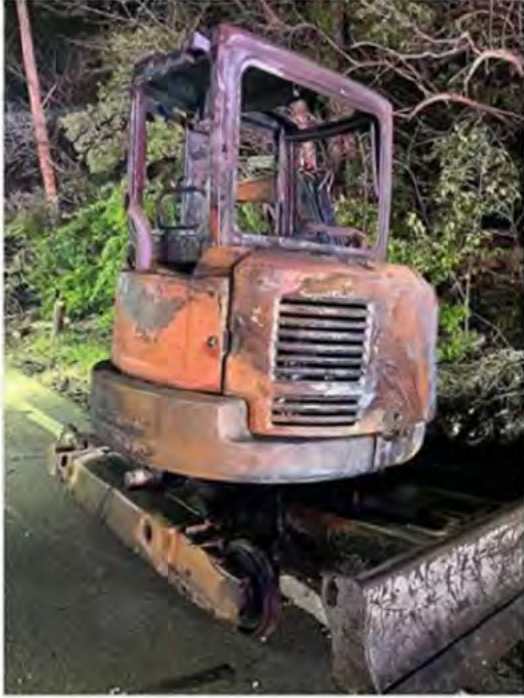
The natural gas ignited during Spire's excavation activities, resulting in severe burns to the Spire Machine Operator. The location of the pipeline damage was then made safe by closing two nearby valves. Repair was completed by removing the damaged 1-inch nipple and welding on a permanent repair sleeve. Three Spire employees, the Machine Operator, Working Foreman, and Serviceperson were injured. The Machine Operator was hospitalized for extended treatment.

*Figure 5: Spire Mini-Excavator and Pipe Repair (Source Spire Response to Staff Data Request 0001.3B).*

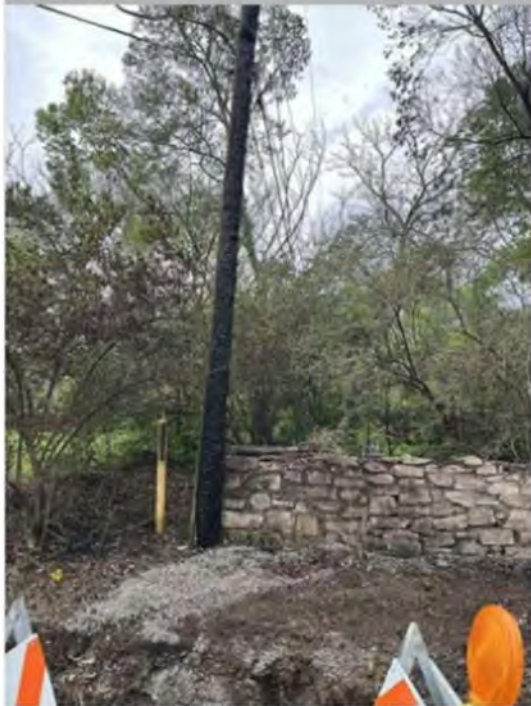
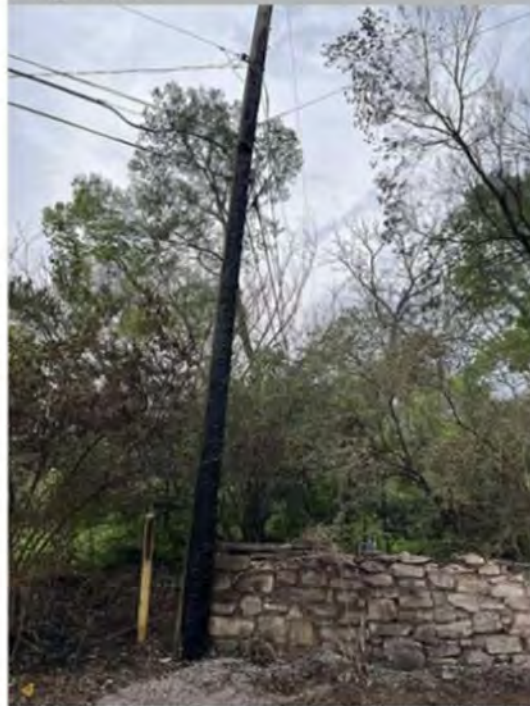
*Figure 6: Damaged Power Pole and Pipeline Marker (Source: Spire Response to Staff Data Request 0001.3B)*

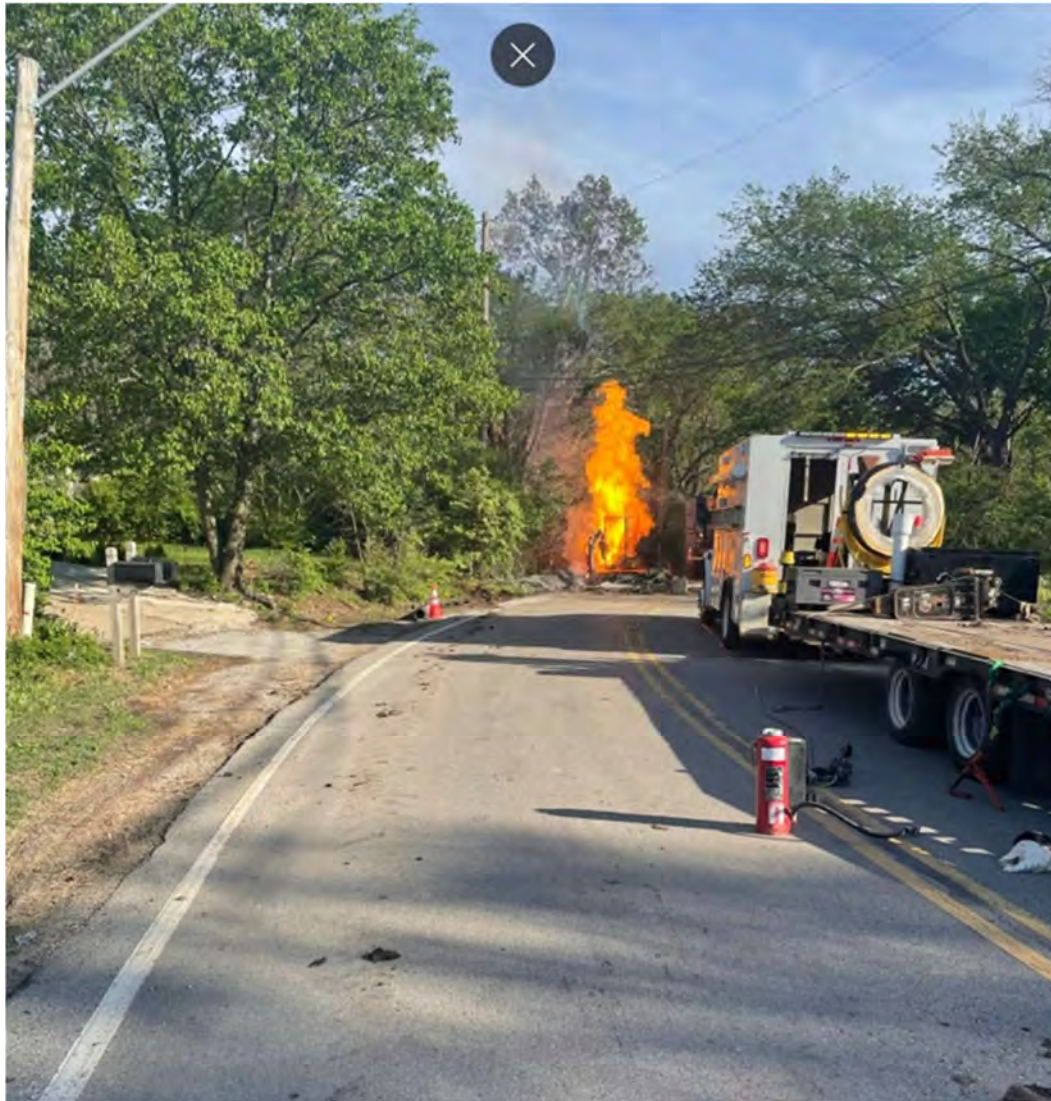
*Figure 8: View Looking South at Gas Fire (Source: Spire Response to Staff Data Request 0001.3B)*
