Exhibit No.: 117
Issues: Taum Sauk Upper
Reservoir
Witness: Paul C. Rizzo
Sponsoring Party: Union Electric Company
Type of Exhibit: Direct Testimony
Case No.: ER-2011-0028
Date Testimony Prepared: September 3, 2010

MISSOURI PUBLIC SERVICE COMMISSION

DIRECT TESTIMONY

PAUL C. RIZZO

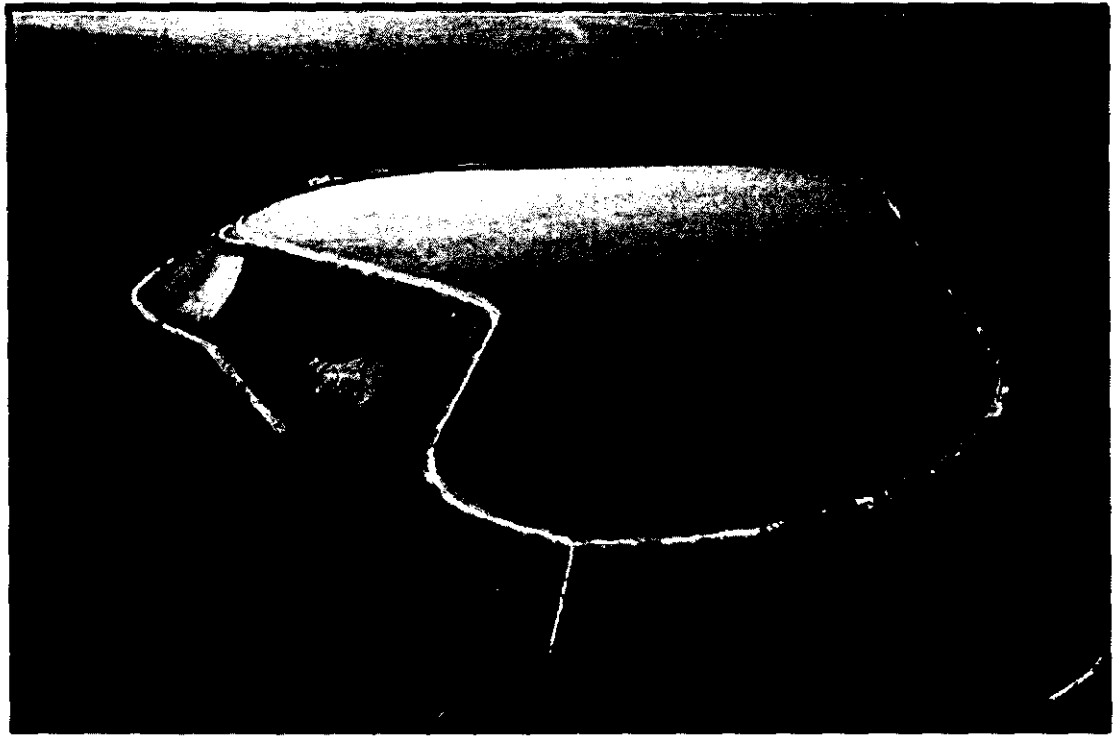
2 **ORIGINAL UPPER RESERVOIR CONCRETE FACED ROCKFILL DAM**

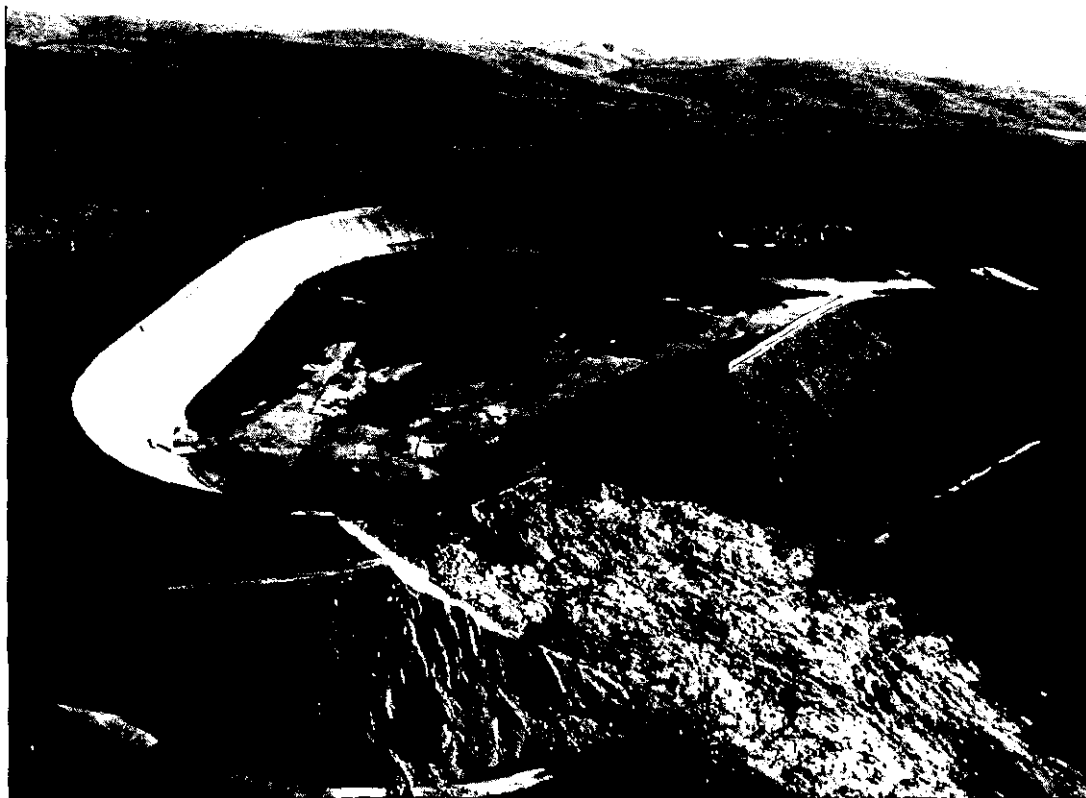
3 **THE RESERVOIR BREACH – DECEMBER 15, 2010**

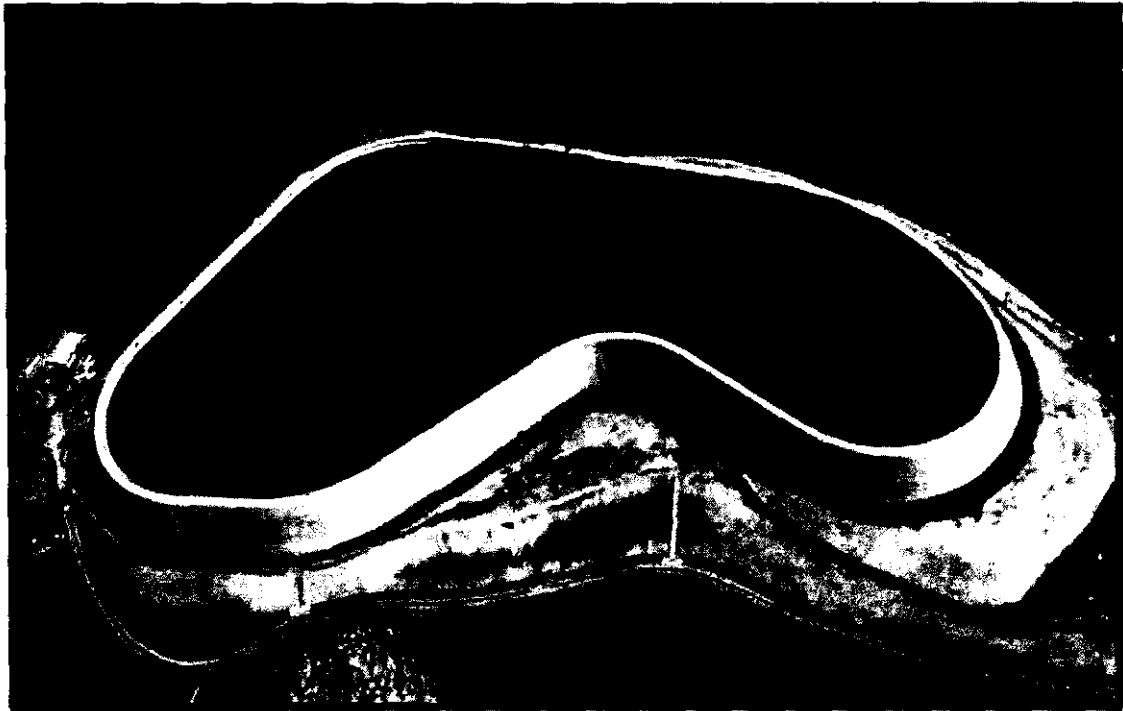
2 **THE NEW ROLLER COMPACTED CONCRETE UPPER RESERVOIR DAM**

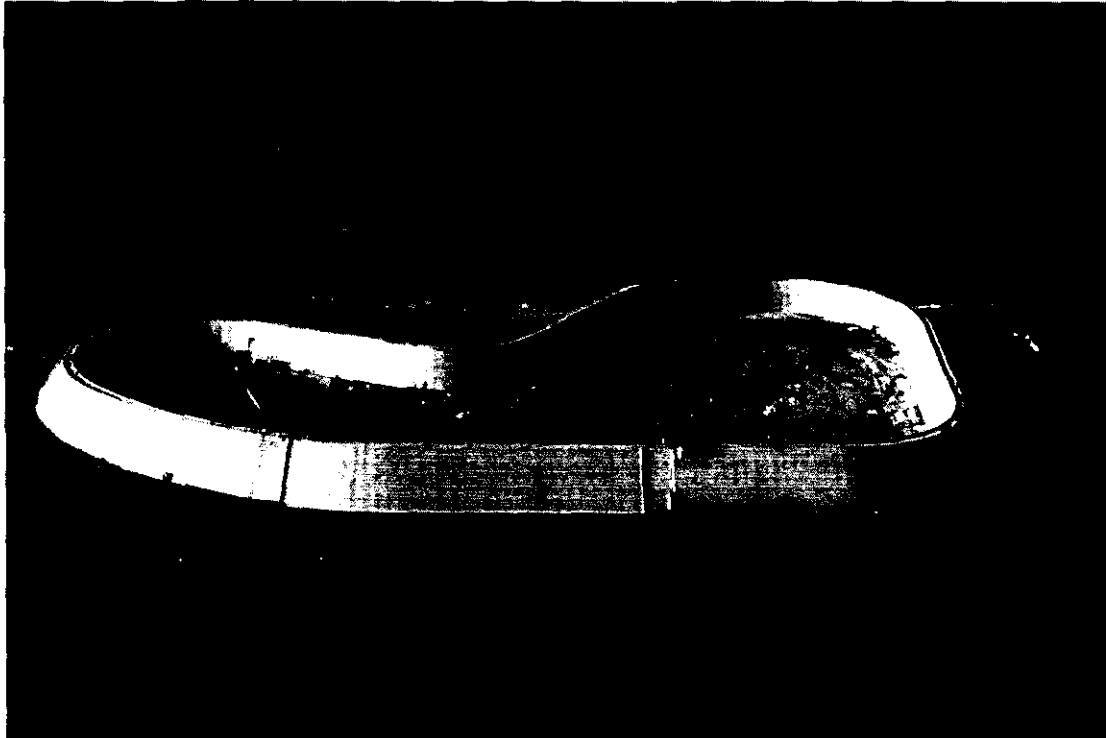
6
7 **OVERFLOW RELEASE STRUCTURE – FOREFRONT OF THE PHOTO**

1 prevented much of the damage from the 2005 breach. Specifically, the Overflow
2 Release Structure on the new facility will release overflowing water in a controlled
3 manner down the slope on the east side of the Upper Reservoir on AmerenUE property.
4 The risk of damage to public and private property and injury to the public is significantly
5 mitigated by this safety feature.

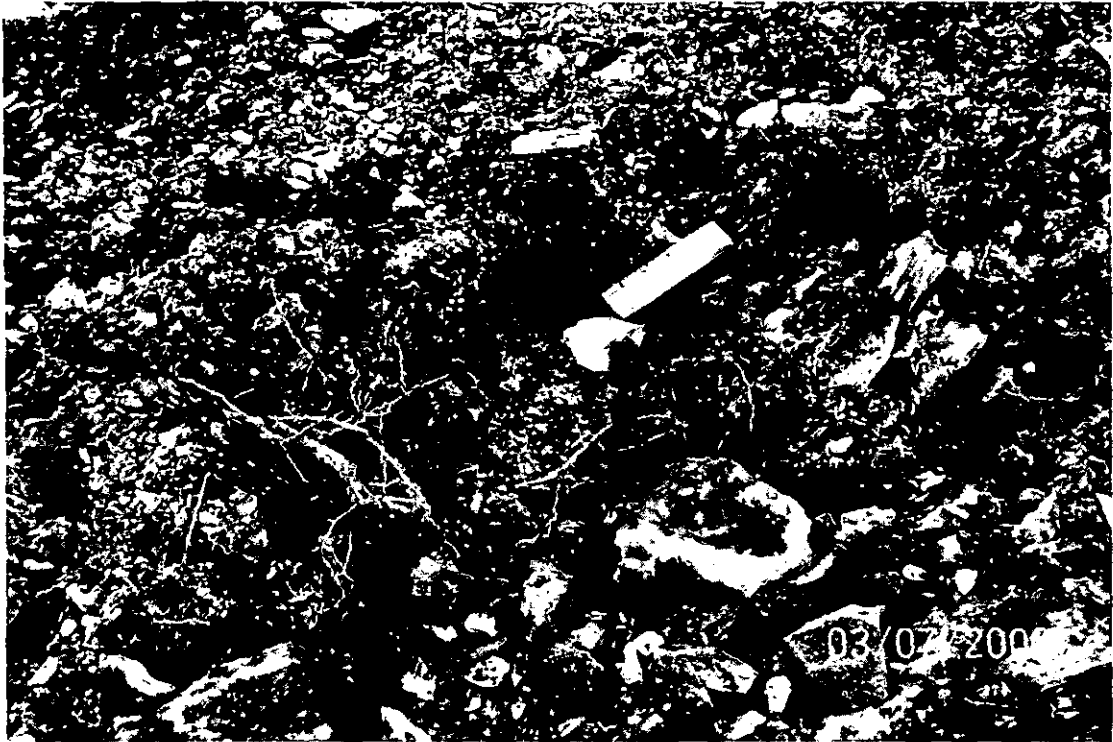
12 Yet our field investigation disclosed areas where as much as 18 inches of virgin, low-
13 strength material, including top soil and vegetation, was left in place under the CFRD.
14 The photographs below show some of the material that was found below the
15 foundation of the CFRD.

2 **DEBRIS AT THE ORIGINAL FOUNDATION ROCK INTERFACE**
