November 4, 2016

Finding of Compliance

Missouri Department of Natural Resources
Southeast Regional Office/Public Drinking Water Program
Report of Inspection
Indian Hills Utilities Operating Co. Inc.
500 Northwest Plaza Drive, Suite 500, St. Louis, MO 63074
Crawford County Missouri
MO6036052
November 4, 2016

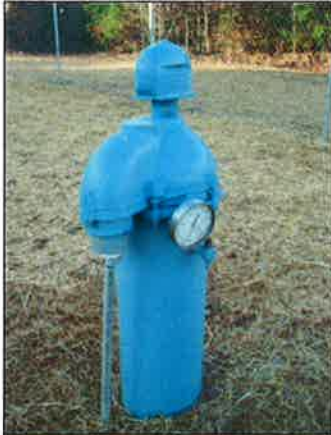
Photo #:001
Date Taken: 10/26/2016
By: Michelle Oglesby
Program: PDWB
File: Crawford County
Location: Indian Hills Utilities Operating Co. Inc.
Description: Well #1

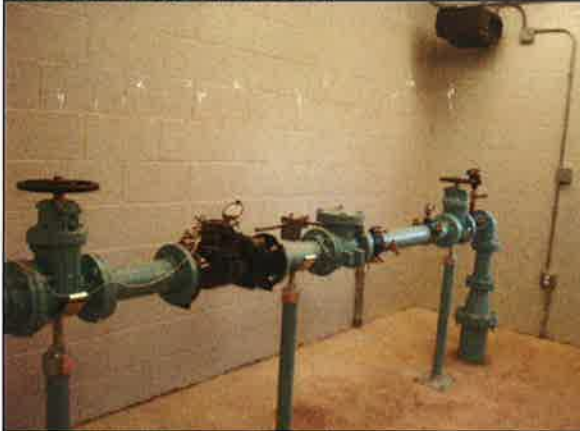
Photo #:002
Date Taken: 10/26/2016
By: Michelle Oglesby
Program: PDWB
File: Crawford County
Location: Indian Hills Utilities Operating Co. Inc.
Description: Well #1 - Piping

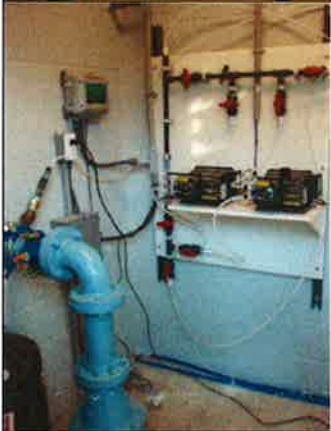
Photo #:003
Date Taken: 10/26/2016
By: Michelle Oglesby
Program: PDWB
File: Crawford County
Location: Indian Hills Utilities Operating Co. Inc.
Description: Well #1 – Chlorine Room with chlorine pumps.

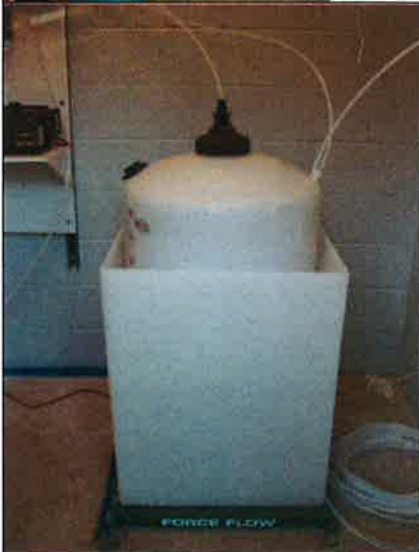
Photo #:004
Date Taken: 10/26/2016
By: Michelle Oglesby
Program: PDWB
File: Crawford County
Location: Indian Hills Utilities Operating Co. Inc.
Description: Well #1 – Chlorine Room with chemical storage.

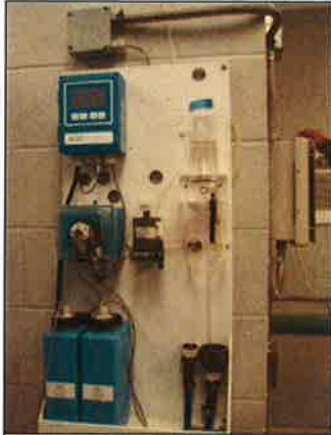
Photo #:005
Date Taken: 10/26/2016
By: Michelle Oglesby
Program: PDWB
File: Crawford County
Location: Indian Hills Utilities Operating Co. Inc.
Description: Well #1 – Continuous chlorine reader.

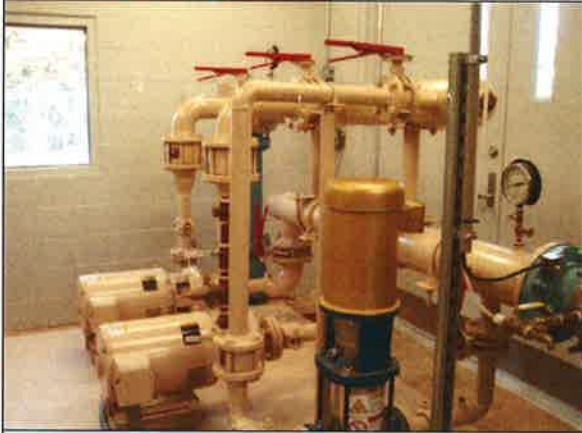
Photo #:006
Date Taken: 10/26/2016
By: Michelle Oglesby
Program: PDWB
File: Crawford County
Location: Indian Hills Utilities Operating Co. Inc.
Description: Well #1 – Booster Pump Station

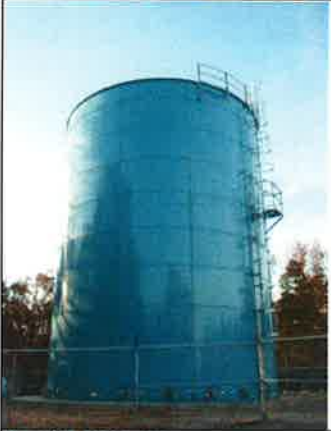
Photo #:007
Date Taken: 10/26/2016
By: Michelle Oglesby
Program: PDWB
File: Crawford County
Location: Indian Hills Utilities Operating Co. Inc.
Description: Well #1 – 263,000 gallon standpipe.

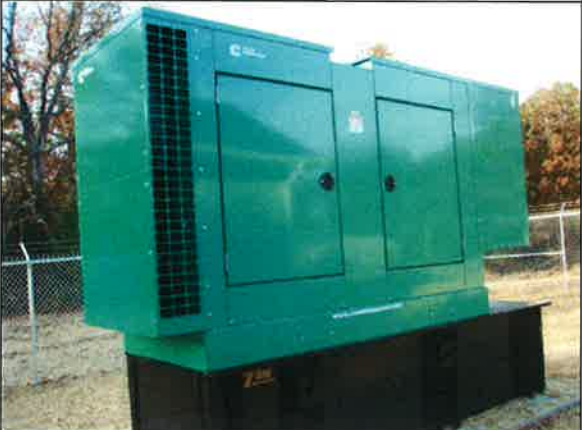
Photo #:008
Date Taken: 10/26/2016
By: Michelle Oglesby
Program: PDWB
File: Crawford County
Location: Indian Hills Utilities Operating Co. Inc.
Description: Well #1 – Generator

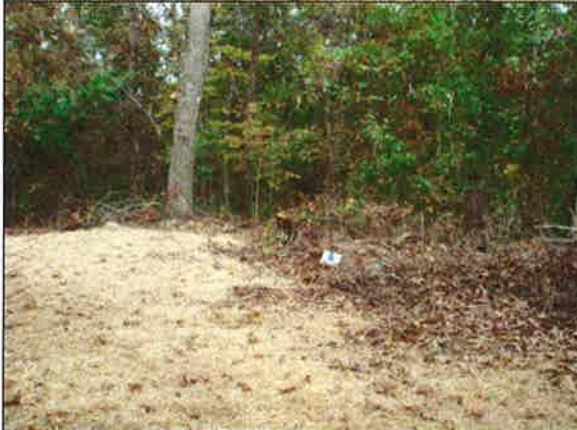
Photo #:010
Date Taken: 10/26/2016
By: Michelle Oglesby
Program: PDWB
File: Crawford County
Location: Indian Hills Utilities Operating Co. Inc.
Description: Location where Well #2 booster pumps station was located.

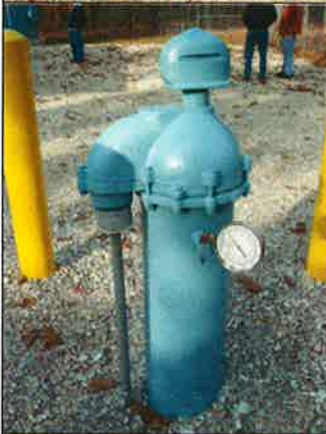
Photo #:011
Date Taken: 10/26/2016
By: Michelle Oglesby
Program: PDWB
File: Crawford County
Location: Indian Hills Utilities Operating Co. Inc.
Description: Well #3

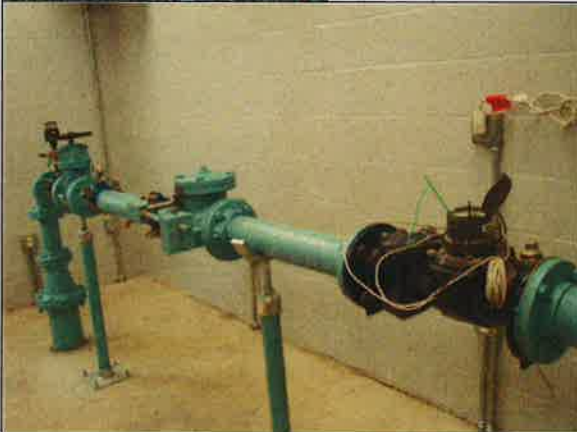
Photo #:012
Date Taken: 10/26/2016
By: Michelle Oglesby
Program: PDWB
File: Crawford County
Location: Indian Hills Utilities Operating Co. Inc.
Description: Well #3 - Piping

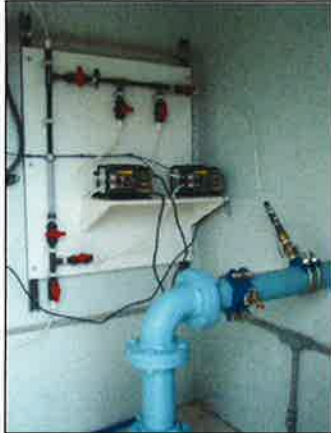
Photo #:013
Date Taken: 10/26/2016
By: Michelle Oglesby
Program: PDWB
File: Crawford County
Location: Indian Hills Utilities Operating Co. Inc.
Description: Well #3 – Chlorine Room with chlorine pumps.

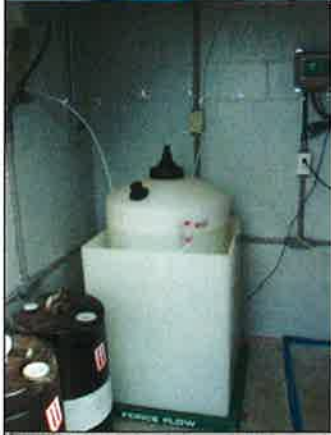
Photo #:014
Date Taken: 10/26/2016
By: Michelle Oglesby
Program: PDWB
File: Crawford County
Location: Indian Hills Utilities Operating Co. Inc.
Description: Well #3 – Chlorine Room with chemical storage.

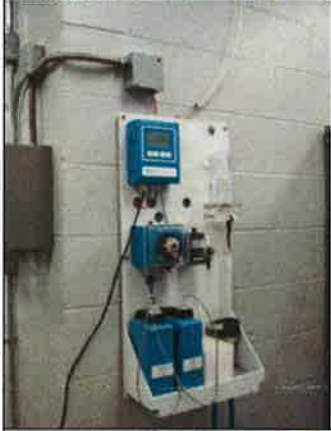
Photo #:015
Date Taken: 10/26/2016
By: Michelle Oglesby
Program: PDWB
File: Crawford County
Location: Indian Hills Utilities Operating Co. Inc.
Description: Well #3 – Continuous chlorine reader.

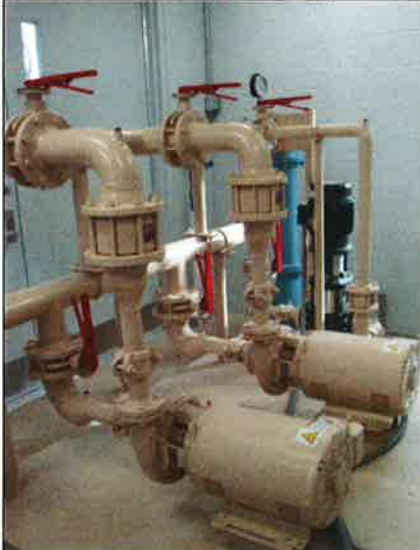
Photo #:016
Date Taken: 10/26/2016
By: Michelle Oglesby
Program: PDWB
File: Crawford County
Location: Indian Hills Utilities Operating Co. Inc.
Description: Well #3 – Booster Pump Station.

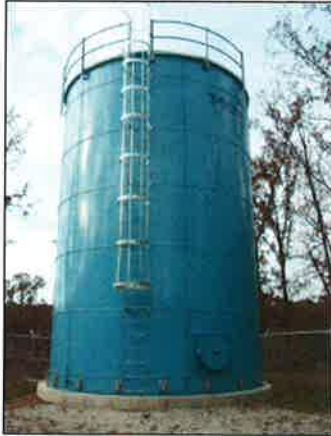
Photo #:017
Date Taken: 10/26/2016
By: Michelle Oglesby
Program: PDWB
File: Crawford County
Location: Indian Hills Utilities Operating Co. Inc.
Description: Well #3 – 53,000 gallon standpipe.
