3.200 Kuhle H20  
Boone County  
PWS ID #3036153

**SIGNIFICANT DEFICIENCY  
RESPONSE REQUIRED**

**Missouri Department of Natural Resources  
Northeast Regional Office  
Report of Inspection  
Kuhle H20  
708 Cunningham Drive, Columbia, MO 65202, Boone County  
MO3036153  
February 16, 2017**

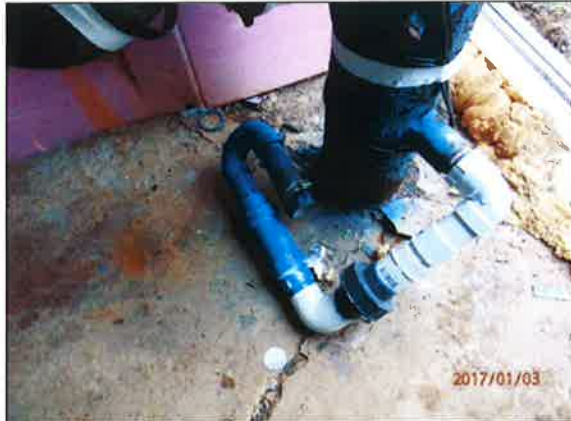
11. The current well vent installation is improperly constructed. The well vent needs to be modified or replaced with an adequately sized vent (at least 1.5 inches in diameter) that is screened with 18-mesh screen and turned in the downward position to ensure contamination is not pulled into the well. The current vent needs to be modified to extend at least 12" above the sanitary seal and away from the wellhead and discharge piping. It should terminate in an inverted "U" and be properly screened.

Photo #: 1  
Date/Time Taken: 01/03/2017 at approx. 0914 hours  
By: Richard Morrow  
Program: PDW Unit  
File: 3.200  
Facility: Kuhle H20  
Location: Well House  
Description: The well vent installation is improperly constructed. The vent needs to be modified to extend at least 12" above the sanitary seal and away from the discharge piping. It should terminate in an inverted "U" and be properly screened.

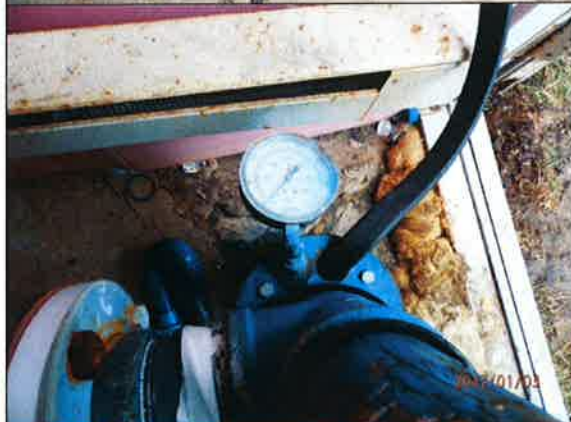
1. There are openings in the wellhead for the airline and electrical service to the pump that are not adequately sealed which could allow contamination into the well. Missouri Public Drinking Water Regulation 10 CSR 60 4.025(4)(A)4.A. states that a significant deficiency effecting the sanitary condition is present for a source if there are any improperly constructed, sealed, or inadequately screened opening in the well head. The use of caulking compound to plug openings in a wellhead is temporary only and is not an acceptable method for a permanent seal in the wellhead. The openings need to be properly sealed with threaded connections or rubber grommet pipe seals. Any opening in the wellhead is considered a significant deficiency.

Photo #: 2  
Date/Time Taken: 01/03/2017 at approx. 0915 hours  
By: Richard Morrow  
Program: PDW Unit  
File: 3.200  
Facility: Kuhle H20  
Location: Wellhead  
Description: There are openings in the wellhead for the airline and electrical service to the pump that are not adequately sealed. The openings need to be properly sealed with threaded connections or rubber grommet pipe seals.

The system must consult with the department about a corrective action plan to address these deficiencies within 30 days and has up to 120 days to correct the deficiency or to be on schedule with a department approved corrective action plan.

**REQUIRED ACTIONS:** The facility shall consult with the Northeast Regional Office **within 30 days**, explaining what actions will be taken to correct the significant deficiencies or be following a department approved corrective action plan.

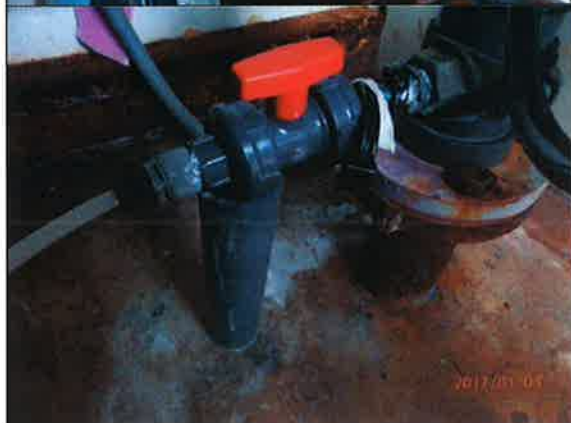
9. The well house does not meet the minimum sanitary construction standards. The concrete foundation is cracked and boards and siding are missing on the eastern side of the building. Additionally, the chlorine injection and associated ball valve are being braced with a piece of pipe and some of the wiring is not in conduit and exposed, which is a safety issue. The system should contract an engineering firm to prepare plans and specifications for a new well house.

Photo #: 3  
Date/Time Taken: 01/03/2017 at approx. 0916 hours  
By: Richard Morrow  
Program: PDW Unit  
File: 3.200  
Facility: Kuhle H20  
Location: Well House  
Description: The well house does not meet the minimum sanitary construction standards. The chlorine injection and ball valve is being braced with a piece of pipe. The system should contract an engineering firm to prepare plans and specifications for a new well house.

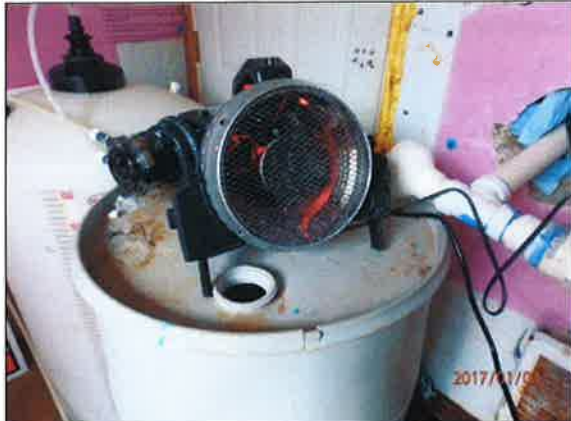
13. The hypochlorite tank is not vented to the outside. The chlorine tank needs to be vented to the outside to prevent further corrosion to the piping and metal works inside the well house.

Photo #: 4  
Date/Time Taken: 01/03/2017 at approx. 0916 hours  
By: Richard Morrow  
Program: PDW Unit  
File: 3.200  
Facility: Kuhle H20  
Location: Well House  
Description: The hypochlorite tank is not vented to the outside. The chlorine tank needs to be vented to the outside to prevent further corrosion to the piping and metal works inside the well house.

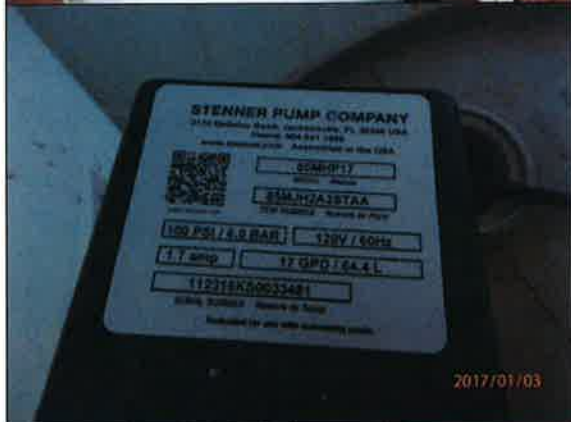
17. Reportedly, there is a mechanical issue with the spare chlorination pump and there is only one operating pump. The system should maintain disinfection redundancy by having two pumps available in case the lead pump becomes inoperable. This way the system is not pumping untreated or improperly treated water into the distribution system.

Photo #: 5  
Date/Time Taken: 01/03/2017 at approx. 0916 hours  
By: Richard Morrow  
Program: PDW Unit  
File: 3.200  
Facility: Kuhle H20  
Location: Well House  
Description: There is only one operating chlorination pump. The system should maintain disinfection redundancy by having two pumps available in case the lead pump becomes inoperable.

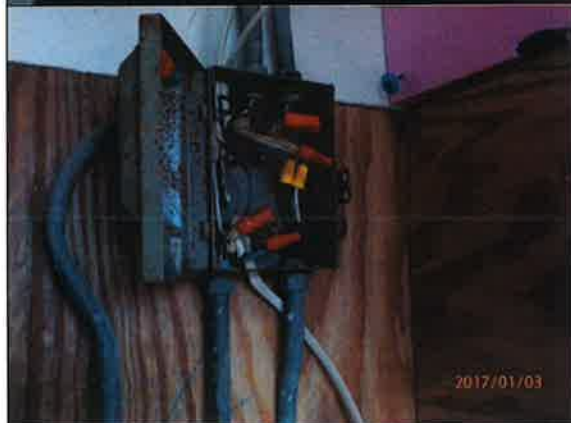
Photo #: 6  
Date/Time Taken: 01/03/2017 at approx. 0918 hours  
By: Richard Morrow  
Program: PDW Unit  
File: 3.200  
Facility: Kuhle H20  
Location: Well House  
Description: The well house does not meet the minimum sanitary construction standards. Some of the wiring is not in conduit and exposed, which is a safety issue.

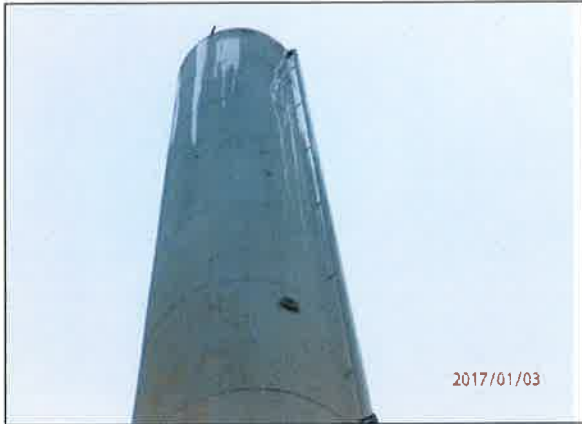
22. Currently, there appears to be a bulge in the eastern side of the standpipe near the top. In 2008 when the standpipe was constructed the bulge was not visible but a photo in 2010 shows the damage. This may have been caused by ice formation or a plugged overflow or vent. This issue needs to be thoroughly examined the next time the standpipe is inspected to verify the structural integrity of the tank and to determine the cause of damage.

<p>Photo #: 7 Date/Time Taken: 01/03/2017 at approx. 0922 hours By: Richard Morrow Program: PDW Unit File: 3.200 Facility: Kuhle H20 Location: Standpipe Description: There appears to be a bulge in the eastern side of the standpipe near the top. This may have been caused by ice formation or a plugged overflow or vent. This issue needs to be thoroughly examined the next time the standpipe is inspected.</p>

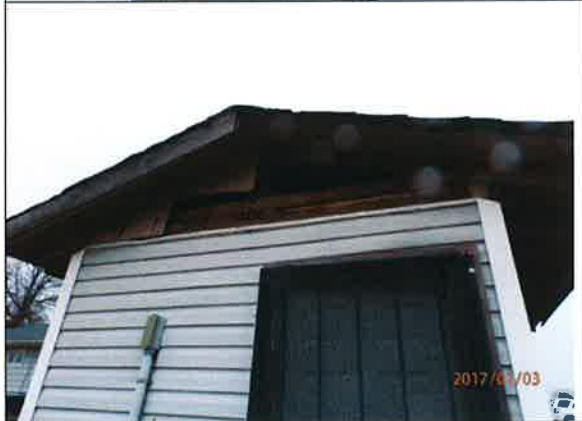
<p>Photo #: 8 Date/Time Taken: 01/03/2017 at approx. 0927 hours By: Richard Morrow Program: PDW Unit File: 3.200 Facility: Kuhle H20 Location: Well House Description: The well house does not meet the minimum sanitary construction standards. The concrete foundation is cracked and boards and siding are missing on the eastern side of the building.</p>
