Exhibit No. \_\_\_\_\_  
Issues: System Condition and Improvements  
Witness: Jacob Freeman  
Type of Exhibit: Direct Testimony  
Sponsoring Party: Confluence Rivers Utility  
Operating Company, Inc  
File Nos.: WR-2023-0006 / SR-2023-0007  
Date: December 21, 2022

**Missouri Public Service Commission**

**Direct Testimony**

**Confluence Rivers Utility Operating Company, Inc**

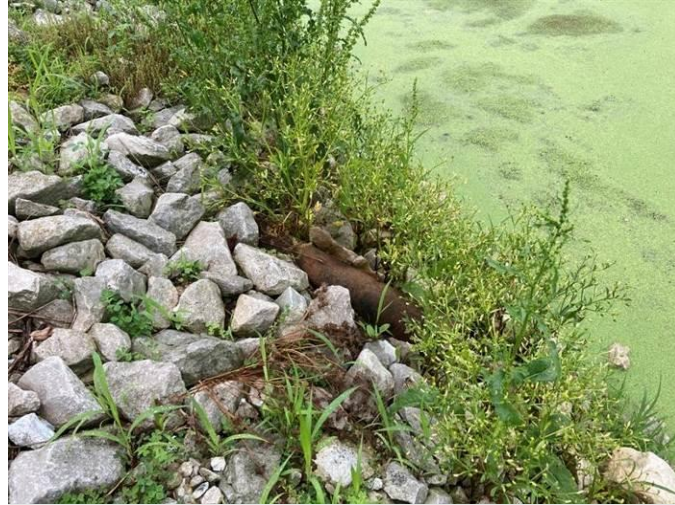
15 In general terms, the system was in satisfactory physical condition at the time of  
16 acquisition. That said, several issues were obvious with the system. The lagoon berms  
17 had been rocked with rip rap to help prevent varmint damage to the berms which could  
18 potentially cause berm leaks. Nevertheless, vegetation had grown through the rock and,  
19 due to poor system maintenance, had become overgrown around the lagoon berms. Basic  
20 system maintenance should be done to prevent such vegetation as it could result in berm  
21 damage. Similarly, all three lagoon cells were covered in duckweed, indicating low  
22 levels of dissolved oxygen in the lagoon cells and therefore poor wastewater treatment.

*Typical condition of berms and duckweed layer on lagoon surface*

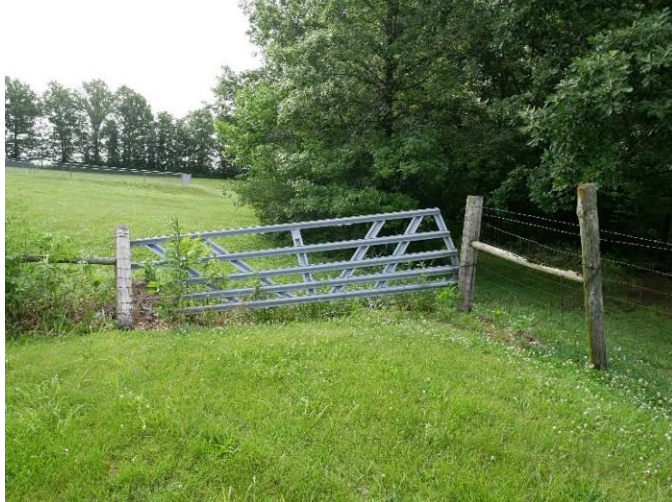
The facility fencing was composed of hog-wire with two strands of barbed wire at the top. Some portions of the fence were in poor condition and had not been repaired, with barbed wire hanging and the fence sagging or leaning over in some locations. One of the access gates was also failing as the supporting fence post had fallen over allowing the gate and fence to topple. These issues compromise site security, potentially exposing any trespassers to wastewater and/or treatment equipment.

*Examples of fence damage in need of repair*

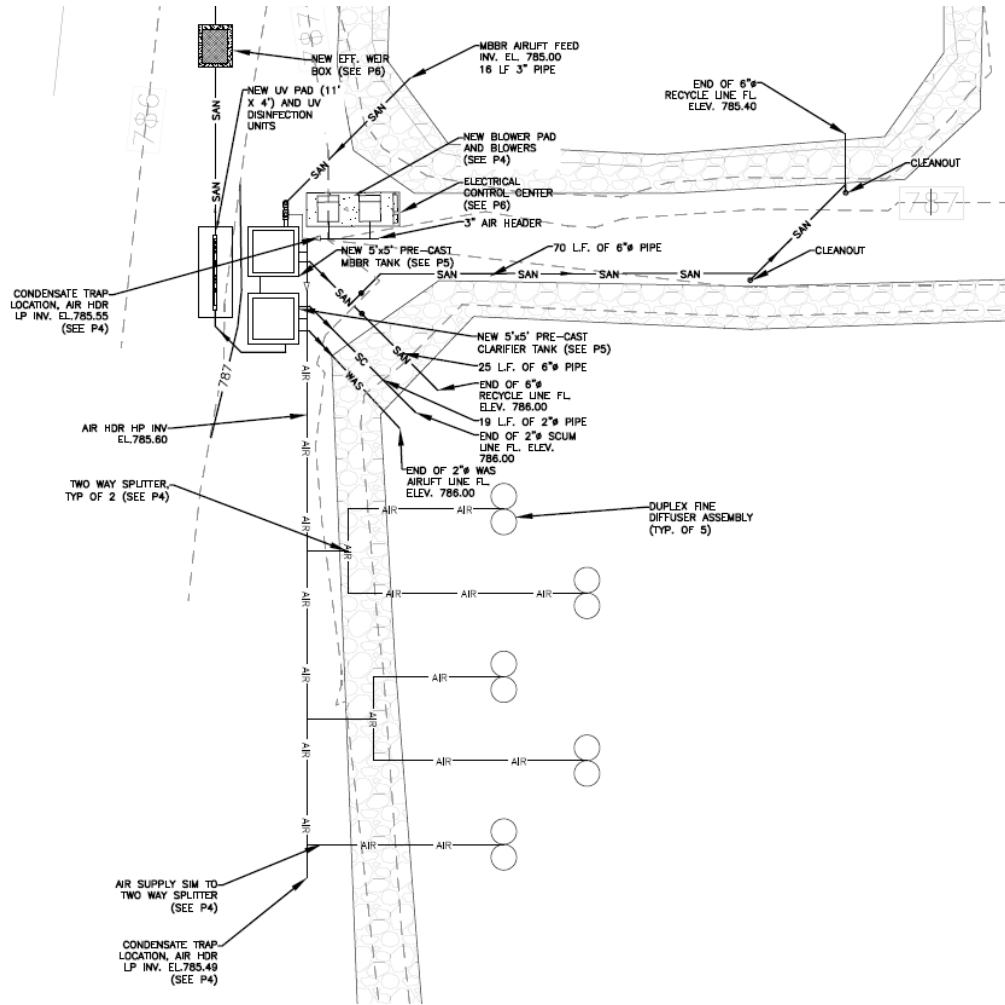
1 treated wastewater will flow through a new ultraviolet disinfection system. After flowing  
 2 through the disinfection system, the flow will go through a new effluent weir with flow  
 3 measurement and then to the existing discharge. See the basic layout of these  
 4 improvements plans below.

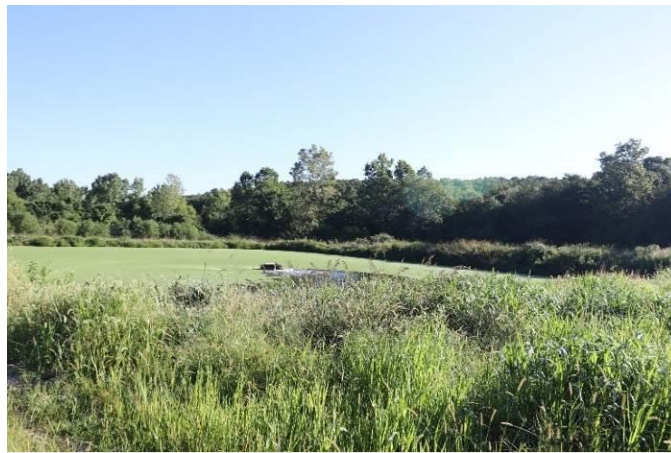
11 *Vegetation growth around 3-cell lagoon*

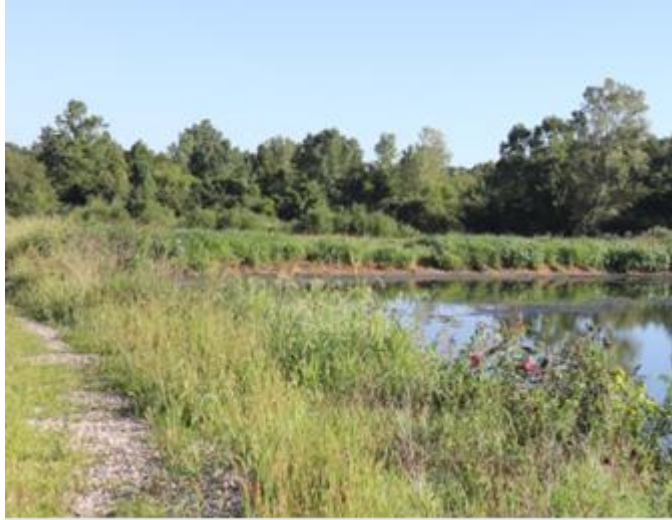
12  
13 There was significant berm damage in many locations due to muskrats digging burrows  
14 into the berms and lack of access caused by vegetation growth prevented anyone from  
15 attempting to repair the damaged berm. Poor flow through the facility had also led to the  
16 formation of sludge islands in the lagoon's second and third cells.

*Accumulation of solids in second lagoon and varmint damage to berm visible in background*

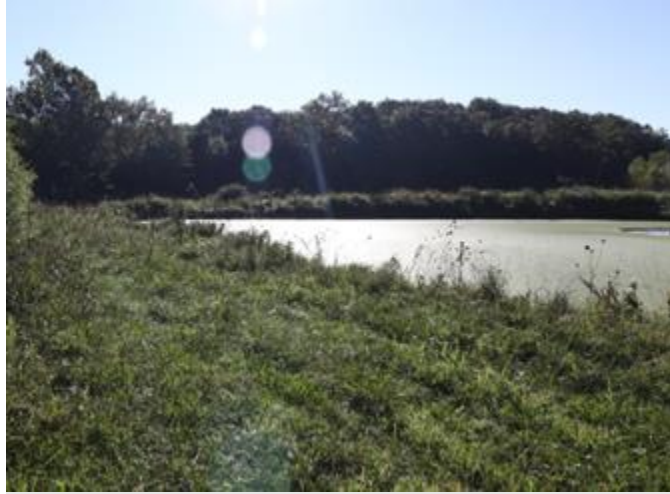
9       The access road to the facility is a steep road running down the back of a dam  
10 which holds back one of the lakes in the Terre du Lac community. The road had a gravel  
11 surface which had not been re-rocked in some time making the facility difficult or  
12 impossible to access in inclement weather. Similarly, the gravel road around the facility  
13 berms was in poor condition making it difficult for operations staff to conduct basic  
14 operations and maintenance activities.

*Poor condition of road around facility berm*

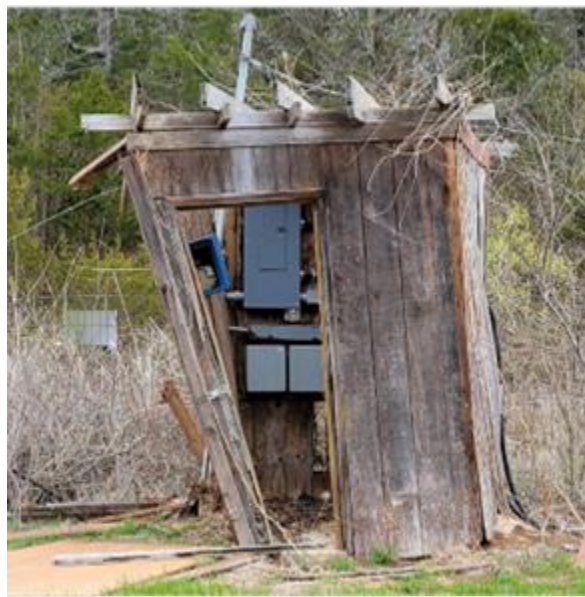
The control structure which housed the power and control systems for the two floating aerators was also extremely overgrown and in a failing condition, putting the function of the primary treatment equipment at risk of imminent failure. The poor condition of the control structure shortened the useful life of all the housed equipment and poor operational control of the facility.

*Condition of power/control structure at acquisition*

1  
2  
3           The failed power and control structure has been torn down and a new power pole  
4 added to ensure reliable power is present to operate not only the new aerators, but also  
5 the additional treatment processes to be installed as improvements continue at the  
6 facility. New control systems were also installed to operate the new aerators. The area  
7 where the control structure was located has been graded to prepare for the equipment that  
8 will be installed as part of the remaining process improvements still to be implemented.

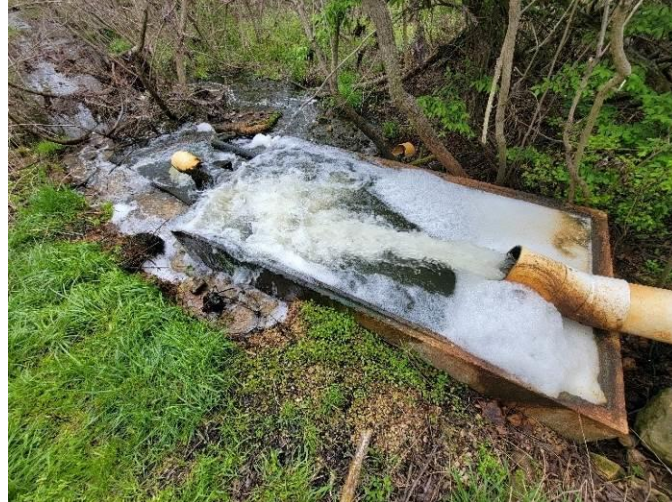
11 to the facility. In fact, flows have been so high that effluent has overflowed the walls of  
12 the chlorine contact chamber. The dilution of wastewater with storm/lake water has  
13 made the facility visually appear to be meeting some permitted limits, however dilution is  
14 not an acceptable means of treatment as even with the dilution occurring the facility has  
15 consistently violated limits for *E.coli* and ammonia. Furthermore, the excessive flows  
16 have led to excessive erosion in the ditch around the outfall, as the system was not  
17 designed for the level of flow received. Even if the maintenance and I&I issues were  
18 resolved, it is likely that the facility would still be incapable of meeting the ammonia  
19 limits. Therefore, process improvements would still be necessary to meet all permitted  
20 limits.

*Disinfection system overwhelmed with high flows due to I&I issues. Note overflows over the sides of the contact chamber walls*

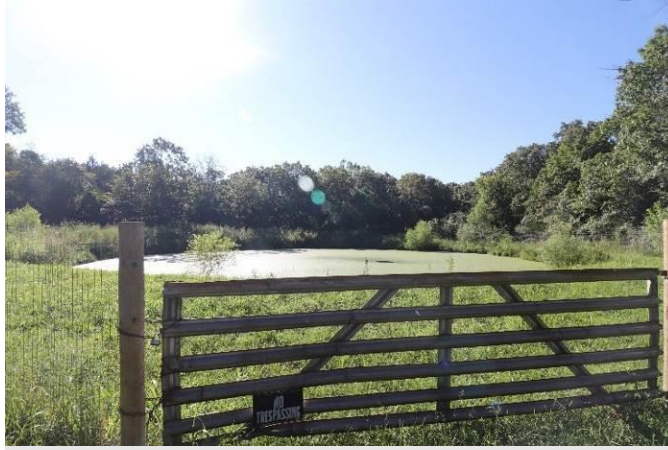
*Overgrowth around lagoon, varmint damage on berms visible*

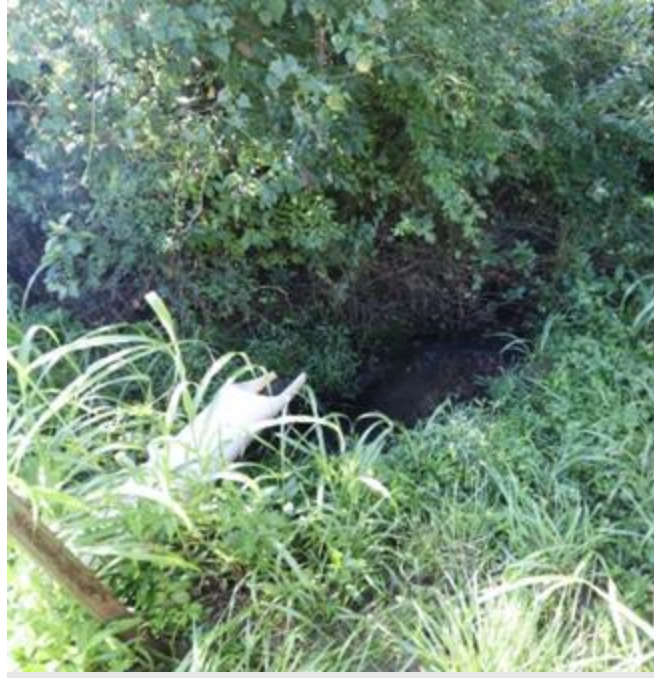
In addition to the overgrowth and varmint issues, the access road and roads around the berms were poorly maintained with no rock to ensure that the facility remains accessible to operations staff during inclement weather events. As mentioned, the system had no disinfection installed. This meant the facility was incapable of meeting *E.coli* limits, allowing harmful pathogens to be released into the environment. Beyond the system's inability to meet limits associated with disinfection, the single cell lagoon is also incapable of achieving consistent compliance with BOD limits and meeting the newer nutrient limits which are now implemented in NPDES permits (ammonia, phosphorus, etc.). Without significant process improvements the facility will be in constant noncompliance.

*Discharge from single cell lagoon with no disinfection equipment*

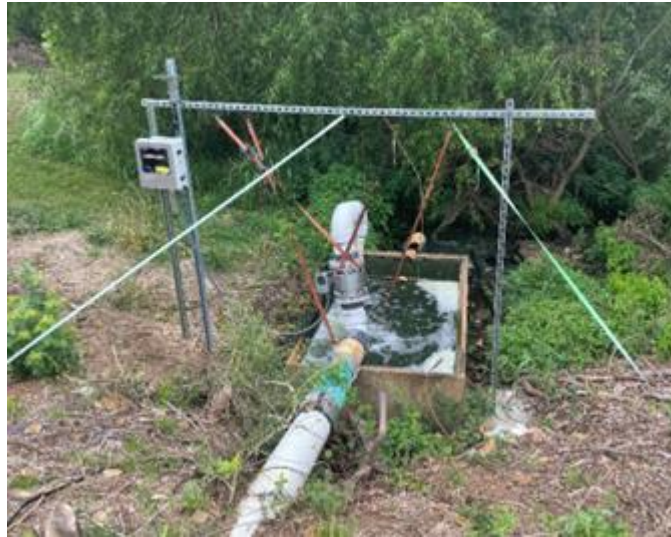
3  
4 *Temporary installation of flow meter and remote monitoring, note that while flow is still excessively high it*  
5 *is significantly reduced from flow at acquisition*  
6

7 To combat the severe I&I issues facing the facility, Confluence Rivers has begun  
8 repairing the collection system structures (manholes and cleanouts), and lining both the  
9 structures and sewer mains. While the level of I&I has been reduced, the flows are still  
10 significant and repairs to the collection system continue. Finally, Confluence has  
11 reworked and rocked the area around the outfall to prevent further erosion around the  
12 outfall caused by excessive I&I.

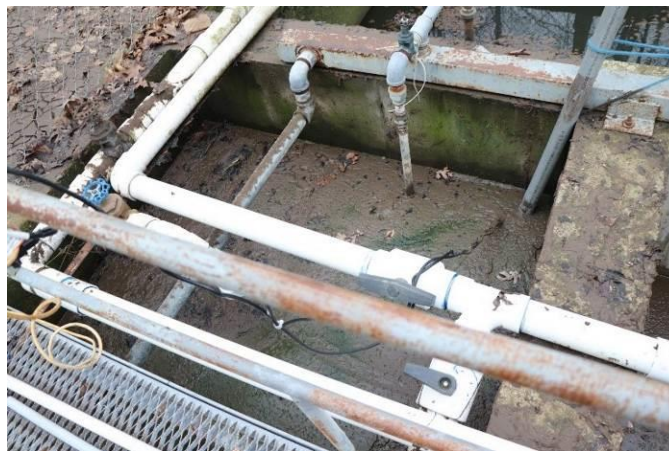
*Overfilled sludge digester*

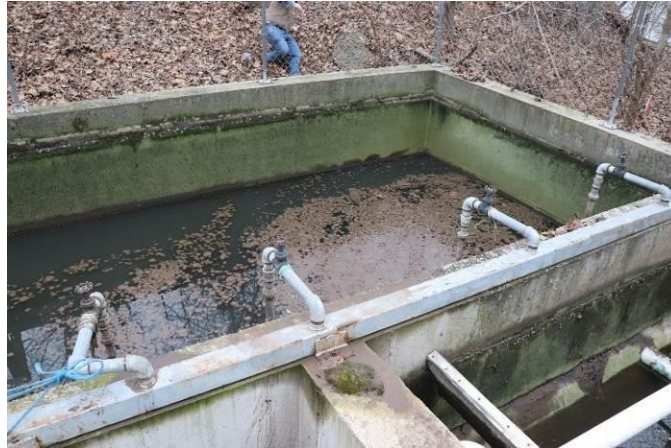
11 The condition of the aeration and piping equipment throughout the facility was  
12 also extremely poor. As is visible in the images above, most of the piping around the  
13 facility was often composed of cobbled together from scraps of piping with numerous  
14 connectors on even short straight runs of piping (visible in the above photo of the  
15 clarifier). This indicates poor maintenance practices as well as a general unwillingness to  
16 reinvest in the system by previous ownership. A majority of these clarifier components  
17 were poorly secured with many simply tied in place with rope. The steel aeration piping  
18 that was present at the facility was severely corroded, especially at the connection points

1 making the system prone to air leaks reducing the efficiency of the aeration system. As  
2 with the PVC piping at the facility, some of the steel pipes were also held in place with  
3 ropes.

4 *Poor condition of steel aeration piping (note blue ropes holding pipes in place at left) also note aeration*  
5 *system was not running and floating sludge in aeration basin*  
6  
7

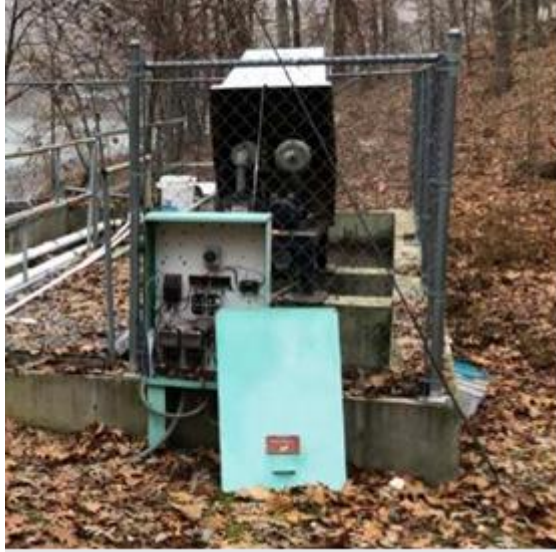
8 Beyond the poor condition of the aeration piping throughout the facility, the  
9 electrical and mechanical components of the aeration system were also in very poor  
10 condition. The power service ran across the ground to the control panel, and there was  
11 exposed wiring and signs of water infiltration in the control panel. The blowers were in  
12 poor condition and would not function when Confluence Rivers closed on the facility,  
13 effectively halting the primary treatment process of the treatment facility.

*Poor condition/nonfunctional blowers and control system*

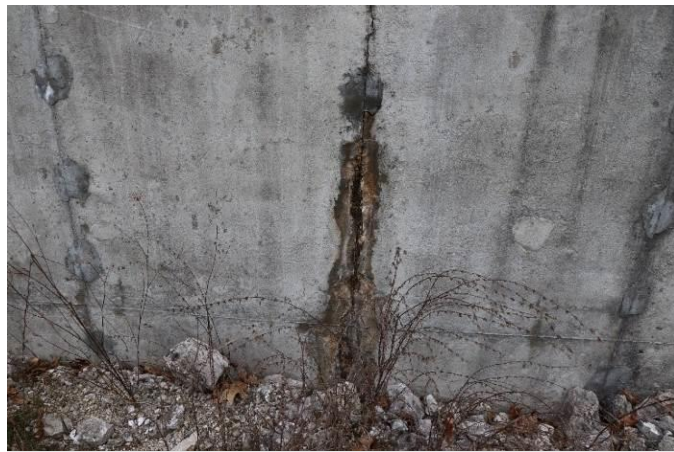
Beyond the issues with the operations and function of the facility, other portions of the facility were also in poor or failing condition. The concrete tanks had many areas where cracking had occurred and which had not been patched or repaired, leading to seeping of untreated wastewater in an illegal SSO.

*Cracks in concrete tankage*

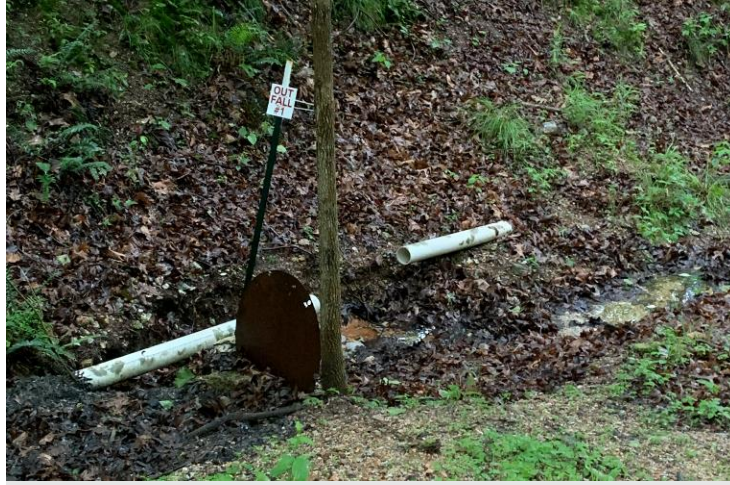
In addition, the facility outfall was also severely damaged at some point prior to acquisition by Confluence Rivers. The plant is situated in a gulley between hills on the edge of The Lake of the Ozarks. Due to the location and original installation of the outfall pipe, over time, erosion had caused damage to the outfall pipe. Rather than

1 repairing the pipe the previous owners simply cut the pipe off, well uphill of the receiving  
2 waters.

*Outfall pipe terminating short of the receiving waters*

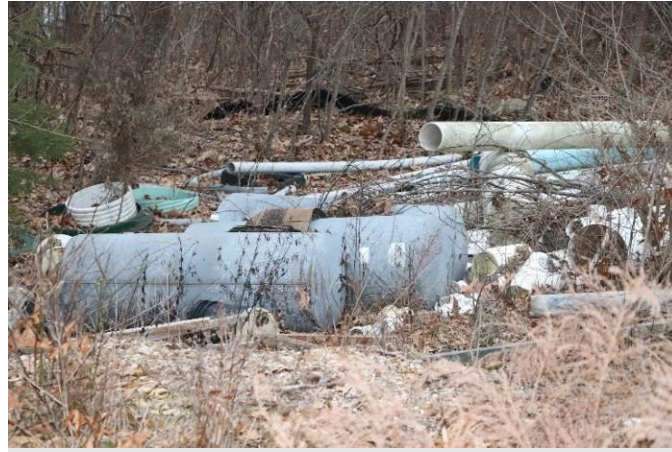
3  
4  
5 The facility access road was in poor condition leading up to acquisition.  
6 Inaccessibility is likely part of the reason that sludge hauling had been neglected so long  
7 as the access road was too steep, damaged and primitive to allow access by a vac truck  
8 needed for hauling sludge. The site also had a large amount of trash and debris dumped  
9 haphazardly in the gully below the plant, most of which appeared to be components of  
10 the septic tanks and grinder stations previously utilized in the system. This was likely the  
11 result of maintenance work performed in the system, which produced waste that instead  
12 of being disposed of properly was simply dumped near the plant.

*Old equipment dumped downhill from the facility*

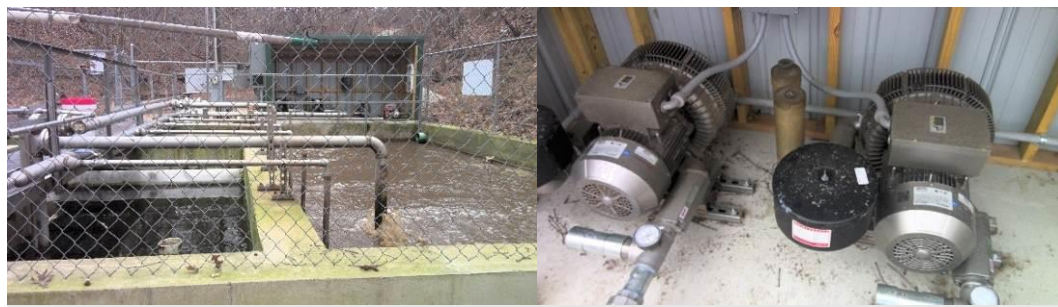
*New aeration piping, blowers, and valving*

1  
2  
3 The aeration overhaul included replacing the blowers, air piping and valving, drop  
4 pipes, diffusers, and sludge returns/wasting lines. The system had been in such poor  
5 condition that the aeration equipment needed to be replaced in order to restore proper  
6 treatment to the plant. As described above, the primary treatment process of the plant  
7 was not functioning at acquisition and has now been completely restored with these  
8 improvements.

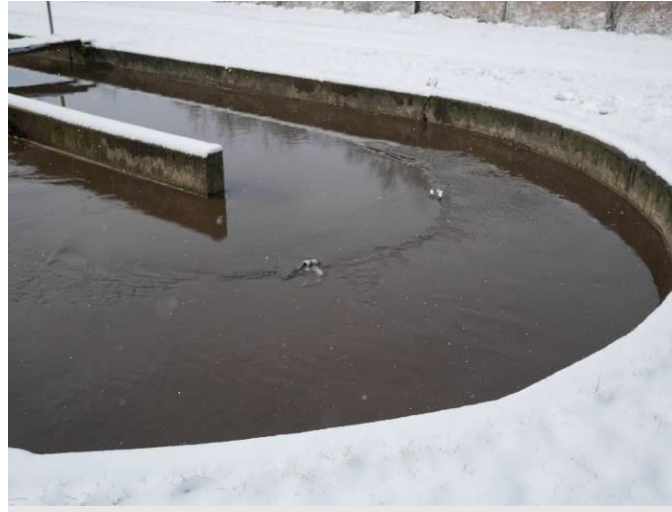
1 function of the system and disrupting flow. In the 180° turns at each end of the track the  
2 flow had diminished such that sludge had accumulated to the point that it broke the  
3 surface of the basin.

4  
5 *Sludge accumulation breaking the surface of water in the Oxidation Ditch*

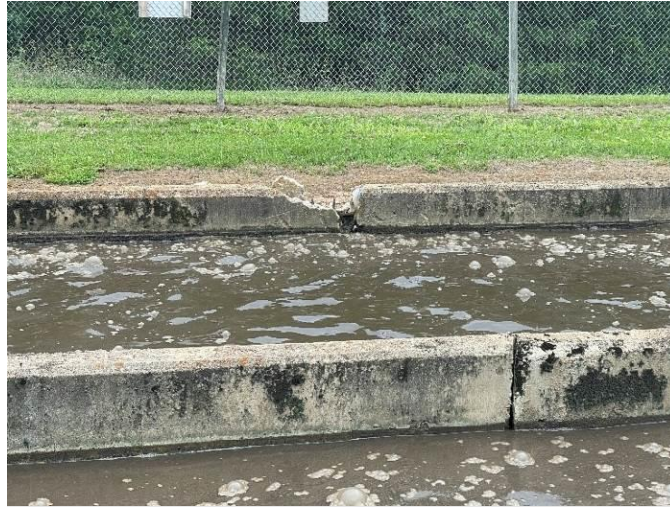
11 Additionally, the general condition of the concrete structure of the Oxidation ditch  
12 was also poor, with many points where concrete had cracked and degraded, causing  
13 locations where wastewater could potentially leak out of the facility.  
14  
15  
16

*Examples of damaged concrete in oxidation ditch track*

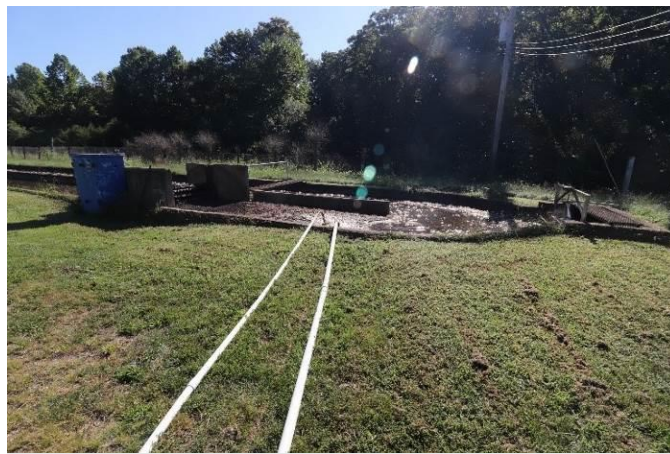
At some point in the facility’s history, the RAS line running from the clarifier to the oxidation ditch track had failed, and rather than properly plumbing in a replacement line, a line was run above ground from the clarifier to the oxidation ditch track. This creates a tripping hazard on the site, results in the new line being exposed to UV deterioration resulting in a shortened useful life and raises the possibility of freezing in cold weather causing the clarifier to be unable to return sludge and potentially resulting in sludge releases from the facility. Along with this, the telescoping valve on the RAS line was in poor condition and held together in part with ropes tied to the clarifier structure.

*Above ground RAS lines at Oxidation Ditch*

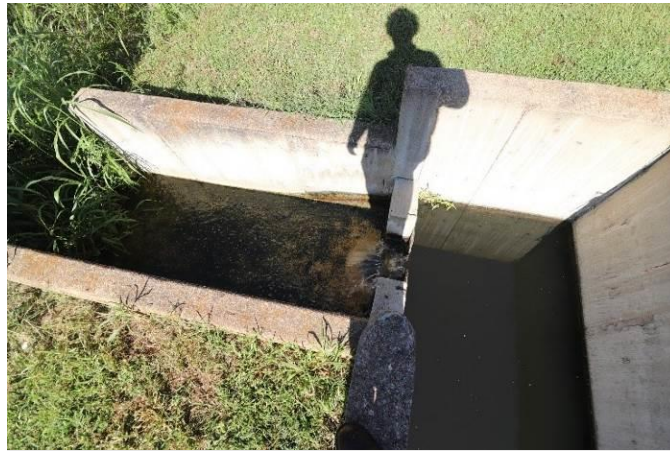
12  
13 *No dechlorination installed at end of contact chamber*

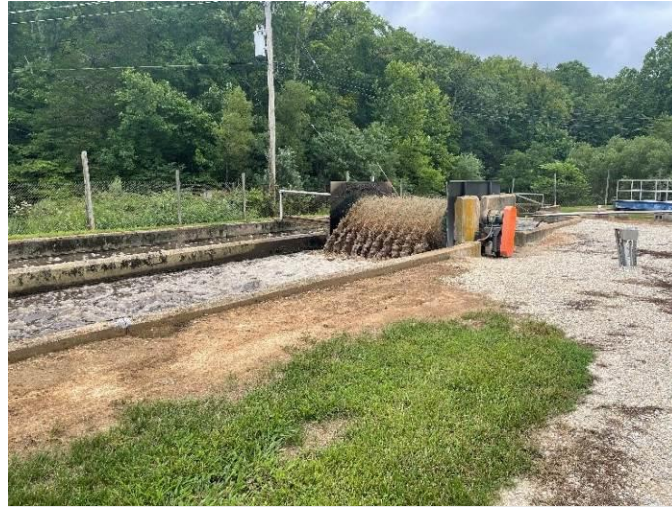
*Repaired brush aerator*

8 A. Confluence Rivers has begun to make significant improvements to the Terre du Lac  
9 Oxidation Ditch facility. The nuisance vegetation was removed from the fence line to  
10 prevent damage to the fencing. Portions of the access road have been re-rocked to  
11 prevent erosion damage which could limit access to the facility. The damaged brush  
12 aerator was repaired, including installation of a new rotor, brushes, motor and gearbox  
13 assembly, and the damaged brush assembly was replaced on the functioning aerator.  
14 This has restored aeration in the facility to its designed capacity.

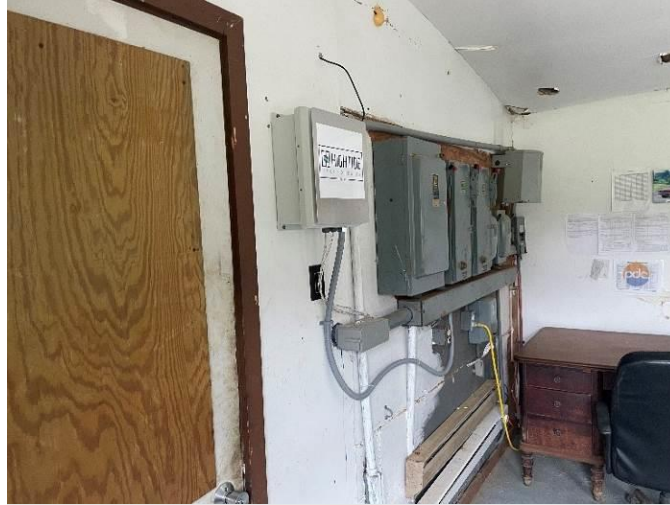
*Remote monitoring equipment in Oxidation Ditch control room*

As with all Confluence River systems, remote monitoring and flow monitoring has been added to the facility to properly evaluate facility performance, provide operations staff with active monitoring of equipment status, and providing operators with immediate notification of any abnormal operating conditions.

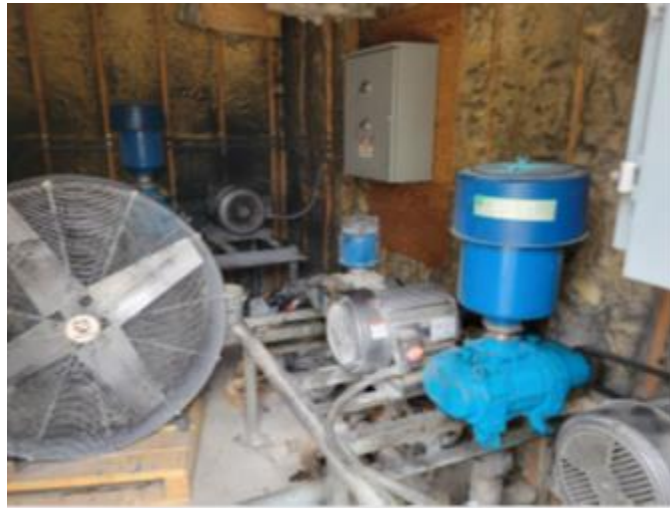
7 Beyond issues directly related to the treatment at the plant, there are other issues  
8 at the facility which should be addressed. The blowers are currently housed in a shack  
9 which is in poor condition, largely due to poor interior finishing leading to early wear and  
10 tear.

11 *Poor condition of blower building interior, also visible electrical and control system with no ability to connect*  
12 *emergency power source.*  
13  
14

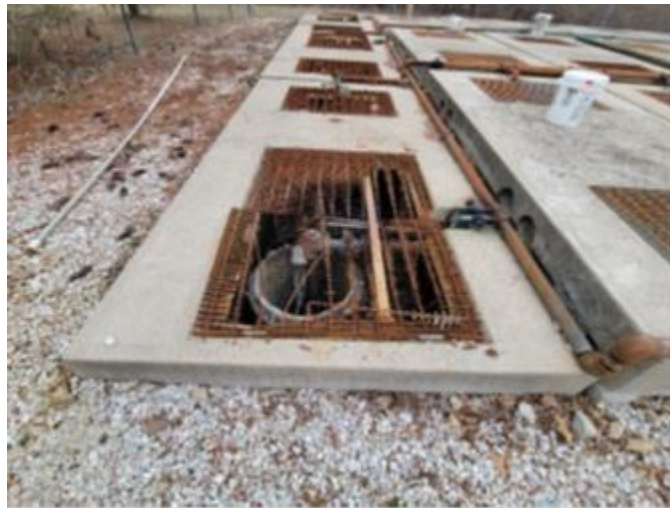
1 totalized flow measurement. Some of the grating over the flow equalization basins has  
2 degraded and is no longer safe to walk across.

3  
4 *Rusted grating over the flow equalization tank.*

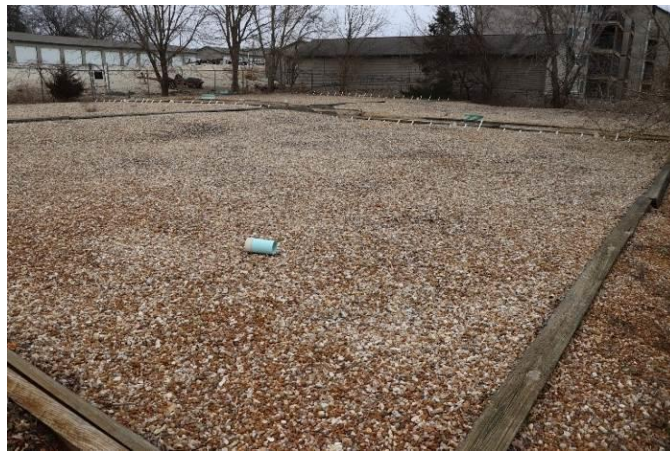
*Overview of Cedar Glen facility at acquisition*

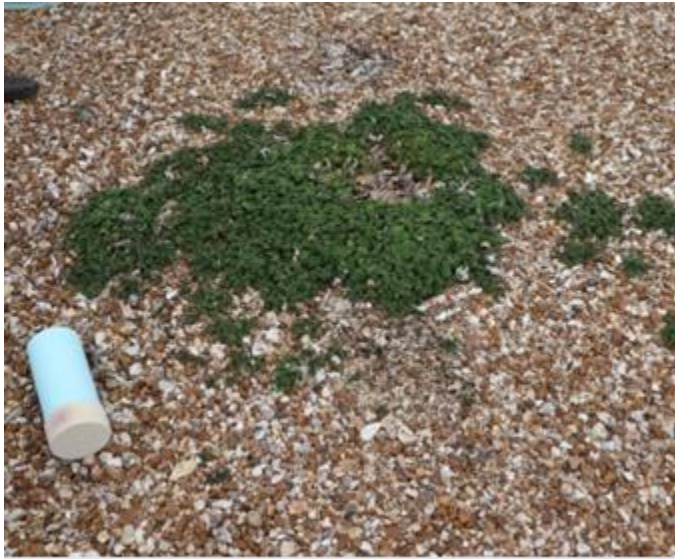
10  
11 *Vegetation growing on surface of Cedar Glen sand filter*

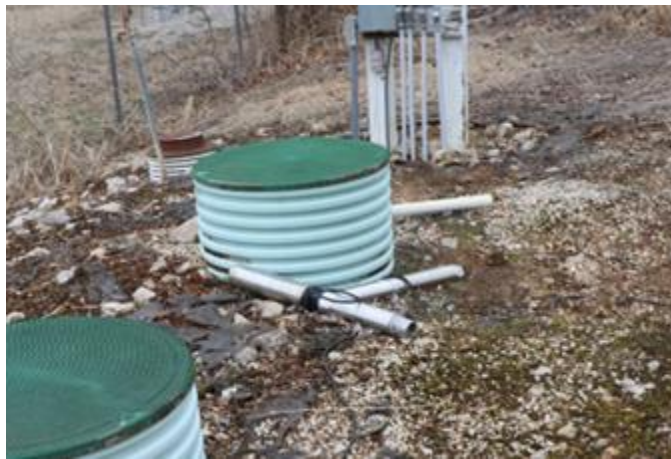
11  
12 *Pile of burnt-out submersible pumps near influent septic tank*

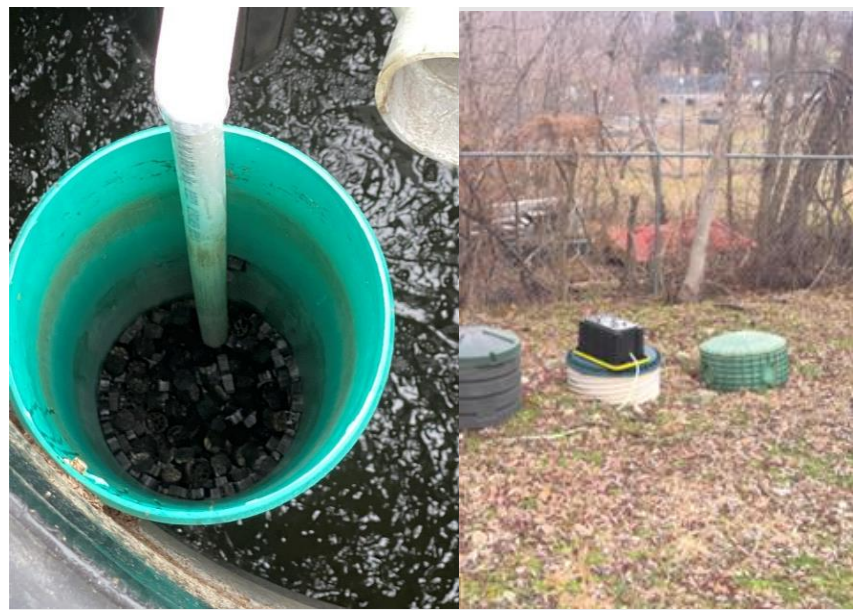
8  
9 *Micro MBBR in Recirculation tank and small blower running MBBR*

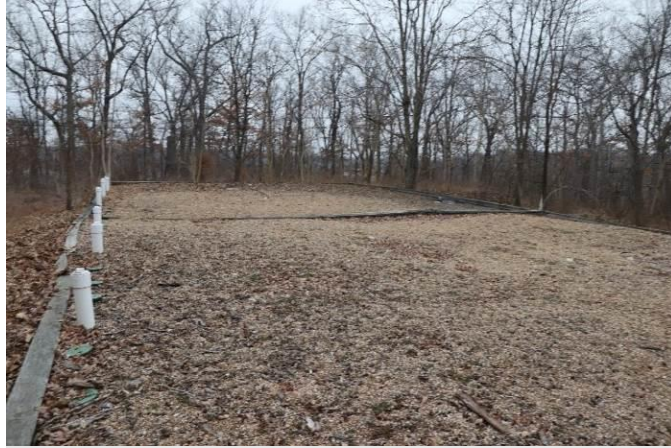
*Overview of facility at acquisition (note debris from overhanging trees on filter beds)*

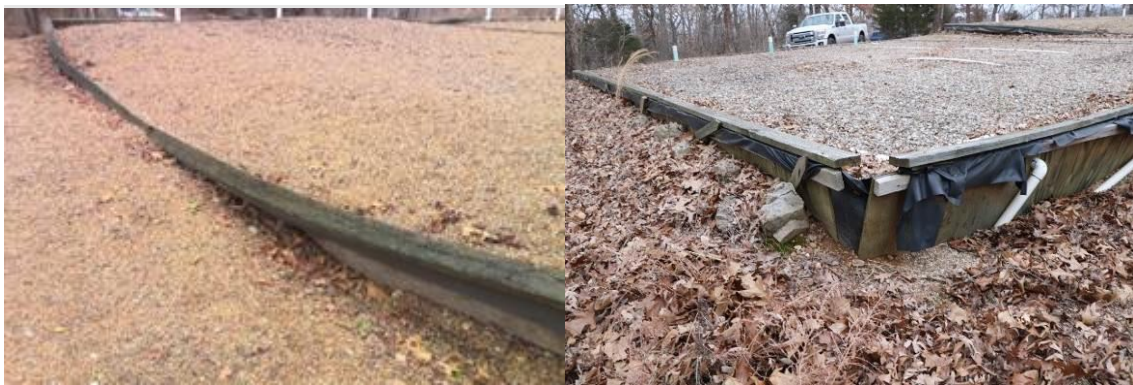
14  
15           *Bowed plywood wall and failing corners at Cimarron Bay Sand filter*  
16  
17

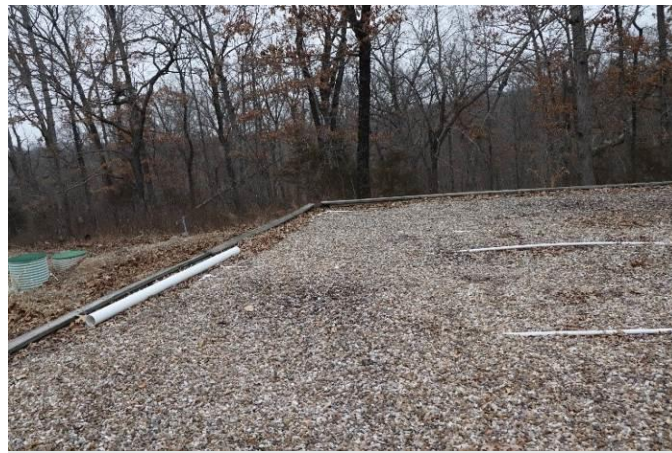
13  
14 *Exposed piping in Cimarron Bay filter beds*

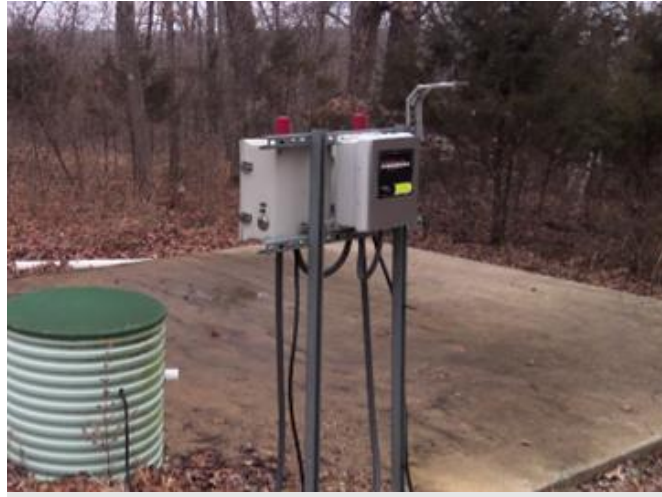
6  
7 *Remote monitoring unit at treatment facility*

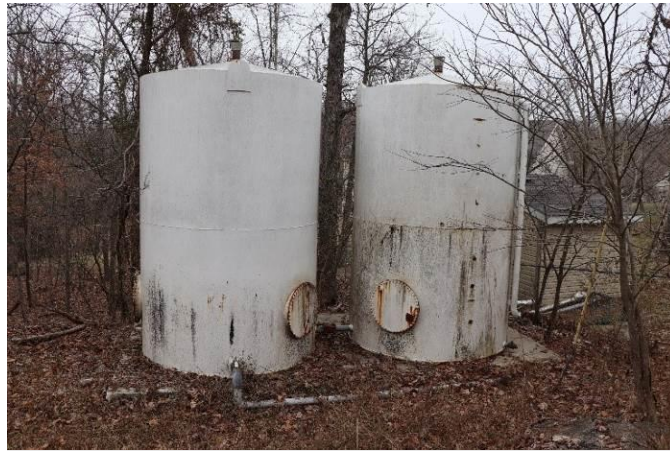
12 *Condition of ground storage tanks at acquisition*

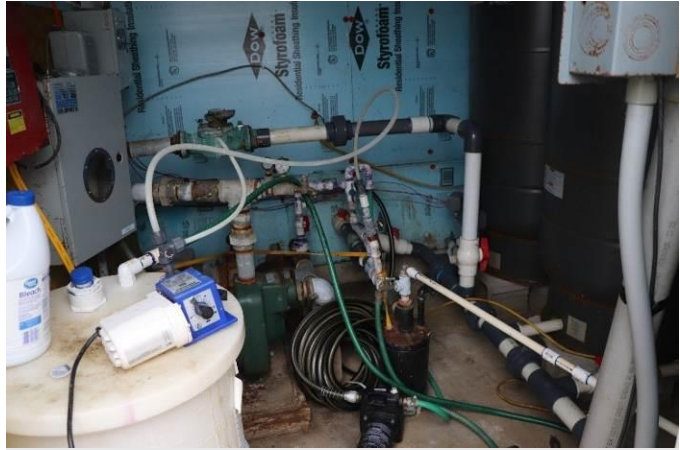
4 *Well house interior, note coils of garden hose, rusted well head plate, exposed wiring, bleach bottle*

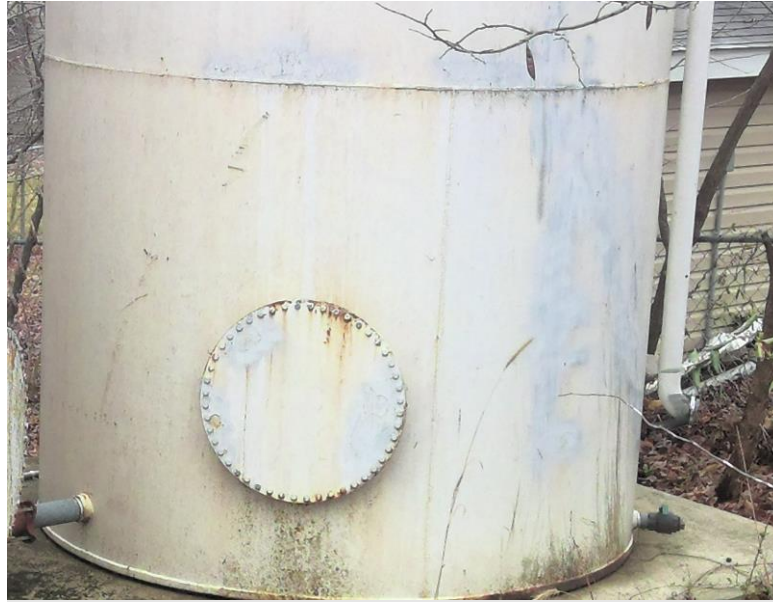
Point repairs on ground storage tank (note slightly different paint color)

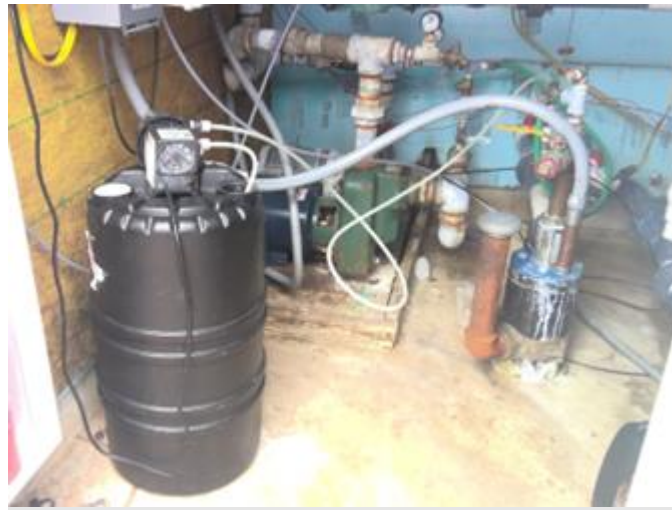
New disinfection system, improved wiring, piping, etc.

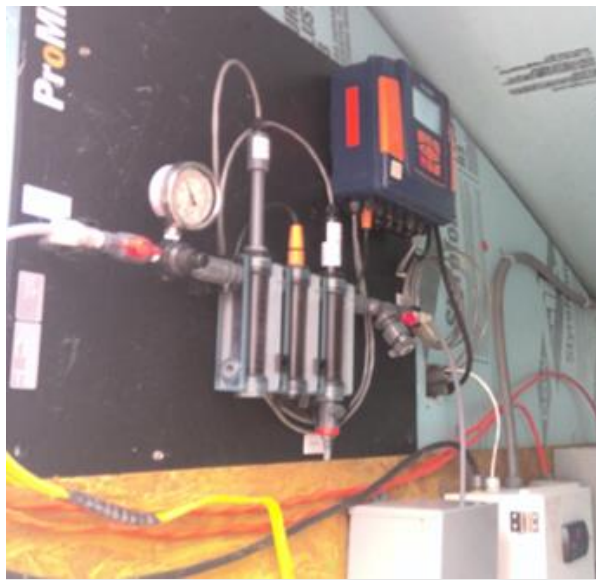
*Chlorine Analyzer system*

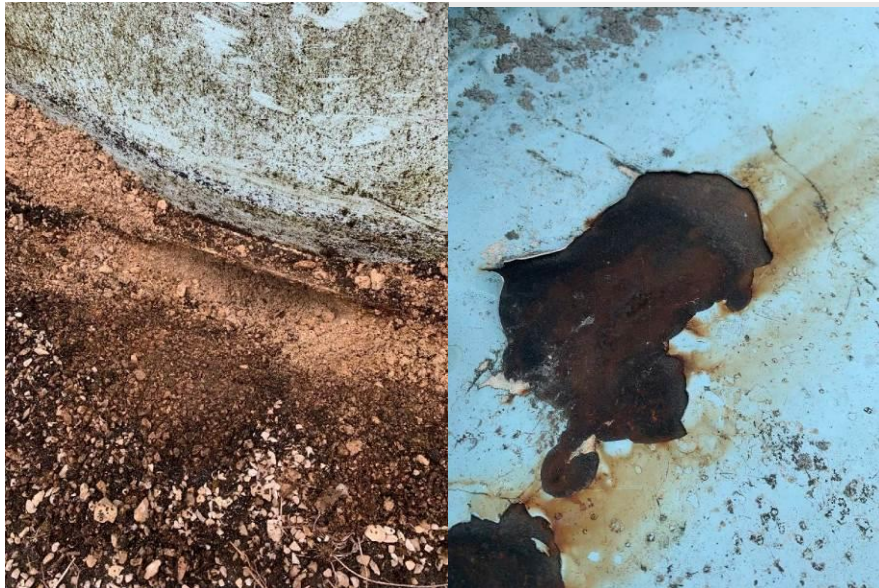
3 *Erosion around standpipe gravel footing / corrosion to standpipe coating*

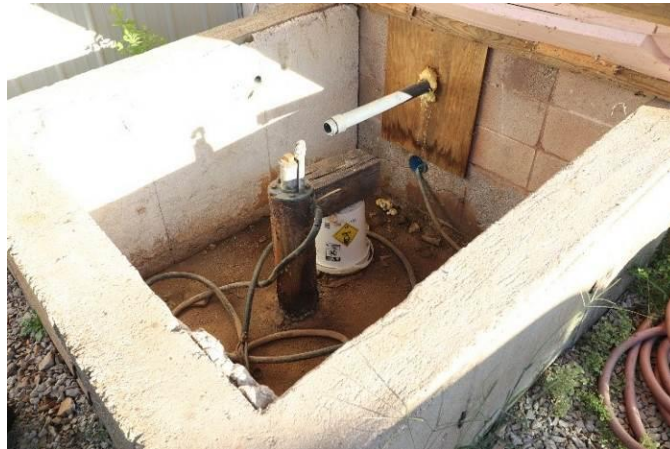
12  
13 *Inactive Well #1: exposed wiring and physical disconnection*  
14

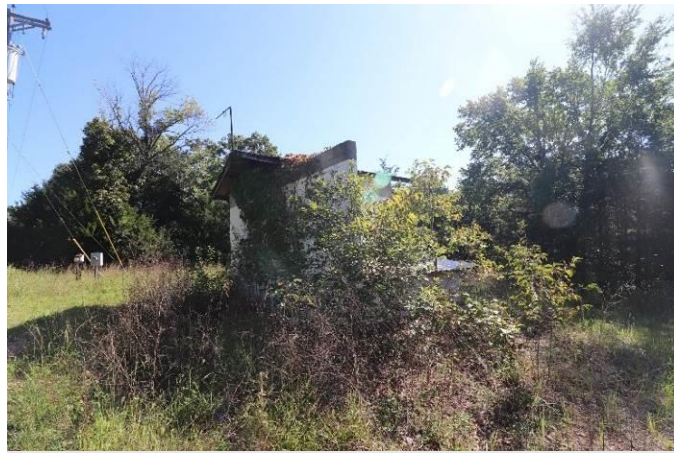
*Vegetation overgrowing the Well #2 well house.*

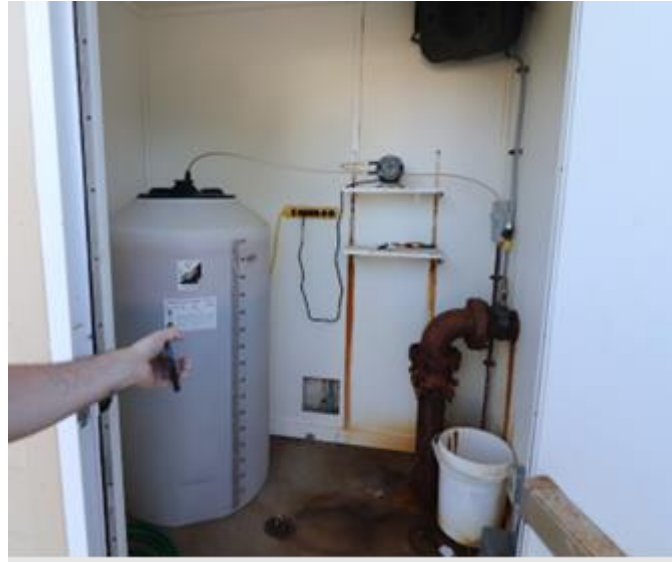
*Well #4 disinfection room with steel rusting*

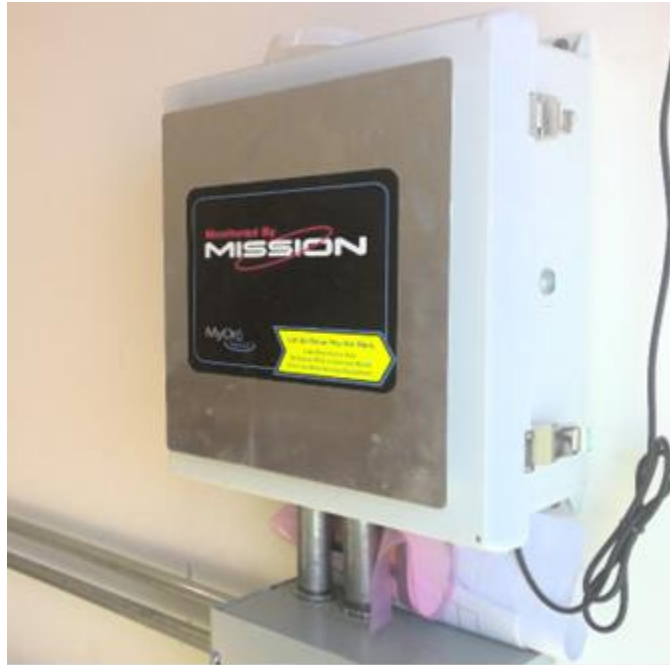
*Remote monitoring system at Prairie Fields*

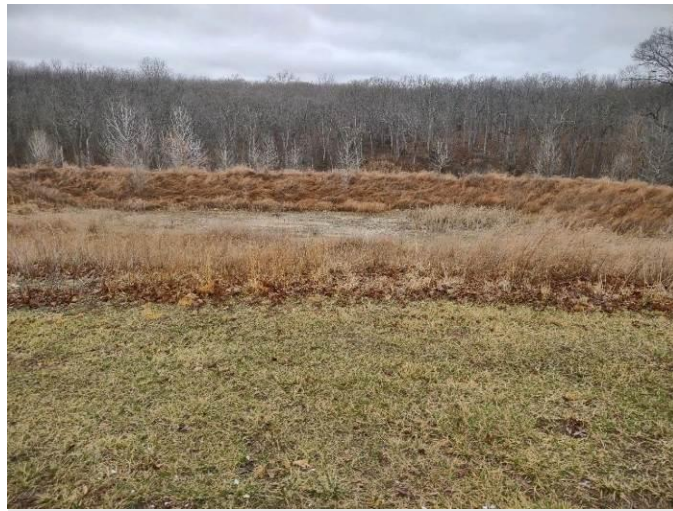
*Overgrowth around Missing Well lagoon*

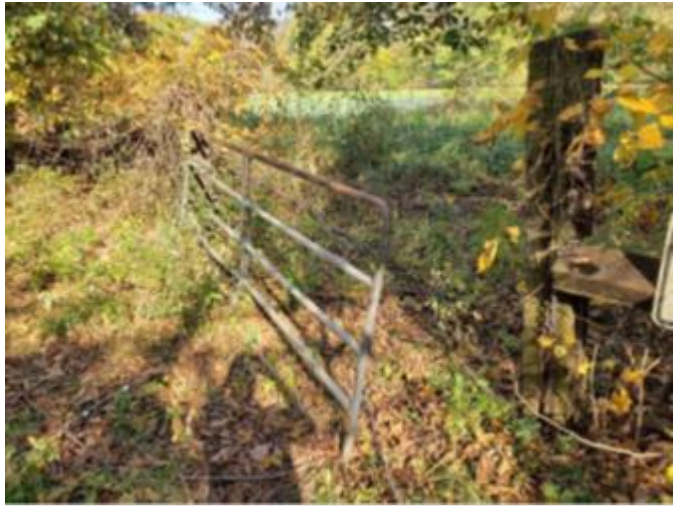
*Fence damage due to overgrowth at Shelton Estates*

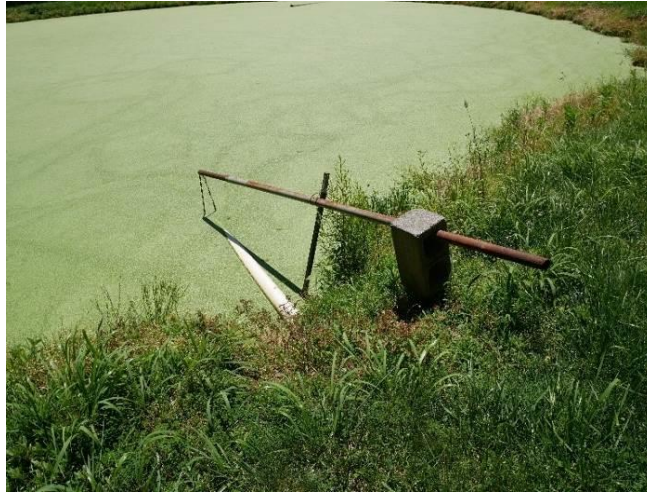
*Duckweed covering surface of Deguire lagoon*

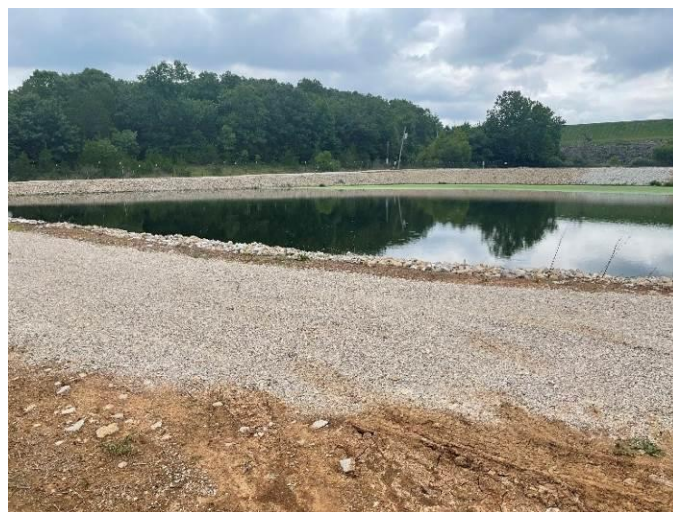
*Berms following repairs and application of rip rap*

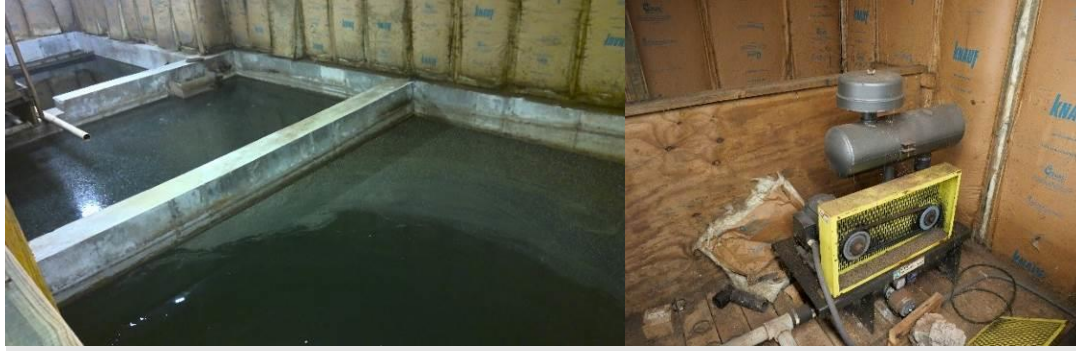
*No functioning aeration present at Cedar Green and single failed blower*

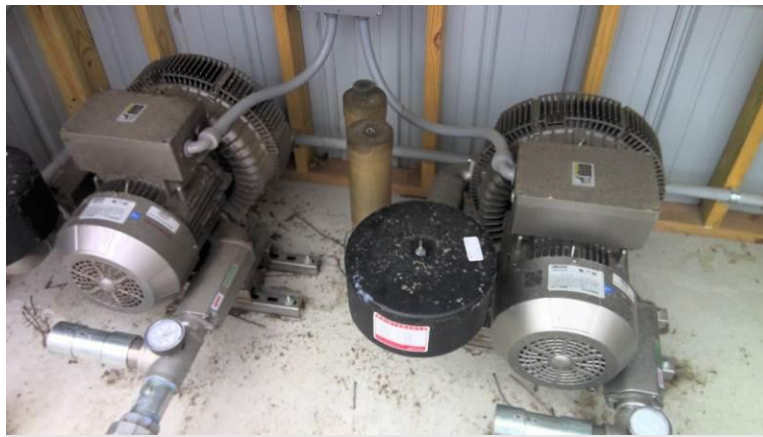
*New blowers at the Chelsea Rose facility which had no functional blowers at acquisition*

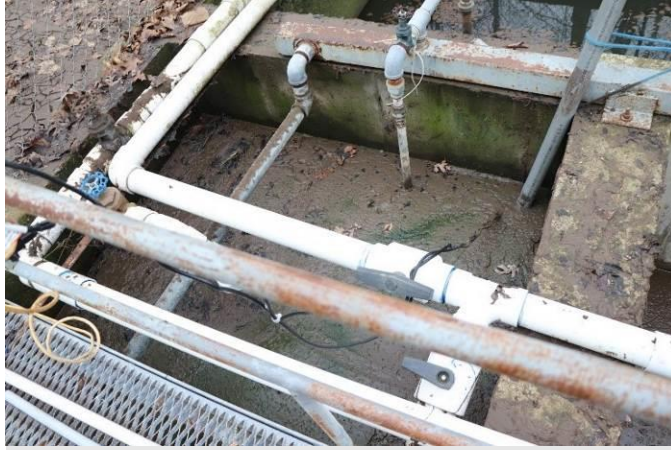
*Rusting aeration piping partially replaced with PVC at Chelsea Rose, no functioning aeration and degraded diffusers present.*
