Exhibit No. \_\_\_\_\_  
Issues: System Condition and Improvements  
Witness: Jacob Freeman  
Type of Exhibit: Direct Testimony  
Sponsoring Party: Confluence Rivers Utility  
Operating Company, Inc  
File Nos.: WR-2023-0006 / SR-2023-0007  
Date: December 21, 2022

**Missouri Public Service Commission**

**Direct Testimony**

**Confluence Rivers Utility Operating Company, Inc**

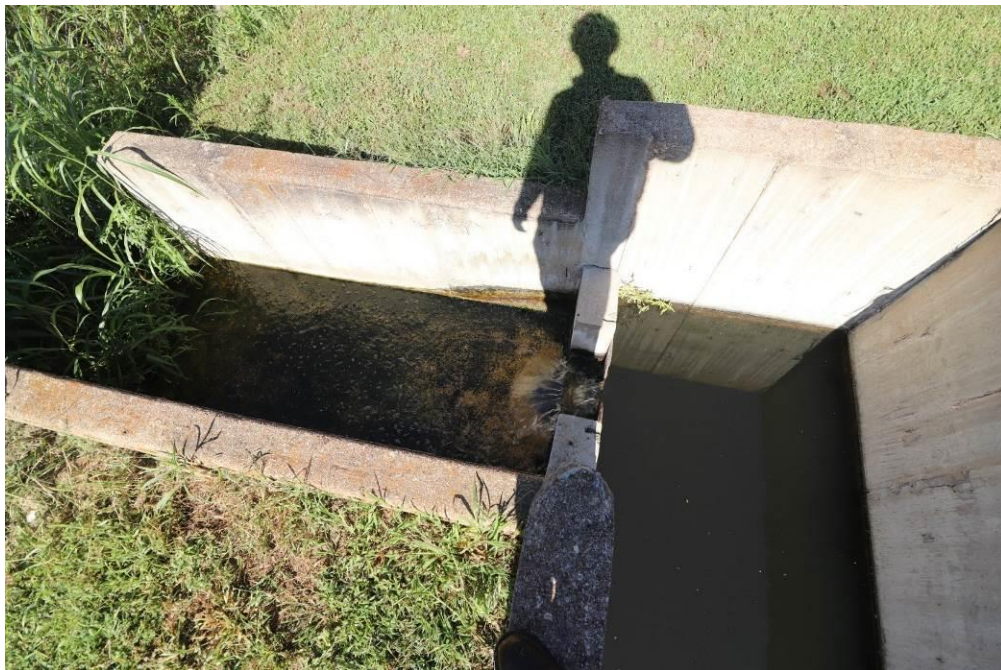
*Dechlorination not installed at Terre du Lac Oxidation ditch*

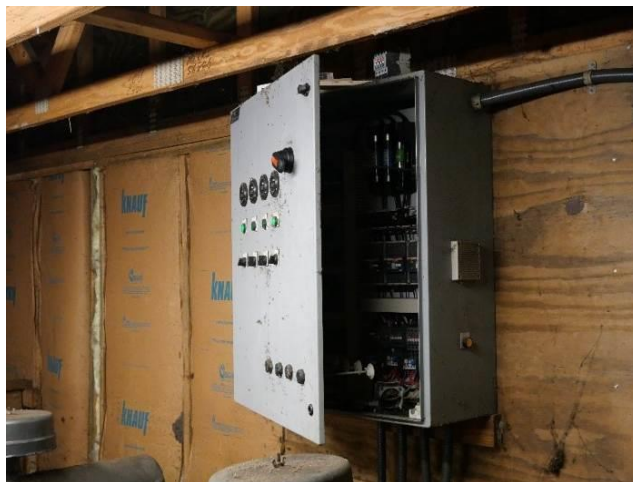
*Damaged control system at Cedar Green facility*

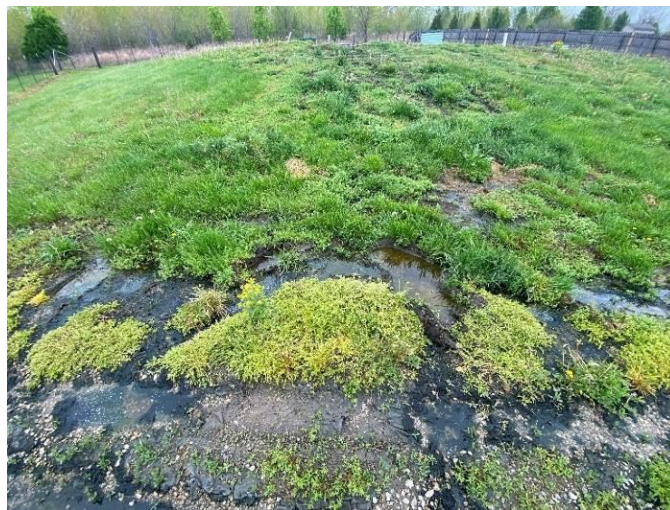
*SSO at Berkshire Glenn (in background) due to sludge clogging filter bed*

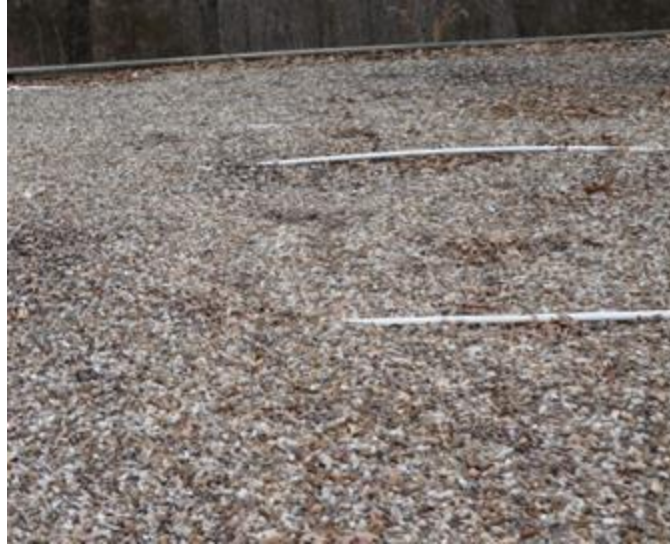
*Damaged distribution piping at Cimarron Bay*

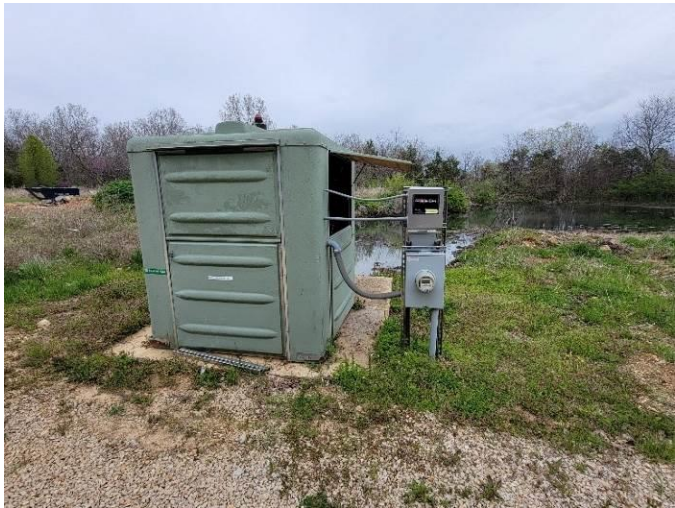
*Example of Terre du Lac lift station with unapproved surge basin*

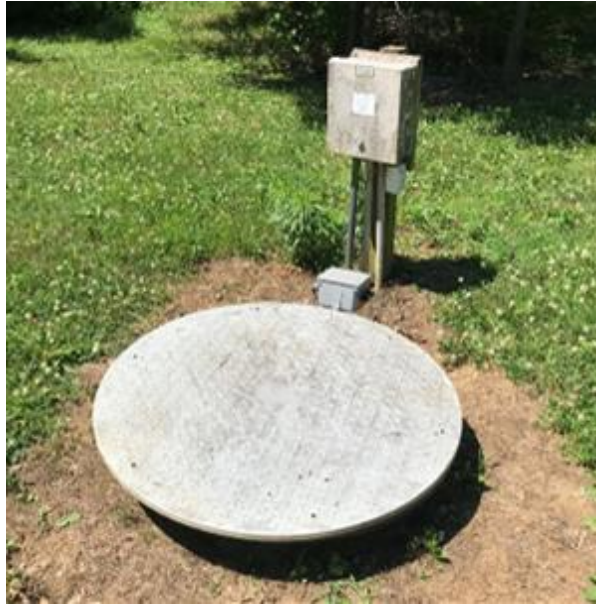
*Lift station at Park Estates, missing redundant pump*

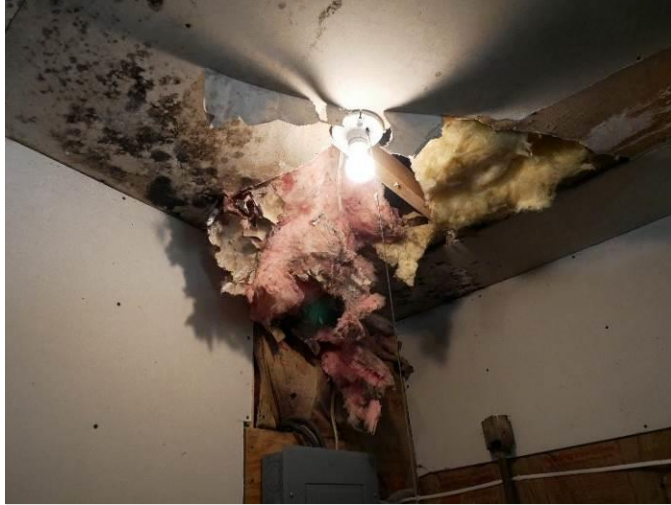
*Failing insulation at Fawn Lake Well house, damaged interior*

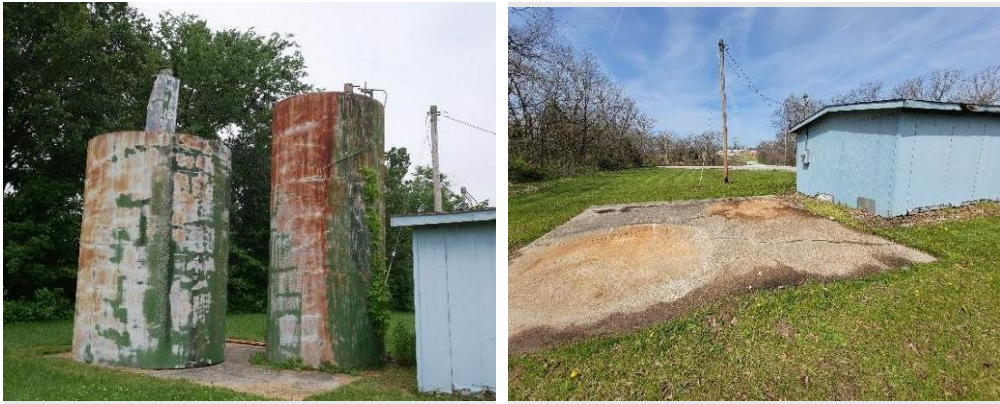
13  
14 *Deteriorating abandoned storage tanks at Fawn Lake (removed by Confluence Rivers)*

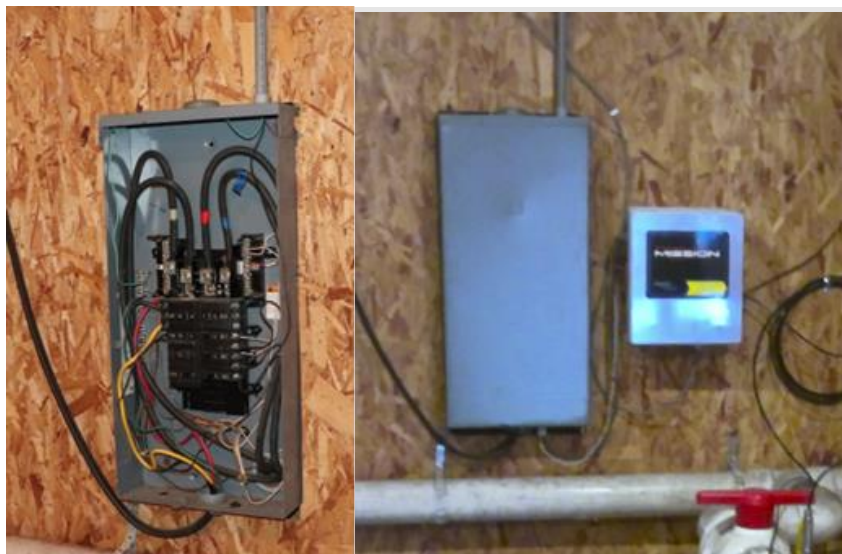
12  
13            *Damaged power panel, exposed wiring at Cedar Glen. Panel repaired and remote monitoring installed.*  
14
