**MISSOURI PUBLIC SERVICE COMMISSION**

**STAFF'S CONSTRUCTION AUDIT AND**

**PRUDENCE REVIEW OF TAUM SAUK**

**UNION ELECTRIC COMPANY,  
d/b/a Ameren Missouri**

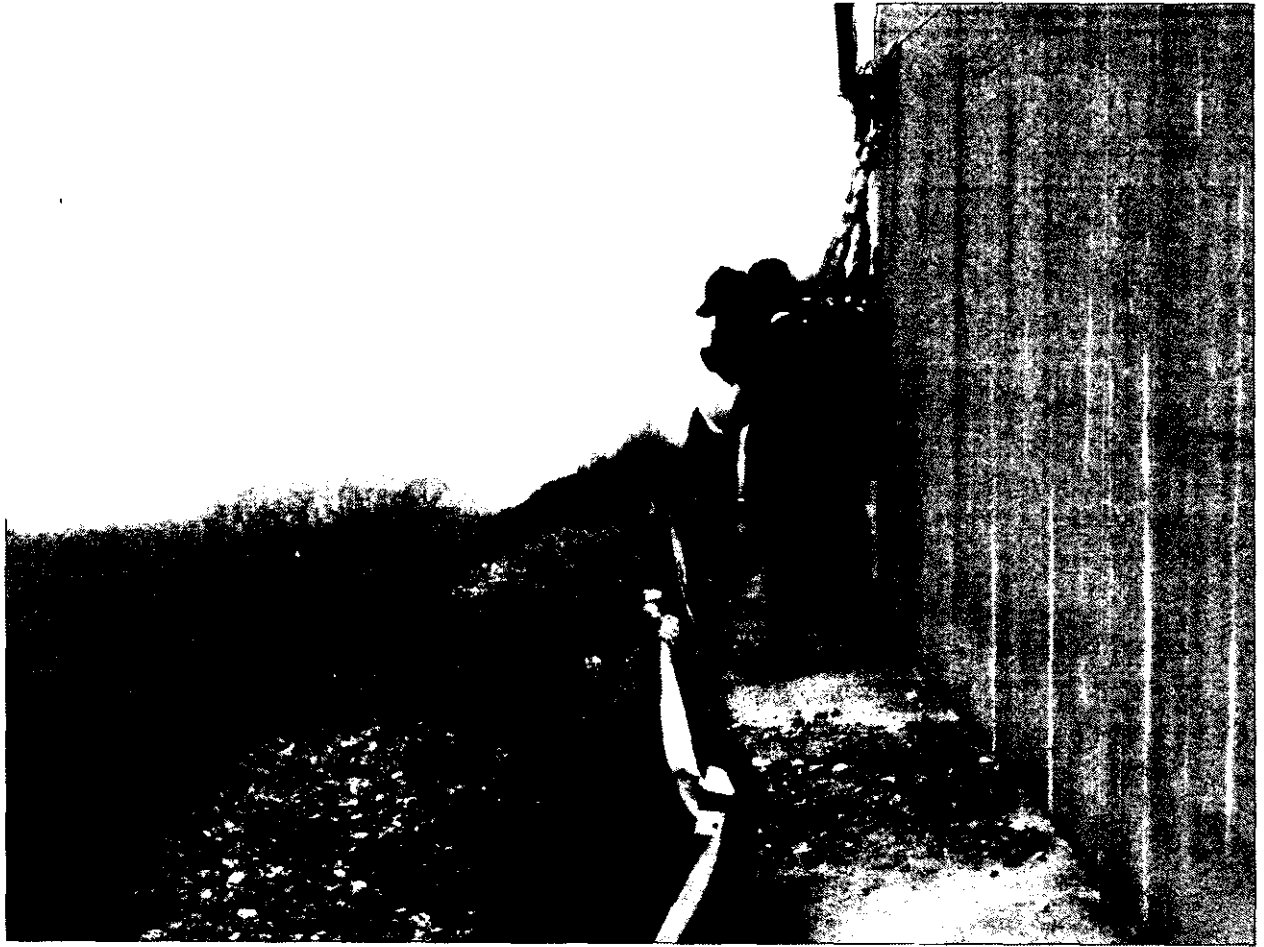
7  
8                   The photograph above shows a location where the parapet wall was overtopped by water  
9 erosion which occurred at several locations around the perimeter of the upper reservoir.

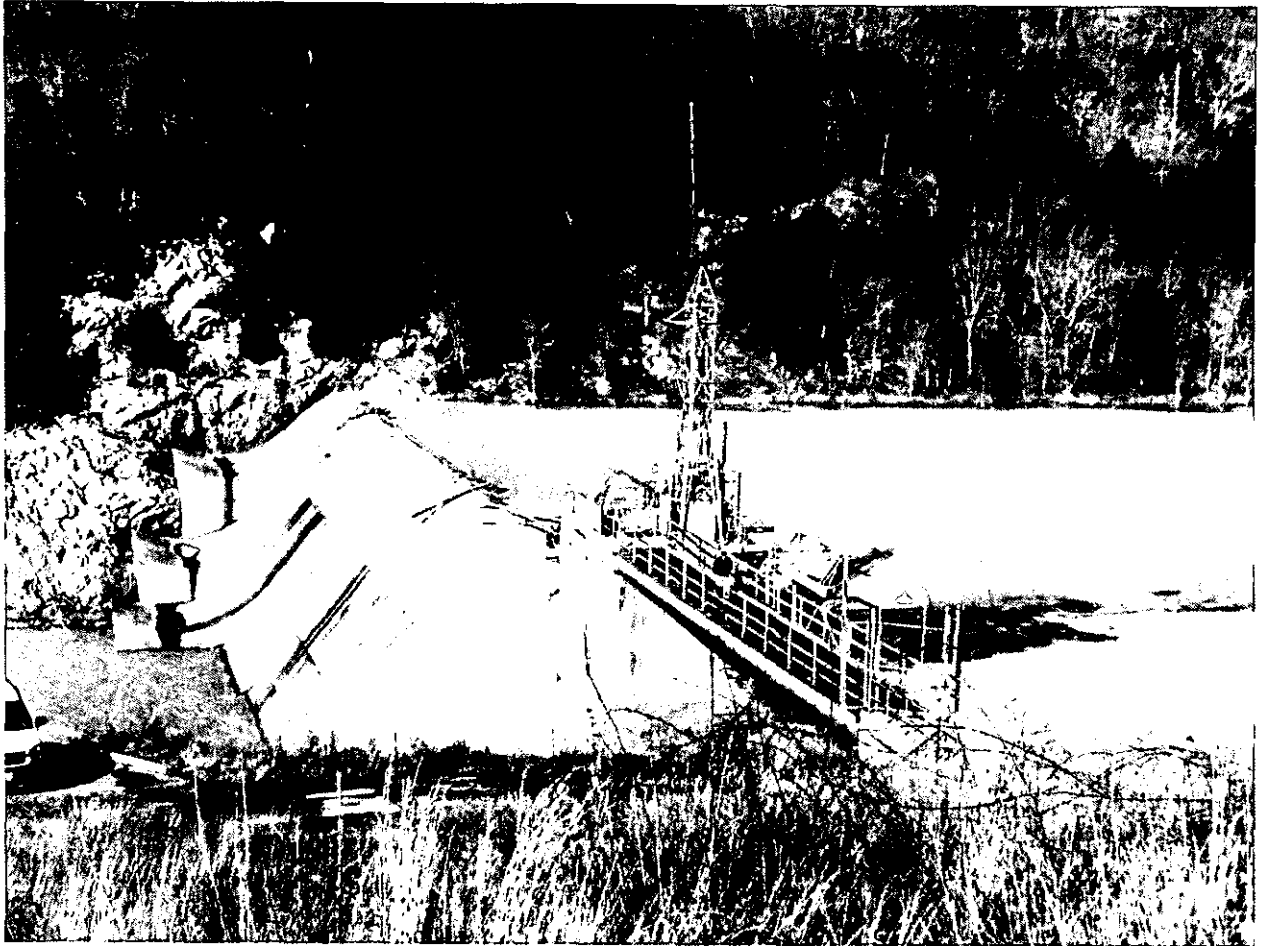
The photograph above shows the lower run of river dam the day after failure of the upper reservoir.

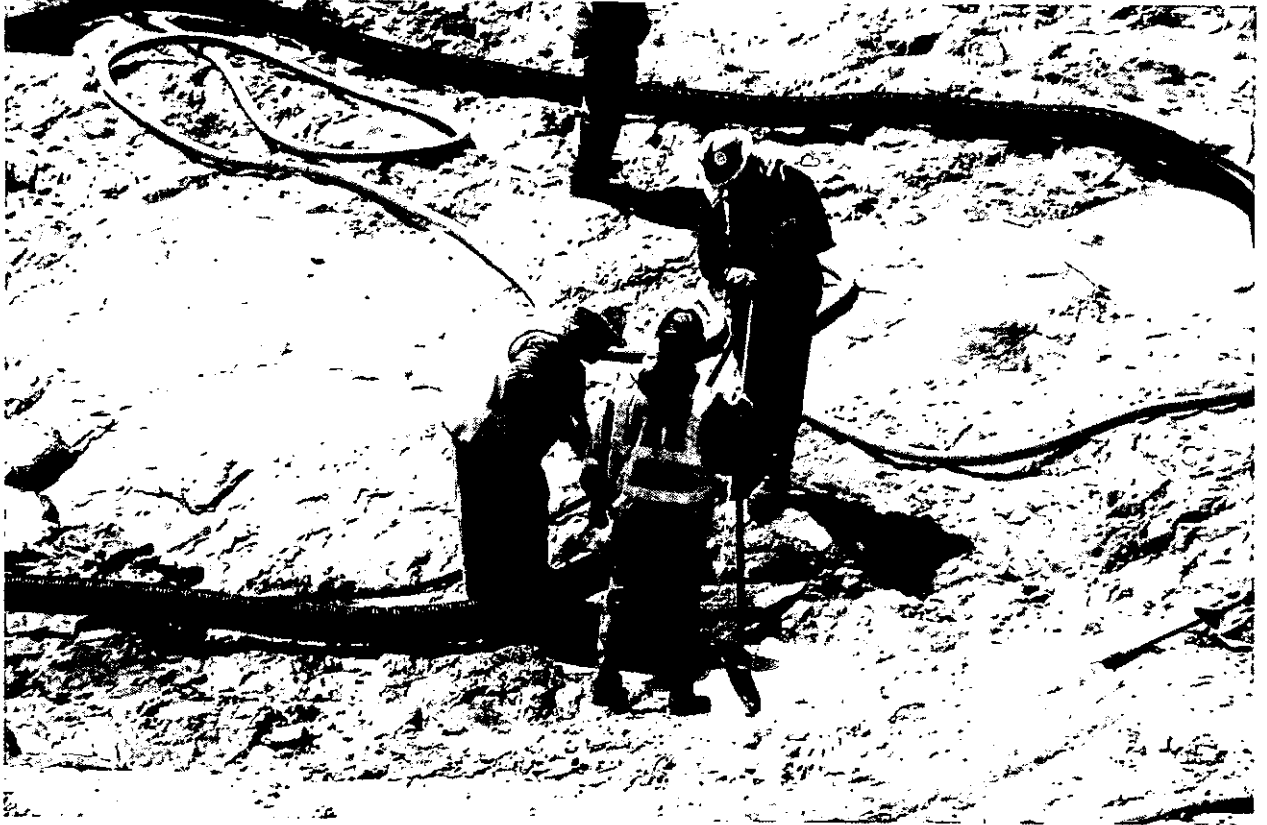
3 The photograph above shows the cleaning and mapping process.
