MISSOURI PUBLIC SERVICE COMMISSION

**STAFF'S CONSTRUCTION AUDIT AND
PRUDENCE REVIEW OF TAUM SAUK
PROJECT FOR COSTS REPORTED AS OF
OCTOBER 31, 2010**

**UNION ELECTRIC COMPANY,
d/b/a Ameren Missouri**

FILE NO. ER-2011-0028

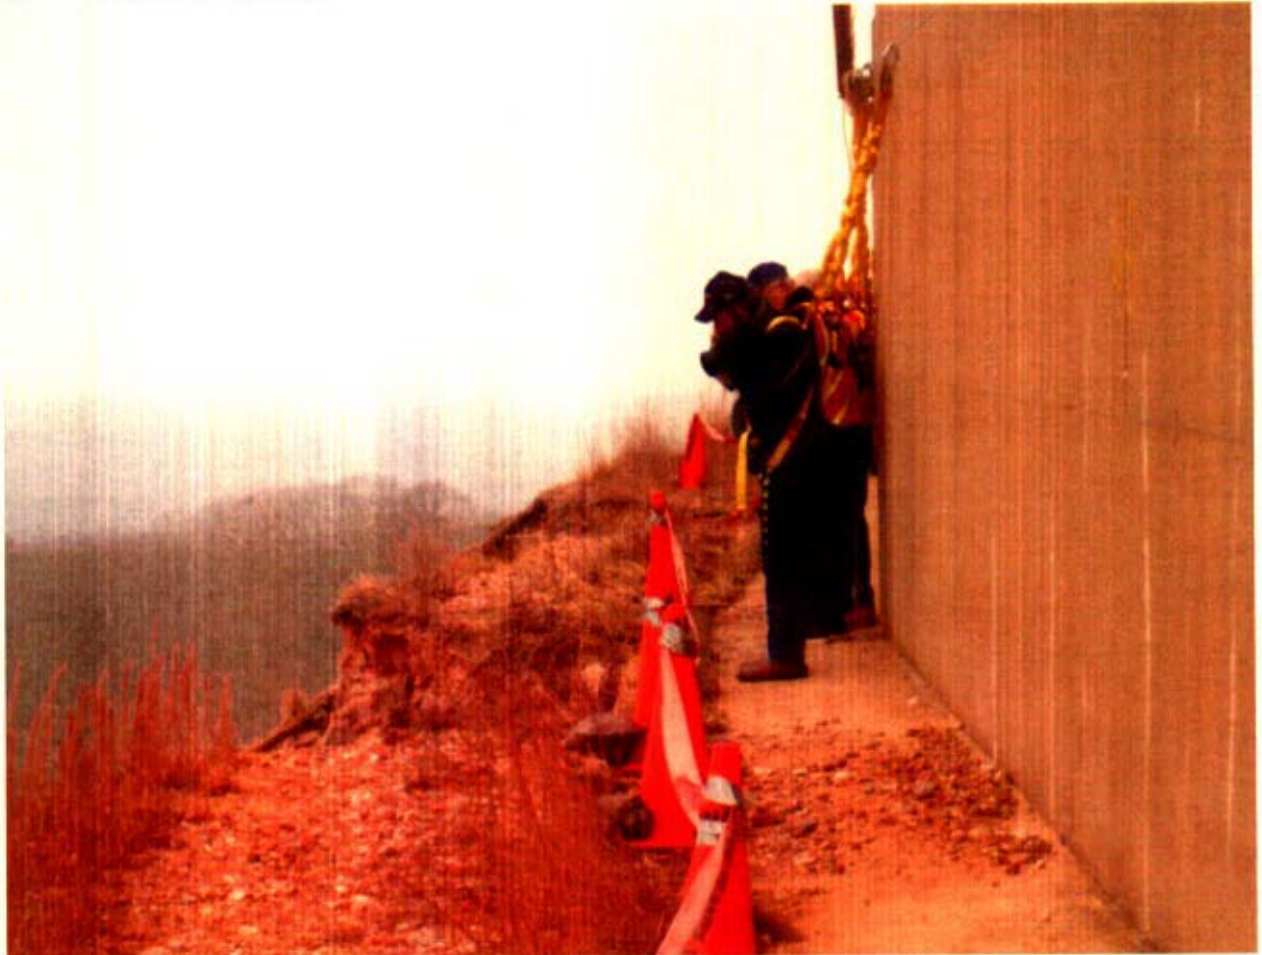
7
8 The photograph above shows a location where the parapet wall was overtopped by water
9 erosion which occurred at several locations around the perimeter of the upper reservoir.

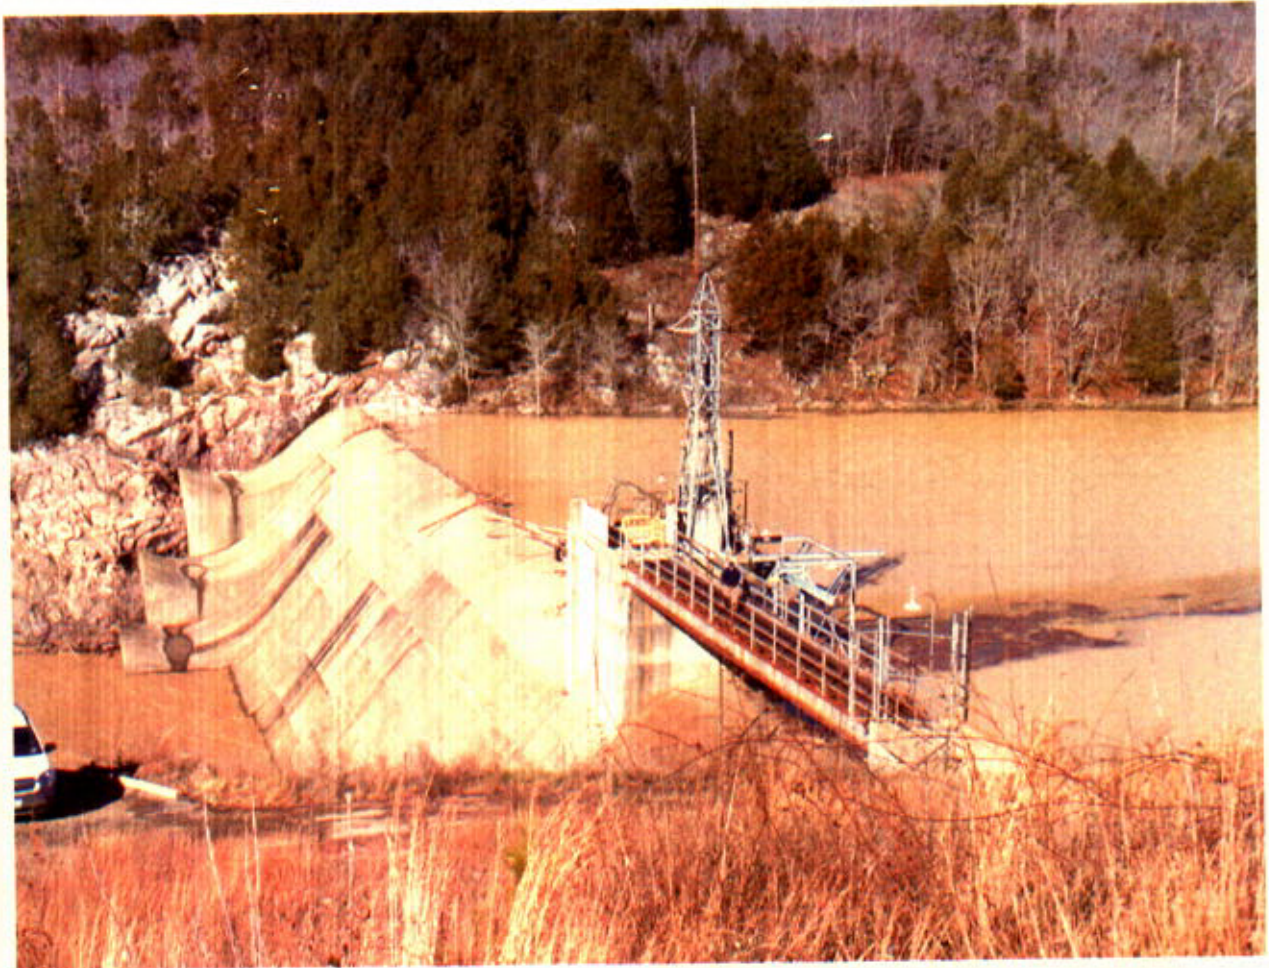
The photograph above shows the lower run of river dam the day after failure of the upper reservoir.
