*Riverfork Homeowners Association*

RE: Riverfork Water Company  
Request for Rate Increase

Recommendations for Riverfork Water Co. standpipe

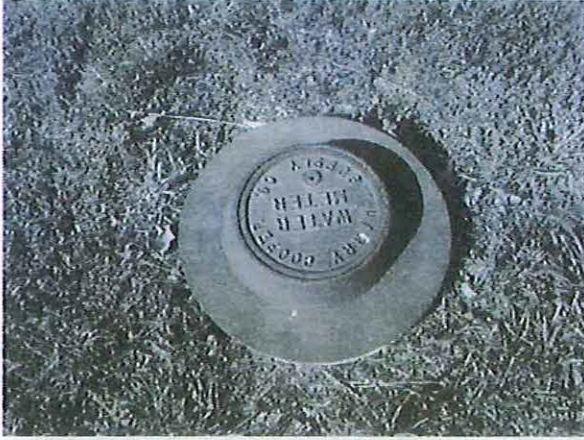
The "Meter Reading" section of Appendix G states, "Inactive meters are always locked when customers move." We fail to understand how RWC locks meters, since meter vault covers (see attached photos) are merely set on top of the meter vault and are not secured in any way. It is easy for even children to lift off the entire meter vault cover. There is no security of meters.

Riverfork Ranch—Typical meter vault cover

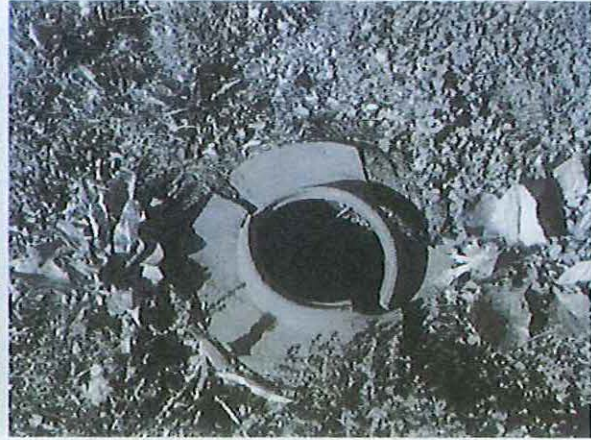
Riverfork Ranch—At least one meter vault cover

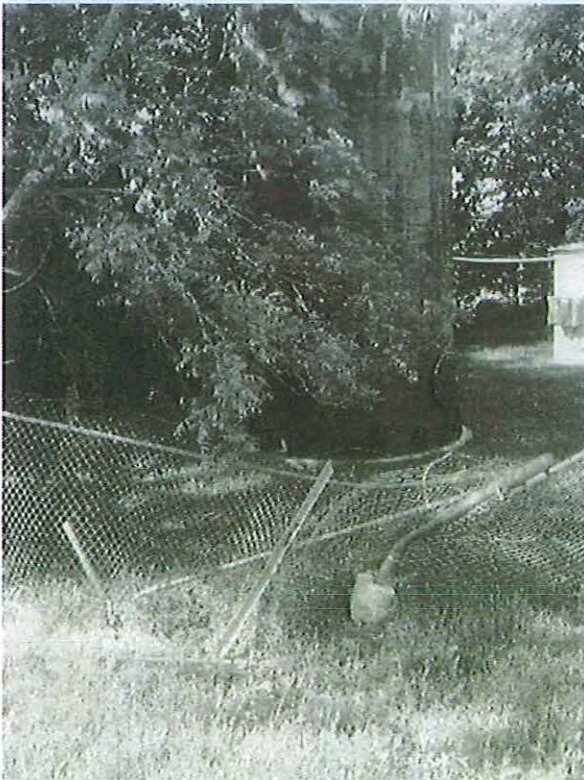
- Note recommendation 14 of MO DNR's letter of February 4, 2015. What the MO DNR letter fails to mention is that nothing has been done to repair the fence damage for **1½ years**. I was the person who called RWC in January, 2014 to report the damage that was done that morning. I also pointed out to RWC that the driver's license plate had been torn off in the accident and that

Lack of security—no action for 1.5 YEARS  
Note deterioration of exterior paint

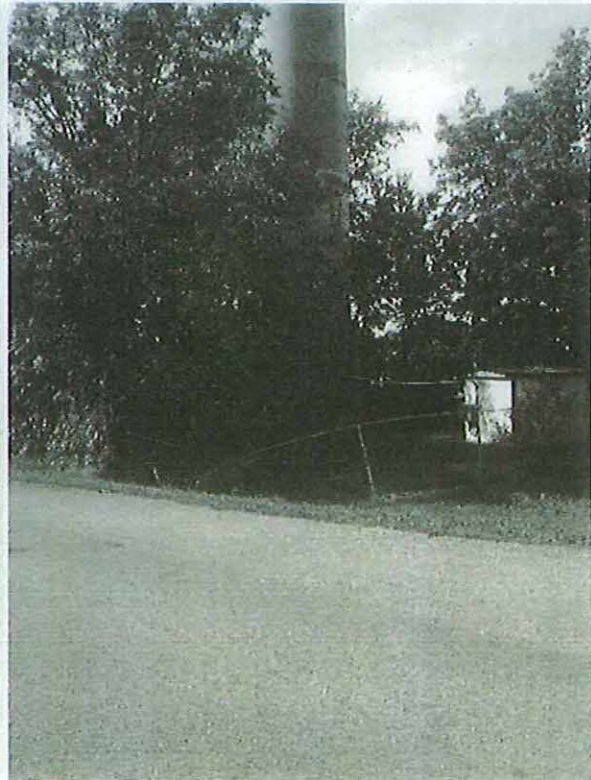
Lack of security—tree and brush overgrowth

(see recommendations 10 and 14 of MO DNR's February 4, 2015 letter)

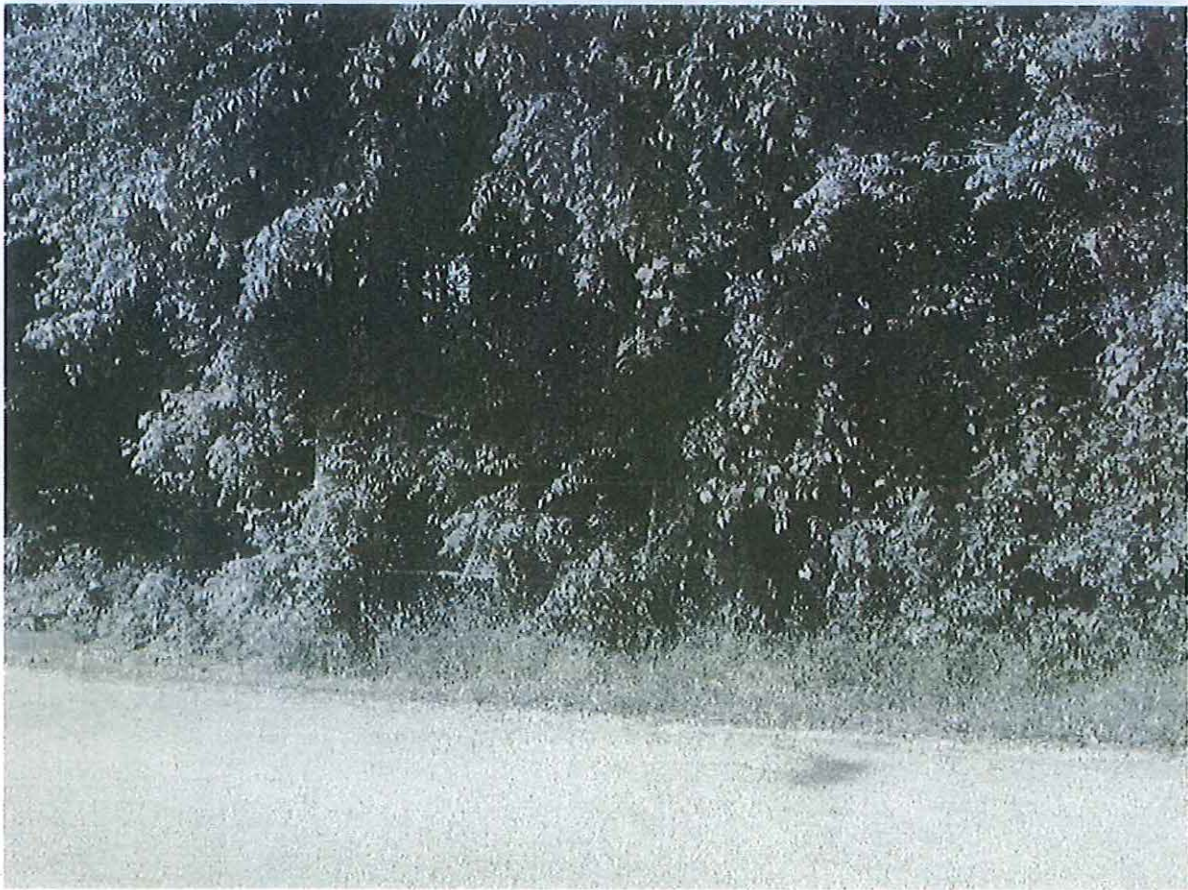
- (Refer to item 11, page 8 of MO DNR letter dated February 4, 2015) MO DNR has repeatedly recommended that the tank overflow piping be extended from approximately 100 ft above grade to within 1-2 ft above grade so that dangerous accumulations of ice don't form during the winter. The tank does overflow periodically. This has created a dangerous condition to public safety because the tank overflows onto Highway M-140 (Equine Valley Road). During wintertime tank overflows, many residents, including me, have observed dangerous ice buildups that cover Highway M-140. Unsuspecting motorists have skidded on the ice on several occasions.

Lack of maintenance—fencing offers no security; ditch has filled in, allowing tank overflows to cross the highway, causing traffic hazards, especially during winter months

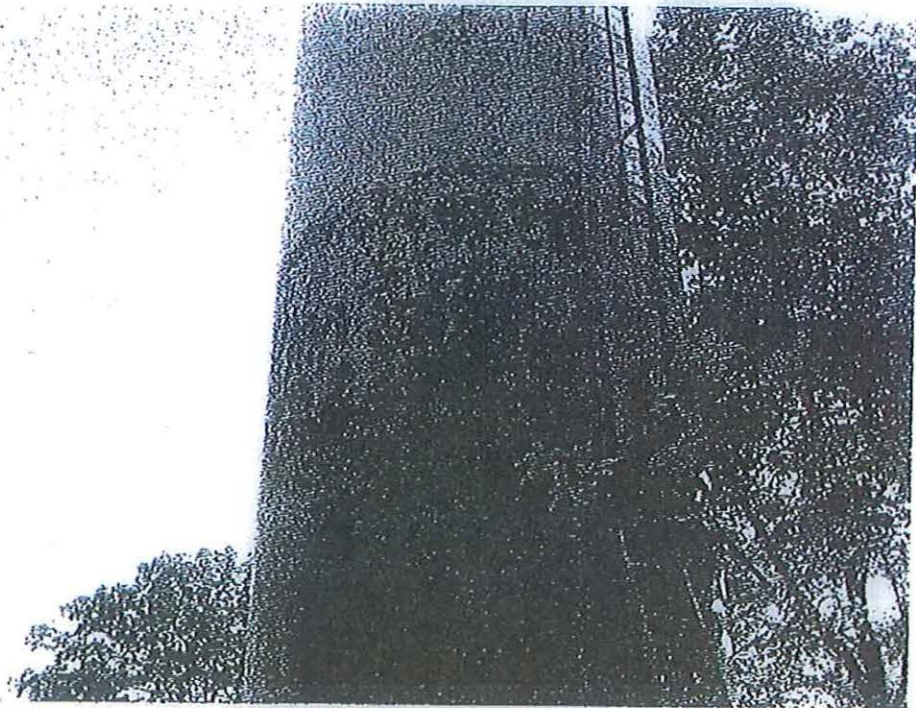
- (extracted verbatim from Paragraph 7 of letter) ***"The exterior paint is in poor condition, with lots of peeling patches and rusted areas, as well as algae growth."*** This item has been the subject of numerous MO DNR inspections. We agree with MO DNR's and Hydro-Spec's recommendations.

Exterior coating is peeling and covered with algae  
Tree limbs should be trimmed away from tank

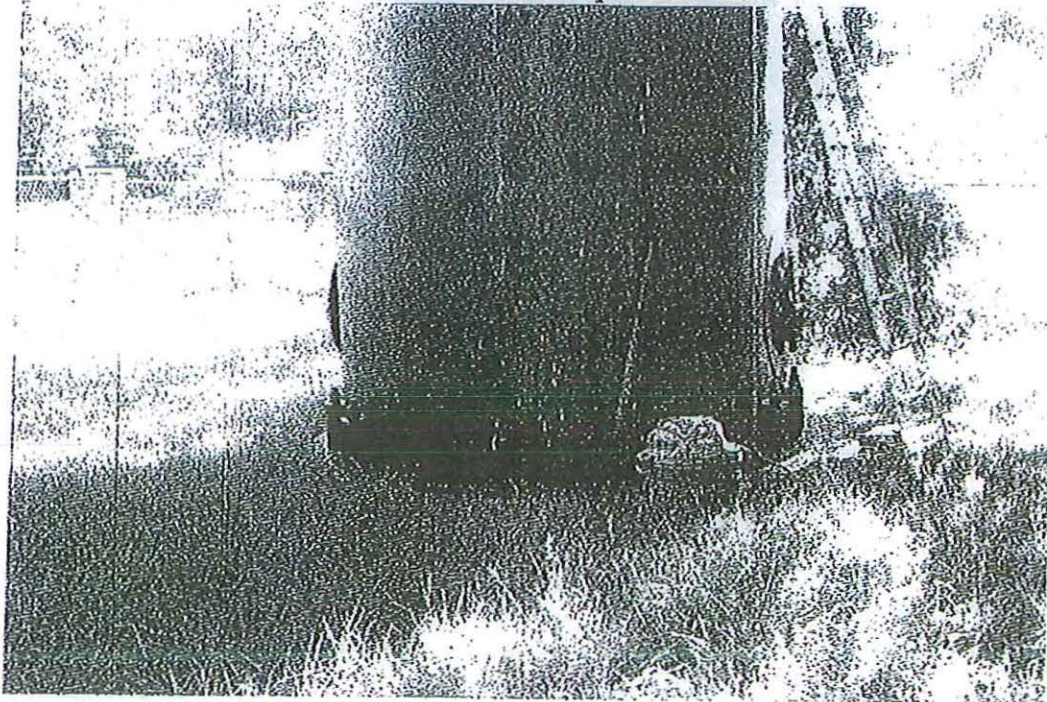
There are 2 - 24 in. dia. manway hatches near base. Anchor bolts are adequate but rusted

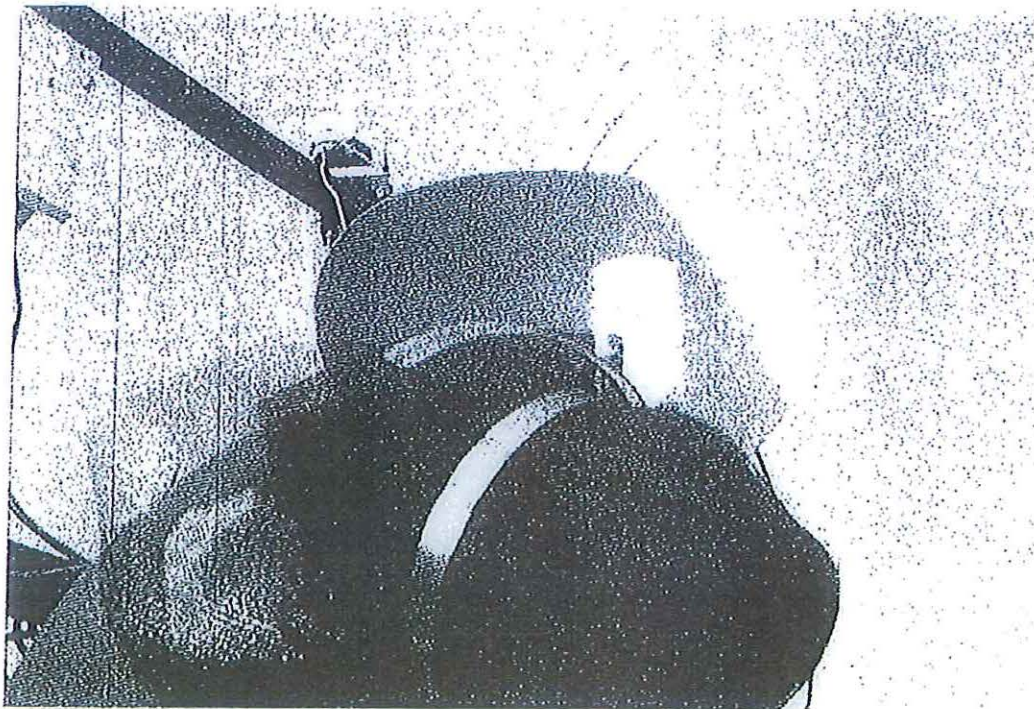
- (extracted verbatim from Paragraph 3 of letter) ***"The roof vent is inadequate, and has been moved from its normal center location. A plate was welded flat where the vent was originally located and an antenna post has been installed directly in the middle of the roof which makes movement on the roof exterior very limited."*** This work was done when RWC chose to enhance its revenue by allowing Total Wireless (a rural wireless internet service provider) to install various antennae equipment on the roof of the tank. Apparently, appropriate technical supervision of Total Wireless's modifications to RWC's water storage tank was not provided at the time of installation. The flat plate on the center of the cone-top roof may have been installed in such a way as to weaken the seam of the tank roof. We also question whether the interior tank epoxy lining was repaired after the flat plate

was welded onto the roof. We submit our opinion to you that inadequate roof venting is well-known to precipitate the sudden partial vacuum collapse of many tanks in the commercial and industrial world. I have personal experience in the forensics of tank collapses and can testify before the MO PSC if you desire.

Roof vent should be replaced. It should be rainproof and properly capped. A Tapco vent is acceptable & recommended

A new, frost-proof 6 in. double-screened vent should be installed. Tapco makes a good one, and they can be reached @ 573-764-7255. Rental tanks are also available from them.

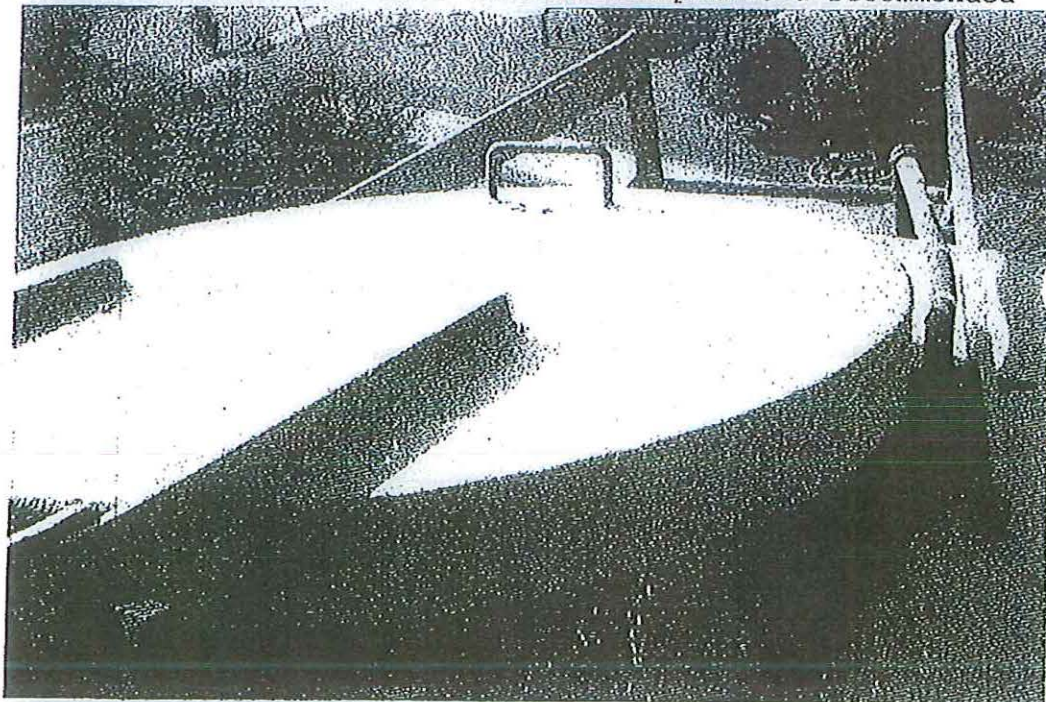
- (extracted verbatim from Paragraph 2 of letter) ***"The exterior access ladder is 15 ft. up from base, and has a notched-rail safety system installed, but should be raised 6 ft. to extend up high enough to allow access onto roof without having to disengage from it. There is no safety handrail around roof perimeter."*** We submit our opinion to you that Hydro-Spec failed to note that this installation is in violation of the following US OSHA regulations: 29CFR1910.27(d)(2)(ii), 29CFR1910.27(d)(3), 29CFR1910.27(d)(2)(ii), 29CFR1910.23(c)(1) or 29CFR1910.132(a), and 29CFR1910.23(a)(2).

Roof entry hatch is not locked. Access ladder stops short with improper siderail. There should be a 42 in. high handrail around top. Antennas should be mounted to the side on a separate pole so as not to interfere with maintenance

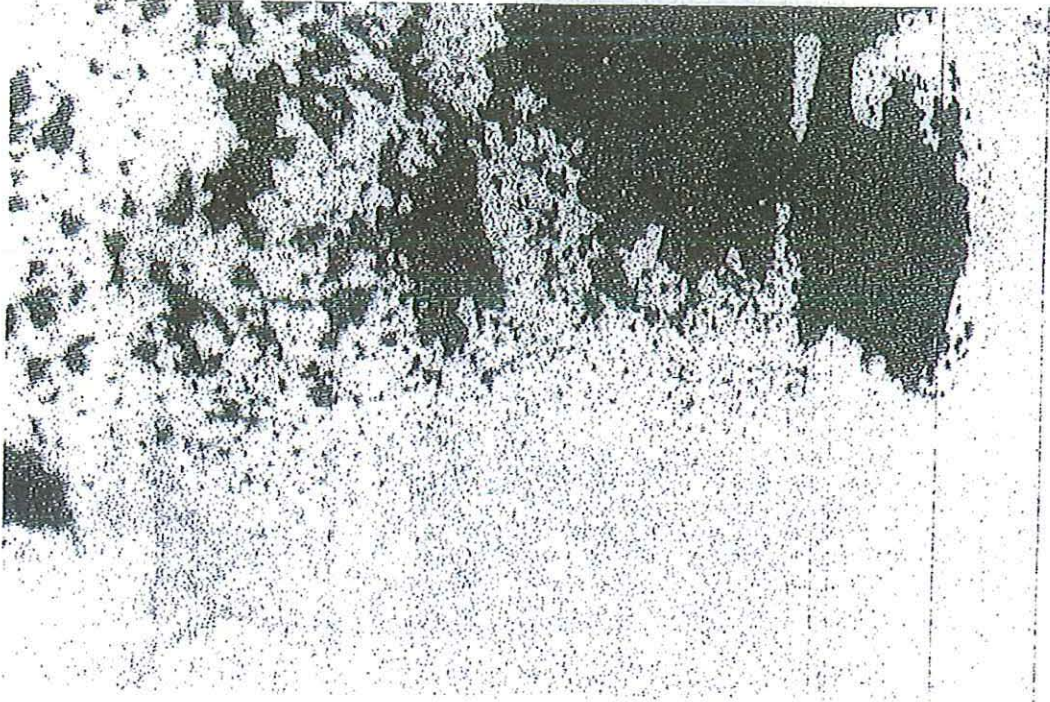
Rust and peeling paint outside

Exterior coating has failed, and should be cleaned & recoated

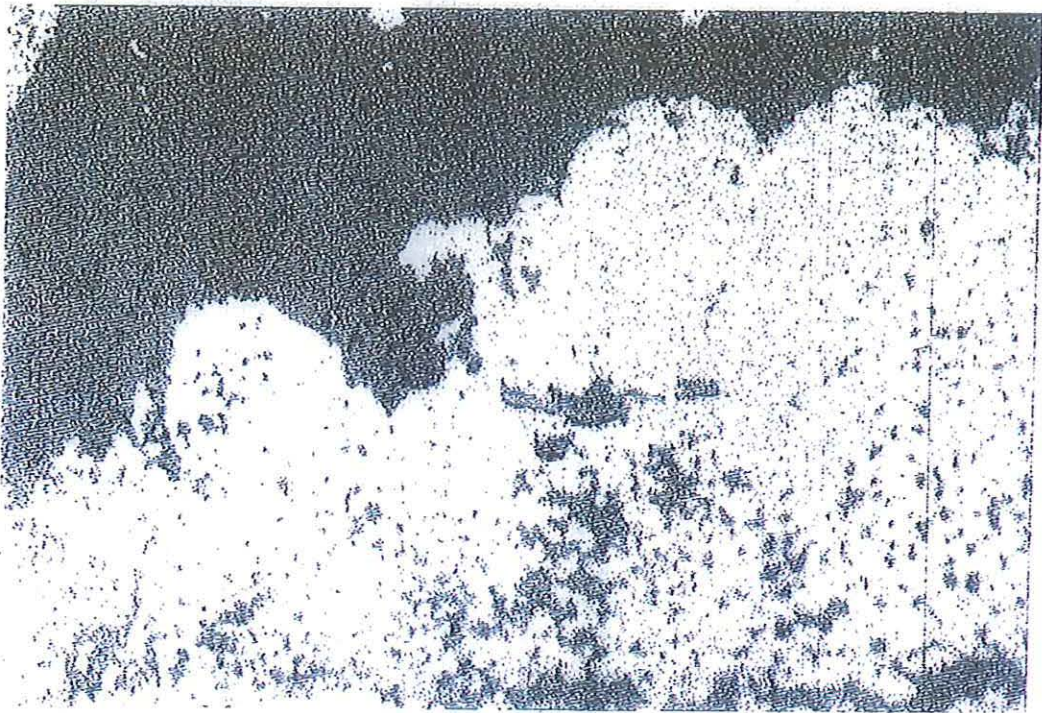
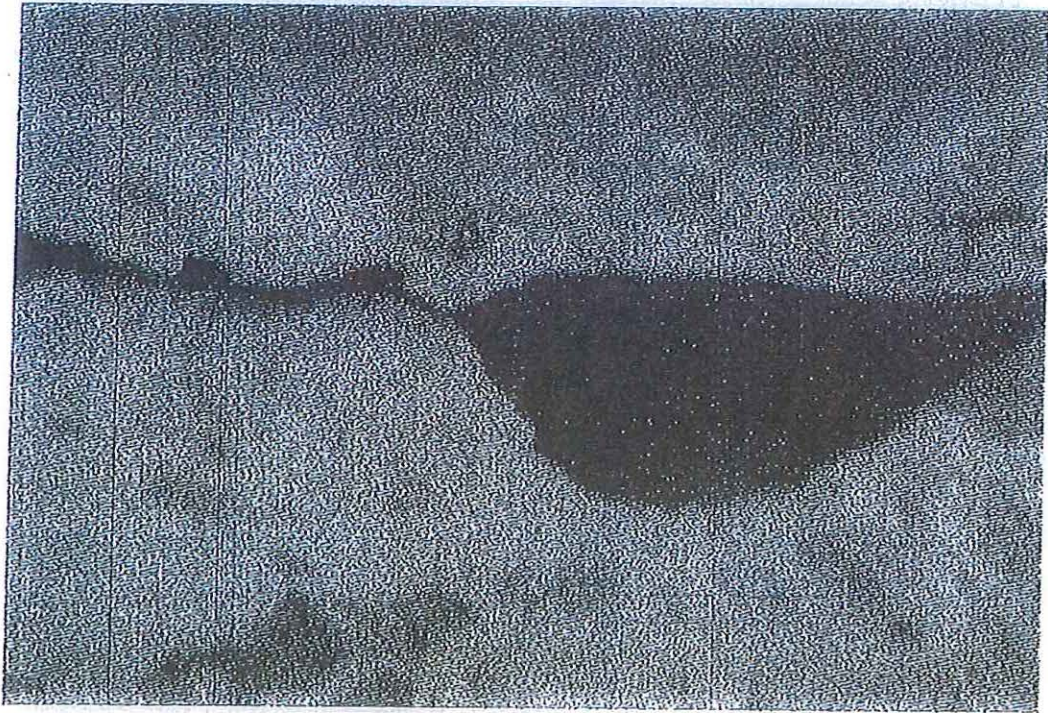
- (extracted verbatim from Paragraph 6 of letter) ***"The tank was drained and all sediment was removed from inside. The interior epoxy is in poor condition and should be removed and recoated."*** Pages 6 and 7 of Hydro-Spec's inspection also contain photos with the following notations (extracted verbatim): ***"Interior epoxy coating is in poor condition. Rust and blistering is evident throughout." "Blisters are common throughout interior epoxy." "Rust along floor to wall seam, blisters on floor evident."*** Although this report was submitted in 2009, NOTHING has been done to date. Residents who live in closest proximity to the water tower (e.g. Davis Drive, Sheron Drive) are now the recipients of dark brown-black iron oxide sludge in their drinking water. When our residents call RWC to complain, they are routinely told, "It's not our problem. Your plumbing is at fault." Since the homes in our subdivision (confirmed with some homeowners on Davis and Sheron Drives) have nothing but copper piping in their homes and the exterior water mains are PVC, the only source for this type of iron sludge is the rusting interior of RWC's water storage tank. Please note that six (6) years have passed since RWC's water storage tank was inspected and it was known at that time that the interior epoxy coating had failed. Lastly, I wish to voice my growing concern about the crevice corrosion that exists at the tank's side shell to bottom weld seam. Although Hydro-Spec's inspection qualified this problem, they didn't quantify it. The highest stress area in the entire tank is this very weld seam. Sooner or later, the weld seam will fail. Hopefully, the tank will "merely" leak, but depending on the

severity of the corrosion, it is possible that the weld seam could fail catastrophically. The known problems of this tank should be rectified **before** this happens. MO DNR and MO PSC, by virtue of the Hydro-Spec inspection and the various MO DNR inspections, have known of the problems in RWC's water storage tank for more than six years (the order to inspect the tank was, no doubt, precipitated by MO DNR's growing concern about the unknown condition of the tank's interior). **When will MO PSC begin proper enforcement action(s) on this item?**

Interior epoxy coating is in poor condition. Rust and blistering is evident throughout.

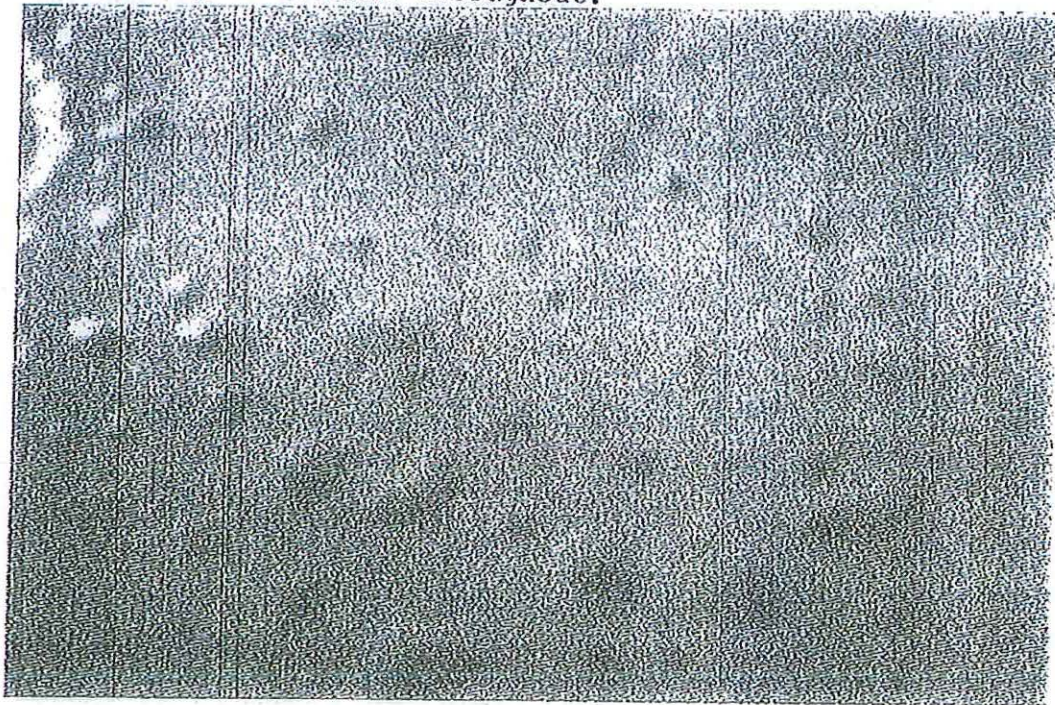
Blisters are common throughout interior epoxy.

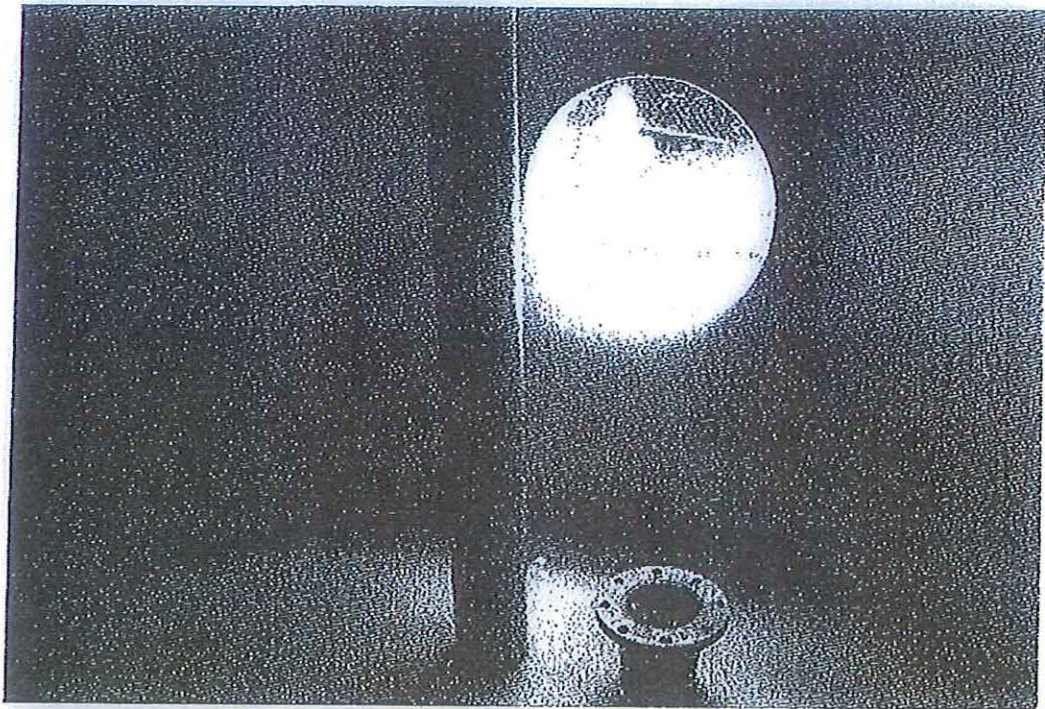
- (extracted verbatim from Paragraph 8 of letter) ***"The influent pipe is 12 in. tall from floor, and the effluent pipe is 8 ft. tall, both are 6 in. dia. steel with flanges."*** As has been noted on page 2 of Hydro-Spec's inspection report and in recommendation 9 on page 7 of MO DNR's February 4, 2015 letter to RWC, the effluent pipe should be extended upward to increase the contact time of chlorine with the water. Please note that MO DNR has stated to me that chlorine residuals are sporadically tested by MO DNR at or near the RWC storage tank facility—NOT downstream, near most residents' homes. MO DNR did recently test chlorine residuals on Finley River Drive and it was found to be satisfactory. However, MO Code of State Regulation 10CSR60-4.055(4) requires a minimum residual chlorine level of 0.2 ppm. Whenever I have taken a sealed water sample to an independent laboratory in Springfield, the residual chlorine content was **zero**. Our contention is that residual chlorine testing should be done more often than once/year, especially since it is known by MO DNR that RWC's chlorination system is improperly controlled. Our request is that MO PSC (or its delegate, MO DNR), RWC and Riverfork Homeowners Association **mutually** agree on a protocol for residual chlorine testing, including frequency.

Influent(short) & effluent(8 ft tall) pipes are shown  
Influent should be extende upward to within 15 ft of roof

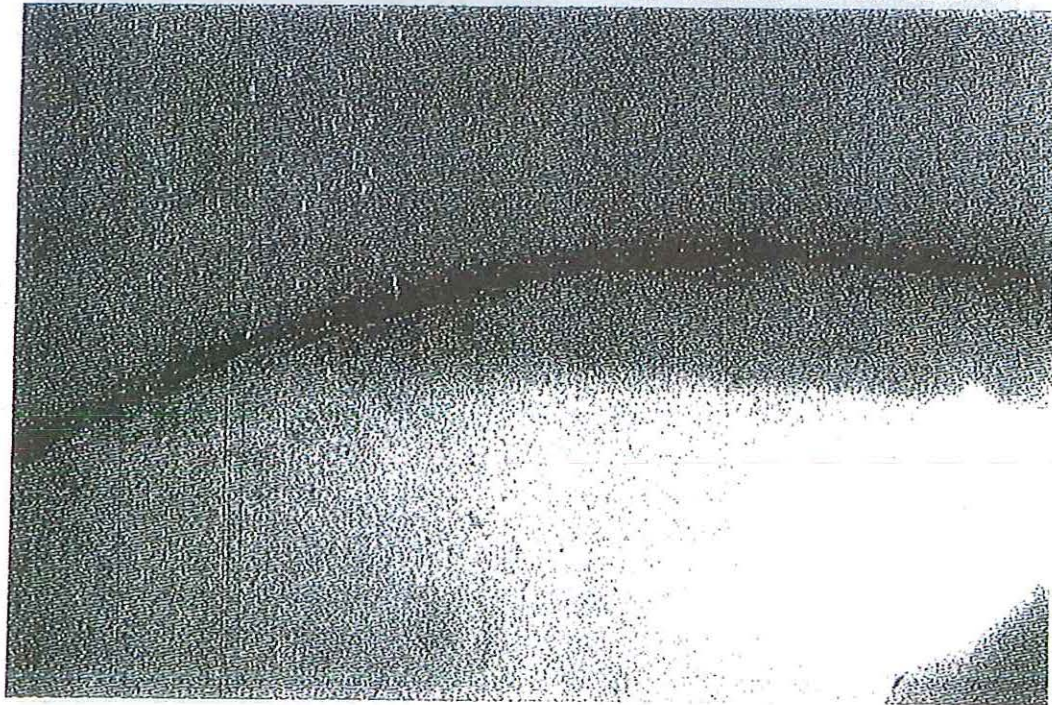
Rust along floor to wall seam, blisters on floor evident

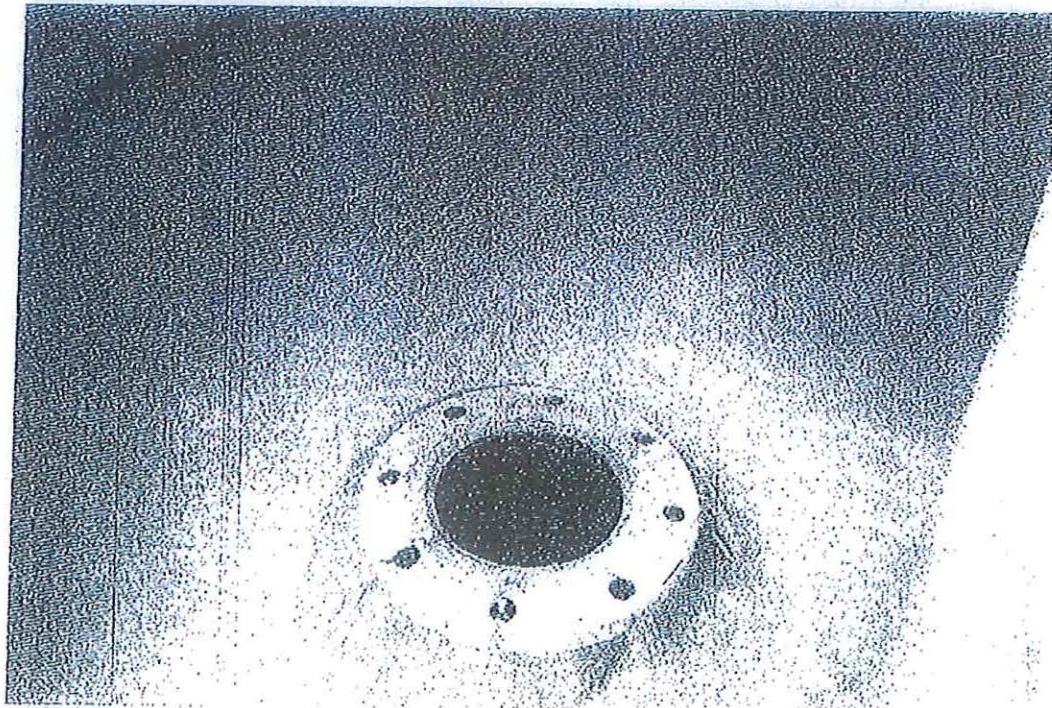
6 in. influent pipe(steel) should be extended upward to within 15 ft. of overflow level for appropriate chlorine circulation

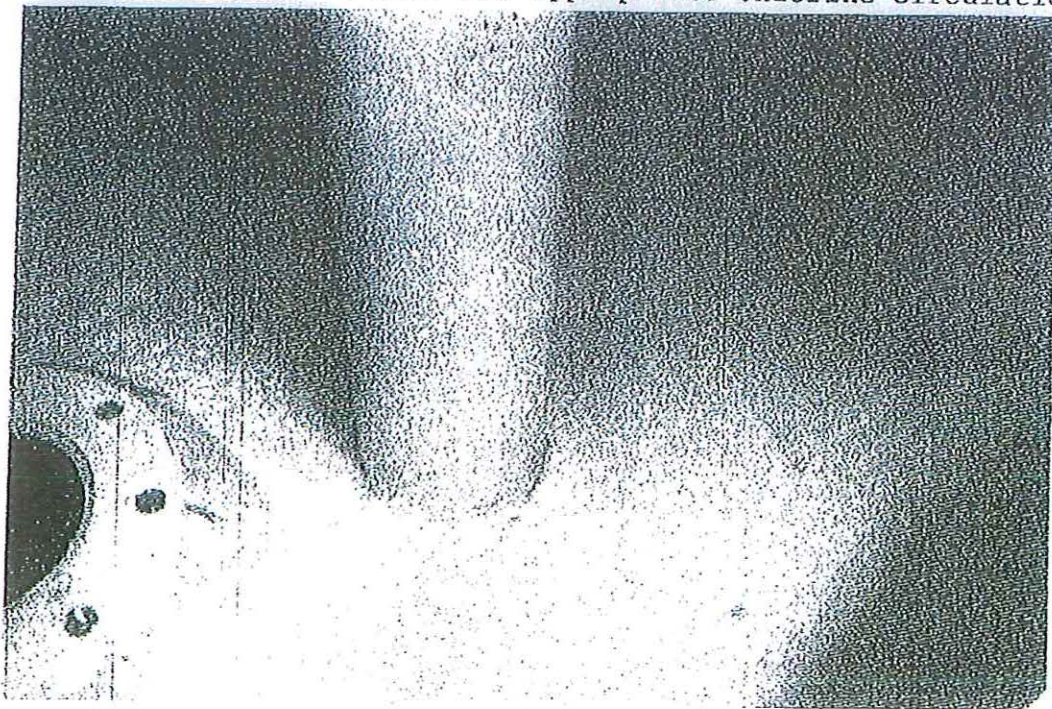
Water flow into tank during refilling. All sediment was removed prior to refilling and sampling and return to service

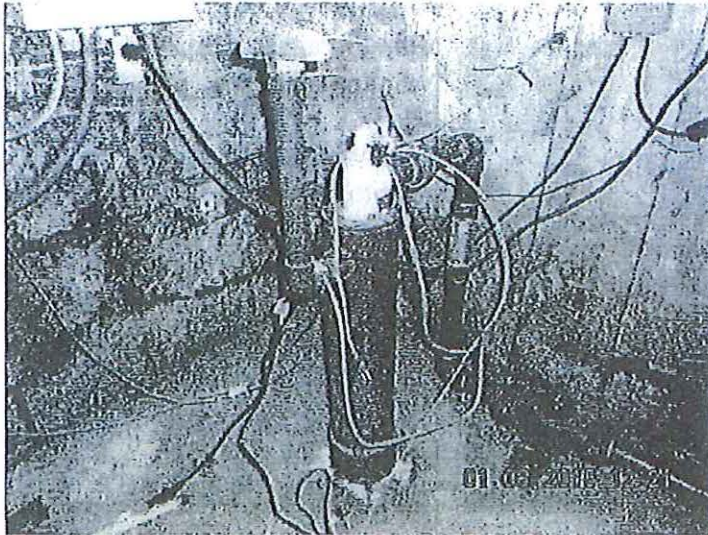
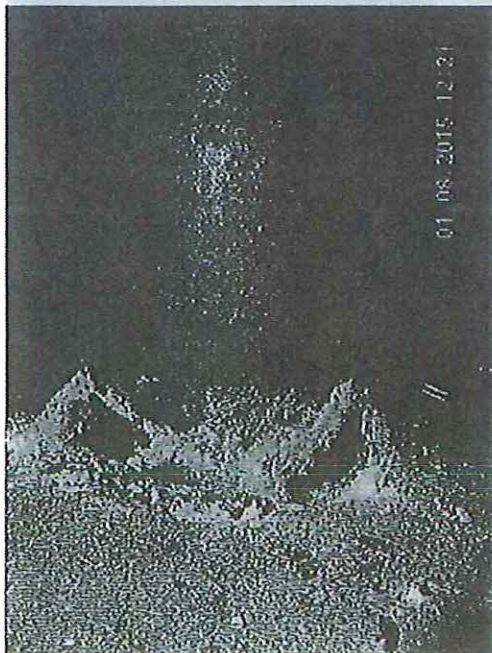
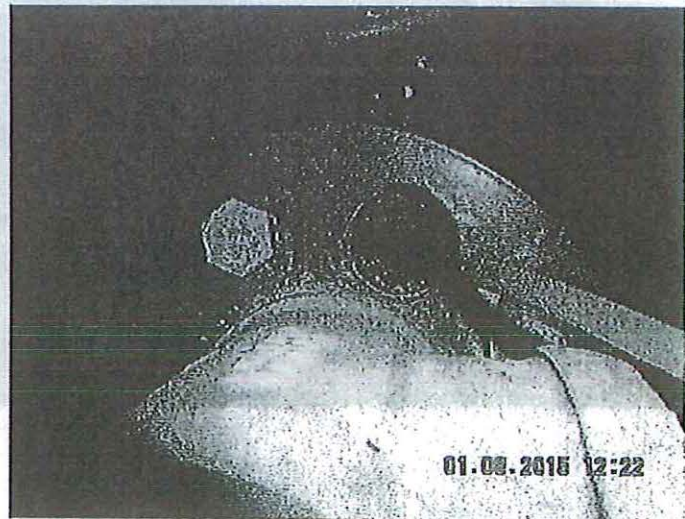
1. The casing was not effectively sealed against the entrance of water under all conditions which is a Significant Deficiency per 10 CSR 60-4.025(4)(A)4.A. Specifically, the drawdown tube through the split seal and casing top-plate was not adequately sealed.

Location: Riverfork Ranch Estates  
Photographer: Charles Collins  
Photograph Date: January 8, 2015  
Comments: Upper-left photograph shows the well head (note the corrosion on the lower one-third of casing), and lower-left photograph is a close-up of the corroded casing (note the existing well head is a replacement of the original). Lower-right photograph shows the unsealed drawdown tube opening through the casing top plate and seal.

Condensate water and debris entering unsealed openings in the well are a significant source of questionable and unsafe bacteriological samples. The openings for electrical wires and the drawdown tube should be sealed with a mechanical seal or silicone caulk. The sanitary seal on submersible pumps should be in good condition and properly installed and should not be cut. All imperfections around the base of a vertical turbine pump should be sealed with silicone caulk.

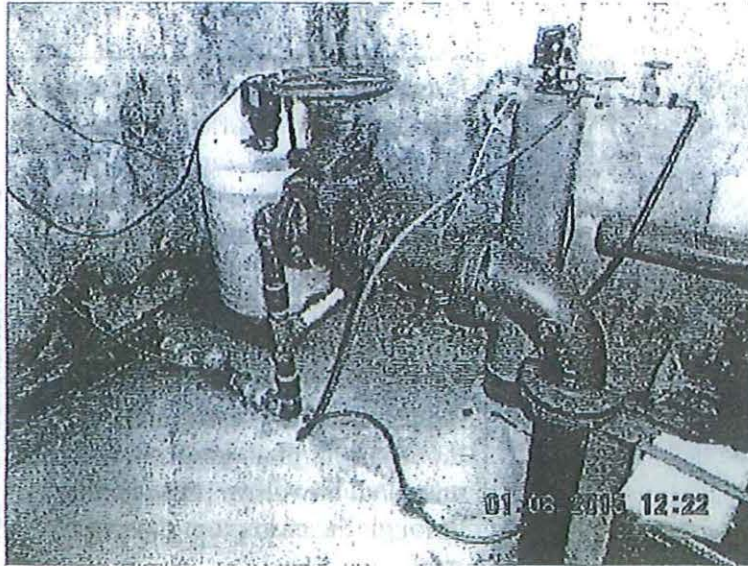
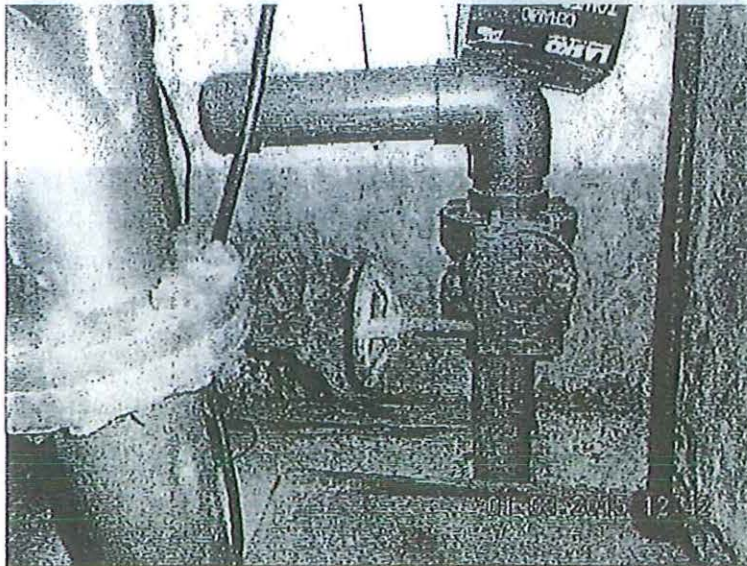
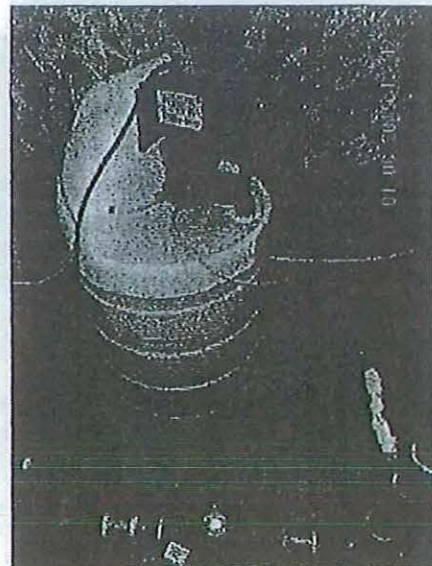
Location: Riverfork Ranch Estates  
Photographer: Charles Collins  
Photograph Date: January 8, 2015  
Comments: Upper-left photograph shows the well discharge piping (note the corrosion on the unpainted bolts). Lower-left photograph is of "booster pump piping" that was retro-fitted to the system. Lower-right photograph shows the chlorination equipment.
