Kings Point Wind Project

Barton, Dade, Jasper and Lawrence Counties, Missouri

Project Progress Report No. 18

January 2021

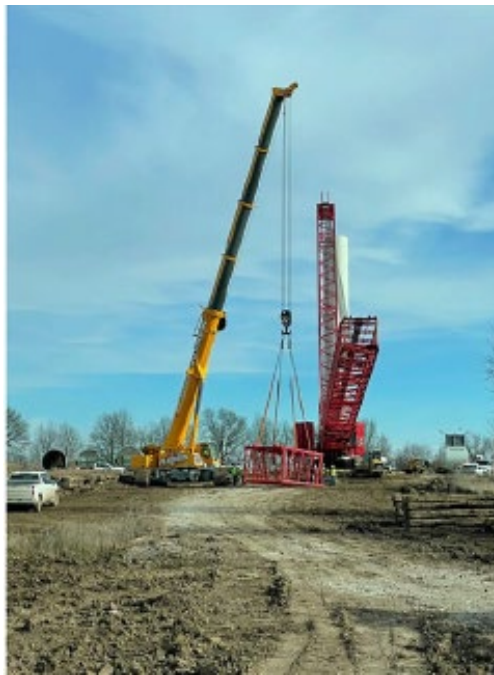
Picture 2. Crane assembly following a breakdown and move.

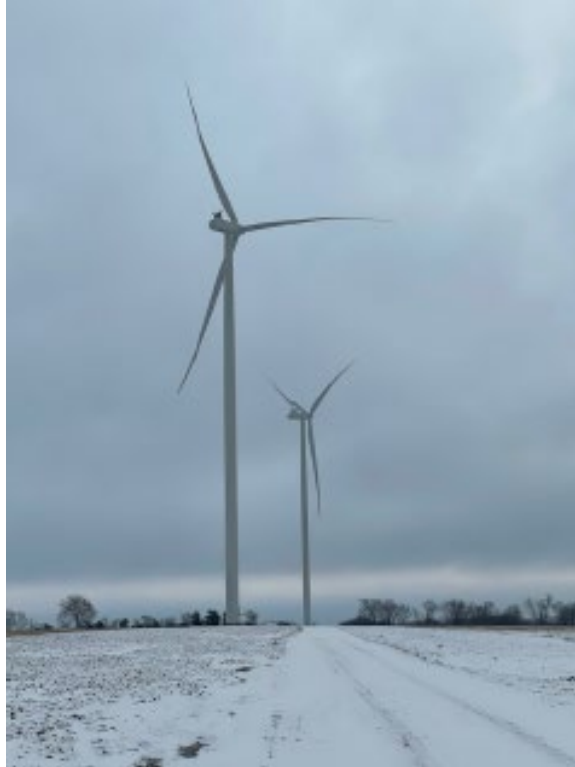
Picture 3. Site activities were again impacted by wintery weather.

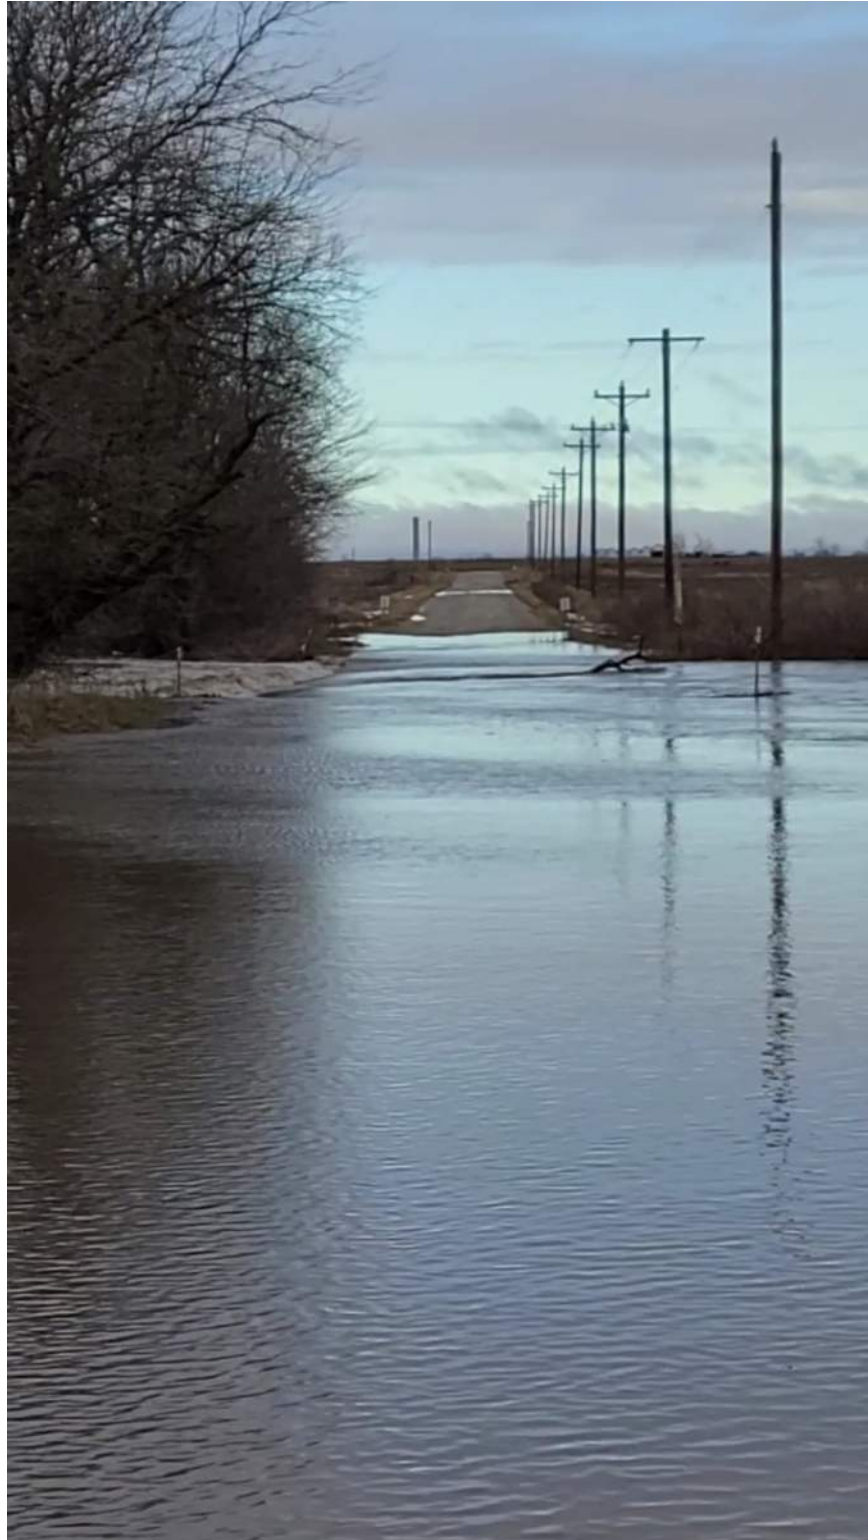
PHOTO 3: 1/25 ROAD FLOODING
