# Gas Incident Report

Laclede Gas Company Case No. GS-2011-0245

3810 Council Grove Avenue Pine Lawn, Missouri January 8, 2011

Energy Unit ... Regulatory Review Division December 2011 Jefferson City, Missouri

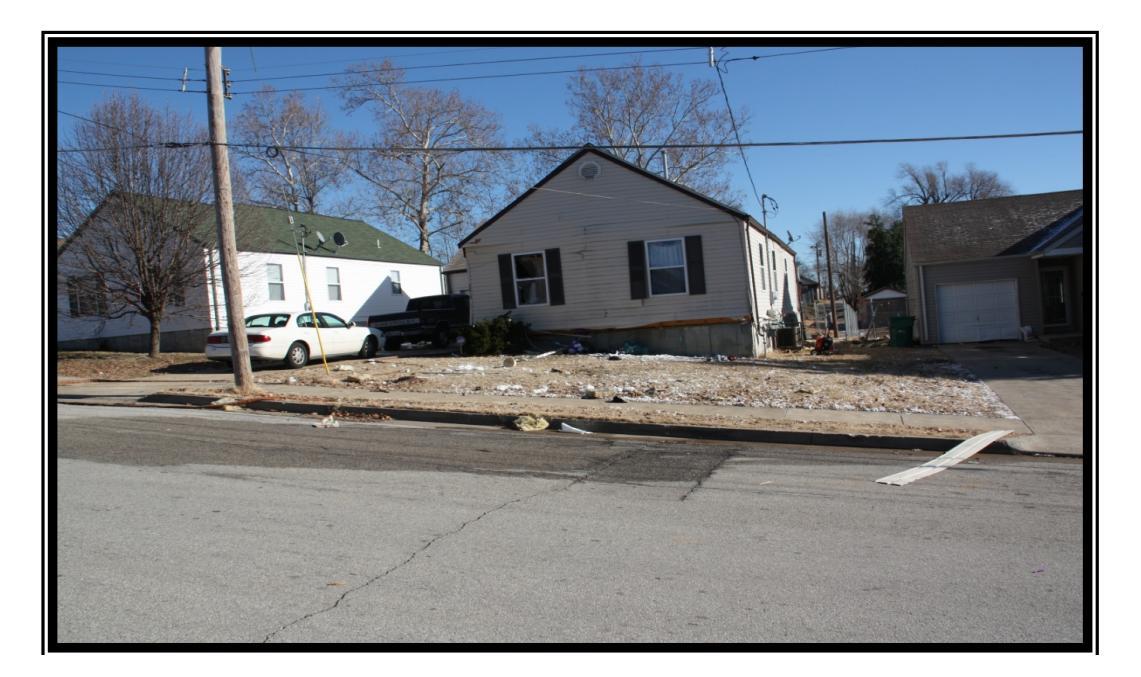
**Photograph 1** View of the incident site at 3810 Council Grove Avenue (photograph courtesy of Laclede Gas Company).

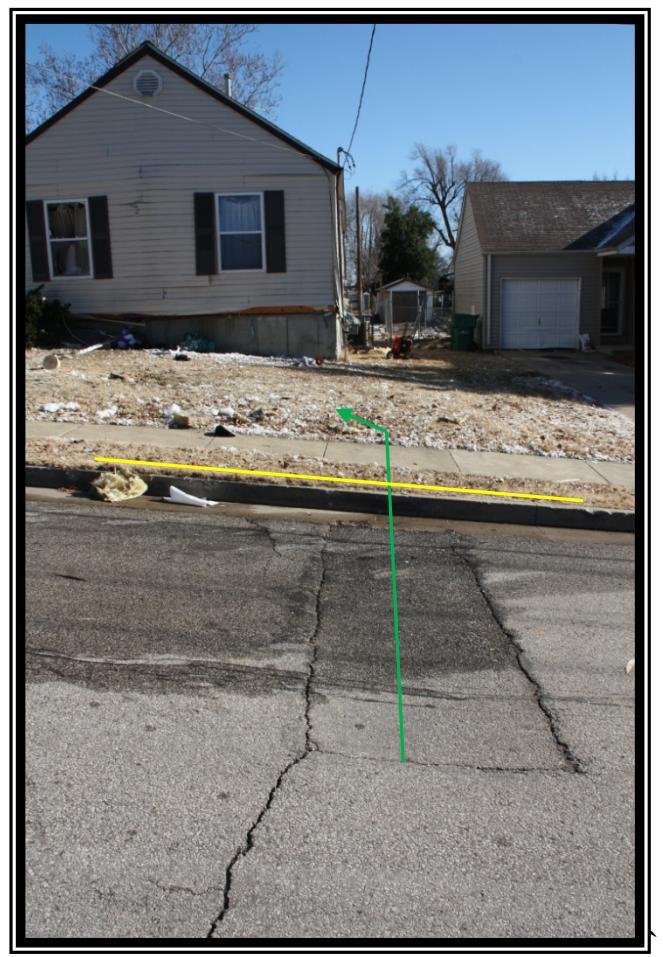
The residence at 3810 Council Grove Avenue was built in 2000 and 2001, and the sanitary sewer lateral installed for this residence crossed beneath the gas main in the vicinity of the fracture, based on observations of the street pavement patch and in the sanitary sewer lateral vent in the front yard. Installation of this sanitary sewer lateral in 2000 or 2001 would have involved a ditch excavated from the surface down to the depth required to install the sewer

Note: The yellow line represents the approximate location of the natural gas main and the green line represents the approximate location of the sewer lateral. The gas main fracture was found at the location where the yellow and green lines intersect.

**Photograph 2** View of the patch in the street in front of 3810 Council Grove Avenue. (photograph courtesy of Laclede Gas Company).

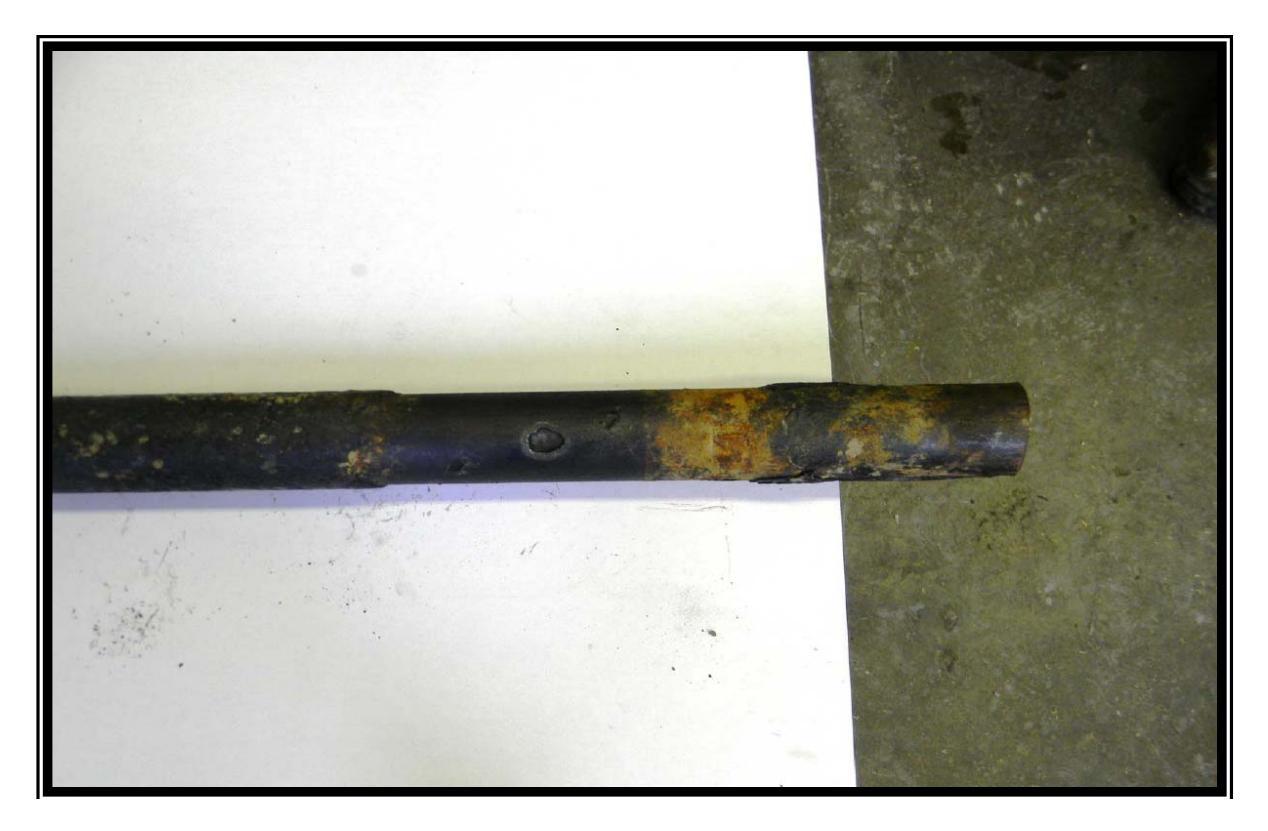
In the days following the incident, Laclede investigated and repaired leaks on the 2-inch diameter gas main along Council Grove Avenue. These leaks were caused by corrosion and involved repairs in front of 3828 and 3824 Council Grove Avenue on January 14 and January 15, respectively. The corrosion leak in front of 3828 Council Grove Avenue appeared to be caused by a copper water service line in direct contact with the 2-inch diameter gas main (See Appendix B-2, Photograph 3). The main segments containing these corrosion repairs were later replaced during a main replacement project in the incident area.

**Photograph 3** View of the corrosion pit and hole in the 2-inch diameter steel natural gas main removed from the front of 3828 Council Grove Avenue (photograph courtesy of Laclede Gas Company).

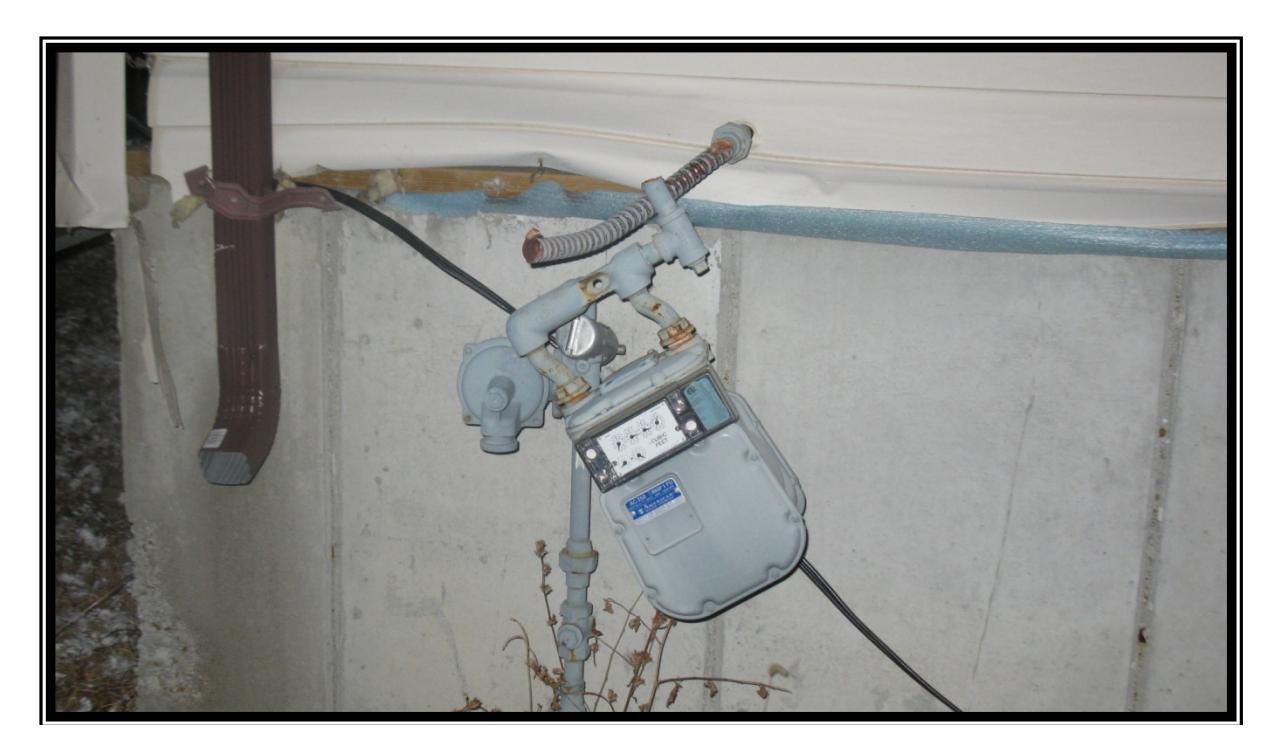
After the leaking gas main was shutdown and the natural gas dissipated, Staff made observations of the incident site. The house at 3810 Council Grove Avenue had sustained considerable damage due to the explosion. Several windows were blown out and the walls had been shifted off of the basement foundation and were bowed out. At the outside gas

meter set, the outlet piping had been pulled upward and was severed (See Appendix B-2, Photograph 4). Looking through the basement windows, scorching was observed on the floor joists. Due to darkness, more extensive observations were not made until the following Monday, January 10, 2011.

Several windows and the large patio door were pushed out or dislodged during the explosion and would have provided venting avenues for any remaining pockets of natural gas. Evidence, such as the broken fuel line at the gas meter, suggests the house was lifted off and settled back on the foundation walls when the explosion occurred. Fire resulting from the ignition was minimal inside 3810 Council Grove Avenue and was concentrated in the basement area.

**Photograph 4** View of the displaced and severed natural gas piping at the southwest corner of the structure at 3810 Council Grove Avenue.

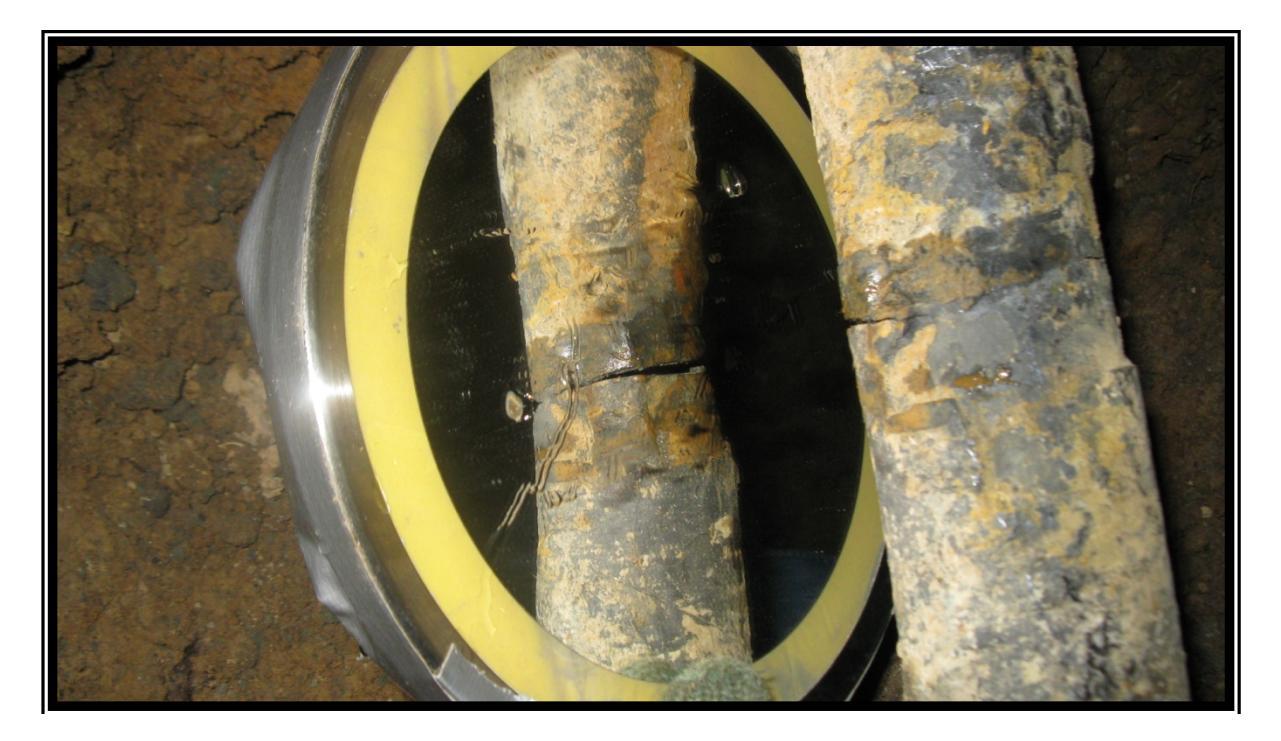
Staff then observed Laclede crews excavating to expose the 2-inch diameter steel gas main at the leak site in front of 3810 Council Grove Avenue. Once the gas main was exposed, Staff observed a circumferential fracture of the pipe and the pipe appeared to have been dented at the fracture site (See Appendix B-3, Photograph 5). The fracture appeared to have initiated on the bottom of the pipe and had propagated approximately 85% around the circumference of the pipe. The fracture also was in line with a previous excavation patch observed in the street from the east curb to a few feet east of the street centerline (See Appendix B-1, Photograph 2). Staff made additional observations in the sanitary sewer lateral vent (located in the front yard) and determined that the sanitary sewer lateral for 3810 Council Grove ran at an angle through the front yard towards the street patch and beneath the fracture in the gas main. Since the street patch did not extend all the way to the sewer main located below the street centerline, it appeared that the old sewer main tap had been used and the newer sewer lateral was connected to the old sewer lateral a few feet east of the sewer main.

**Photograph 5** View of the fracture and dent in the 2-inch diameter steel natural gas main in front of 3810 Council Grove Avenue. Note that the bottom of the pipe is reflected a mirror.

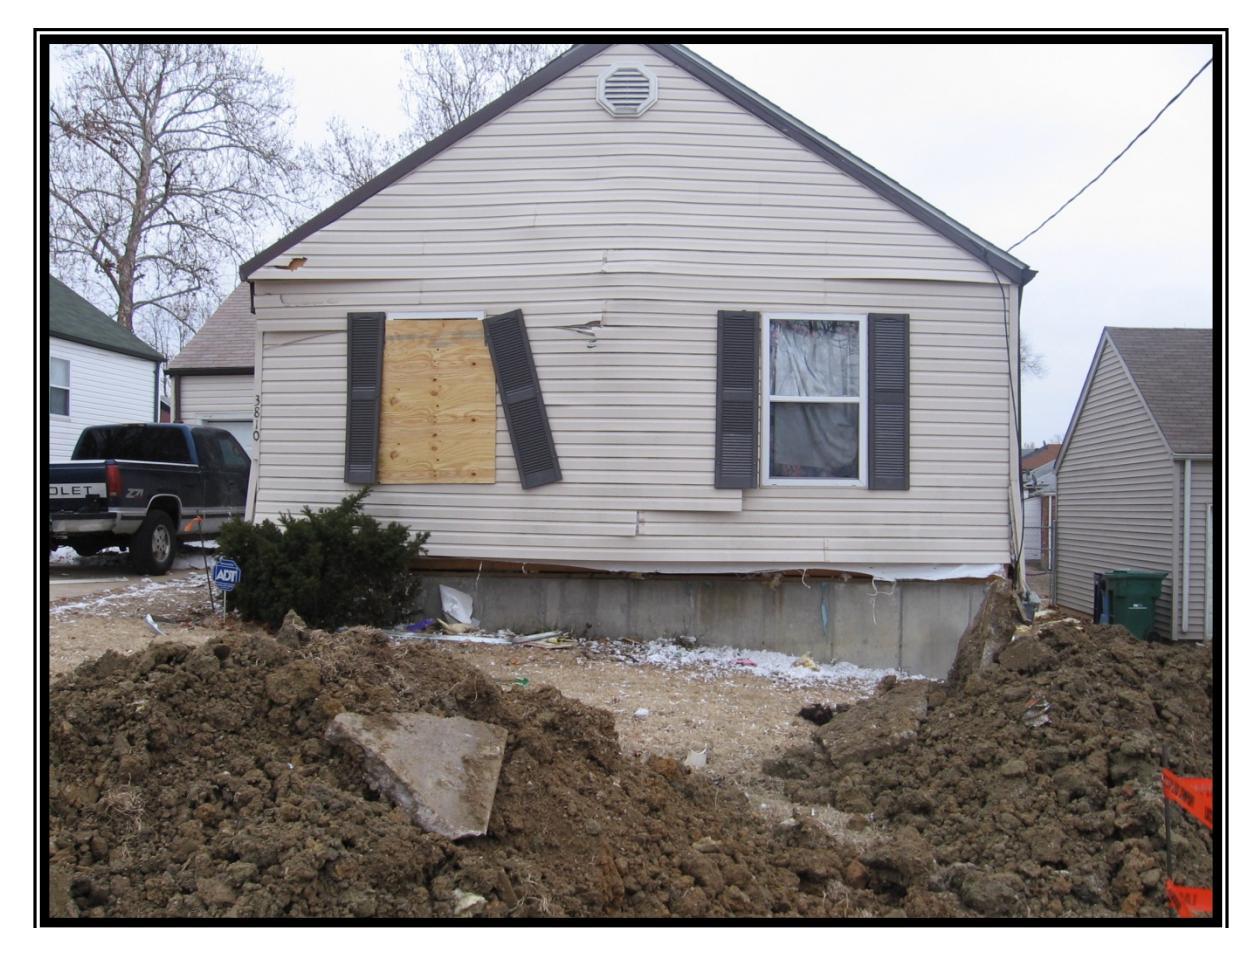
The west exterior wall was dislodged and pushed out and the south exterior wall was dislodged from the top of the foundation, both of which provide evidence of a heaving or pushing effect from inside. The relatively short distance of the thrown debris surrounding the structure, and displacement of some windows and a sliding glass patio door also resemble the occurrence of an explosion producing low order damage.

**Photograph 6** View of the west side of 3810 Council Grove Avenue. Note the vertical crack and displaced siding between the windows

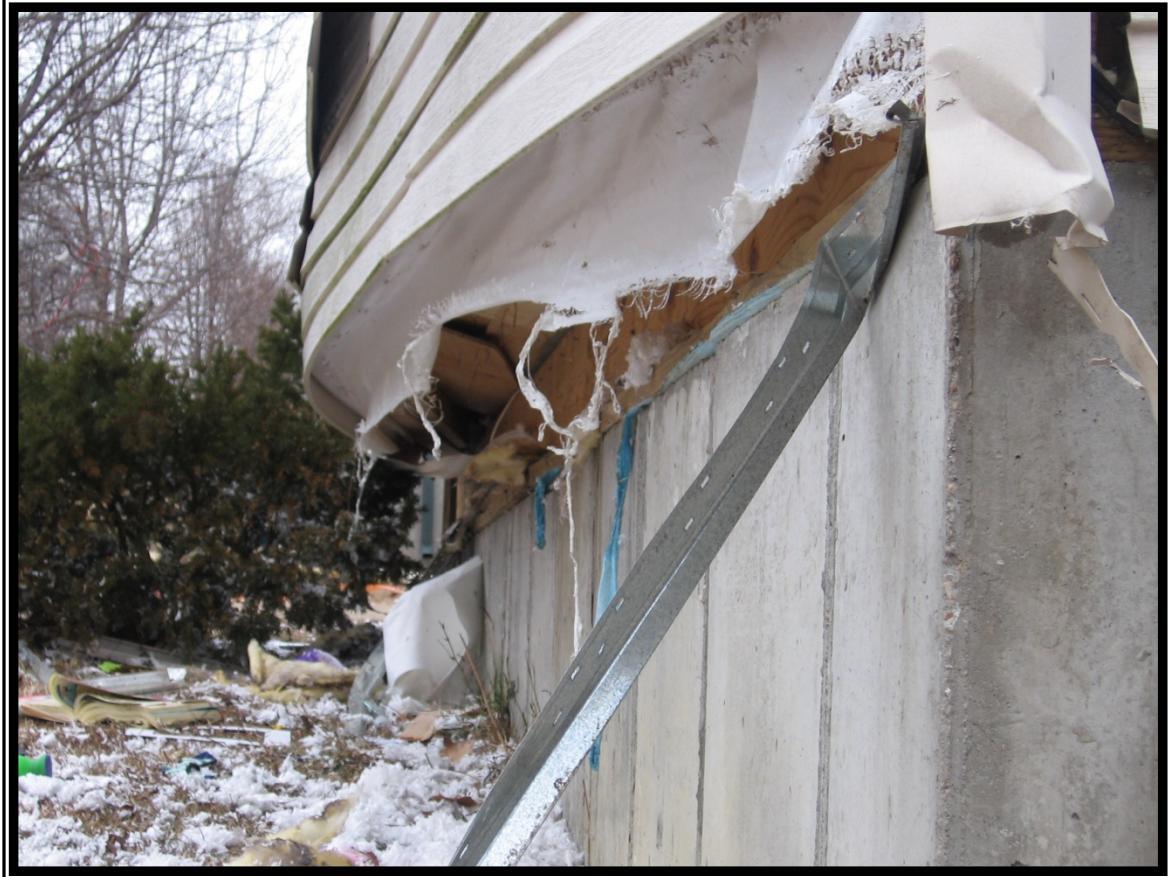
**Photograph 7** Close-up view of the west side of 3810 Council Grove Avenue. Note that the wall is displaced outward from the top of the foundation.

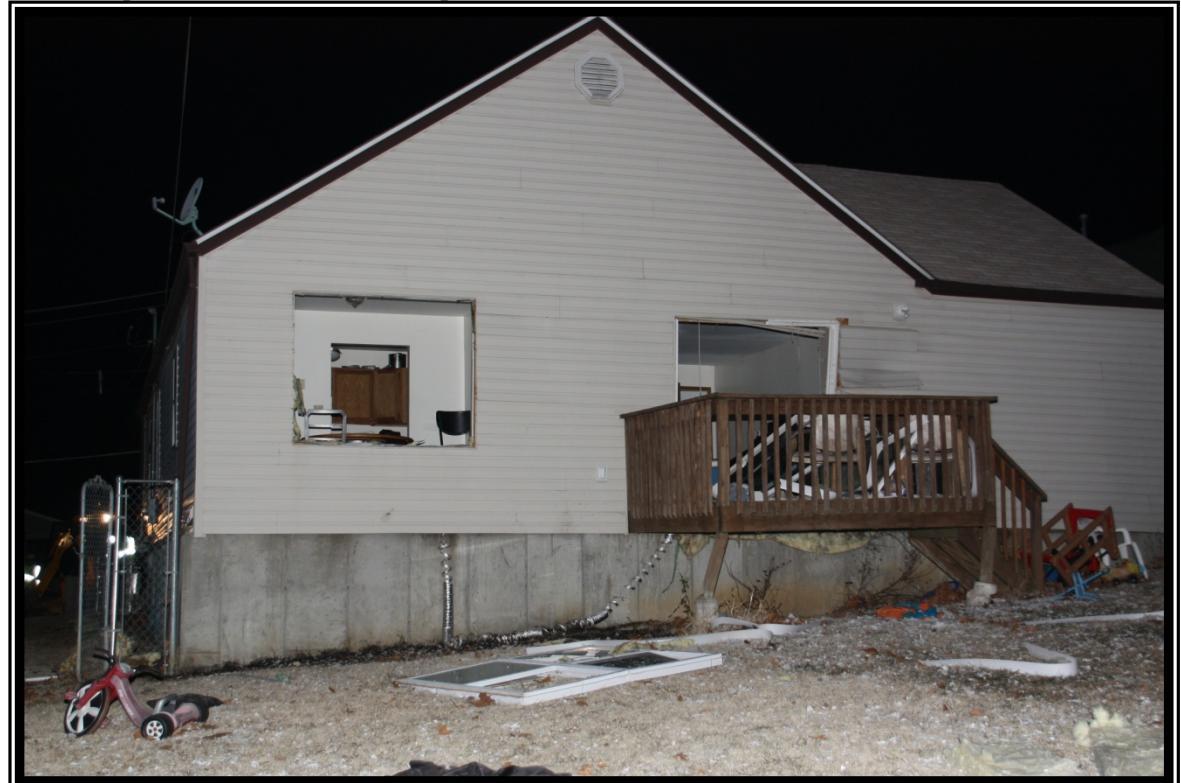
**Photograph 8** View of the east side of 3810 Council Grove Avenue. Note the displaced window and sliding glass door to the deck. Note also the structure has shifted to the right and the lack of burning inside of the structure (photograph courtesy of Laclede Gas Company).

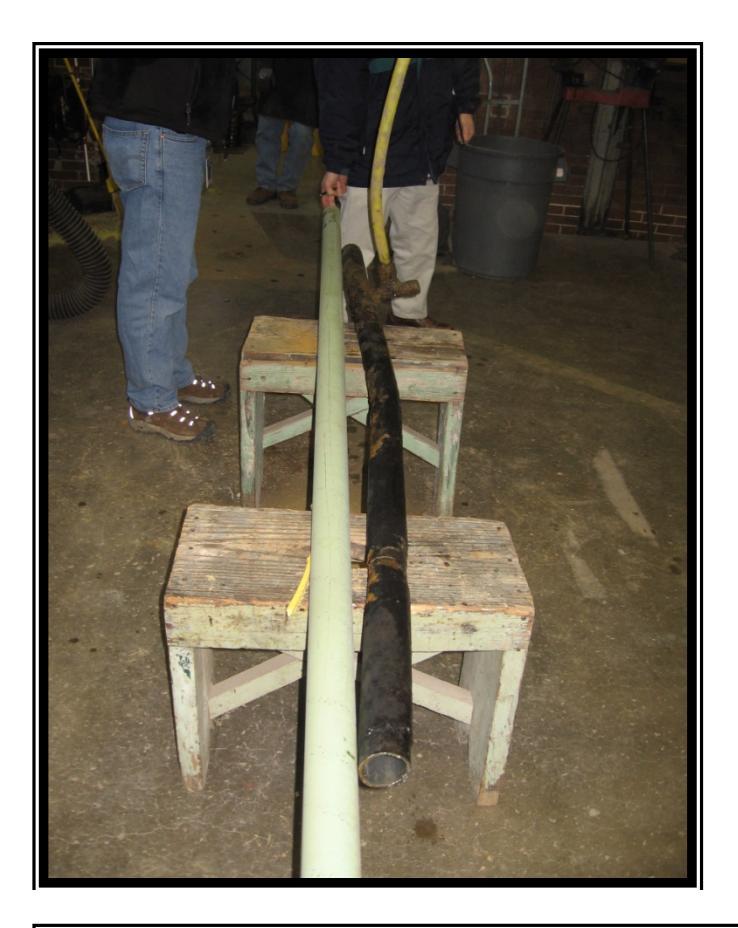
The damage to the pipe observed by Staff in the area of the fracture could have occurred any time prior to the incident. However, the most likely time that the damage occurred was at the time of the sewer lateral construction for 3810 Council Grove Avenue in 2000 or 2001 near the gas main. The two dents were 25.5 inches apart, which would correspond to a 2-foot backhoe bucket. The pipe was bent upward in this same area, which would correspond to the pipe being lifted upward by a backhoe bucket during mechanical damage. It is likely that a backhoe was used to install the sanitary sewer lateral and struck the steel gas main with enough impact and upward lifting force to cause the two pipe dents and the upward pipe bend observed in the pipe.

**Photograph 9** View of the removed segment of 2-inch diameter steel natural gas main. Note the bend in the piping.

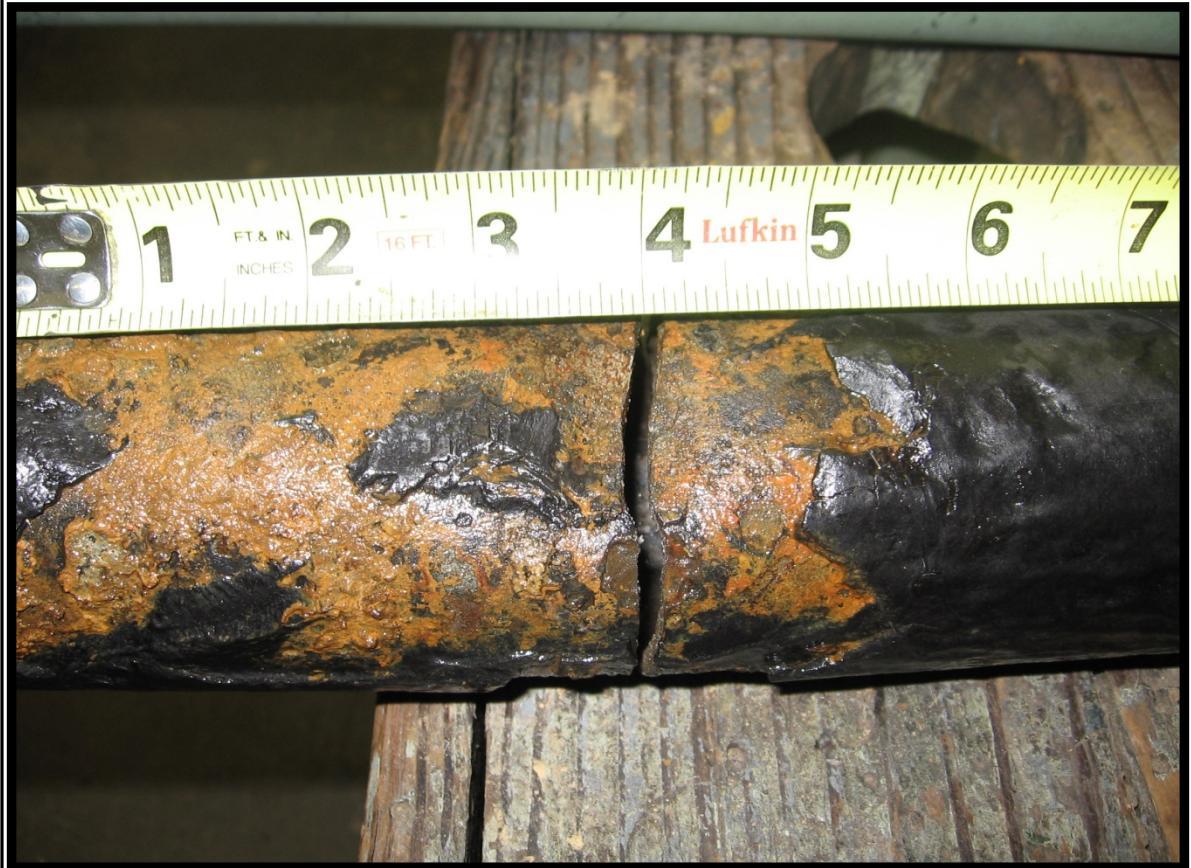
As mentioned previously in this Report, an approximate seven-foot segment of the 2-inch diameter steel gas main containing the fracture was removed, transported to Laclede Claim's evidence locker, and later transported to Laclede's lab for observation and cleaning. The fracture was observed, measured and photographed (See Appendix B-5, Photographs 9 and 10). The fracture initiated in a dent created during previous excavation damage. Corrosion pitting was also observed at some locations along the pipe.

**Photograph 10** View of the fracture and dent in the 2-inch diameter steel natural gas main removed from the excavation in front of 3810 Council Grove Avenue.

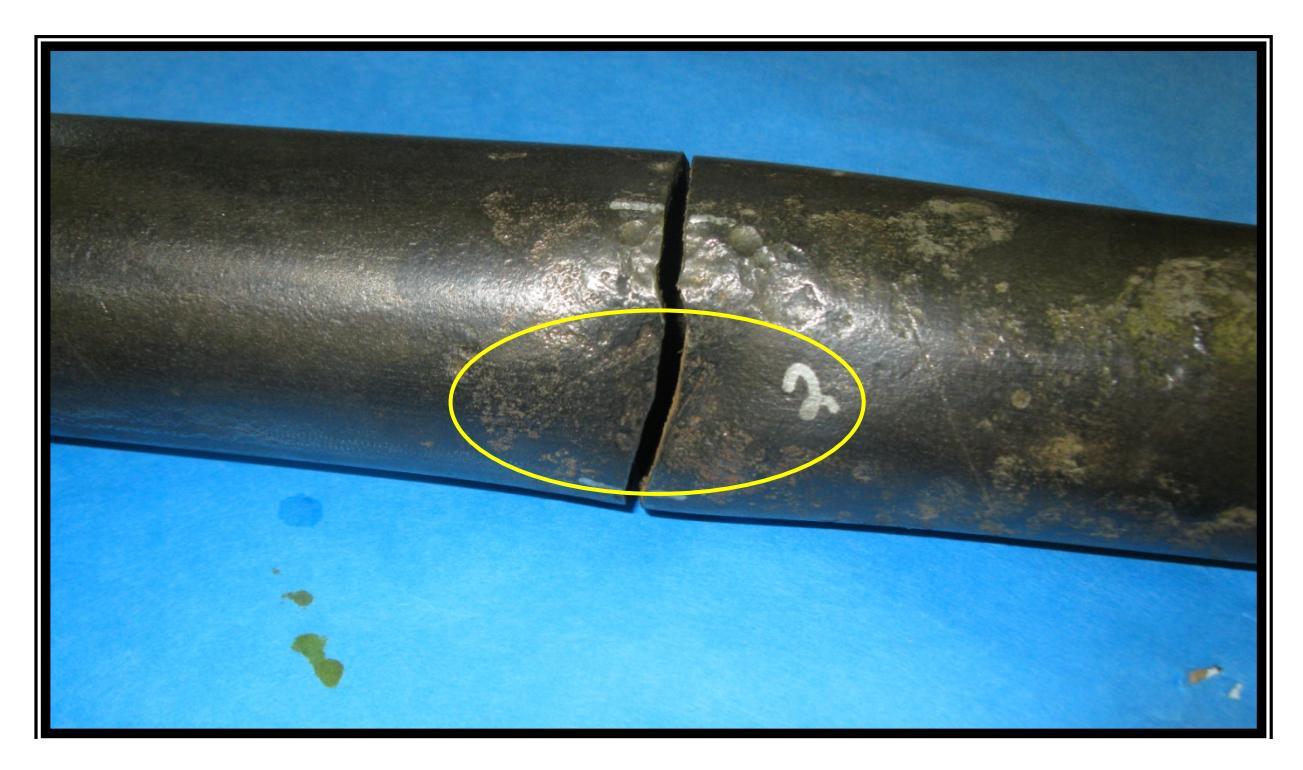
The MoPSC Staff arranged for a failure analysis of the removed steel pipe segment (length of 80.5 inches) by a third-party laboratory. Staff and Company personnel observed the laboratory testing on April 13, 2011, which resulted in the following information. Laboratory measurements of the 2-inch steel pipe confirmed a nominal outside diameter of 2.375" and a nominal wall thickness of 0.154". Two dents were observed on the pipe, located approximately 25.5" apart. The fracture occurred at one of these dent locations - the pipe was dented 5/32" inward (See Appendix B-6, Photograph 11). There also was an approximate 20degree bend in the pipe that started at the second dent location. The bend and two dents were indicative of mechanical loading caused by excavation equipment. The pipe fracture was circumferential, and the crack was 85% around the pipe's circumference. The pipe fracture was primarily brittle even though steel pipe is normally ductile (tensile testing was conducted on the pipe at a location away from the fracture and the steel sample deformed in a ductile manner). The fracture origin corresponds with the dented area from mechanical loading. The pipe's average hardness was measured using the Rockwell "B" scale (HRB) near the fracture (HRB = 81.6) and at a location away from the fracture (HRB = 75.3). The higher hardness at the fracture was likely the result of the local cold-work from the dent. The longitudinal pipe seam weld was located on the opposite side of the pipe from the fracture origin and did not appear to have played any role in the failure. There were no manufacturing defects in the pipe that led to the failure. There was external corrosion and pitting in numerous locations on the outside surface of the pipe, and some of the pitting was severe. There was some pitting at one location in the vicinity of the fracture, but not in the dented area with the fracture origin (See Appendix B-6, Photograph 11).

The corrosion along the coated steel gas main serving 3802 to 3914 Council Grove Avenue was also evaluated. None of the corrosion leaks that had occurred prior to the incident were near the fracture at 3810 Council Grove, but there was some corrosion pitting in the area of the fracture. As noted below, the fracture origin was most likely in the dent caused by the third-party damage and the observed corrosion pitting was located outside of the dent. This indicates that the corrosion pitting on the pipe was not involved in the initiation of the fracture at the point of the mechanical damage.

The fracture initiated in the area of the pipe that had been weakened from the mechanical damage (dent) and where downward forces were applied to the pipe by soil settlement. The bending stresses due to the backfill settlement acting at the stress concentrators created by the mechanical damage in the pipe finally caused a fracture to initiate in the pipe at the location

**Photograph 11** View of the fracture and dent in the 2-inch diameter steel natural gas main. Note the corrosion pitting at the top of the pipe around the fracture. The dent is identified in the yellow oval.
