Exhibit No.:  
Issues: Taum Sauk Upper  
Reservoir  
Witness: Paul C. Rizzo  
Sponsoring Party: Union Electric Company  
Type of Exhibit: Direct Testimony  
Case No.: ER-2011-0028  
Date Testimony Prepared: September 3, 2010

**MISSOURI PUBLIC SERVICE COMMISSION**

**CASE NO. ER-2011-0028**

**PAUL C. RIZZO**

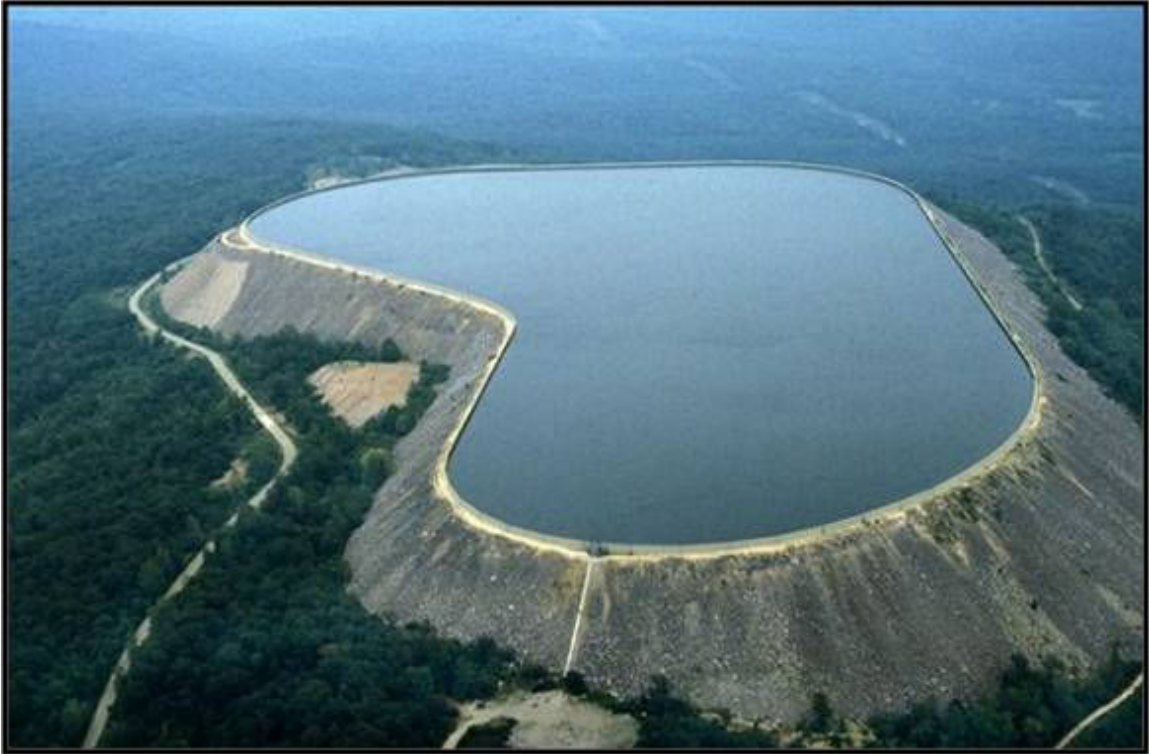
2 **ORIGINAL UPPER RESERVOIR CONCRETE FACED ROCKFILL DAM**

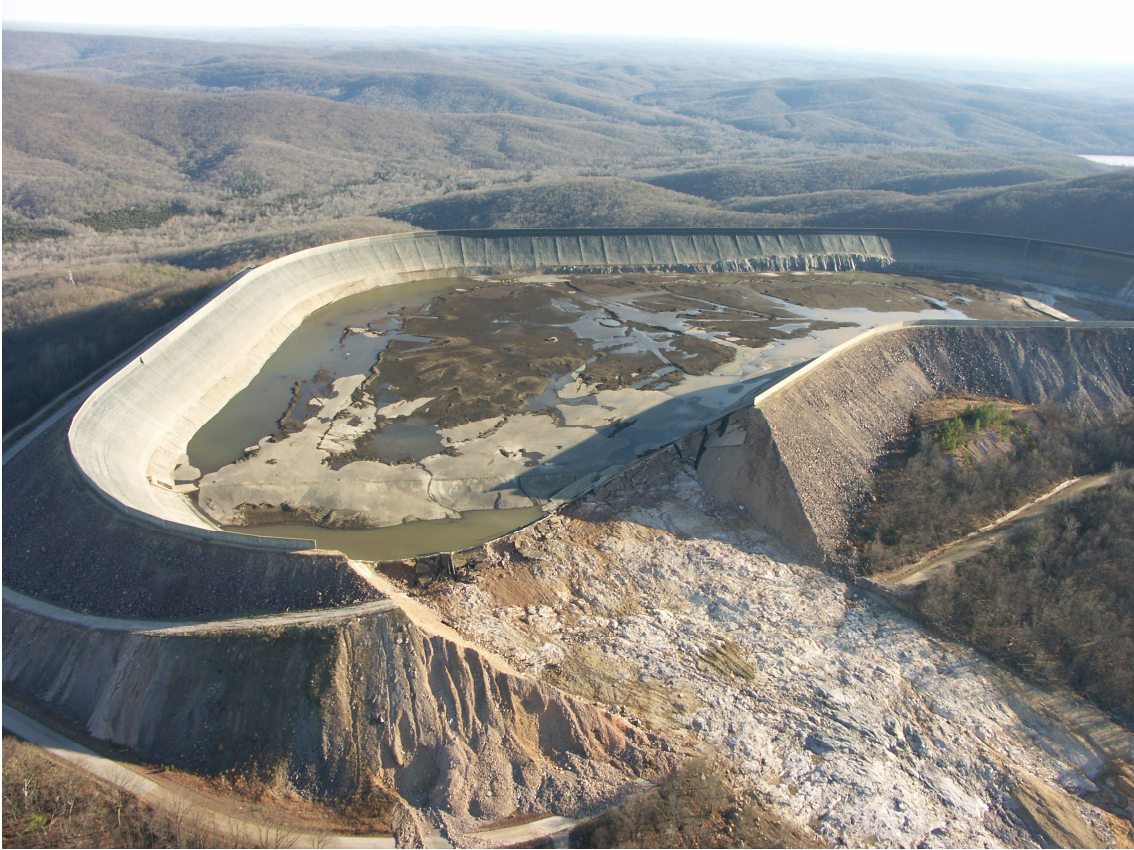
3 **THE RESERVOIR BREACH – DECEMBER 15, 2010**

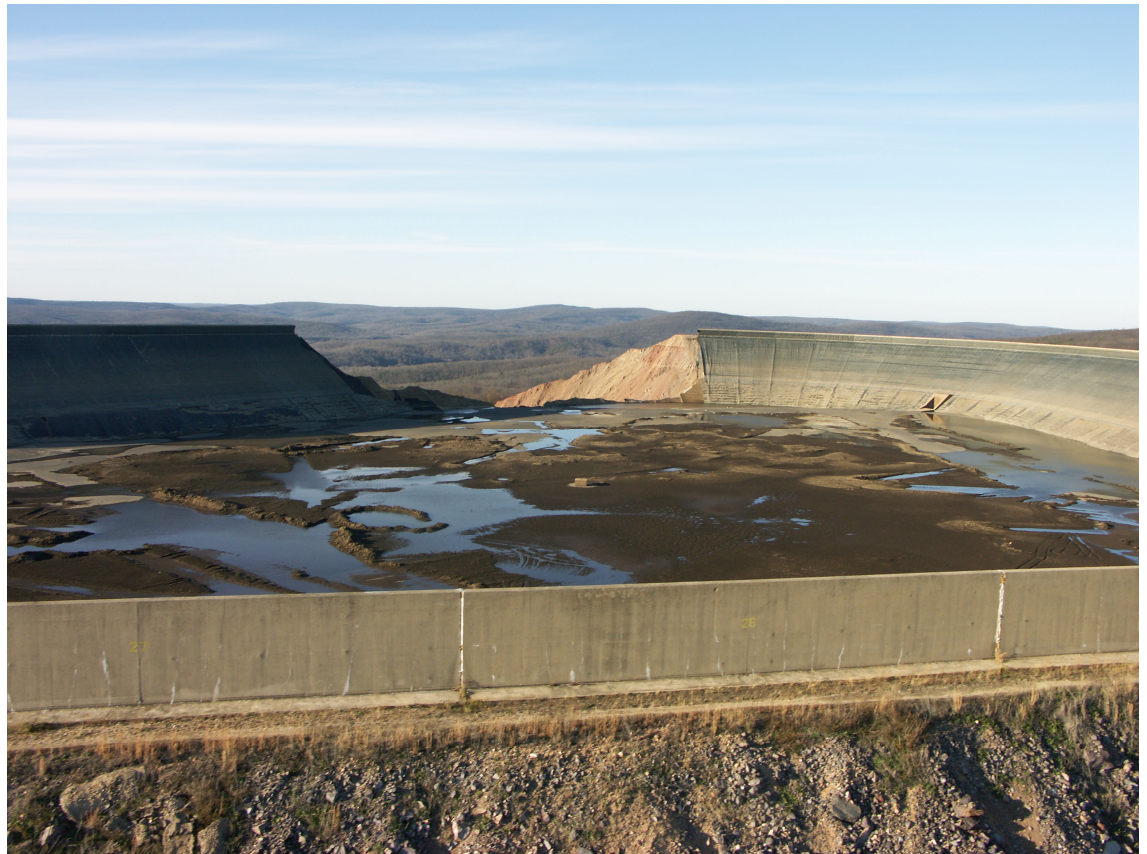
**OLD PARAPET WALL AS IT APPEARED AFTER THE BREACH**

14 A. Yes. After the 2005 failure, considerable undermining of the parapet wall  
15 was observed. This problem would also have been discovered relatively early in the  
16 PFMA process, had a PFMA been conducted in 2008, and the FERC would have  
17 directed that the operating level of the Upper Reservoir immediately be lowered even  
18 further. In addition, the FERC would have required AmerenUE to repair or replace the  
19 parapet wall. As the parapet wall was embedded into the upstream concrete face of the  
20 facility, the entire wall would have had to be replaced, along with a portion of the  
21 upstream concrete face. I estimate that effort would have taken at least 2 years, with a  
22 cost on the order of \$5 million.

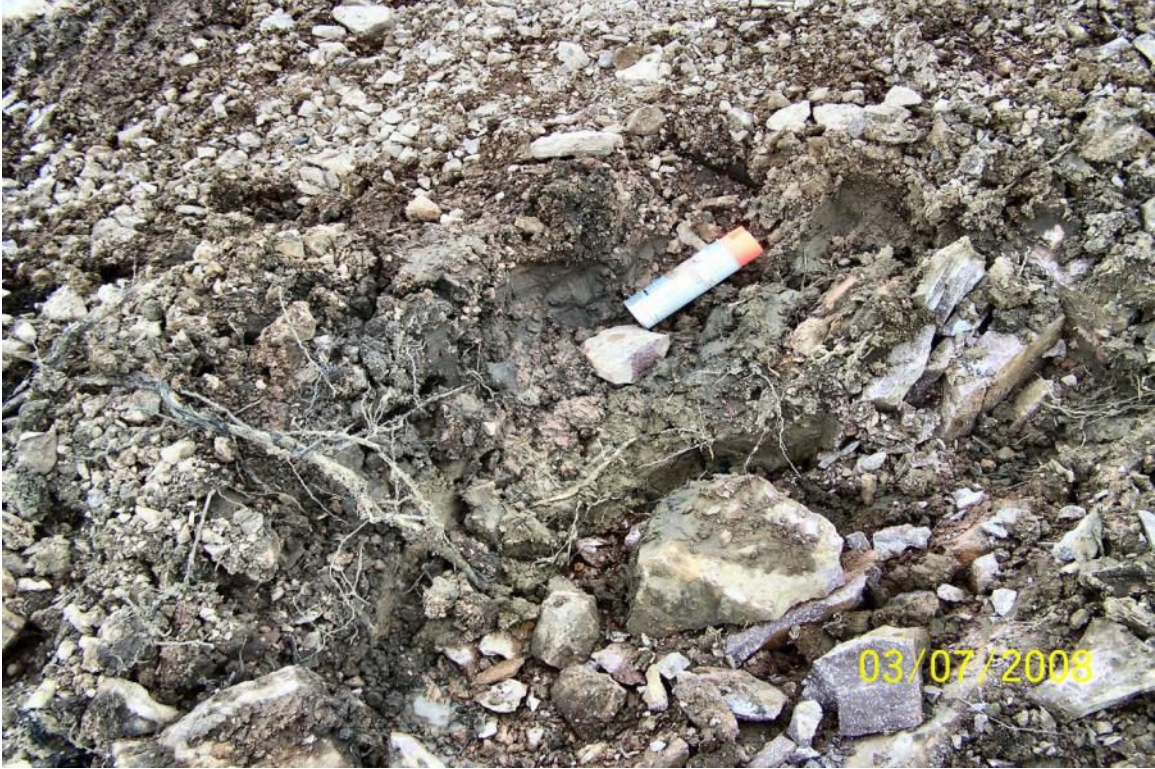
12 Yet our field investigation disclosed areas where as much as 18 inches of virgin, low-  
13 strength material, including top soil and vegetation, was left in place under the CFRD.

2 **DEBRIS AT THE ORIGINAL FOUNDATION ROCK INTERFACE**

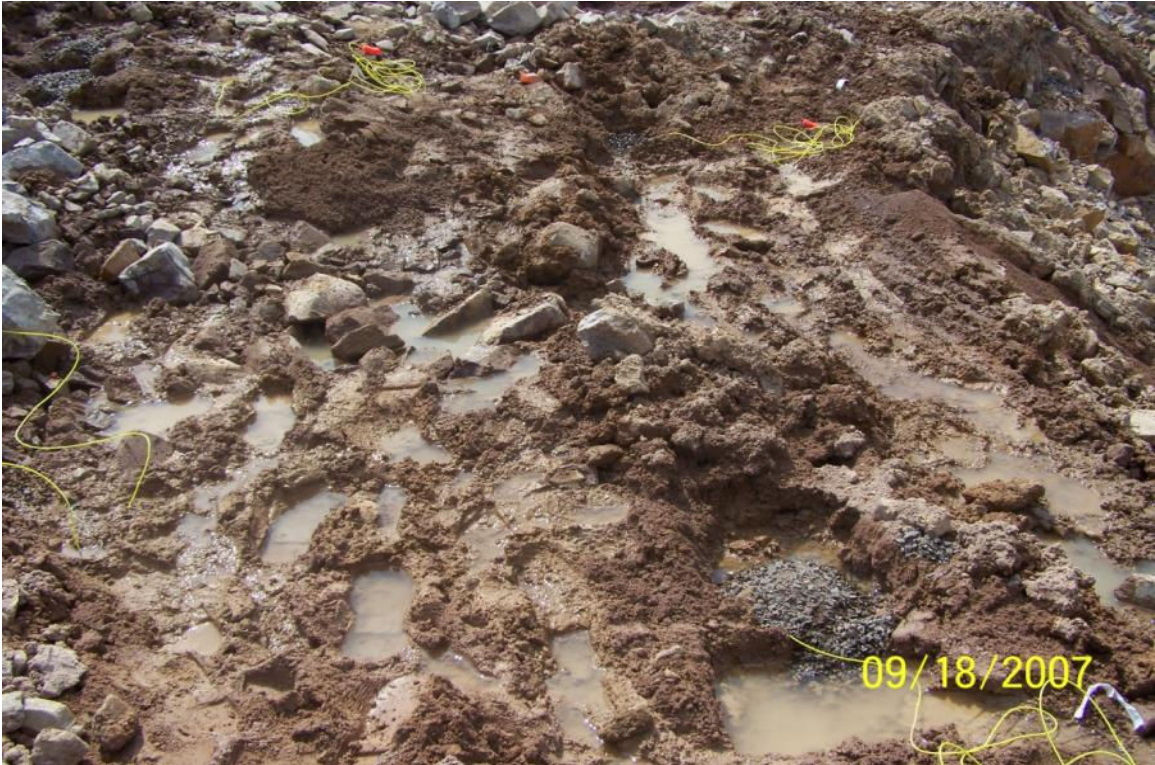
2 **SILTY CLAYEY SAND AT THE ORIGINAL FOUNDATION ROCK INTERFACE**

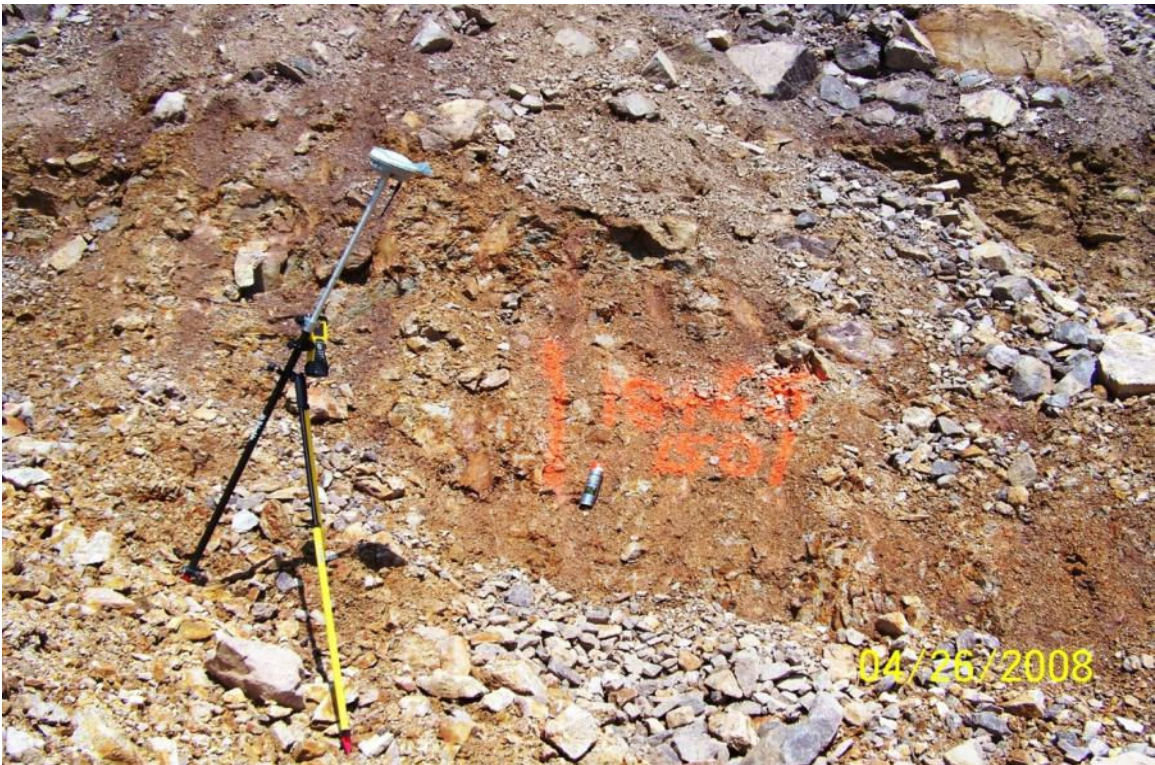
4 **CLAYEY MATERIAL AT ORIGINAL FOUNDATION ROCK INTERFACE**

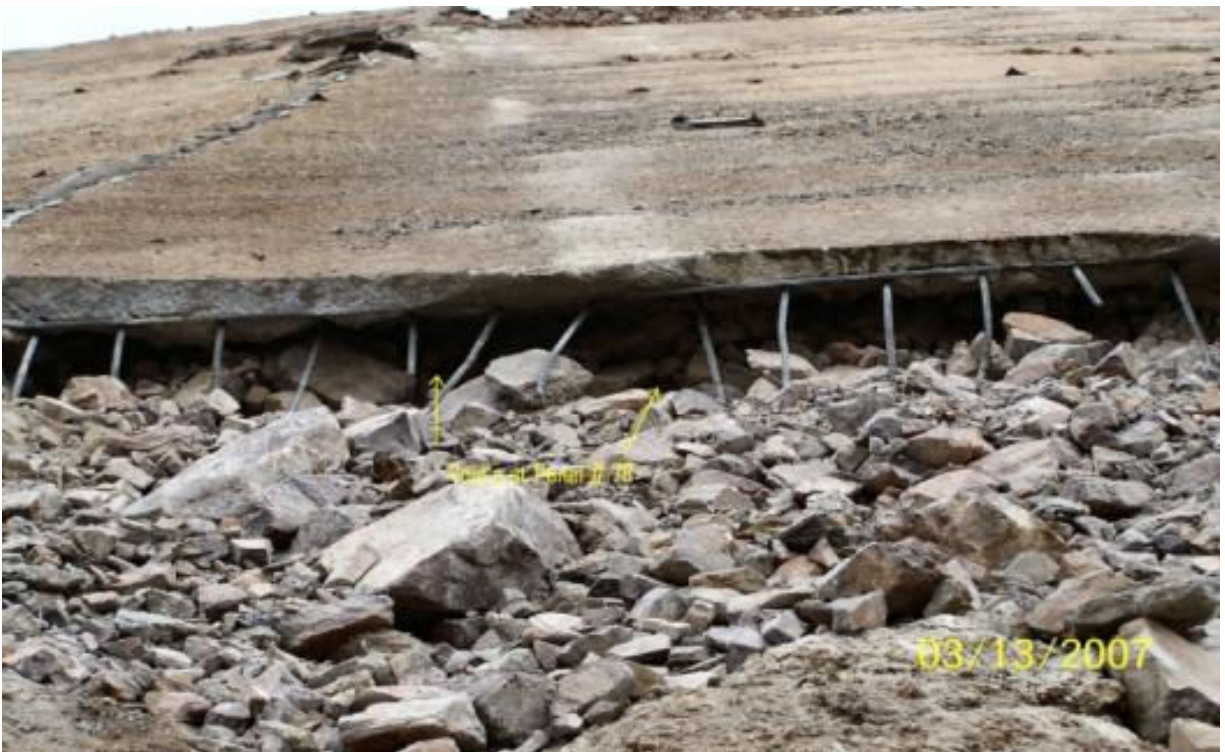
4 The concrete facing failed to perform as intended, and consequently the loss of  
5 water from the Upper Reservoir became so large by 2004 that AmerenUE had to place  
6 an additional membrane on the concrete facing to bring the leakage under control. This  
7 installation was completed in October, 2004. Following the failure, it was apparent that  
8 water movement within the CFRD had created significant voids beneath the concrete  
9 facing, compromising the integrity of the CFRD. Voids as large as 3-4 feet can be seen  
10 in the photo below.

#### 12 **VOIDS UNDER ORIGINAL UPSTREAM CONCRETE FACE**
