**MISSOURI PUBLIC SERVICE COMMISSION**

**REBUTTAL TESTIMONY**

**MISSOURI-AMERICAN WATER COMPANY**

**CASE NO. WU-2017-0296**

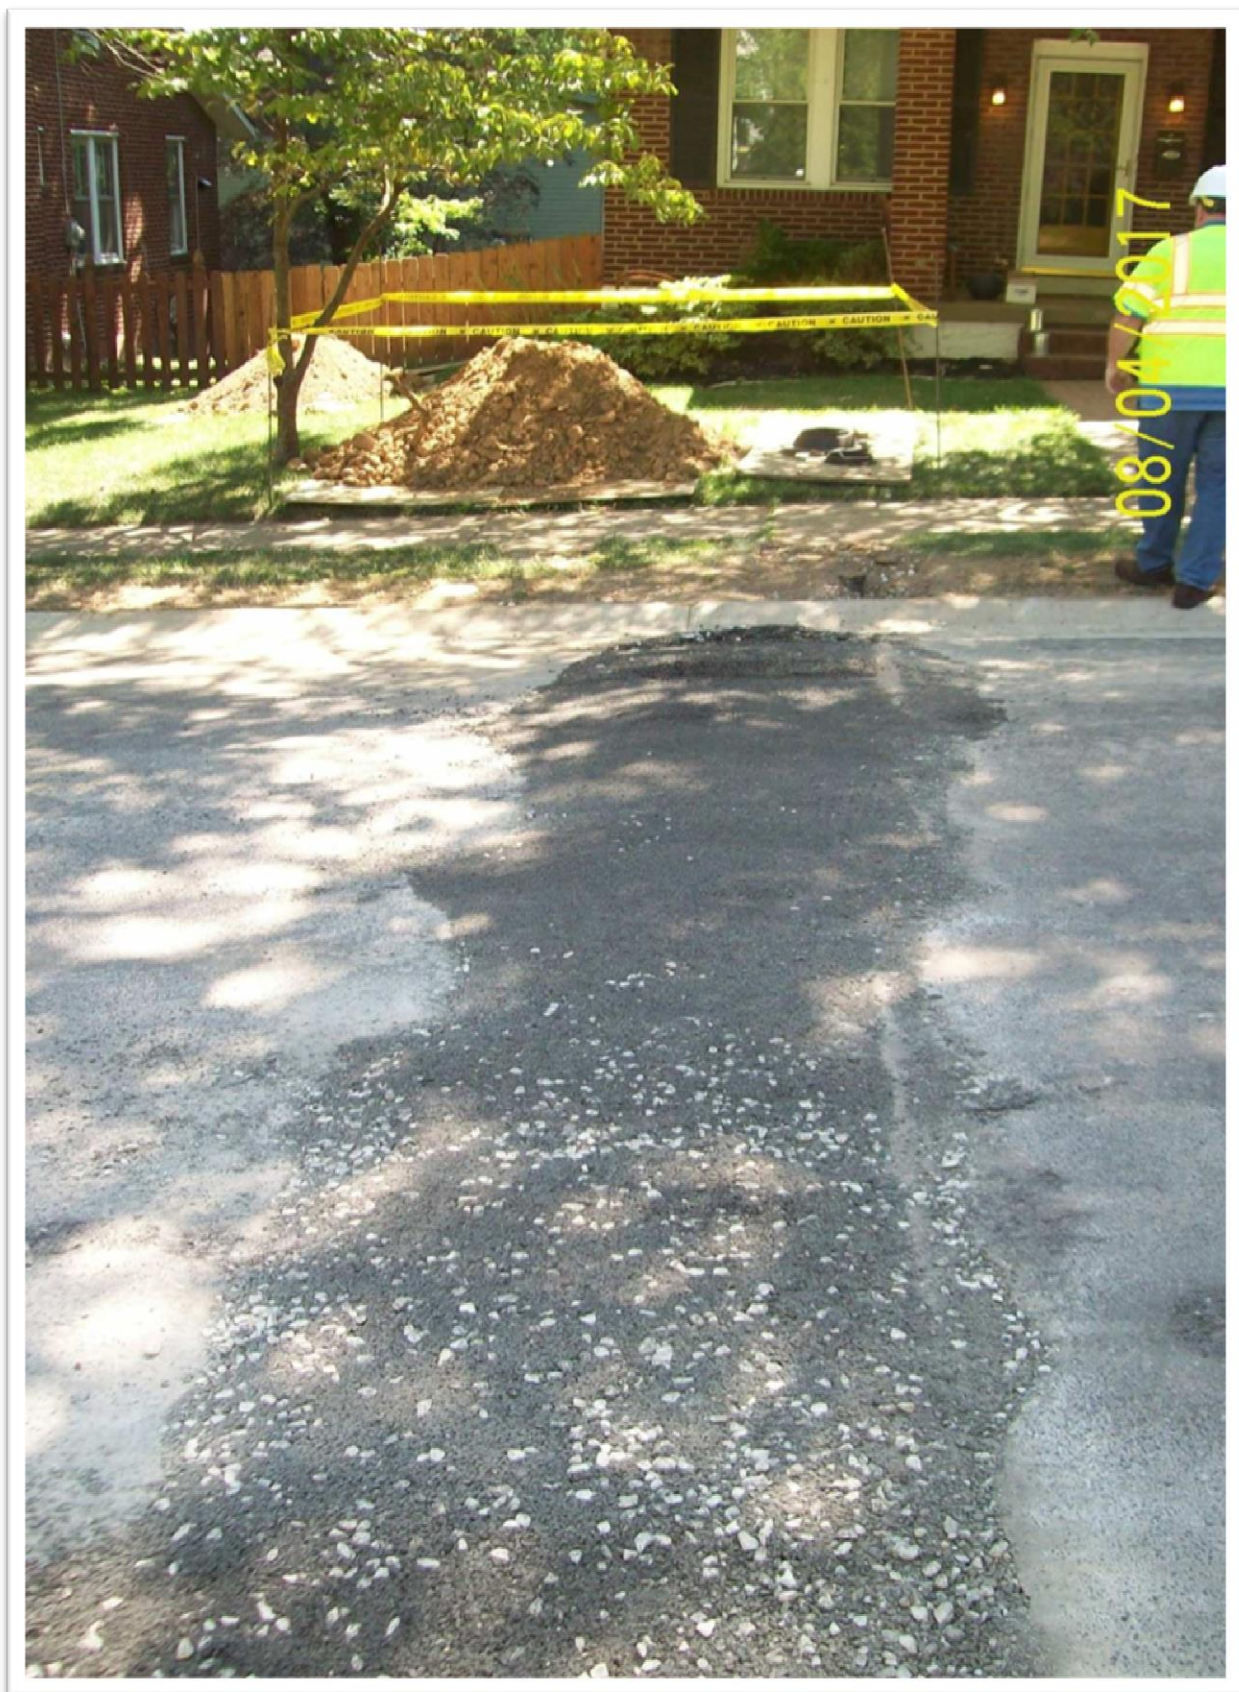
21 A. First, we observed yard and street patches where several LSLs had been  
22 replaced. Second, we witnessed a MAWC-hired plumbing contractor installing a new one-  
23 inch copper service into place to replace an old LSL.

An example of a LSL replacement where the water main is on the opposite side of the street from the customer's home. This photograph is in the St. Louis County service area where the customer owns the entire service line.

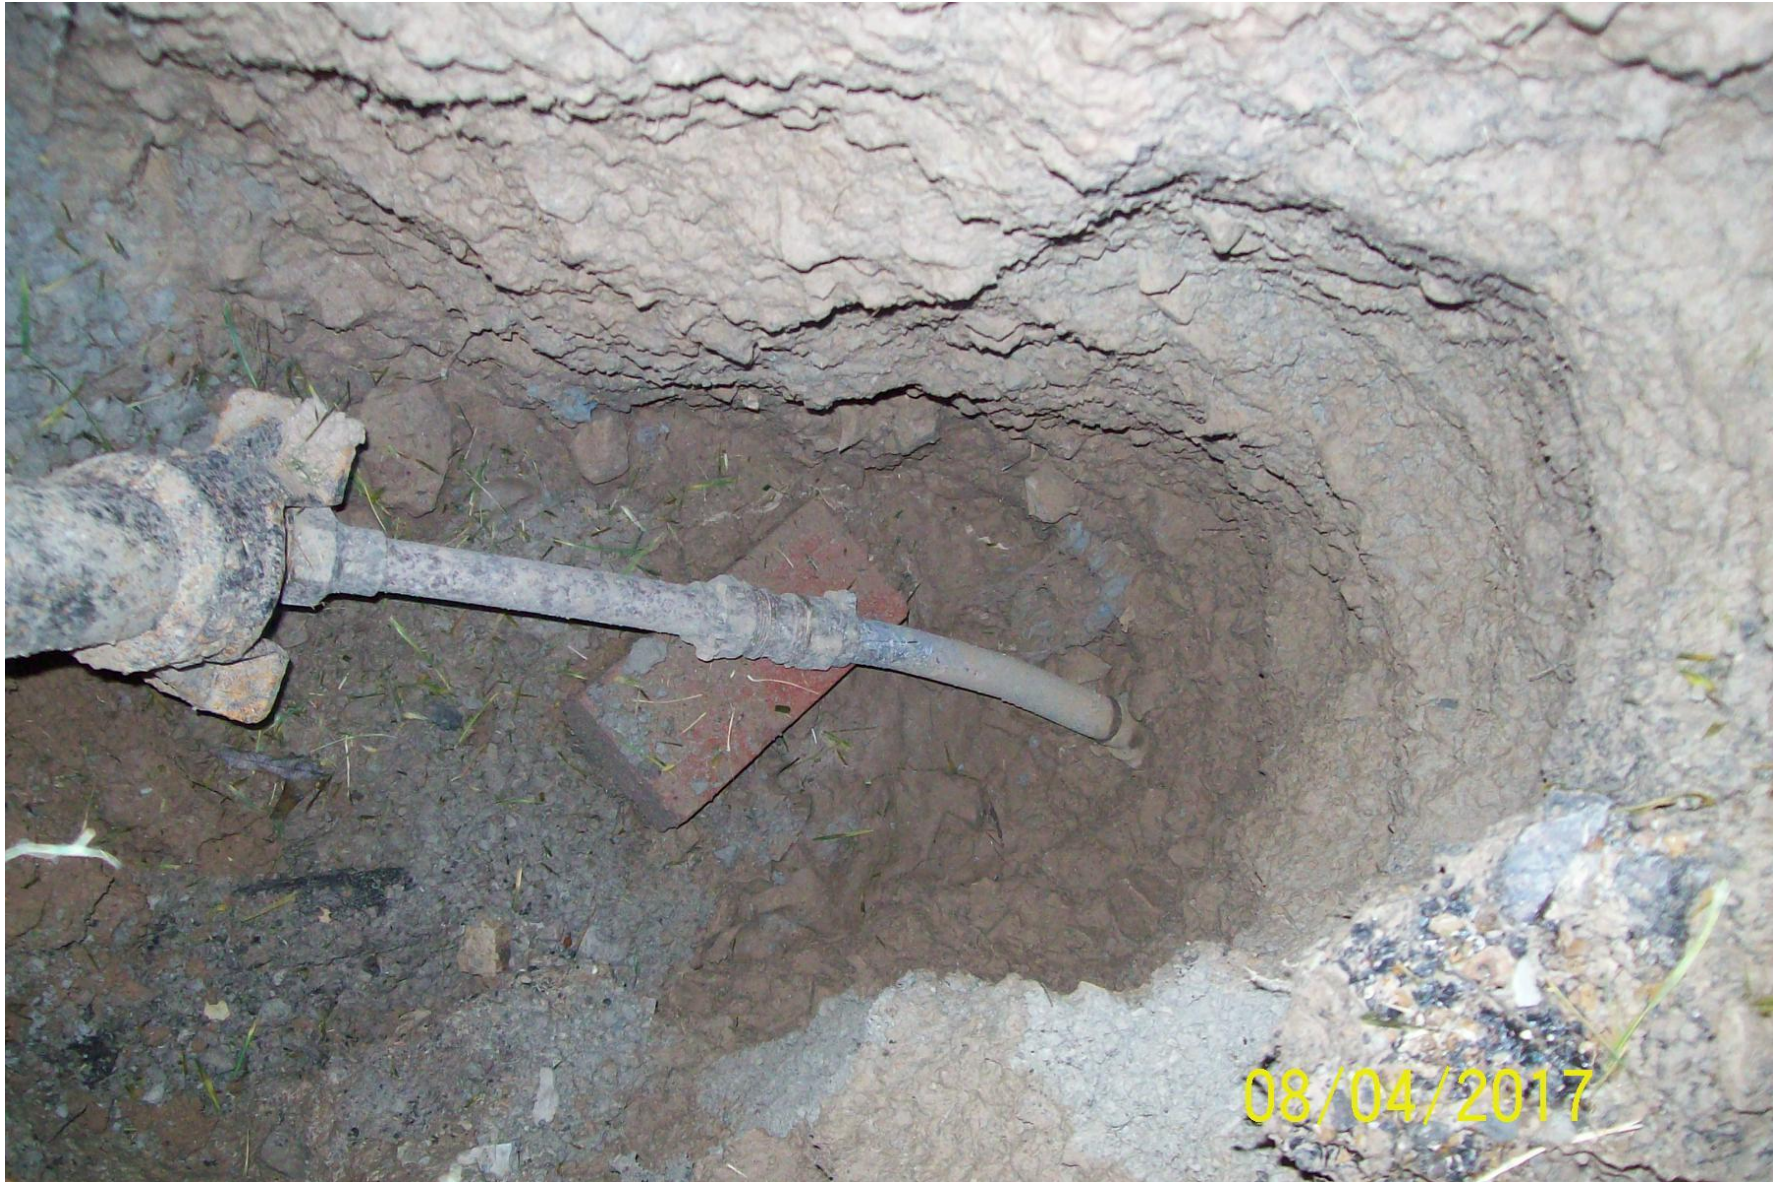
8 A. At the site visit, MAWC stated it digs the service line up at the meter pit or  
9 curb stop in the customer's yard to verify what material the service line is constructed of.  
10 This would be approximately near the middle of the service line. Staff observed one such  
11 hole MAWC had excavated. A picture is attached as Schedule JD-r3.

This picture shows a customer's service line that MAWC has exposed during a water main replacement. MAWC exposed the customer's service line to verify if it is lead. On the left is a short piece of copper which is then connected to a lead service line.

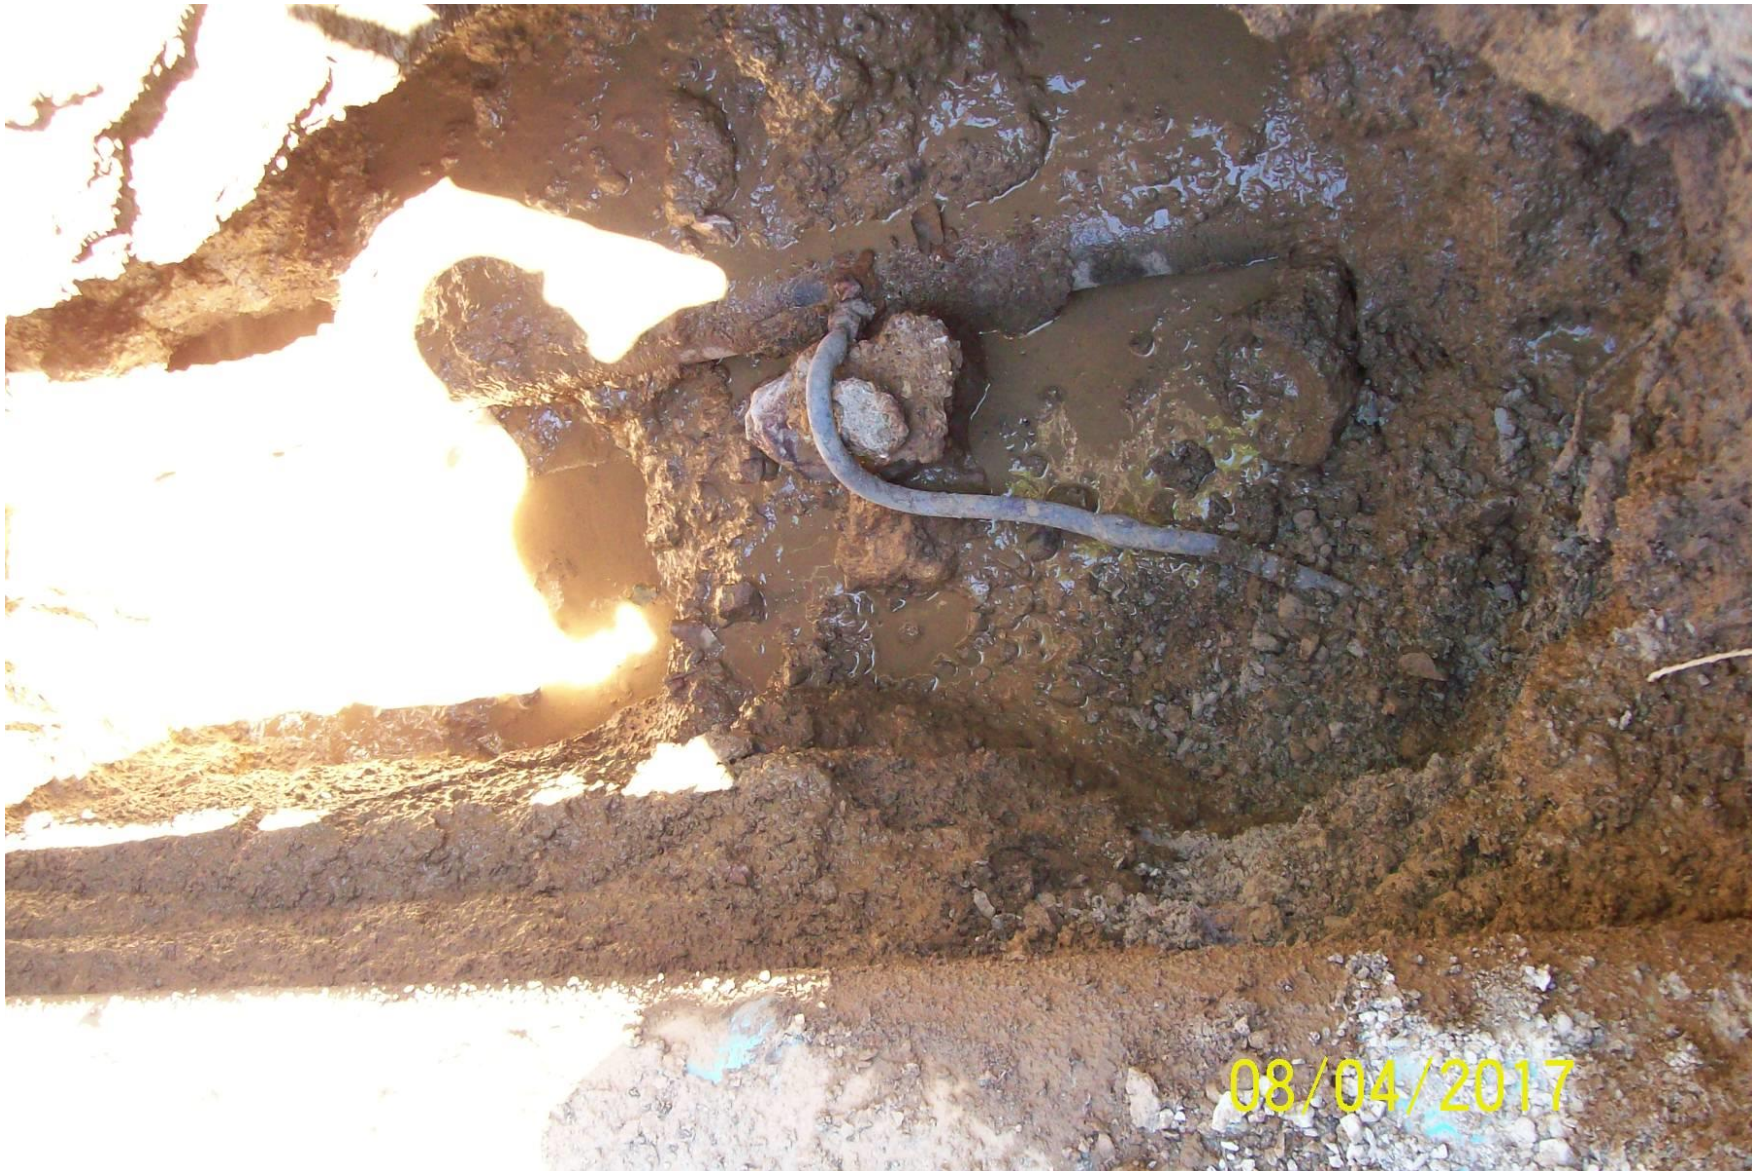
2 A. Next, we observed a LSL still connected to the old four-inch cast iron water  
3 main, which MAWC was replacing with a new eight-inch PVC main. We also saw where  
4 MAWC had dug up a service line in a customer's yard to verify it was a LSL. Attached as  
5 Schedules JD-r2, JD-r3, and JD-r4 are three pictures depicting this.

Pictured here is a lead service line connected to an old four-inch cast iron water main, appearing near the top of the picture. The old main is being replaced with a new eight-inch PVC water main, appearing at the bottom of the picture, and the lead pipe portion of the service line will be replaced with new copper pipe.
