Big Island Causeway

The causeway created some major problems for the reinstallation/separation of the water line from the sewer line. There were service lines in the original installation which were installed in the same trench as shown in the picture above. According to the DNR, service lines should come under the juridiction of National codes. The waterline has been removed from the upper road and reinstalled in the lower main road. The new water line is suppose to be relocated a minimum of 10 horizontal feet from the sewer line, which satisfies the codes for the DNR. Unfortunately the newly installed water lines are at the lowest level of the complete system. In case of a system sewer leak the contaminated sewer water could by gravity end up surrounding the 4 "drinking water line.

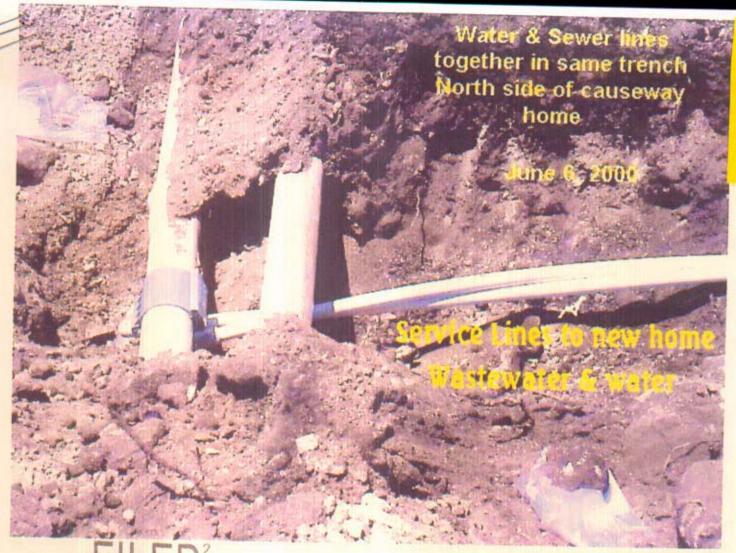
The service lines with the blue extensions pass perpendicularly over the sewer line without a sleeving as required for the mains. Contamination can occur from leaking service lines as well as leaking mains. Health risk issues should always be a consideration.
