Validation of GNSS under 500,000 Volt Direct Current (DC) Transmission Lines

Position, Location and Navigation Group, Schulich School of Engineering, University of Calgary

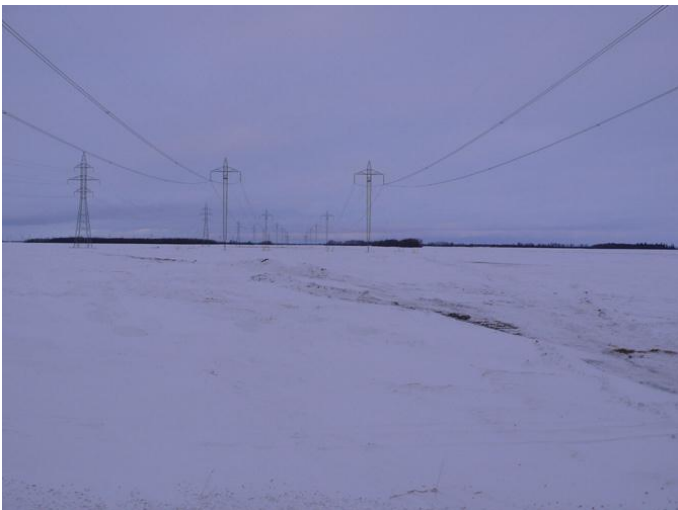
Figure 1 - Test Site

Figure 1 shows a picture of the test site located on the Nelson River Bipole system, operated by Manitoba Hydro in Winnipeg, Manitoba, Canada. Two visually identical 500 kV DC bipoles are located on the right side, with one parallel AC line at the left. Lines were located approximately 5 m above the ground. Data was collected over two days. During the first day of data collection the HVDC lines had a 537 MW and 531 MW load. During the second day of the data collection, the HVDC lines had 1124 MW and 1218 MW loading. Despite the loading difference, results were consistent on both days.

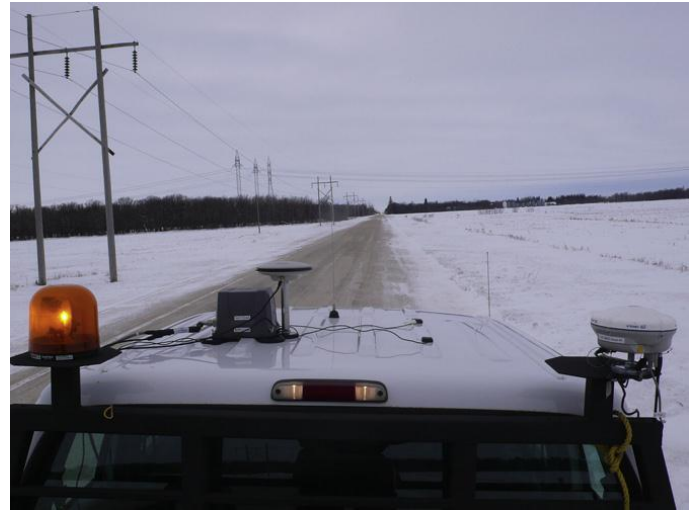
Specific components of the test equipment installed on the vehicle roof were the Trimble R8 rover unit, the antenna for the high sensitivity GPS receiver, the NovAtel 702 GG pinwheel antenna used by the V3 mobile unit, the NovAtel SPAN INS, and the PLAN group Leapfrog-II L-Band Front-End module. The IMU component of the NovAtel SPAN SE system was deployed on the roof of the vehicle to provide a rigid and stable mounting point via four magnets.

Figure 3 - Mobile GNSS, inertial, and RF equipment elements mounted on roof of test vehicle. Trimble R8 rover unit at bottom right, high sensitivity GPS antennas on roof at right, NovAtel 702 GG dome antenna center left directly adjacent to LCI IMU (gray box) at center left.

Equipment supporting the mobile portion of the collection effort was divided between the roof of the test vehicle, depicted in Figure 3, and the cab of the truck where the operation of the navigation systems were monitored and managed.

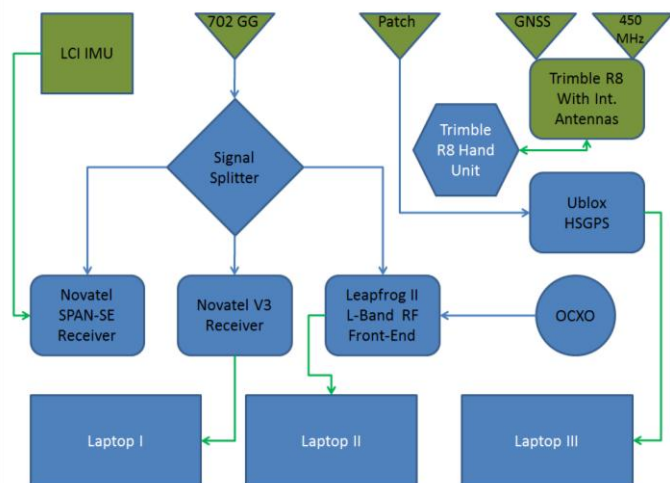
Figure 4 - Deployed equipment functional diagram. Equipment external to vehicle shown as green elements (antennas, IMU, Trimble R8), equipment installed inside vehicle shown in blue. Cabled RF links shown with blue arrows, digital data links shown with green arrows. (For interpretation of the references to color in this figure legend, the reader is referred to the web version of this article.)

The block diagram of the complete navigation test system suite is shown in Figure 4.

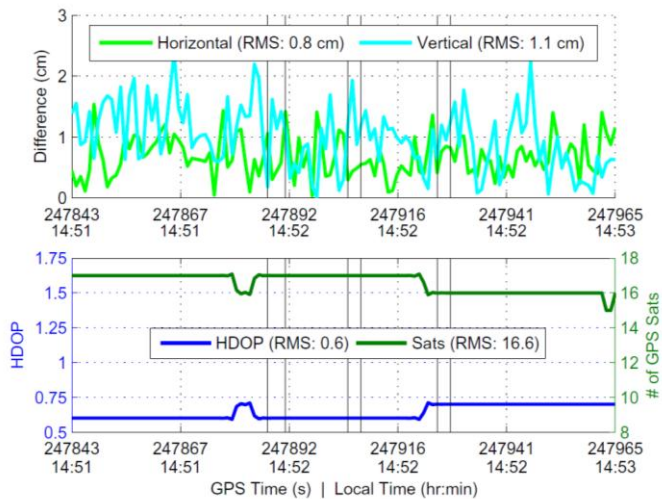
The position differences between the Trimble Real Time Kinematic (RTK) system and the reference trajectory are shown in Figure 5. Position differences of several centimetres are common amongst receiver manufacturers and processing software, thus the differences shown on the top of Figure 5 are completely normal. The differences are due to antenna phase center variation, projection of the reference solution to the Trimble R8 antenna phase center, carrier phase noise and multipath and differences in filtering and estimation techniques used.

The horizontal dilution of precision (HDOP) and number of satellites presented in the bottom half of Figure 5 is consistent with open sky conditions. The solution of the RTK system may, for example, reject a satellite without a fixed ambiguity, occlude some satellites near the horizon or have difficulty maintaining signal lock for a

Figure 5 - Position differences and satellite geometry (vertical lines represent time directly beneath transmission lines), receiver: Trimble R8, processed by: Trimble Internal RTK Solution, data: L1 + L2 + GPS + GLONASS, test segment: 14.

low elevation satellite. The values presented in Figure 5 show ideal data, with no reason to yield navigation impediments. An HDOP of 0.6 is among the best values currently available with a GPS+GLONASS receiver at the latitude of the tests (50.1° N).

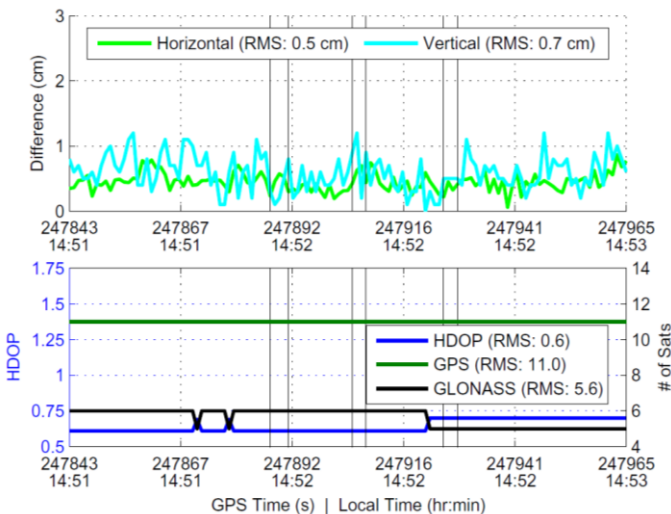
Position differences as processed by PLANSoft™ are shown in Figure 8 with differences less than 1.1 cm as compared to the reference trajectory. The HDOP is exceptional throughout both segments and the number of satellites remains consistent with open sky conditions. No transmission line effect is detected as the vehicle traverses the line.

Figure 8 - Position differences and satellite geometry (vertical lines represent time directly beneath transmission lines), receiver: NovAtel V3, processed

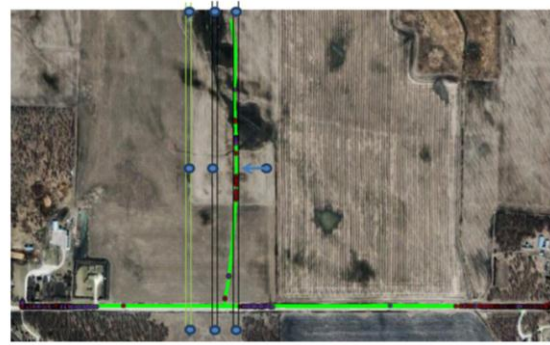
Figure 10 shows the trajectories traveled during the data collection and each cycle slip is plotted on the trajectory. Figure 10 contains all the NovAtel data collected, not just the segment analyzed (i.e. segment 14). This additional data was included to show the impact of trees on cycle slips versus the lines and towers overhead.

On the east and west ends of the data collection 362 cycle slips occurred, while only 28 cycle slips occurred beneath the transmission lines. This is due to the trees present on either side of the road, where low elevation satellites affected by these trees experience a large number of cycle slips. Some slips occur just east of the north/south trajectory where trees are present south of the road. Most importantly, although a few cycle slips occur under the lines, there is only a weak correlation between the location of the transmission line towers and the location of the cycle slips. This indicates that the transmission lines and their corresponding towers, regardless of their electric current carrying characteristics, are not causing cycle slips at a level that would impede centimetre level accuracy. Albeit cycle slips are occurring under the lines, the impact is negligible when comparing the navigation solutions to the truth solution.

Figure 10 - Geo-located cycle slips for all data collected (red: 24 January, purple: 25 January, blue tower locations).

It is also noteworthy that, despite a tower being located a few tens of metres from the northern most point of the data collection (where the vehicle turned to return south), no cycle slips were recorded in this area, further confirming the low effects of transmission line towers on carrier phase tracking capabilities.
