**BEFORE THE PUBLIC SERVICE COMMISSION
OF THE STATE OF MISSOURI**

**APPLICATION AND
MOTION FOR WAIVER**

APPENDIX A

**Missouri Department of Natural Resources
Kansas City Regional Office, Air Pollution Control
Report of Inspection
Clinton Estates
7113 Southwest Alexandria Circle, Trimble, Clinton
MO0129836**

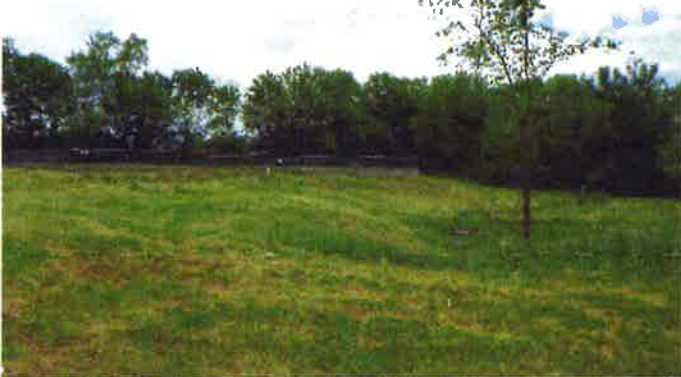
<p>Photograph: #001 Taken By: Suzanne Ward Facility: Clinton Estates Facility ID: MO0129836 Location: 7113 Southwest Alexandria Circle, Trimble, Missouri</p> <p>Description: Sand filters and tank field looking southeast.</p> <p>Date Taken: 05/30/2019 Program: WPC Unit</p>

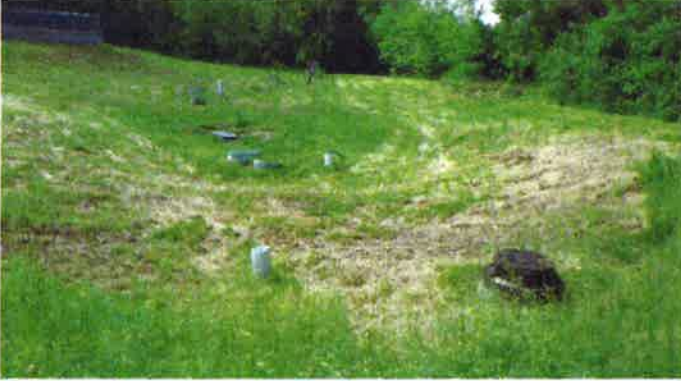
<p>Photograph: #002 Taken By: Suzanne Ward Facility: Clinton Estates Facility ID: MO0129836 Location: 7113 Southwest Alexandria Circle, Trimble, Missouri</p> <p>Description: Tank field looking southeast.</p> <p>Date Taken: 05/30/2019 Program: WPC Unit</p>

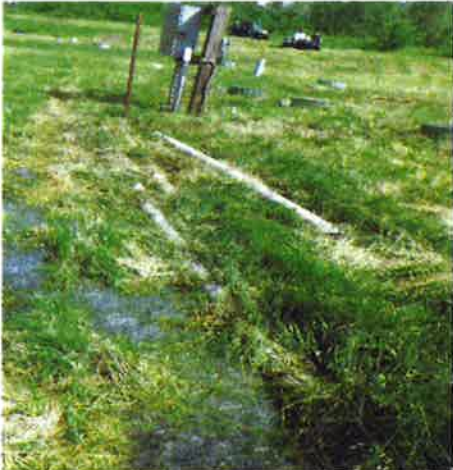
<p>Photograph: #003 Taken By: Suzanne Ward Facility: Clinton Estates Facility ID: MO0129836 Location: 7113 Southwest Alexandria Circle, Trimble, Missouri</p> <p>Description: Standing water, pipes, and hoses in tank field looking north.</p> <p>Date Taken: 05/30/2019 Program: WPC Unit</p>

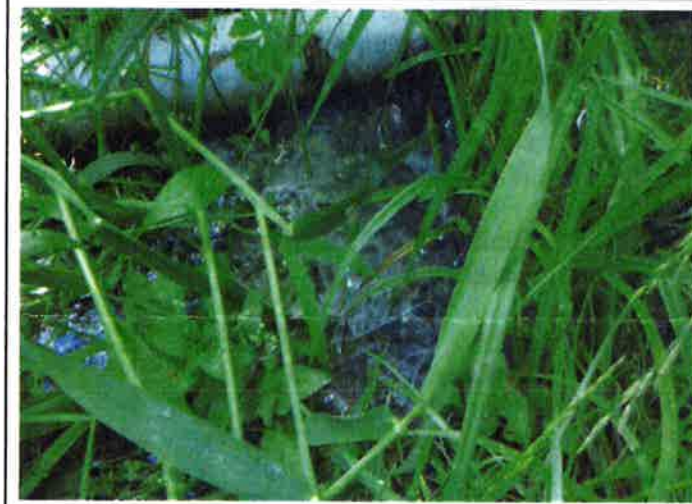
Photograph: #004
Taken By: Suzanne Ward
Facility: Clinton Estates
Facility ID: MO0129836
Location: 7113 Southwest Alexandria Circle,
Trimble, Missouri

I returned on Monday, June 3, 2019, with verbal authorization from Ms. Fisher to look at the unknown white substance. Standing water in the tank area was somewhat lower than during the initial inspection. I observed water spraying from a riser as the recirculation tank pump was engaged; this water was being discharged before passing through all treatment processes, constituting a bypass (Violation #5). The bypass was not reported to the Department (Violation #6). I observed sludge in the standing water in the tank area. The water was slowly flowing to the receiving stream. I observed a white substance in the moving water. At the stream bank where the bypass was entering the stream, I observed a pink-hued slime. Below that, I observed sludge, worm casings, and blood worms. Violations of Chapter 7 general criteria water quality standards were documented (Violation #7). This point was further upstream than monitoring conducted during the initial inspection.

Description: Unknown white substance observed in standing water in the tank field.

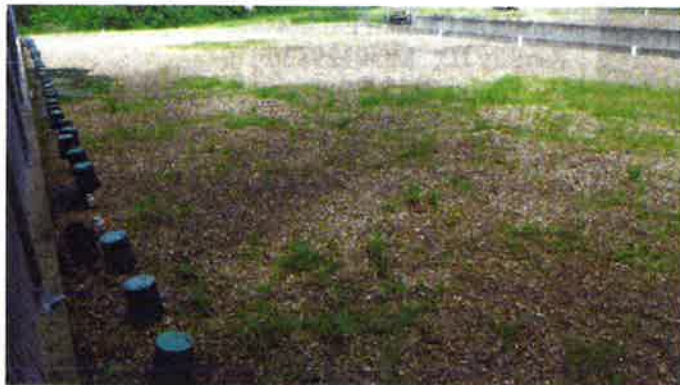
Photograph: #005
Taken By: Suzanne Ward
Facility: Clinton Estates
Facility ID: MO0129836
Location: 7113 Southwest Alexandria Circle,
Trimble, Missouri

The control panel and risers were not inspected closely due to there being standing water in the area. I was unsure if the standing water was originating from the tanks or from recent heavy precipitation events. A small area of the standing water contained an unknown white substance. Grassy vegetation was observed in both filter beds (Violation #3). The south filter bed had a large area of standing water containing algae (Violation #3). The concrete boundaries of the filter beds appeared structurally sound.

Description: South sand filter looking northwest. Standing water with algae around risers on the south side.

Required Action: Remove vegetation from the filter bed media and complete any necessary repairs to prevent standing water. In your response, provide photo documentation and documentation of work completed to the Kansas City Regional Office by August 19, 2019.

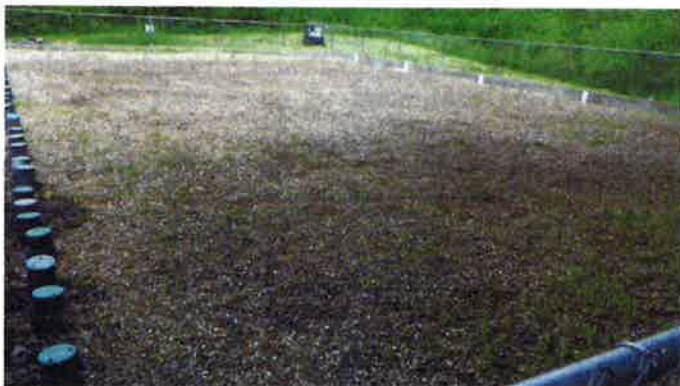
Description: North sand filter looking northwest.

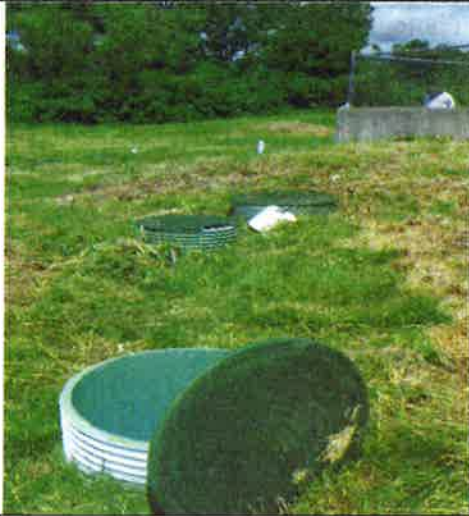
Photograph: #007
Taken By: Suzanne Ward
Facility: Clinton Estates
Facility ID: MO0129836
Location: 7113 Southwest Alexandria Circle,
Trimble, Missouri

Description: Flow measurement sampling station,
valve access, and splitter access looking northwest

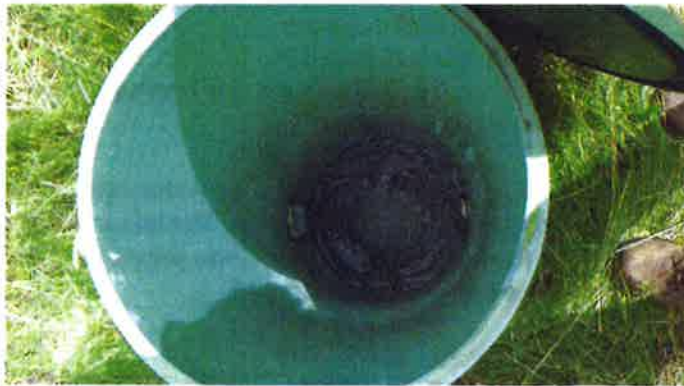
Photograph: #008
Taken By: Suzanne Ward
Facility: Clinton Estates
Facility ID: MO0129836
Location: 7113 Southwest Alexandria Circle,
Trimble, Missouri

Sampling was conducted from the flow measurement/sampling station then downstream and upstream from the stream outfall. Violations of the permitted effluent limitations for Ammonia as Nitrogen were documented (Violation #4). See the table in the Sampling and Monitoring section. The outfall at the stream was marked with a sign. Residential Sewage Treatment Company has installed a tablet feeder for dechlorination at the stream outfall, but the facility does not currently conduct chlorination disinfection. No dechlorination tablets were in the feeder at the time of the inspection.

Description: Flow measurement & sampling
station. Samples were collected here.

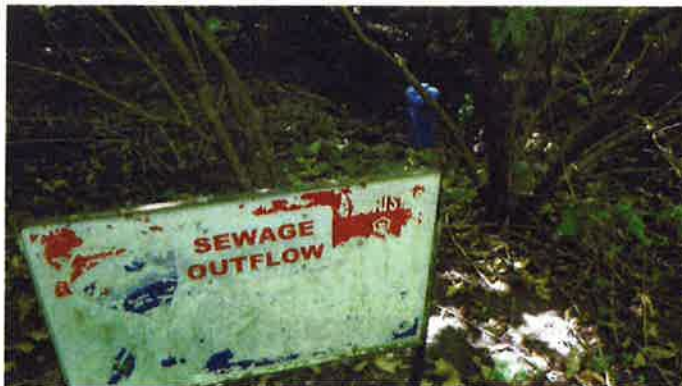
Photograph: #009
Taken By: Suzanne Ward
Facility: Clinton Estates
Facility ID: MO0129836
Location: 7113 Southwest Alexandria Circle,
Trimble, Missouri

Description: Outfall sign at stream

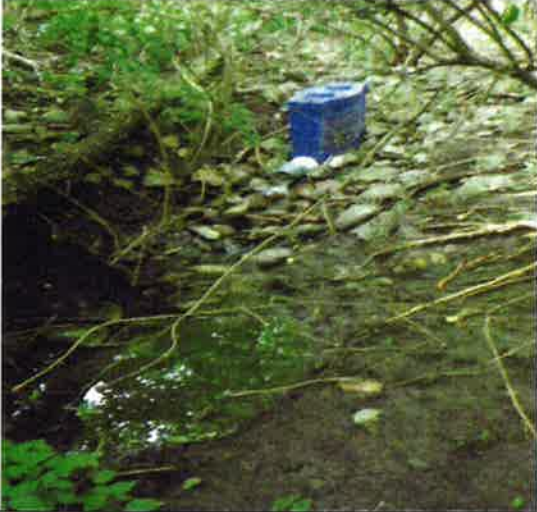
<p>Photograph: #010 Taken By: Suzanne Ward Facility: Clinton Estates Facility ID: MO0129836 Location: 7113 Southwest Alexandria Circle, Trimble, Missouri</p> <p>Description: Tablet feeder for dechlorination installed at stream, but this facility does not have chlorination. No tablets were observed inside the tablet feeder.</p> <p>Date Taken: 05/30/2019 Program: WPC Unit</p>

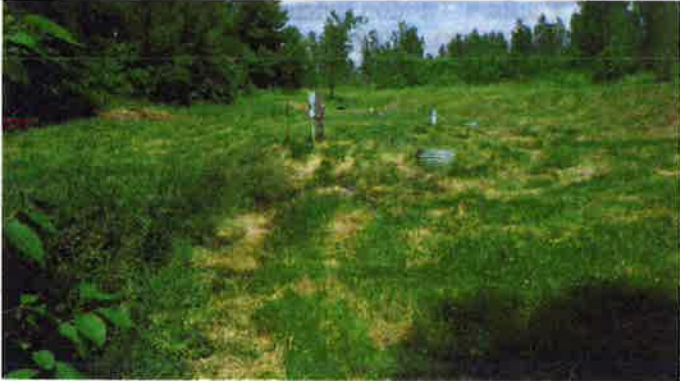
<p>Photograph: #011 Taken By: Suzanne Ward Facility: Clinton Estates Facility ID: MO0129836 Location: 7113 Southwest Alexandria Circle, Trimble, Missouri</p> <p>Description: Area of standing water extends from tank area south to the stream. The unmowed grass on the left side of the photo was presumably left unmowed due to wet ground.</p> <p>Date Taken: 06/03/2019 Program: WPC Unit</p>

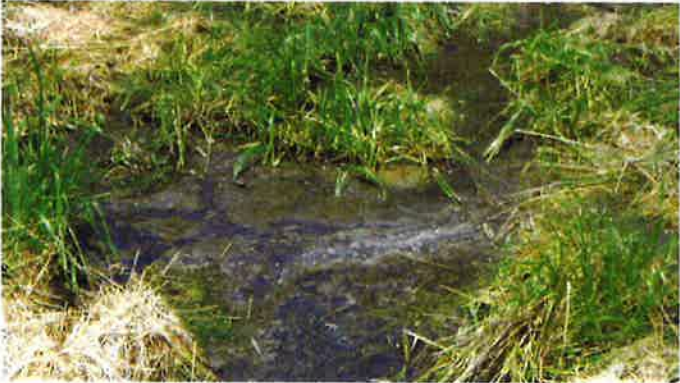
<p>Photograph: #012 Taken By: Suzanne Ward Facility: Clinton Estates Facility ID: MO0129836 Location: 7113 Southwest Alexandria Circle, Trimble, Missouri</p> <p>Description: Sludge in standing water in the tank area.</p> <p>Date Taken: 06/03/2019 Program: WPC Unit</p>

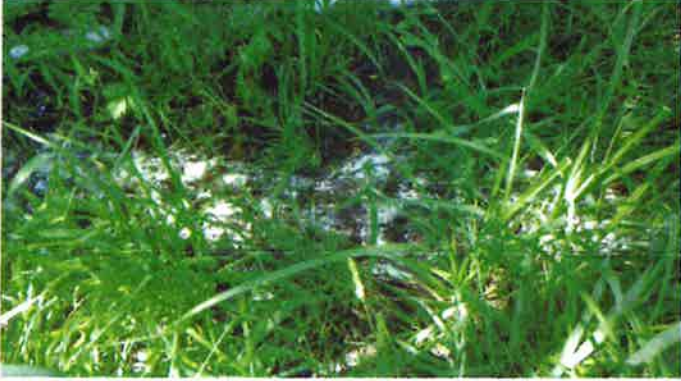
<p>Photograph: #013 Taken By: Suzanne Ward Facility: Clinton Estates Facility ID: MO0129836 Location: 7113 Southwest Alexandria Circle, Trimble, Missouri</p> <p>Description: White residue in bypassing water running from the tank area to the stream.</p> <p>Date Taken: 06/03/2019 Program: WPC Unit</p>

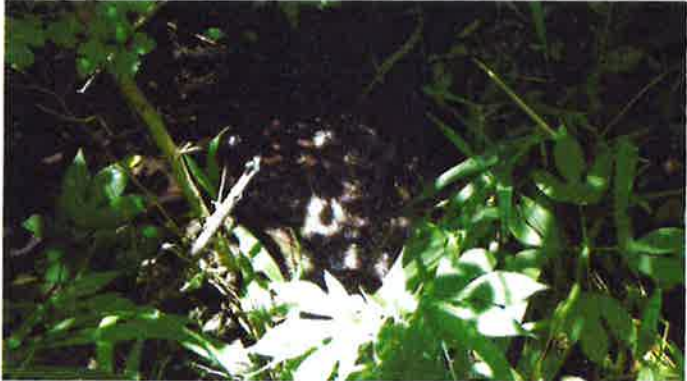
<p>Photograph: #014 Taken By: Suzanne Ward Facility: Clinton Estates Facility ID: MO0129836 Location: 7113 Southwest Alexandria Circle, Trimble, Missouri</p> <p>Description: Pink hued slime on the stream bank where the bypass enters the stream.</p> <p>Date Taken: 06/03/2019 Program: WPC Unit</p>

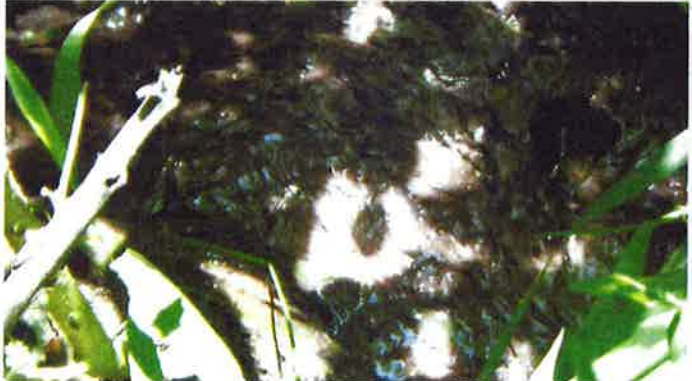
<p>Photograph: #015 Taken By: Suzanne Ward Facility: Clinton Estates Facility ID: MO0129836 Location: 7113 Southwest Alexandria Circle, Trimble, Missouri</p> <p>Description: Pink hued slime (zoomed in) on the stream bank where the bypass enters the stream.</p> <p>Date Taken: 06/03/2019 Program: WPC Unit</p>

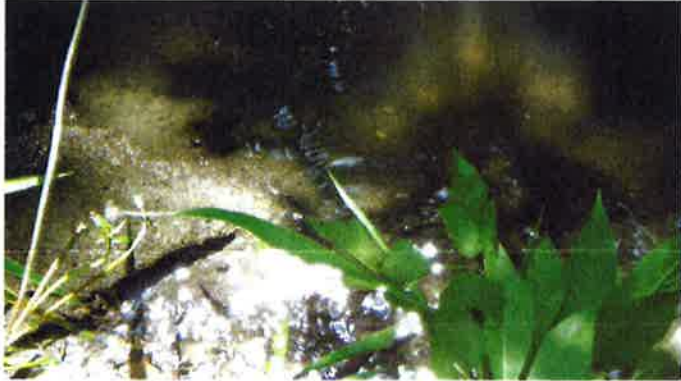
5. **On June 3, 2019, caused the formation of putrescent, unsightly, or harmful bottom deposits in waters of the state, a tributary to Dick's Creek, in violation of Special Condition 5 of MSOP MO0129836 and Chapter 7 General Criteria Water Quality Standards [RSMO § 644.076.1, 10 CSR 6.010(8)(A)4, and 10 CSR 7.031(4)(A)].**

<p>Photograph: #016 Taken By: Suzanne Ward Facility: Clinton Estates Facility ID: MO0129836 Location: 7113 Southwest Alexandria Circle, Trimble, Missouri</p> <p>Description: Sludge on the stream bank and bed where bypass enters the stream</p> <p>Date Taken: 06/03/2019 Program: WPC Unit</p>

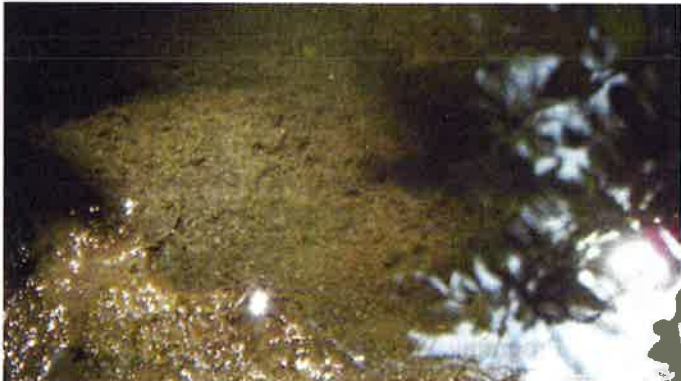
<p>Photograph: #017 Taken By: Suzanne Ward Facility: Clinton Estates Facility ID: MO0129836 Location: 7113 Southwest Alexandria Circle, Trimble, Missouri</p> <p>Description: Sludge on the stream bank (zoomed in) and bed where bypass enters the stream. Blood worms were observed.</p> <p>Date Taken: 06/03/2019 Program: WPC Unit</p>

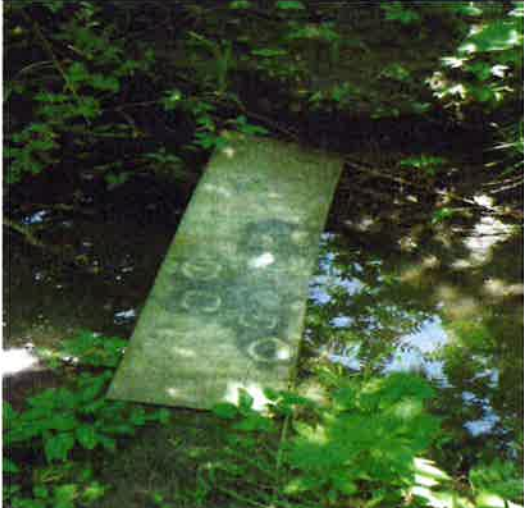
<p>Photograph: #018 Taken By: Suzanne Ward Facility: Clinton Estates Facility ID: MO0129836 Location: 7113 Southwest Alexandria Circle, Trimble, Missouri</p> <p>Description: Bridge over the creek a few feet upstream of the bypass.</p> <p>Date Taken: 06/03/2019 Program: WPC Unit</p>

1. During the second site visit, a bypass discharge was observed at the facility. Bypasses are not authorized at this facility. If a bypass is observed, the facility shall identify and repair the malfunction in the wastewater treatment system, which is causing the bypass. Report bypasses to the Kansas City Regional Office or Environmental Emergency Response orally or via the online MoGEM system (www.dnr.mo.gov/mogem) within 24 hours from the time of awareness of the bypass per 40 CFR 122.41(m)(3)(i), as required by Special Condition 10 and Standard Conditions Part I of MSOP MO0129836. The 24-hour report should be followed up with a 5-day written submission describing the bypass.
