Staff from the Missouri Department of Natural Resources (Department) conducted an inspection on March 20, 2020 of the Cedar Glen Condominiums water system located on Cedar Glen Drive, Camdenton in Camden County. The entity operates under the authority of Cedar Glen Condominiums, MO3071205.

**Missouri Department of Natural Resources
Central Field Operations
Report of Inspection
Cedar Glen Condominiums
Cedar Glen Drive, Camdenton, Camden County
PWS ID# MO3071205
May 28, 2020**

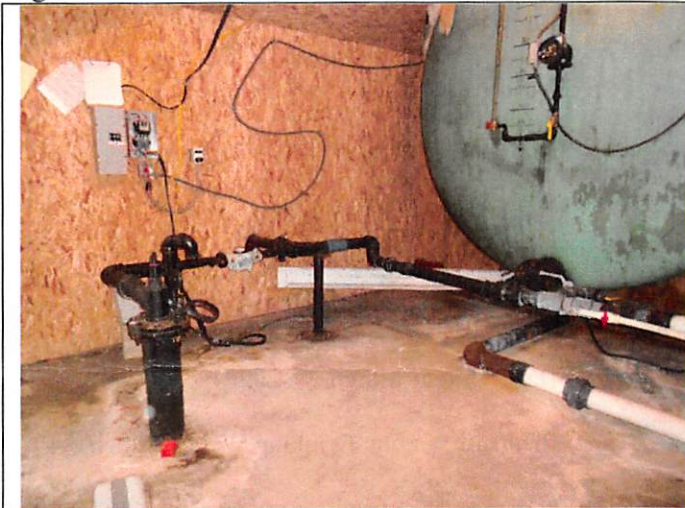
Photograph: # 1
Taken By: Darrell Barber
Entity: Cedar Glen Condominiums
Permit: MO3071205
Location: Inside Well House

I met Jim Heppler at Cedar Glen Condominiums and reviewed the well (Photograph #1), the 35,000-gallon hydropneumatic pressure tank (Photographs #1, #3, & #4), well house piping (Photograph #1 & #2) and overall condition of the well house (Photographs #3 - #6). During the inspection, I also reviewed the water system's records. As part of the inspection, I collected a routine bacteriological drinking water sample from sample point #02. I delivered the sample to the Camden County Health Department courier location to be analyzed by the Missouri State Public Health Lab.

Description: Well, 35,000-gallon pressure tank and related piping.

The well casing and all exposed piping should be protected against deterioration, physical damage, and freezing. Paint the exterior of the well casing and piping to protect it from corrosion.

The Department recommends replacing the plastic piping in the well house.

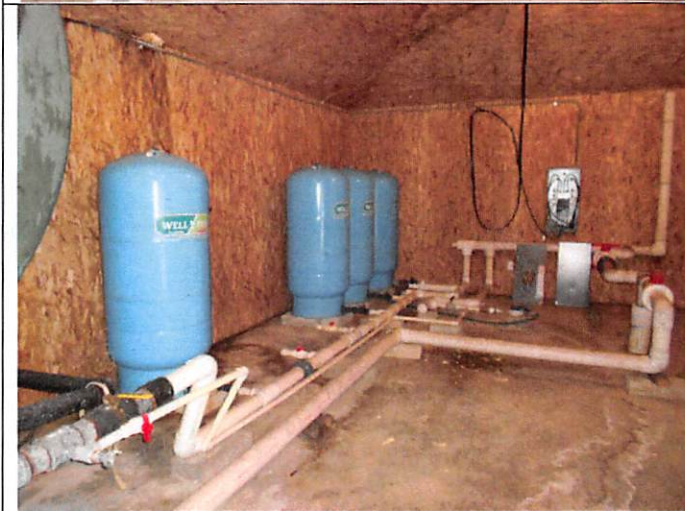
Photograph: # 2
Taken By: Darrell Barber
Entity: Cedar Glen Condominiums
Permit: MO3071205
Location: Inside Well House

- 4. The water system has piping components that do not comply with AWWA standards. Specifically, the piping in the well house includes sections of four-inch solvent-welded plastic pipe and plastic ball valves.**

Description: Well house piping. Bladder tanks are available for emergency use when large pressure tank is out of service for cleaning or repairs.

AWWA standards require all piping larger than two inches to be bolted-flanged mechanical joint, threaded or fusion welded pipe. Plastic piping is more susceptible to failure over time and should be replaced.

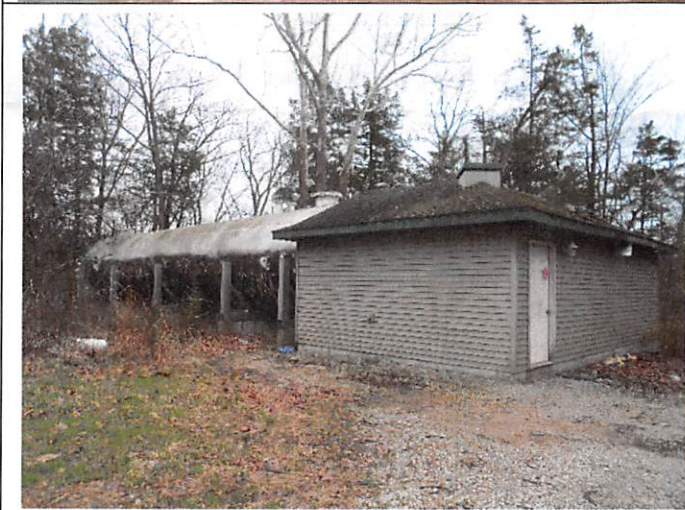
Photograph: # 3
Taken By: Darrell Barber
Entity: Cedar Glen Condominiums
Permit: MO3071205
Location: Outside near Well House

The water system utilizes a single 35,000-gallon hydropneumatic pressure tank to provide storage and maintain system pressure. The use of hydropneumatic storage as the only means of storage is not recommended for systems serving over 50 connections (**Recommendation #5**). The exterior of the 35,000-gallon pressure tank needs to be cleaned and painted (**Recommendation # 6**) and the water system needs to establish a tank cleaning and inspection program (**Recommendation #7**). The area around the well house and pressure tank need to be cleared of all trees and brush (**Recommendation #8**).

Description: Exterior of 35,000-gallon pressure tank and well house.

The Department recommends cleaning and painting the exterior of the 35,000-gallon pressure tank. If the interior has not been inspected in the past three years, the interior should be inspected, cleaned, and repainted with Missouri Department of Natural Resources Public Drinking Water Branch approved paint as necessary.

The Department recommends removing the trees and brush around the well house and pressure tank.

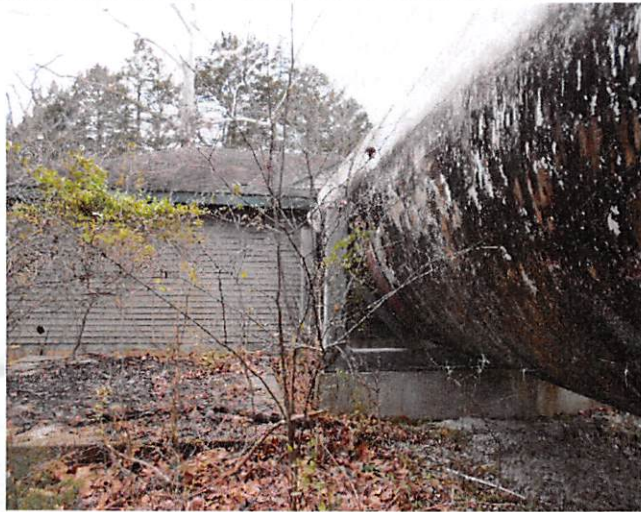
Photograph: # 4
Taken By: Darrell Barber
Entity: Cedar Glen Condominiums
Permit: MO3071205
Location: Outside near Well House

- 5. The use of hydropneumatic storage as the only source of storage is not appropriate for the size of the water system.**

Description: 35,000-gallon hydropneumatic pressure tank and exterior of well house.

Continued use of hydropneumatic storage as the only means of storage is not recommended. There may be other options that are more appropriate for this system. Please consult your engineer to determine a more specific solution to address your storage needs. A construction permit from the Missouri Department of Natural Resources Public Drinking Water Branch must be obtained to construct the additional storage needed for this community public water system. To obtain this construction permit, submit two copies of an engineering report, plans, and specifications each bearing the seal of a professional engineer registered in Missouri along with an application for a construction permit to Missouri Department of Natural Resources, Public Drinking Water Branch, P.O. Box 176, Jefferson City, Missouri 65102, 573-751-5331.

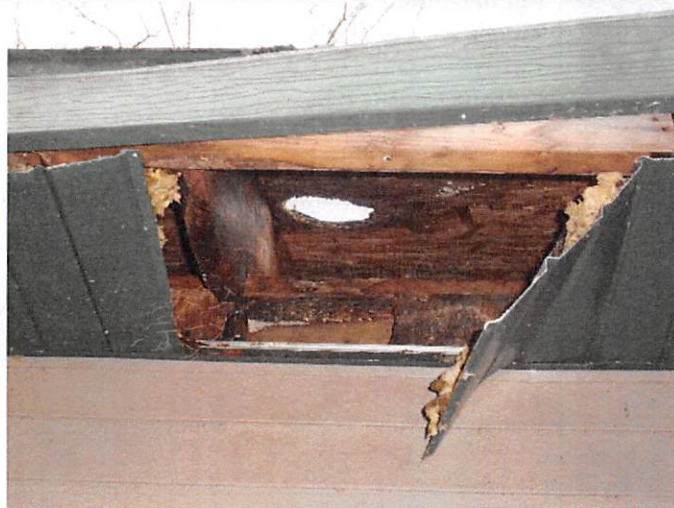
Photograph: # 5
Taken By: Darrell Barber
Entity: Cedar Glen Condominiums
Permit: MO3071205
Location: Outside near Well House

The water system has a valid permit to dispense water that was issued on August 23, 2013. However, the system is not adequately maintaining the public water system. Specifically, the exterior of the well house has significant damage caused by rodents (pack rats) or other large vermin (**Unsatisfactory Finding #1**) (Photographs #5 & #6).

- 1. The public water system failed to properly operate and maintain the system, or is inadequate or of defective design, in violation of Safe Drinking Water Regulation 10 CSR 60-4.080(5). Specifically, there are signs of significant rodent activity in and around the well house, including holes in the well house roof and soffit.**

The well house should be kept free of contaminants, which could be drawn into the water system via the pressure tank recharge air or other openings. If the Department finds that any public water system is improperly operated, inadequate, of defective design or if the water fails to meet standards established in these rules, the water supplier must implement changes required by the Department.

Description: Rodent damage to soffit and roof of well house.

REQUIRED ACTION: Clean out the well house to remove any unnecessary items that are providing harborage for rodents. Also, seal or repair all exterior openings to eliminate rodent activity inside the well house.

REQUIRED ACTIONS for item 1 above: The system shall submit a written statement to the CFO by **June 29, 2020**, explaining what actions have been taken to correct the violations and prevent a reoccurrence in the future.

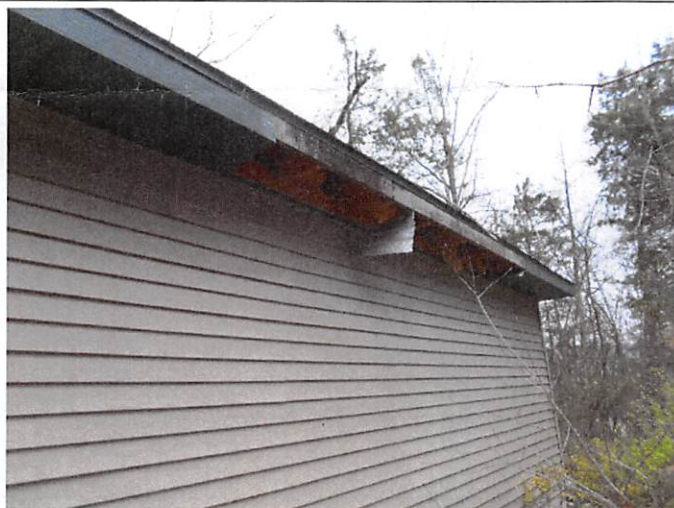
Photograph: # 6
Taken By: Darrell Barber
Entity: Cedar Glen Condominiums
Permit: MO3071205
Location: Outside near Well House

Description: More damage to well house soffit.
