**APPENDIX B**

### NOTICE OF VIOLATION

Attachment #1-Photos 1 through 3

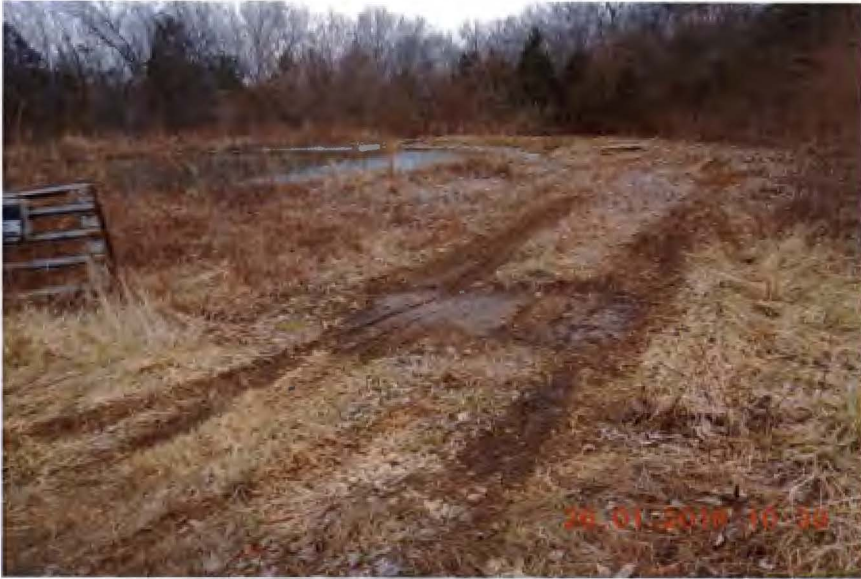
**Photo #:** 001  
**By:** Tim Mattingly  
**Facility:** TDL Utilities  
**Permit:** MO-0057312  
**Location:** St. Francois Co.

**Description:** An overall view of where the brush was removed from around the single cell lagoon system.

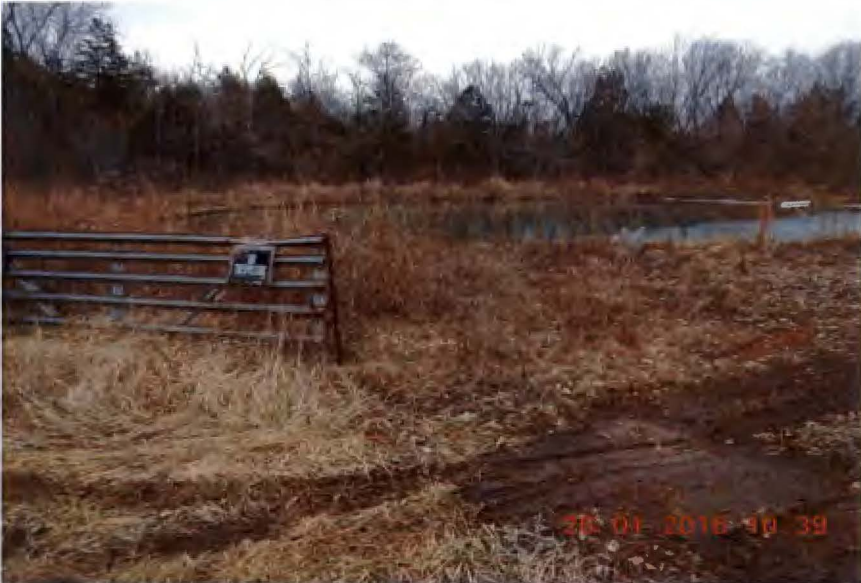
**Photo #:** 002  
**By:** Tim Mattingly  
**Facility:** TDL Utilities  
**Permit:** MO-0057312  
**Location:** St. Francois Co.

**Description:** This is a photo of the single cell lagoon. Approximately half the brush has been removed.

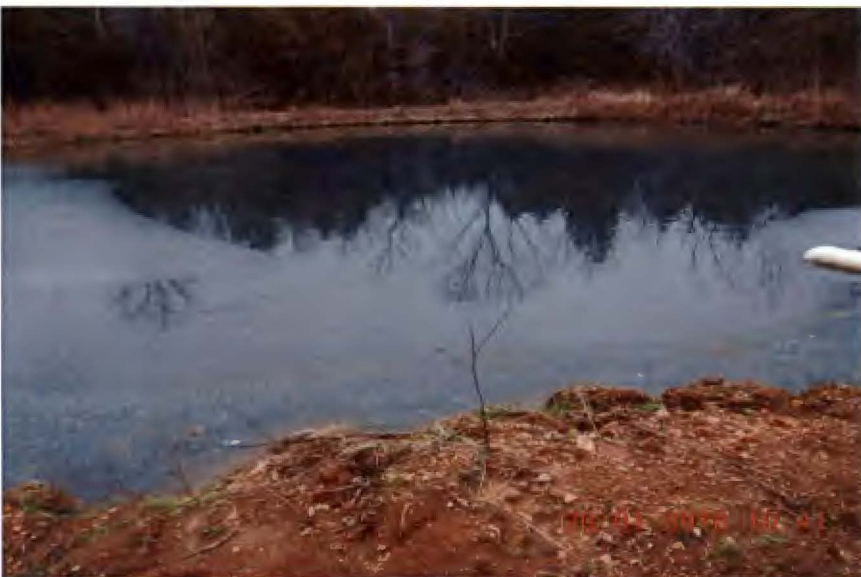
**Photo #:** 003  
**By:** Tim Mattingly  
**Facility:** TDL Utilities  
**Permit:** MO-0057312  
**Location:** St. Francois Co.

**Description:** This is a closer view of the water in the lagoon. To the right you will notice the end of the discharge pipe.

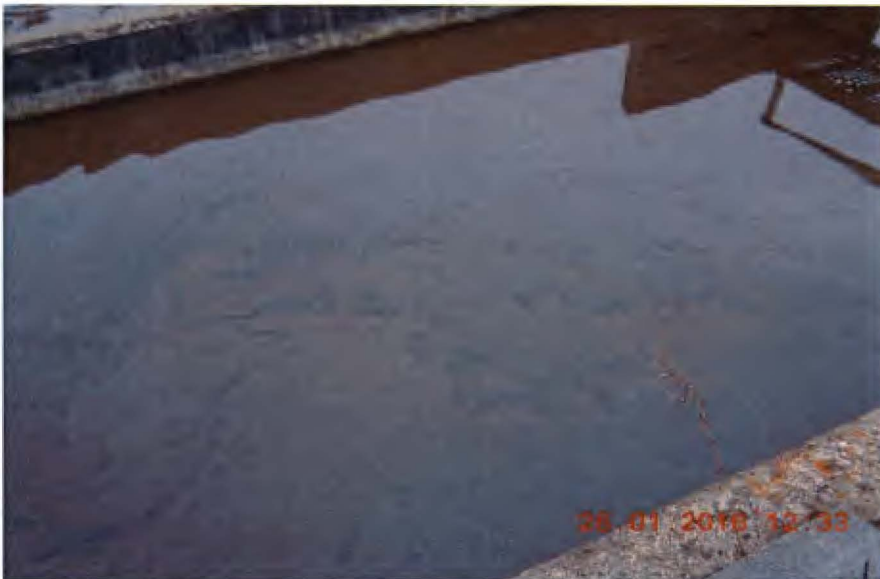
**Photo #:** 002  
**By:** Tim Mattingly  
**Facility:** TDL Ox Ditch  
**Permit:** MO-0095311  
**Location:** St. Francois Co.

**Description:** This picture shows the good color of the mixed liquor and bacterial floc on the date of inspection.

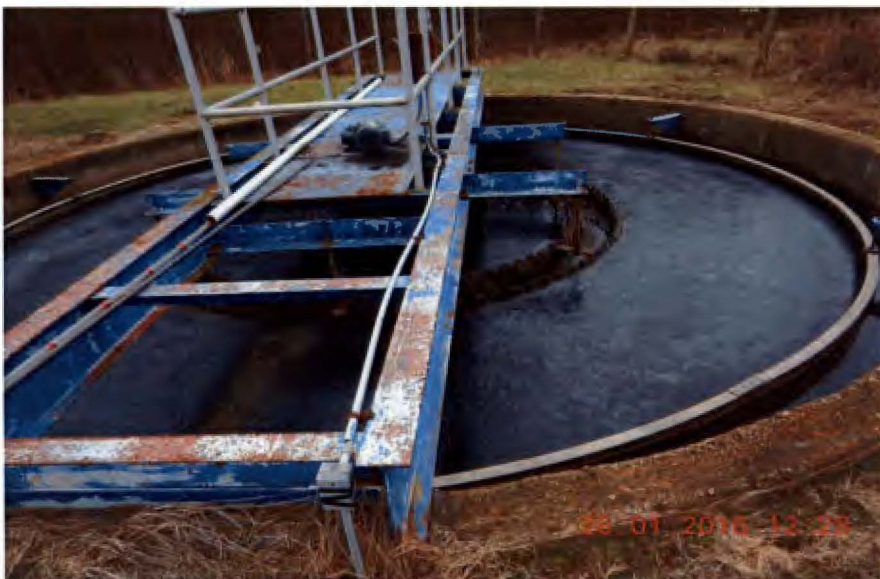
**Photo #:** 003  
**By:** Tim Mattingly  
**Facility:** TDL Ox Ditch  
**Permit:** MO-0095311  
**Location:** St. Francois Co.

**Description:** A photo of the single clarifier at the end of the oxidation ditch. The weir needed cleaning but due to the ice, this was not possible.

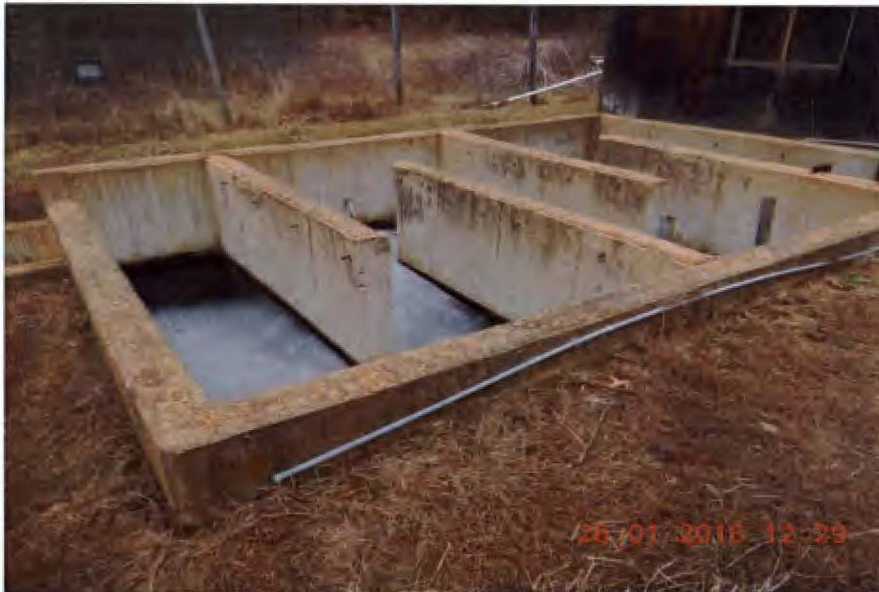
**Photo #:** 004  
**By:** Tim Mattingly  
**Facility:** TDL Ox Ditch  
**Permit:** MO-0095311  
**Location:** St. Francois Co.

**Description:** The serpentine tablet chlorination system. Again, note the ice in the chlorination detention system.

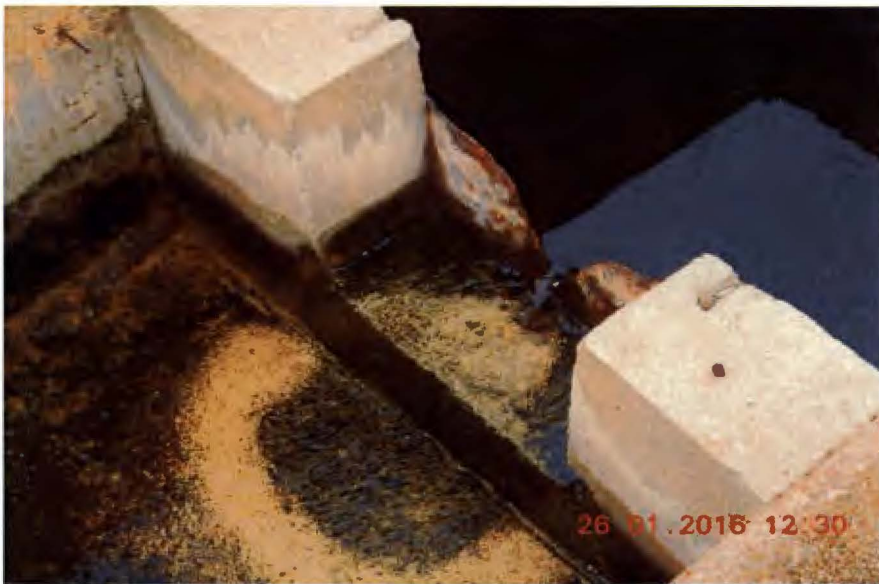
**Photo #:** 005  
**By:** Tim Mattingly  
**Facility:** TDL Ox Ditch  
**Permit:** MO-0095311  
**Location:** St. Francois Co.

**Description:** This is the V-notch weir and discharge structure at the end of the serpentine chlorination detention basin.

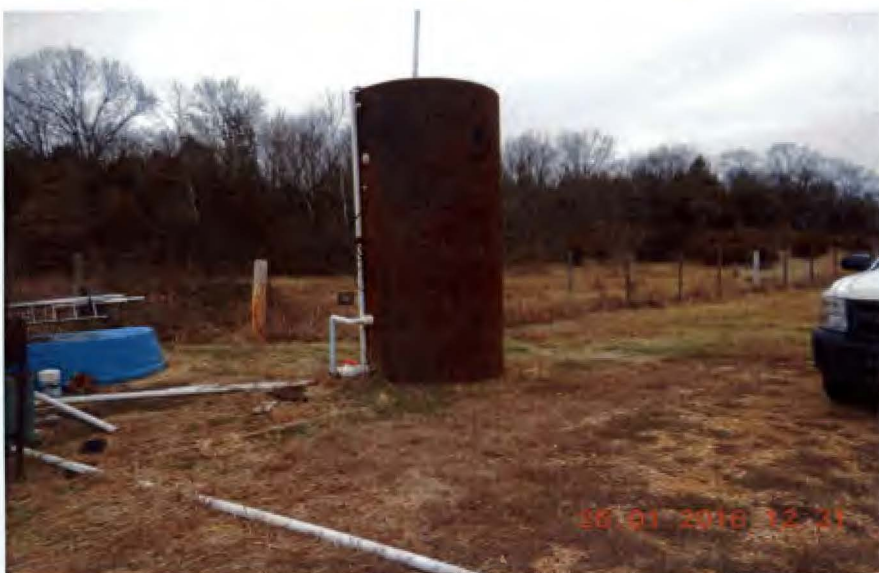
**Photo #:** 006  
**By:** Tim Mattingly  
**Facility:** TDL Ox Ditch  
**Permit:** MO-0095311  
**Location:** St. Francois Co.

**Description:** This photo is an old sludge holding tank that was put in without Department approval and is no longer in use. It is slated to be removed.

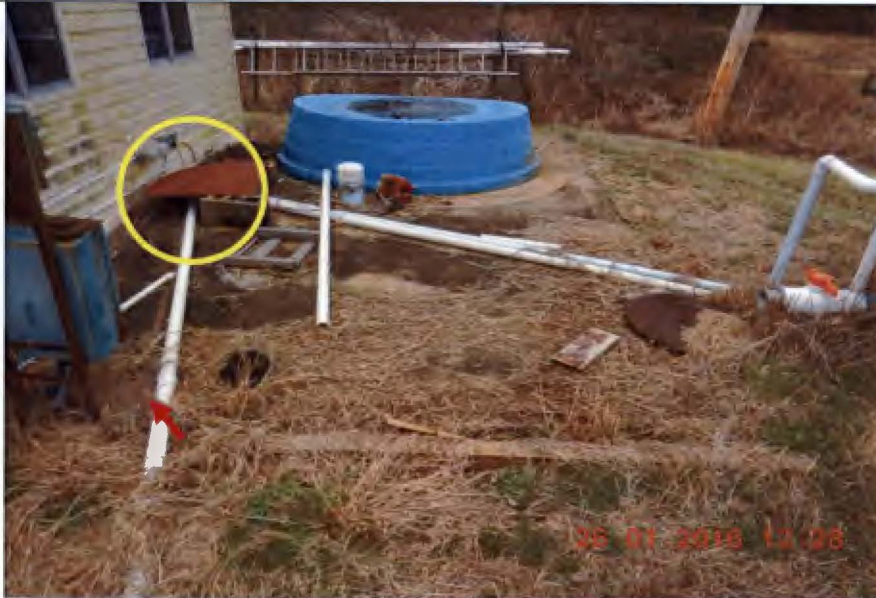
**Photo #:** 007  
**By:** Tim Mattingly  
**Facility:** TDL Ox Ditch  
**Permit:** MO-0095311  
**Location:** St. Francois Co.

**Description:** This is a photo of the sludge storage area. The lid is under the metal plate in the yellow circle. The sludge return line is the pipe with the red arrow pointing at it.

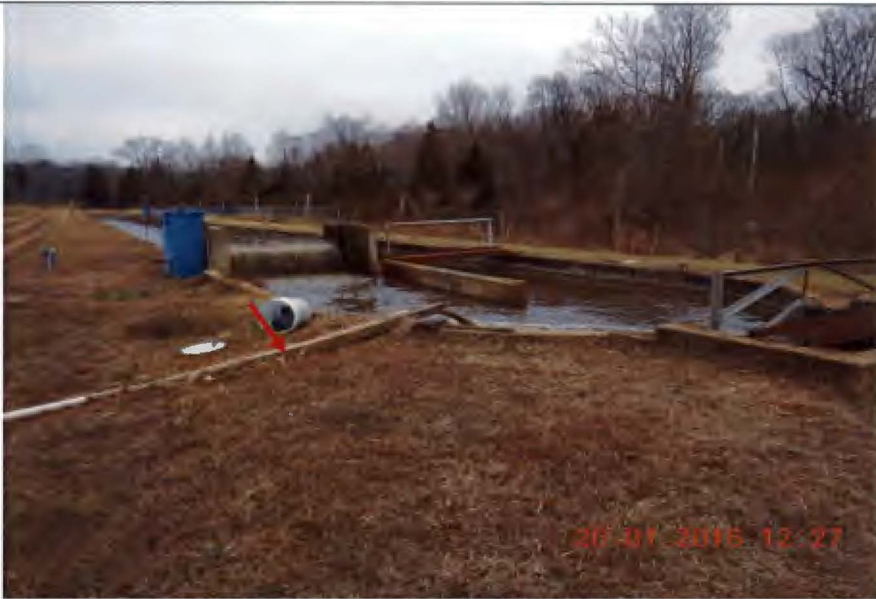
**Photo #:** 008  
**By:** Tim Mattingly  
**Facility:** TDL Ox Ditch  
**Permit:** MO-0095311  
**Location:** St. Francois Co.

**Description:** A view of the oxidation ditch with the sludge return line (red arrow) in the foreground.

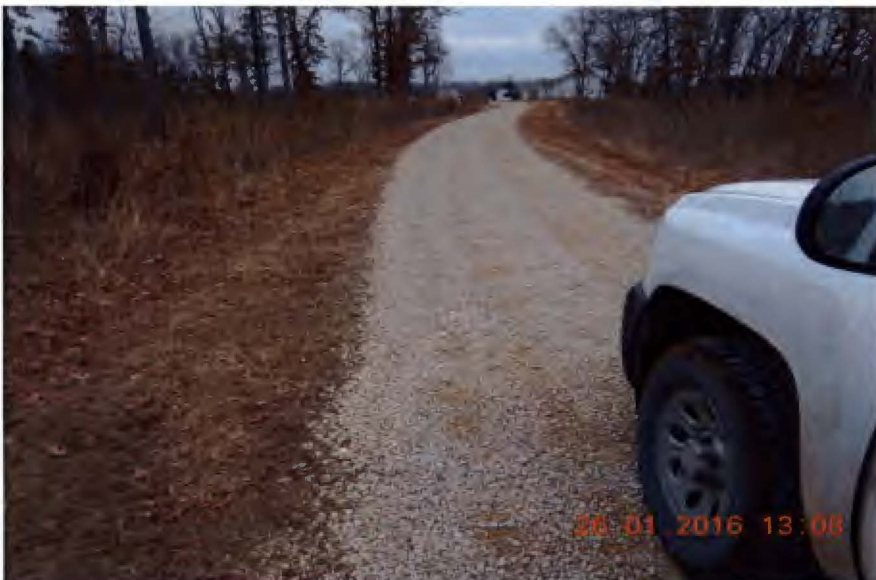
**Photo #:** 009  
**By:** Tim Mattingly  
**Facility:** TDL Ox Ditch  
**Permit:** MO-0095311  
**Location:** St. Francois Co.

No generator had been purchased for emergency electrical generation. The gate was not repaired on the day of inspection, however parts for the repair had been ordered. The service road leading into the oxidation ditch had had rock haul on it and it had been graded.

**Description:** A picture of the newly rocked and graded entrance road into the ox ditch.

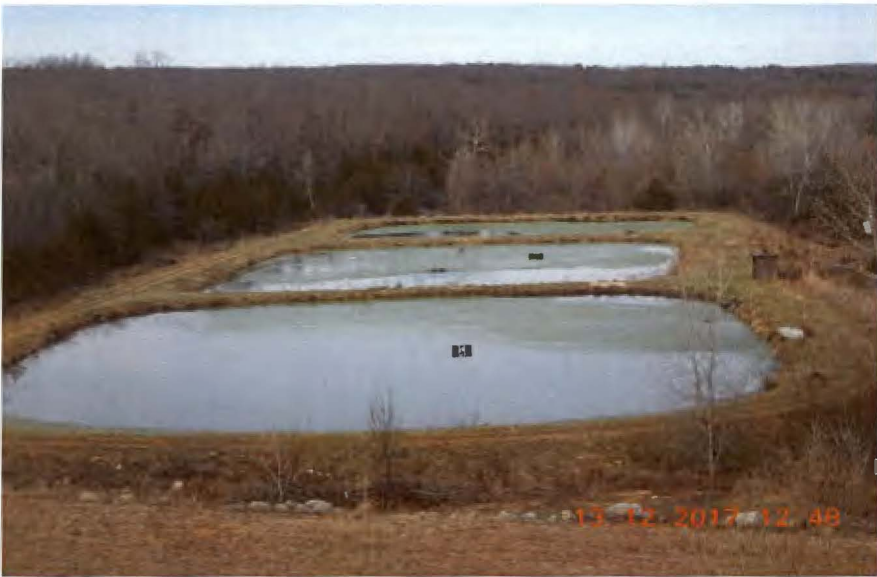
**Photo #:** 002  
**By:** Tim Mattingly  
**Facility:** TDL North  
**Permit:** MO-0035700  
**Location:** St. Francois County

**Description:** This is the TDL North three-cell lagoon on the day of inspection.

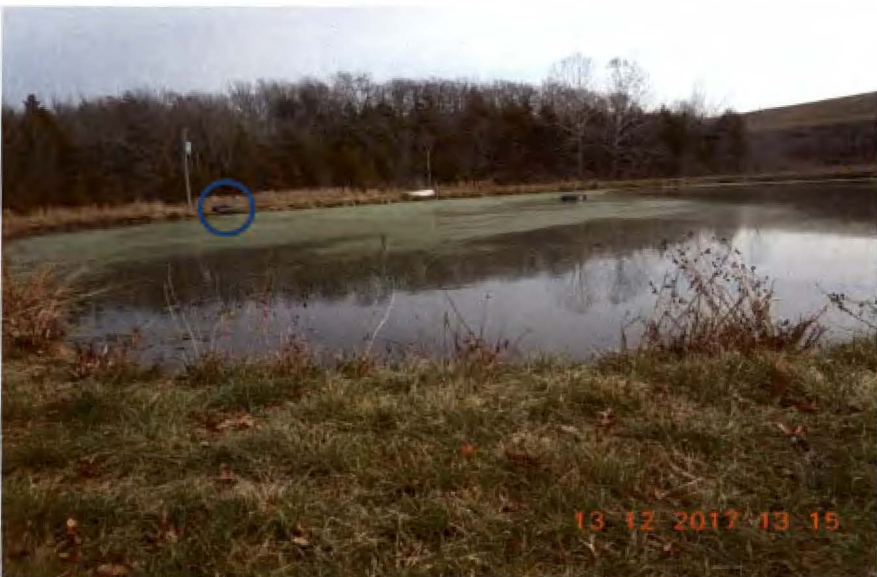
**Photo #:** 003  
**By:** Tim Mattingly  
**Facility:** TDL North  
**Permit:** MO-0035700  
**Location:** St. Francois County

**Description:** A photo of the primary cell of the TDL North lagoon. The aerator in the blue circle will be getting a new electric motor.

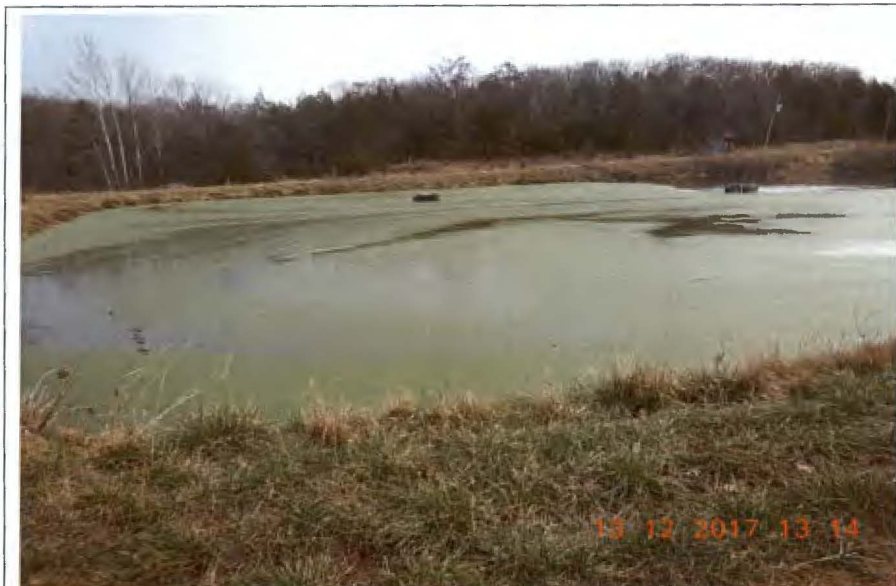
**Photo #:** 004  
**By:** Tim Mattingly  
**Facility:** TDL North  
**Permit:** MO-0035700  
**Location:** St. Francois County

**Description:** A view of the secondary cell of the TDL North lagoon. One aerator (on the right) is running but both are operable.

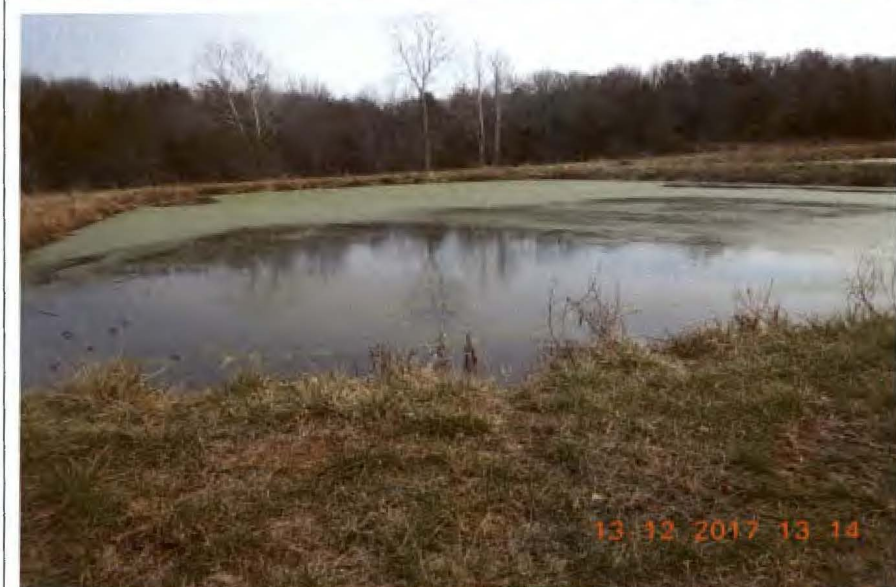
**Photo #:** 005  
**By:** Tim Mattingly  
**Facility:** TDL North  
**Permit:** MO-0035700  
**Location:** St. Francois County

**Description:** A picture of the third cell of the TDL North lagoon system.

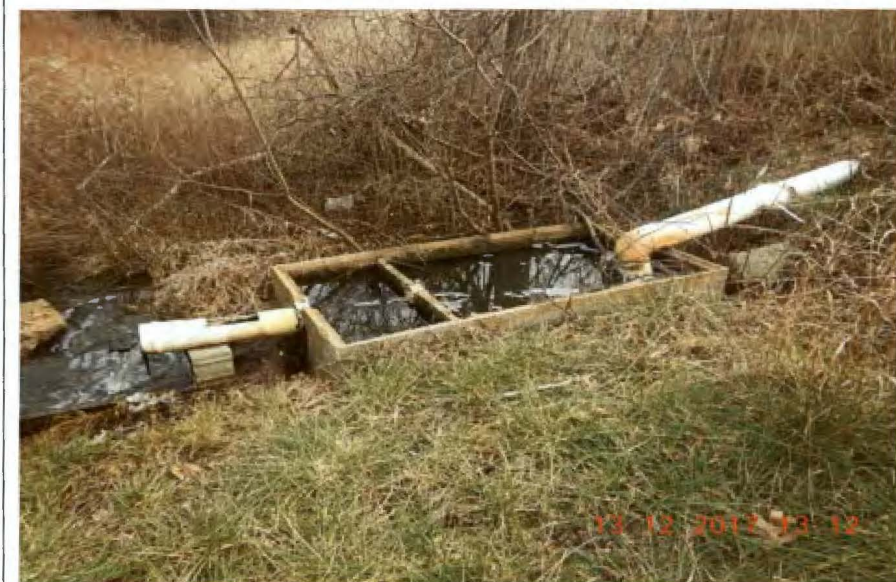
**Photo #:** 006  
**By:** Tim Mattingly  
**Facility:** TDL North  
**Permit:** MO-0035700  
**Location:** St. Francois County

**Description:** This is a picture of the discharge structure at TDL North.

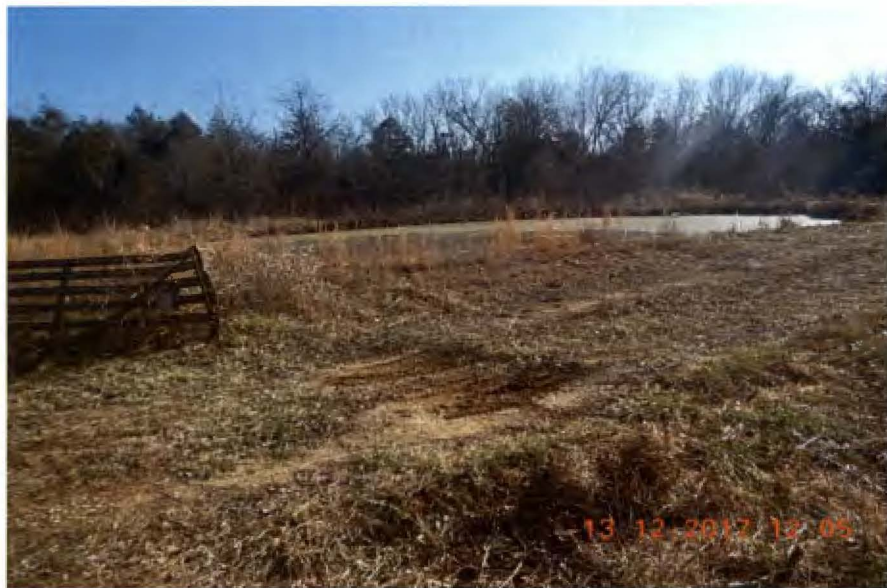
**Photo #:** 002  
**By:** Tim Mattingly  
**Facility:** TDL South  
**Permit:** MO-005312  
**Location:** St. Francois County

**Description:** A photo looking almost due east. You can see the old gate to the right but there is no other fencing left on the perimeter. Very tall vegetation is on the berms.

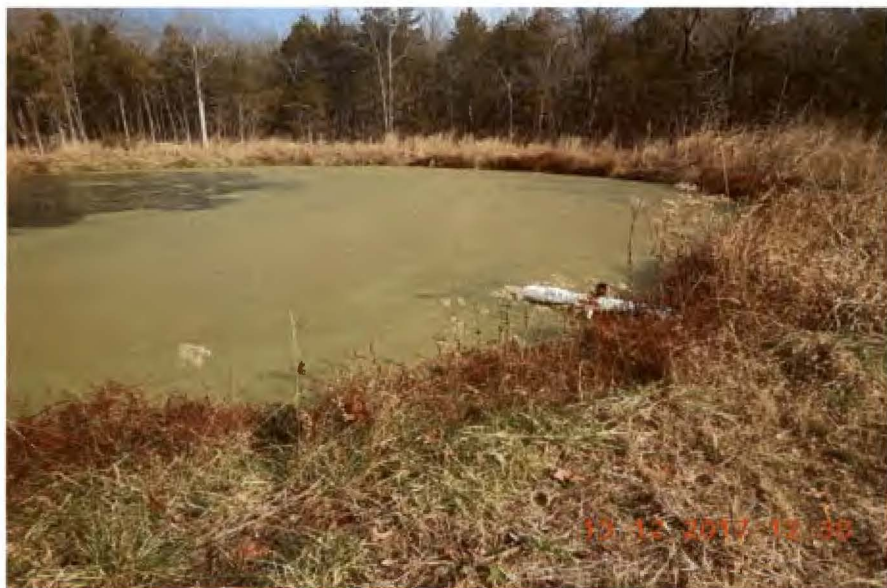
**Photo #:** 003  
**By:** Tim Mattingly  
**Facility:** TDL South  
**Permit:** MO-0057312  
**Location:** St. Francois County

**Description:** A picture of the east side of the lagoon. Note the heavy covering of duck weed.

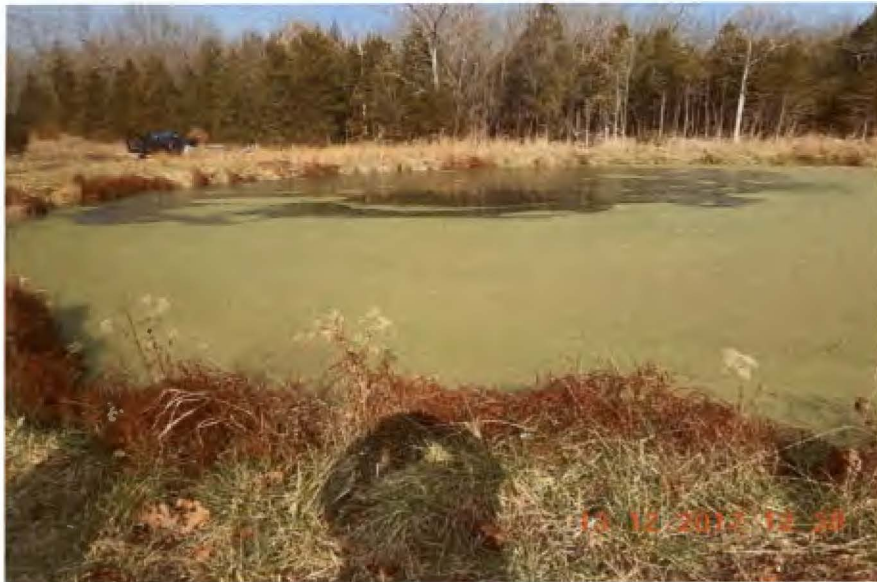
**Photo #:** 004  
**By:** Tim Mattingly  
**Facility:** TDL South  
**Permit:** MO-0057312  
**Location:** St. Francois County

**Description:** A photo of the west side of the lagoon. Some of the duck weed has been killed by the recently cold temperatures.

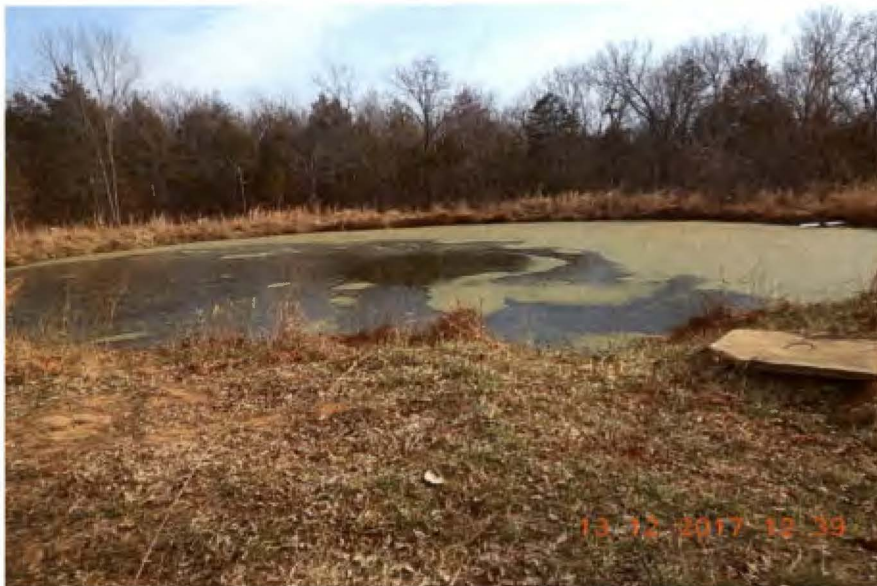
**Photo #:** 005  
**By:** Tim Mattingly  
**Facility:** TDL South  
**Permit:** MO-0057312  
**Location:** St. Francois County

**Description:** An overall view of the south lagoon at Terre du Lac.

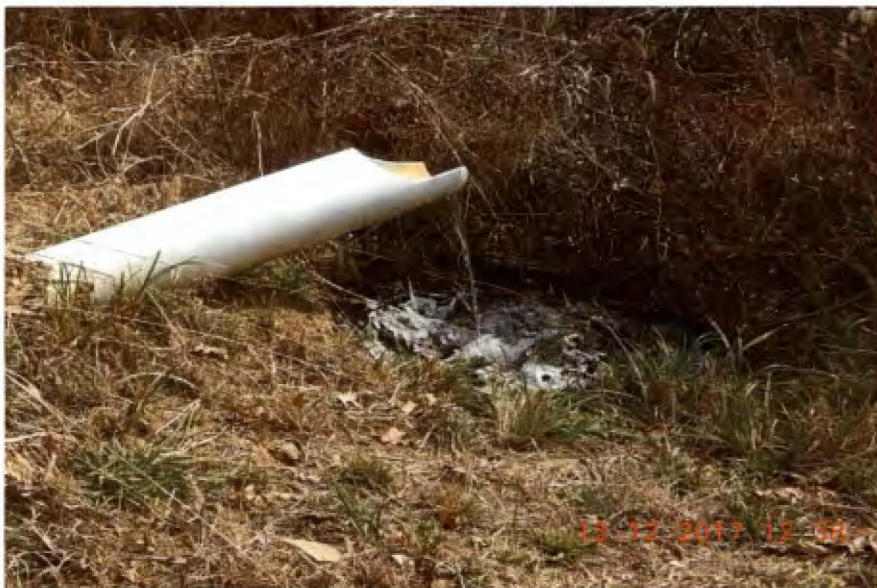
**Photo #:** 006  
**By:** Tim Mattingly  
**Facility:** TDL South  
**Permit:** MO-0057312  
**Location:** St. Francois County

**Description:** A photo of the discharge pipe at TDL South. Some of what you see on the ground is ice. The water splashing on a rock had frozen.

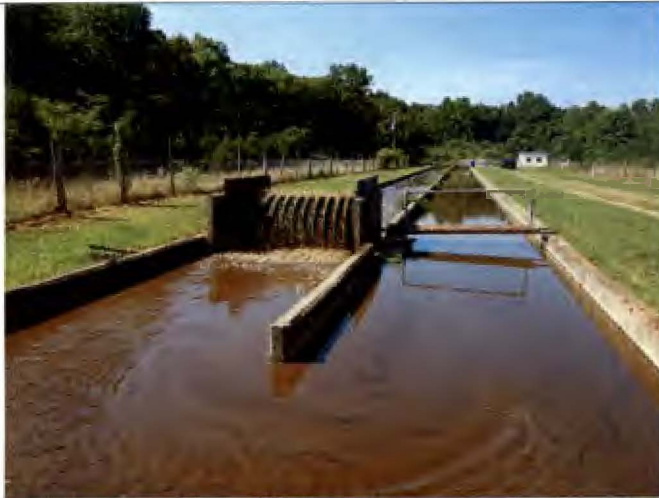
**Photograph #: 001**  
**Taken by:** Wesley Hargraves  
**Entity:** Terre Du Lac Oxidation Ditch  
**Permit:** MO0095311  
**Location:** St. Francois County  
**Description:** View of oxidation ditch and northern rotor. Taken facing south.  
**Date Taken:** July 10, 2019  
**Program:** WPC Unit

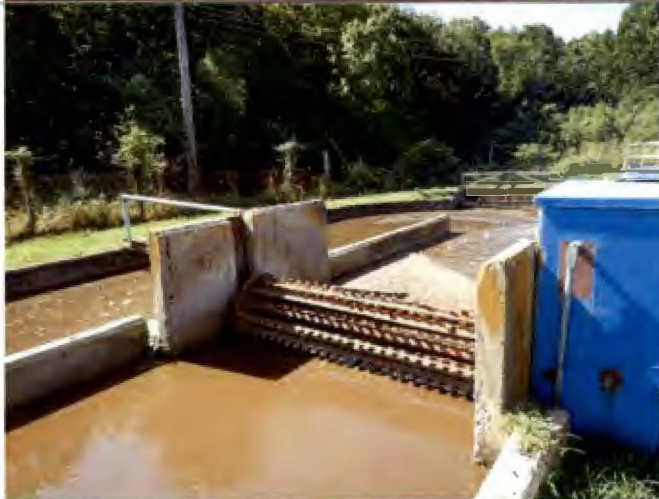
**Photograph #: 002**  
**Taken by:** Wesley Hargraves  
**Entity:** Terre Du Lac Oxidation Ditch  
**Permit:** MO0095311  
**Location:** St. Francois County  
**Description:** View of southern rotor. This rotor was not operable at the time of the inspection. Taken facing south.  
**Date Taken:** July 10, 2019  
**Program:** WPC Unit

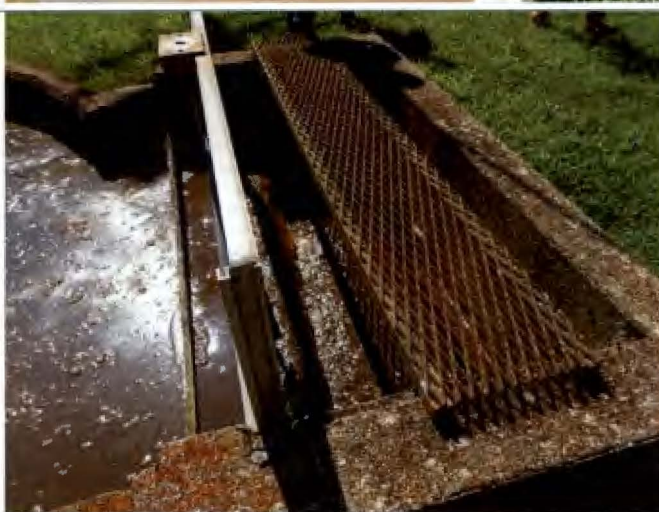
**Photograph #: 003**  
**Taken by:** Wesley Hargraves  
**Entity:** Terre Du Lac Oxidation Ditch  
**Permit:** MO0095311  
**Location:** St. Francois County  
**Description:** View of outlet box to clarifier. Taken facing southeast.  
**Date Taken:** July 10, 2019  
**Program:** WPC Unit

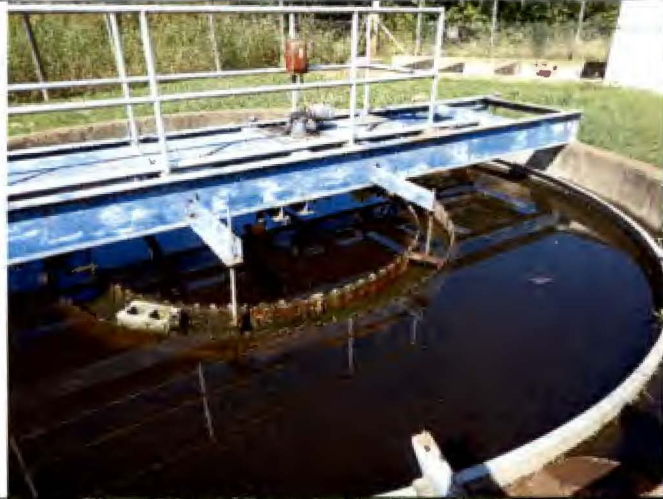
**Photograph #: 004**  
**Taken by:** Wesley Hargraves  
**Entity:** Terre Du Lac Oxidation Ditch  
**Permit:** MO0095311  
**Location:** St. Francois County

**Description:** View of clarifier. Heavy algae growth was observed. Taken facing southwest.

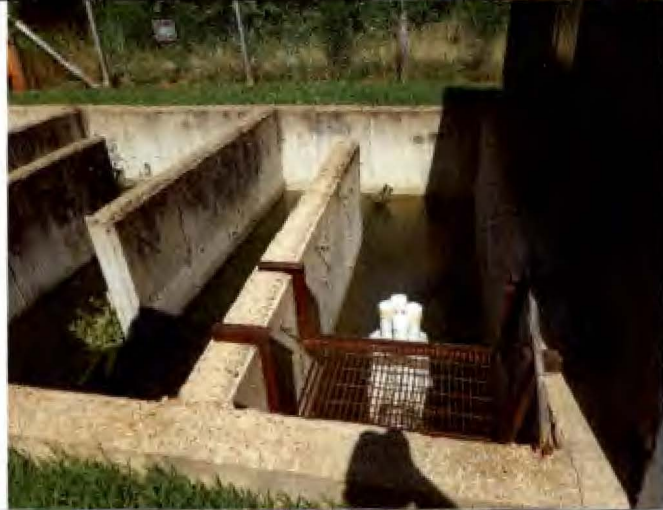
**Photograph #: 005**  
**Taken by:** Wesley Hargraves  
**Entity:** Terre Du Lac Oxidation Ditch  
**Permit:** MO0095311  
**Location:** St. Francois County

**Description:** View of tablet chlorination setup. Taken facing west.

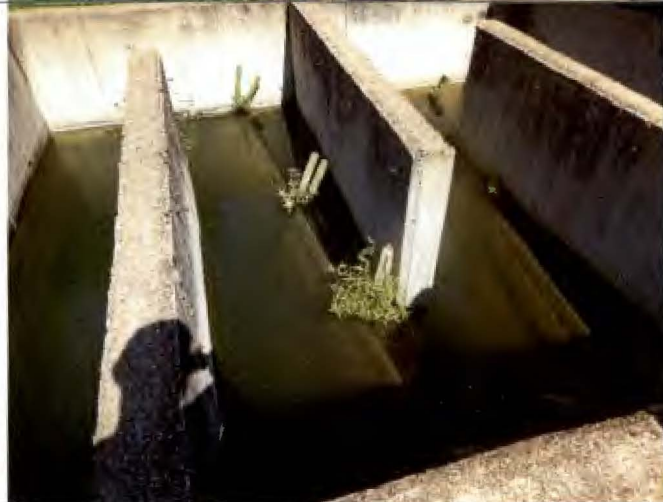
**Photograph #: 006**  
**Taken by:** Wesley Hargraves  
**Entity:** Terre Du Lac Oxidation Ditch  
**Permit:** MO0095311  
**Location:** St. Francois County

**Description:** View of middle section of chlorine contact basin. Deteriorated wooden structures were present in the contact basin. Taken facing west.

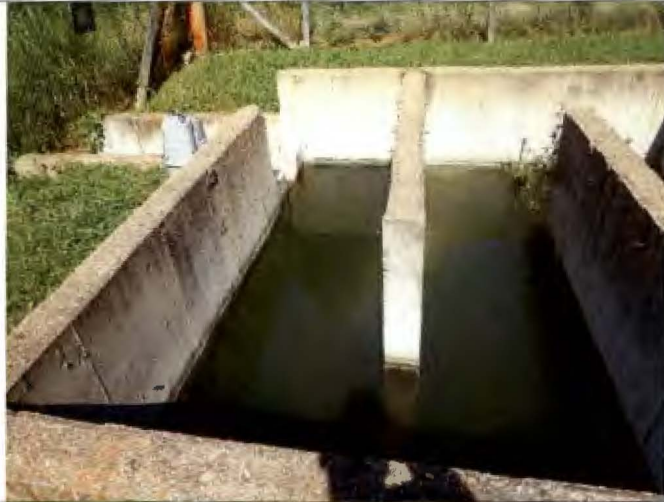
**Photograph #: 007**  
**Taken by:** Wesley Hargraves  
**Entity:** Terre Du Lac Oxidation Ditch  
**Permit:** MO0095311  
**Location:** St. Francois County

**Description:** View of end section of contact basin. Taken facing west.

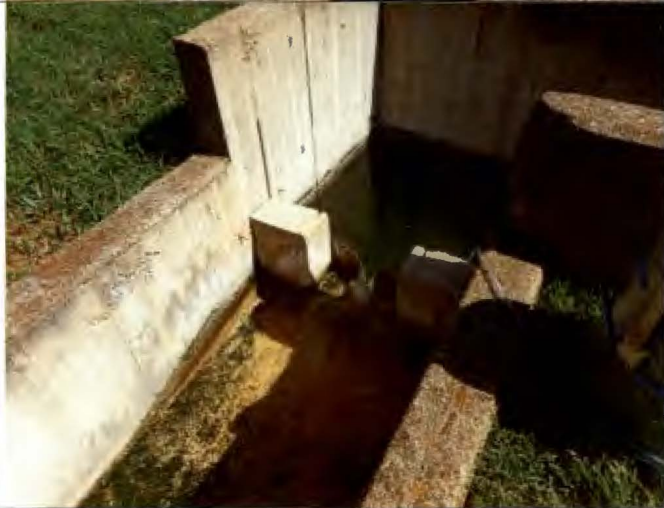
**Photograph #: 008**  
**Taken by:** Wesley Hargraves  
**Entity:** Terre Du Lac Oxidation Ditch  
**Permit:** MO0095311  
**Location:** St. Francois County

**Description:** View of effluent v-notch weir. Taken facing northwest.

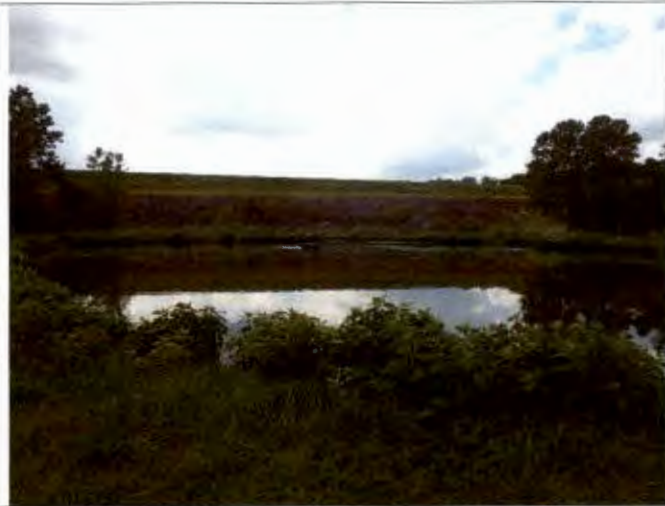
**Photograph #: 001**  
**Taken by:** Wesley Hargraves  
**Entity:** Terre Du Lac North - Three Cell Lagoon  
**Permit:** MO0035700  
**Location:** St. Francois County  
**Description:** View of primary cell. Taken facing south.  
**Date Taken:** July 10, 2019  
**Program:** WPC Unit

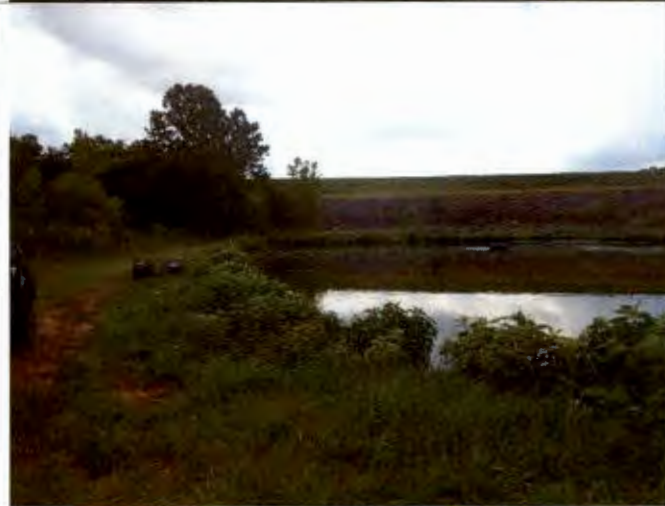
**Photograph #: 002**  
**Taken by:** Wesley Hargraves  
**Entity:** Terre Du Lac North - Three Cell Lagoon  
**Permit:** MO0035700  
**Location:** St. Francois County  
**Description:** View of primary cell and broken aerator. Taken facing southeast.  
**Date Taken:** July 10, 2019  
**Program:** WPC Unit

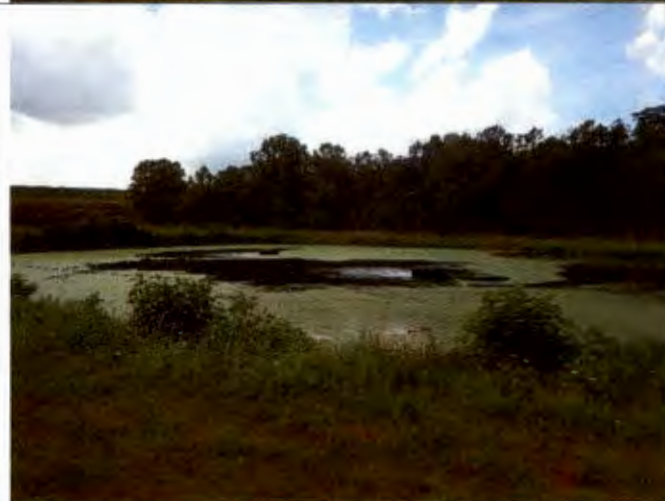
**Photograph #: 003**  
**Taken by:** Wesley Hargraves  
**Entity:** Terre Du Lac North - Three Cell Lagoon  
**Permit:** MO0035700  
**Location:** St. Francois County  
**Description:** View of secondary cell. Taken facing southwest.  
**Date Taken:** July 10, 2019  
**Program:** WPC Unit

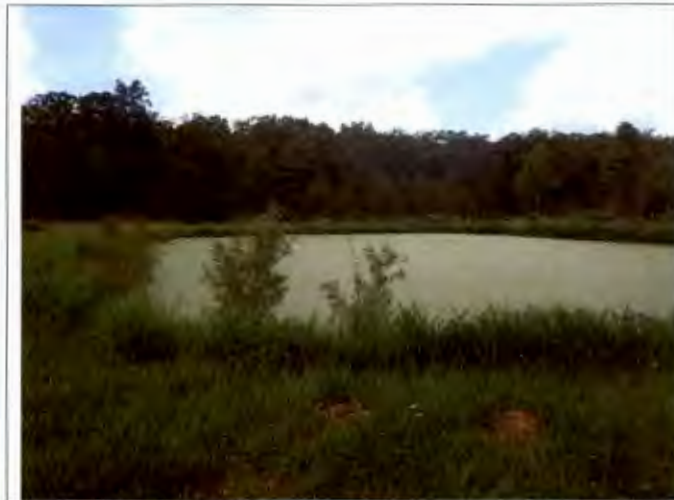
**Photograph #: 004**  
**Taken by:** Wesley Hargraves  
**Entity:** Terre Du Lac North - Three Cell Lagoon  
**Permit:** MO0035700  
**Location:** St. Francois County  
**Description:** View of third cell. Taken facing west.  
**Date Taken:** July 10, 2019  
**Program:** WPC Unit

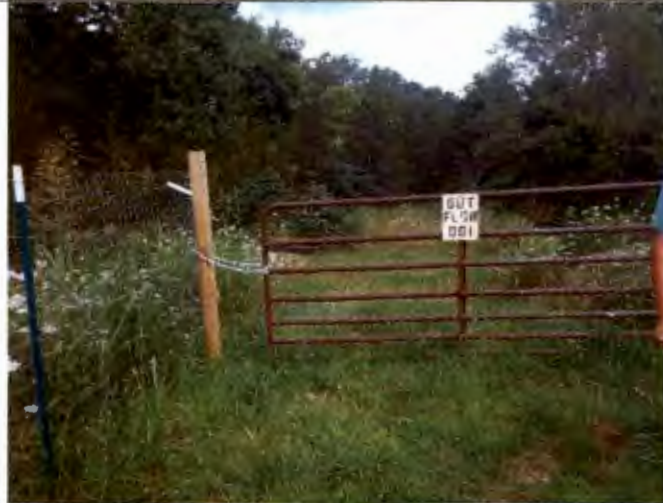
**Photograph #: 005**  
**Taken by:** Wesley Hargraves  
**Entity:** Terre Du Lac North - Three Cell Lagoon  
**Permit:** MO0035700  
**Location:** St. Francois County  
**Description:** View of gate to Outfall. Taken facing north.  
**Date Taken:** July 10, 2019  
**Program:** WPC Unit

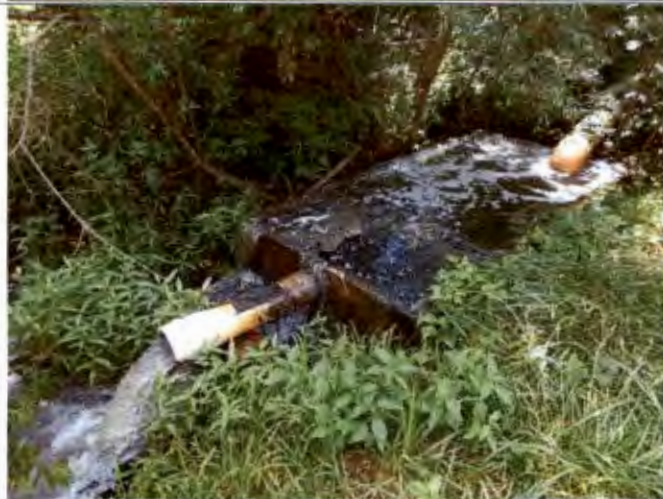
**Photograph #: 006**  
**Taken by:** Wesley Hargraves  
**Entity:** Terre Du Lac North - Three Cell Lagoon  
**Permit:** MO0035700  
**Location:** St. Francois County  
**Description:** View of Outfall #001. Taken facing southeast.  
**Date Taken:** July 10, 2019  
**Program:** WPC Unit

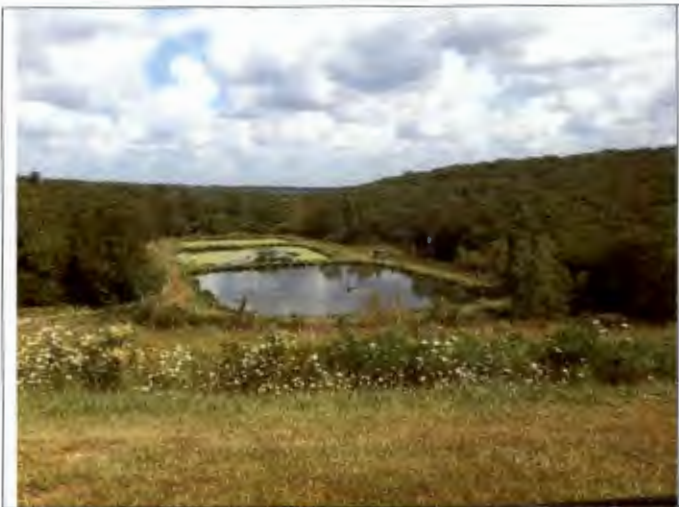
<p><b>Photograph #:</b> 007 <b>Taken by:</b> Wesley Hargraves <b>Entity:</b> Terre Du Lac North - Three Cell Lagoon <b>Permit:</b> MO0035700 <b>Location:</b> St. Francois County</p> <p><b>Description:</b> View of facility from Lac Carmel dam. Taken facing north.</p> <p><b>Date Taken:</b> July 10, 2019 <b>Program:</b> WPC Unit</p>

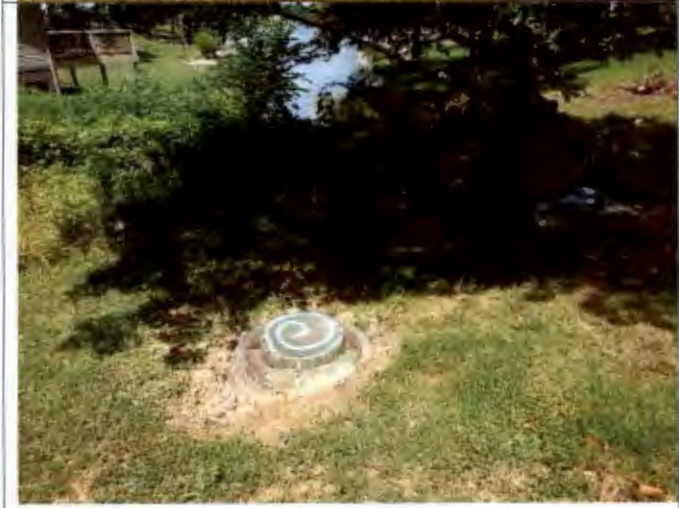
<p><b>Photograph #:</b> 008 <b>Taken by:</b> Wesley Hargraves <b>Entity:</b> Terre Du Lac North - Three Cell Lagoon <b>Permit:</b> MO0035700 <b>Location:</b> St. Francois County</p> <p><b>Description:</b> View of manhole suspected of experiencing an SSO from a similar angle as the photo supplied to the Department. Taken facing northwest.</p> <p><b>Date Taken:</b> July 11, 2019 <b>Program:</b> WPC Unit</p>

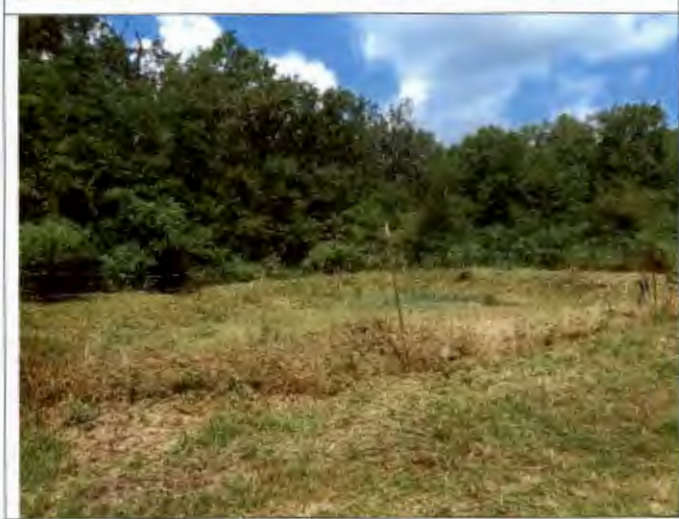
<p><b>Photograph #:</b> 009 <b>Taken by:</b> Wesley Hargraves <b>Entity:</b> Terre Du Lac North - Three Cell Lagoon <b>Permit:</b> MO0035700 <b>Location:</b> St. Francois County</p> <p><b>Description:</b> View of holding basin for first lift station.</p> <p><b>Date Taken:</b> July 10, 2019 <b>Program:</b> WPC Unit</p>

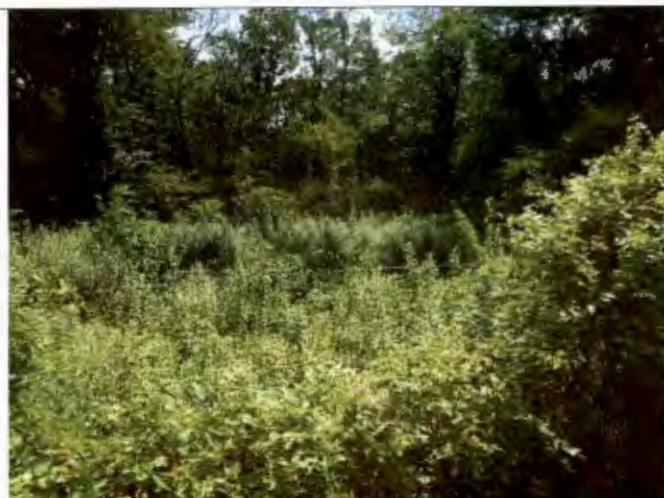
**Photograph #:** 010  
**Taken by:** Wesley Hargraves  
**Entity:** Terre Du Lac North - Three Cell Lagoon  
**Permit:** MO0035700  
**Location:** St. Francois County

**Description:** View of holding basin for the second observed lift station.

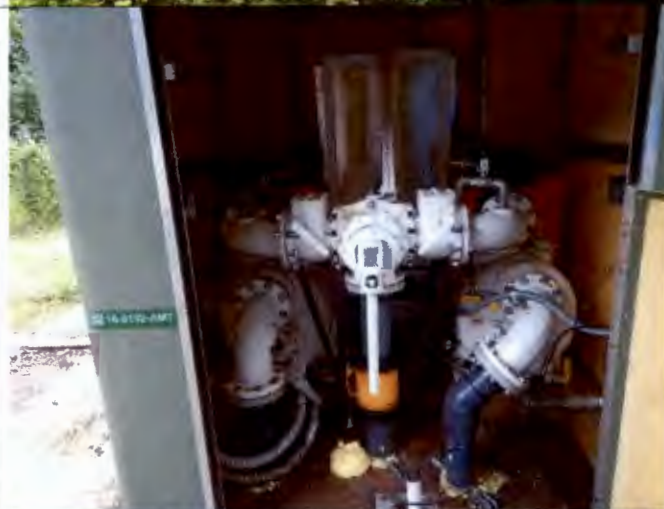
**Photograph #:** 011  
**Taken by:** Wesley Hargraves  
**Entity:** Terre Du Lac North - Three Cell Lagoon  
**Permit:** MO0035700  
**Location:** St. Francois County

**Description:** View of second lift station.

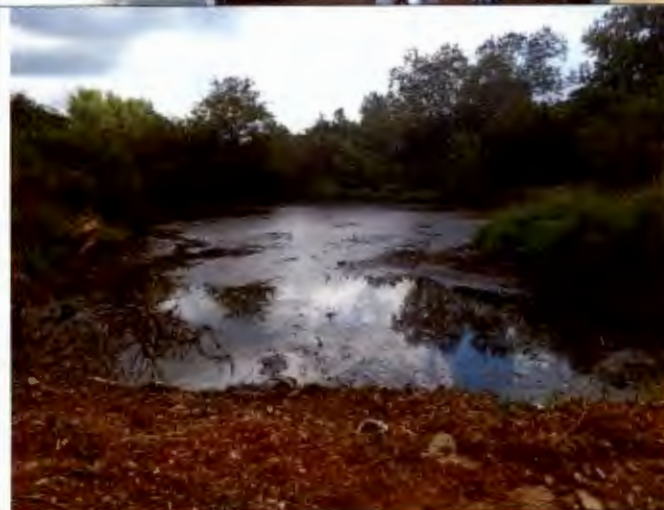
**Photograph #:** 012  
**Taken by:** Wesley Hargraves  
**Entity:** Terre Du Lac North - Three Cell Lagoon  
**Permit:** MO0035700  
**Location:** St. Francois County

**Description:** View of holding basin associated with the third lift station. Taken facing northeast.

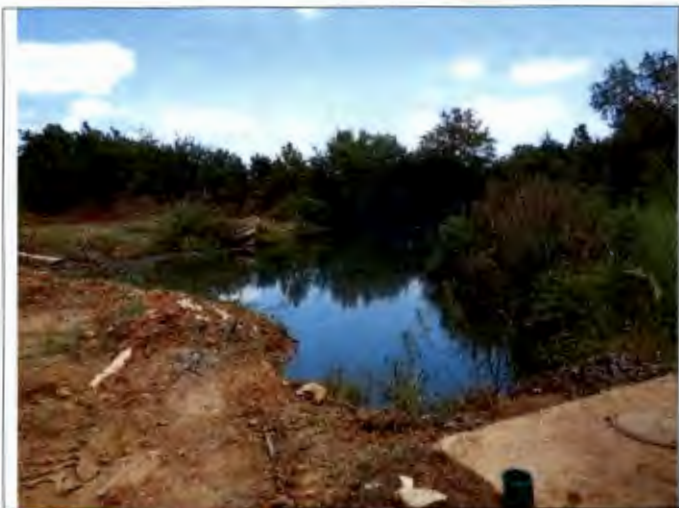
**Photograph #: 013**  
**Taken by:** Wesley Hargraves  
**Entity:** Terre Du Lac North - Three Cell Lagoon  
**Permit:** MO0035700  
**Location:** St. Francois County  
**Description:** View of holding basin associated with the third lift station. Taken facing northeast.  
**Date Taken:** July 23, 2019  
**Program:** WPC Unit

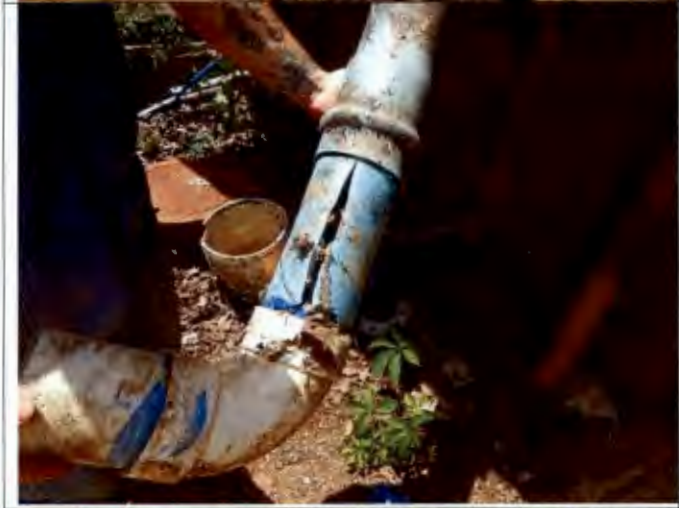
**Photograph #: 014**  
**Taken by:** Wesley Hargraves  
**Entity:** Terre Du Lac North - Three Cell Lagoon  
**Permit:** MO0035700  
**Location:** St. Francois County  
**Description:** View of damaged pipe. The cause of the overflow.  
**Date Taken:** July 23, 2019  
**Program:** WPC Unit

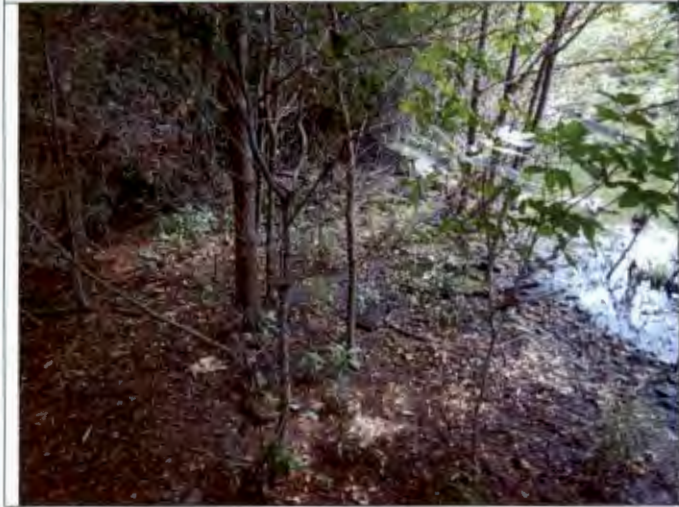
**Photograph #: 015**  
**Taken by:** Wesley Hargraves  
**Entity:** Terre Du Lac North - Three Cell Lagoon  
**Permit:** MO0035700  
**Location:** St. Francois County  
**Description:** View of the berm between the holding basin and the 2<sup>nd</sup> cell of the old lagoon. Water levels had lowered by the time the Department arrived on site. Taken facing east.  
**Date Taken:** July 23, 2019  
**Program:** WPC Unit

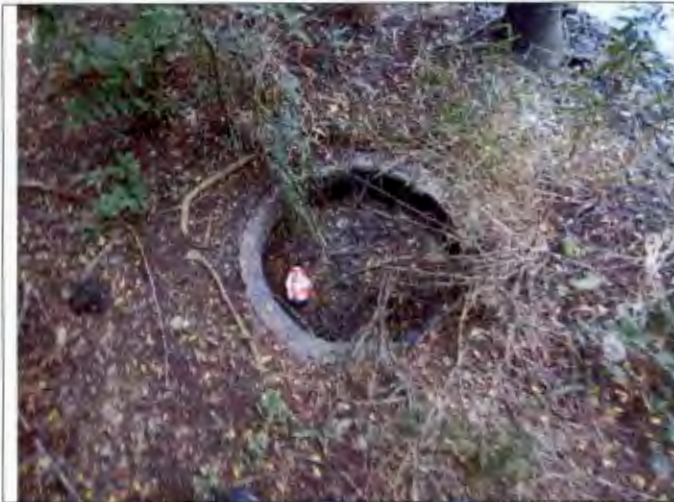
**Photograph #: 016**  
**Taken by:** Wesley Hargraves  
**Entity:** Terre Du Lac North - Three Cell Lagoon  
**Permit:** MO0035700  
**Location:** St. Francois County  
**Description:** View of manhole between 1<sup>st</sup> and 2<sup>nd</sup> cells of the old lagoon.  
**Date Taken:** July 23, 2019  
**Program:** WPC Unit

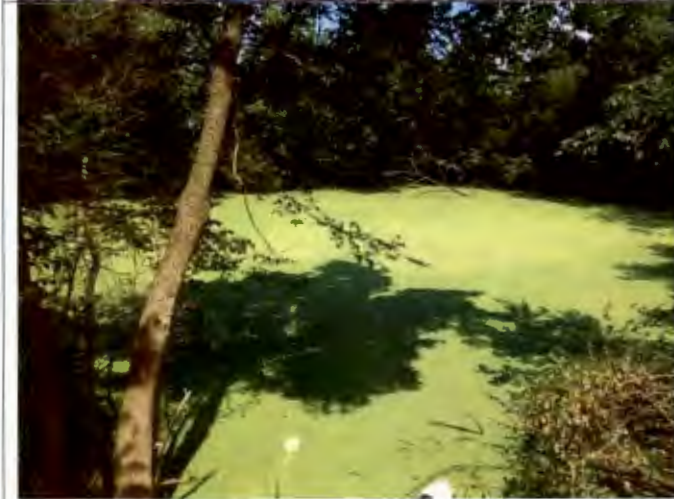
**Photograph #: 017**  
**Taken by:** Wesley Hargraves  
**Entity:** Terre Du Lac North - Three Cell Lagoon  
**Permit:** MO0035700  
**Location:** St. Francois County  
**Description:** View of second cell of the old lagoon. Taken facing northeast.  
**Date Taken:** July 23, 2019  
**Program:** WPC Unit
