**APPENDIX B**

### NOTICE OF VIOLATION

Attachment #1-Photos 1 through 3

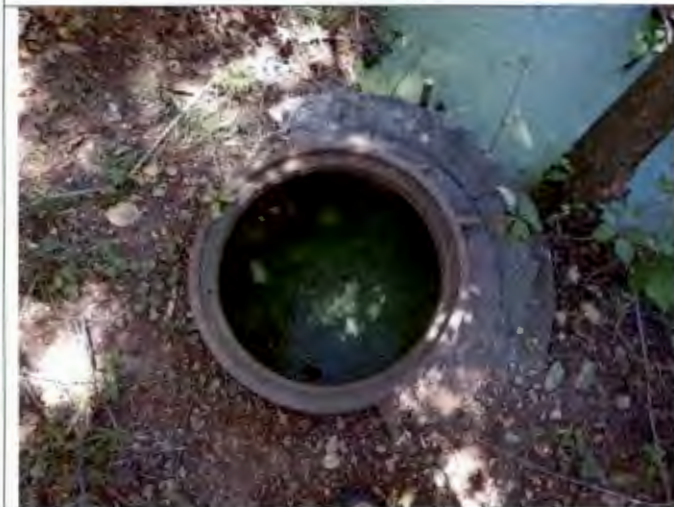
**Photograph #: 018**  
**Taken by:** Wesley Hargraves  
**Entity:** Terre Du Lac North - Three Cell Lagoon  
**Permit:** MO0035700  
**Location:** St. Francois County  
**Description:** View of manhole between 2<sup>nd</sup> and 3<sup>rd</sup> cells of old lagoon.  
**Date Taken:** July 23, 2019  
**Program:** WPC Unit

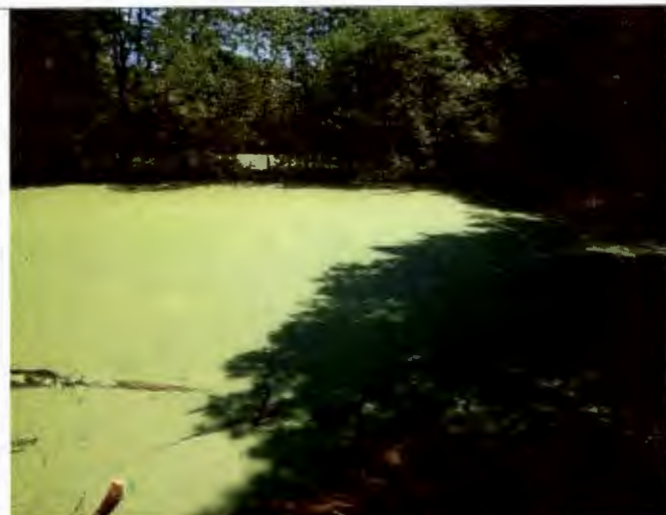
**Photograph #:** 019  
**Taken by:** Wesley Hargraves  
**Entity:** Terre Du Lac North - Three Cell Lagoon  
**Permit:** MO0035700  
**Location:** St. Francois County

**Description:** View of third cell of old lagoon and second cell in the background. Taken facing east.

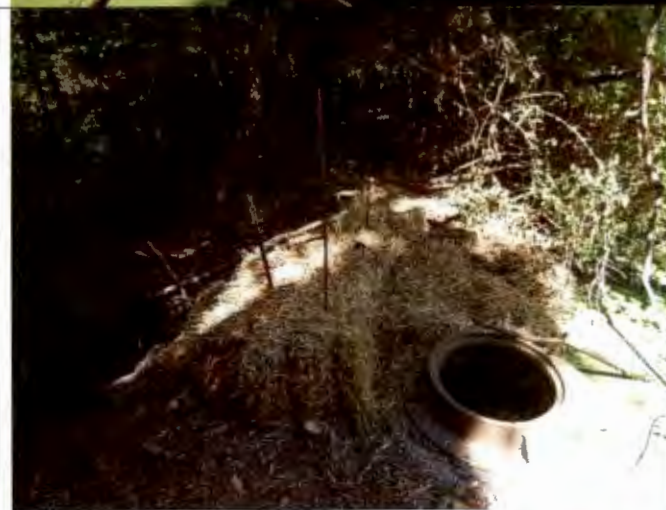
**Photograph #:** 020  
**Taken by:** Wesley Hargraves  
**Entity:** Terre Du Lac North - Three Cell Lagoon  
**Permit:** MO0035700  
**Location:** St. Francois County

**Description:** View of manhole between 3<sup>rd</sup> cell and old outfall as well as the temporary straw bale berm placed in the cut where water topped the berm and discharged. Taken facing north.

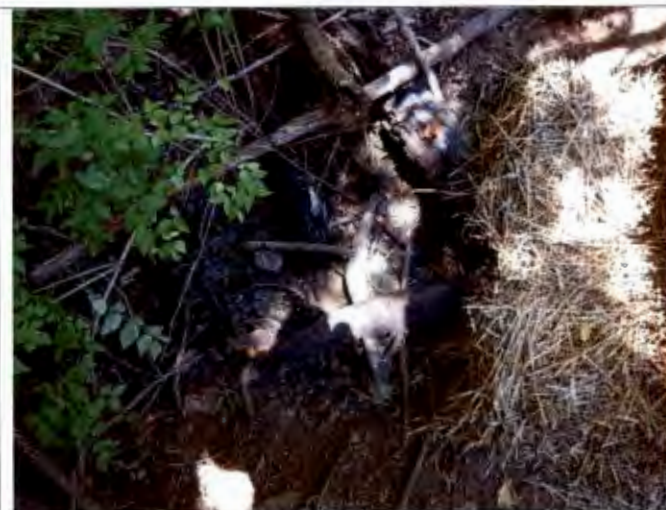
**Photograph #:** 021  
**Taken by:** Wesley Hargraves  
**Entity:** Terre Du Lac North - Three Cell Lagoon  
**Permit:** MO0035700  
**Location:** St. Francois County

**Description:** View of discharge from 3<sup>rd</sup> cell of the old lagoon at base of straw bale berm.

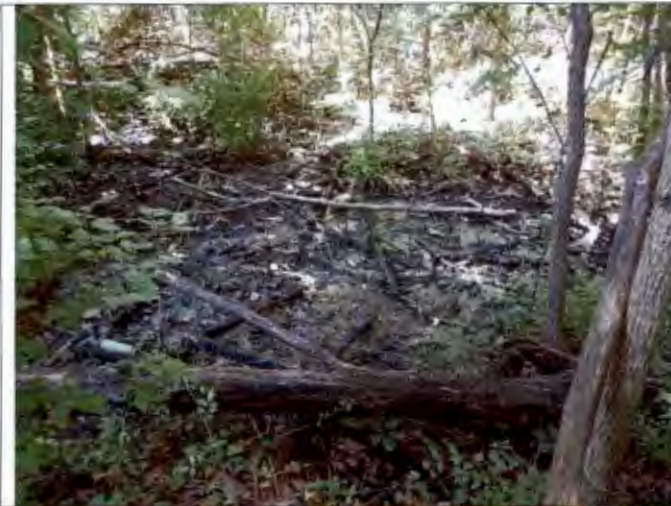
**Photograph #:** 022  
**Taken by:** Wesley Hargraves  
**Entity:** Terre Du Lac North - Three Cell Lagoon  
**Permit:** MO0035700  
**Location:** St. Francois County

**Description:** View of area where discharge flowed to. Taken facing west.

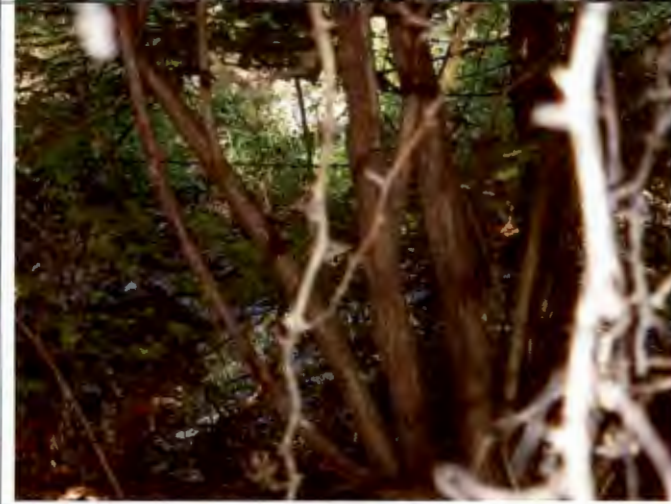
**Photograph #:** 023  
**Taken by:** Wesley Hargraves  
**Entity:** Terre Du Lac North - Three Cell Lagoon  
**Permit:** MO0035700  
**Location:** St. Francois County

**Description:** View of wet area extending past a fence line to the north of the old lagoon. Taken facing north.

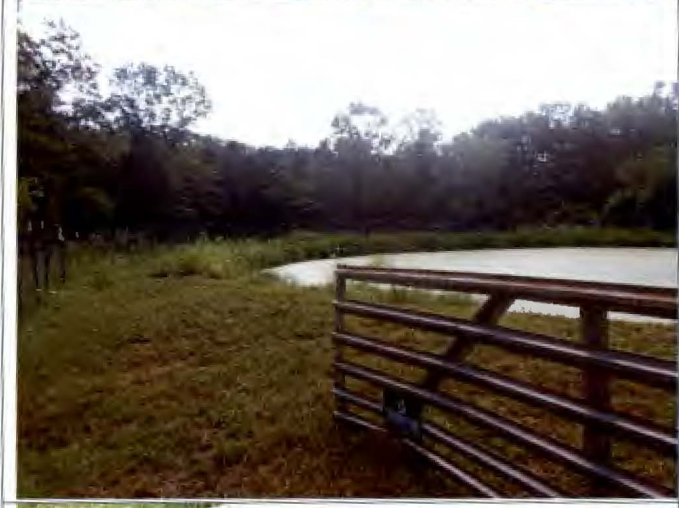
**Photograph #: 002**  
**Taken by:** Wesley Hargraves  
**Entity:** Terre Du Lac South - One Cell Lagoon  
**Permit:** MO0057312  
**Location:** St. Francois County

**Description:** View of north side of lagoon from entrance. Taken facing northeast.

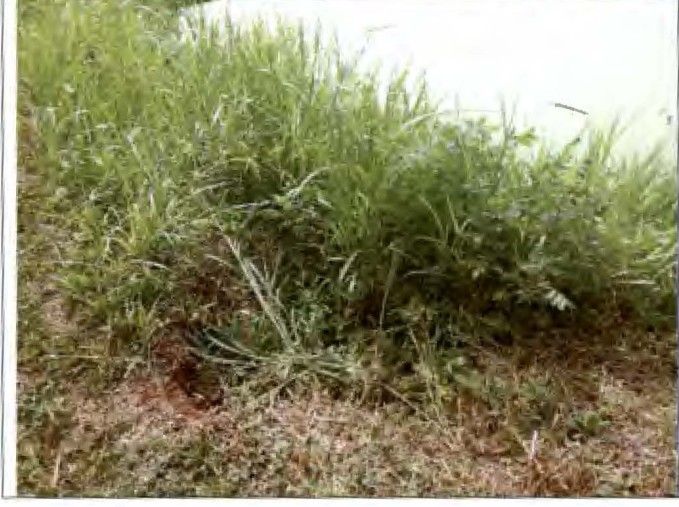
**Photograph #: 003**  
**Taken by:** Wesley Hargraves  
**Entity:** Terre Du Lac South - One Cell Lagoon  
**Permit:** MO0057312  
**Location:** St. Francois County

On July 10, 2019, approximately half of the lagoon had been mowed. By July 11, 2019, the entire lagoon was mowed. Some erosion/damage of the berms was observed. Photo #003, at the end of this report, shows one of these locations.

**Description:** View of berm damage. Taken facing northeast.

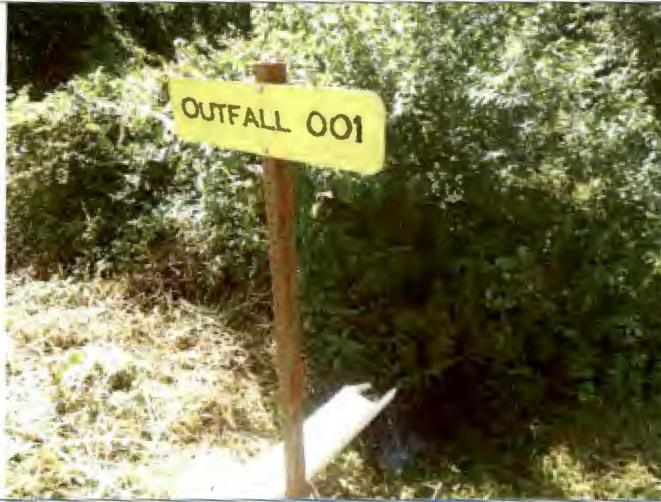
**Photograph #: 004**  
**Taken by:** Wesley Hargraves  
**Entity:** Terre Du Lac South - One Cell Lagoon  
**Permit:** MO0057312  
**Location:** St. Francois County

**Description:** View of Outfall #001. Taken facing southeast.

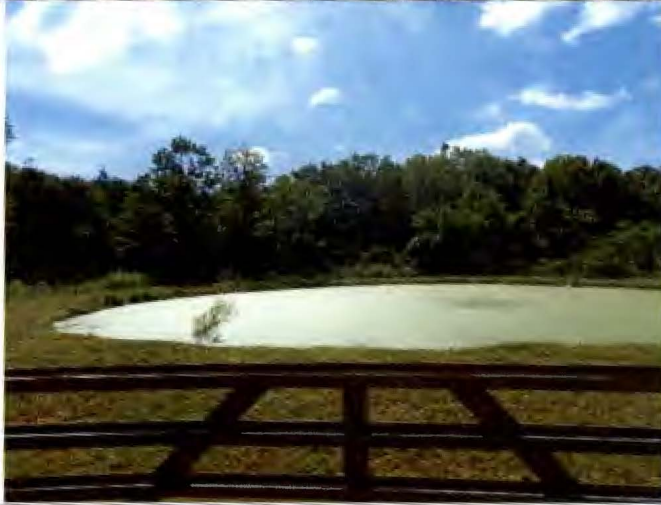
**Photograph #: 005**  
**Taken by:** Wesley Hargraves  
**Entity:** Terre Du Lac South - One Cell Lagoon  
**Permit:** MO0057312  
**Location:** St. Francois County

**Description:** View of north side of lagoon from entrance after additional mowing. Taken facing northeast.
