5.200 BCRSD Brown Station WWTP  
Boone County  
#MO-0135305

**Missouri Department of Natural Resources  
Northeast Regional Office  
Report of Inspection**

**BCRSD Brown Station WWTP**

**February 10, 2020**

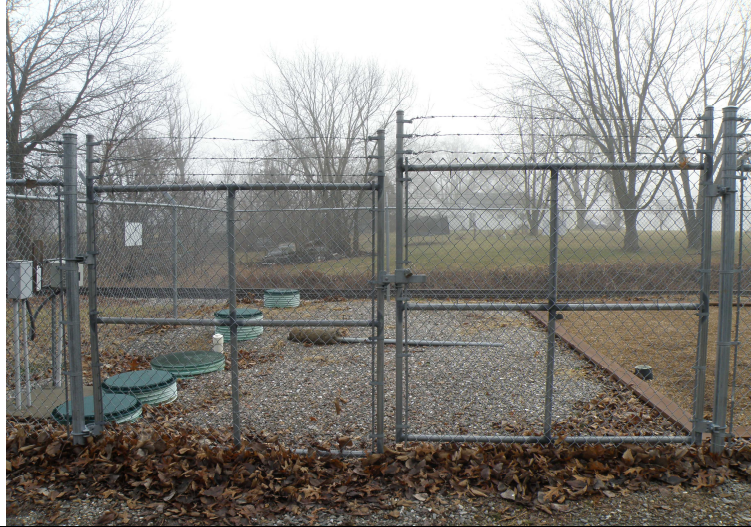
Photograph #: 1  
Taken by: Josh Hufford  
Entity: BCRSD Brown Station WWTP  
Permit: #MO-0135305  
Location: Boone County  
Description: Photo shows the entrance gate was secured with a lock. An appropriate warning sign is posted next to the gate. Taken facing east.  
Date Taken: January 14, 2020  
Program: WPC Unit

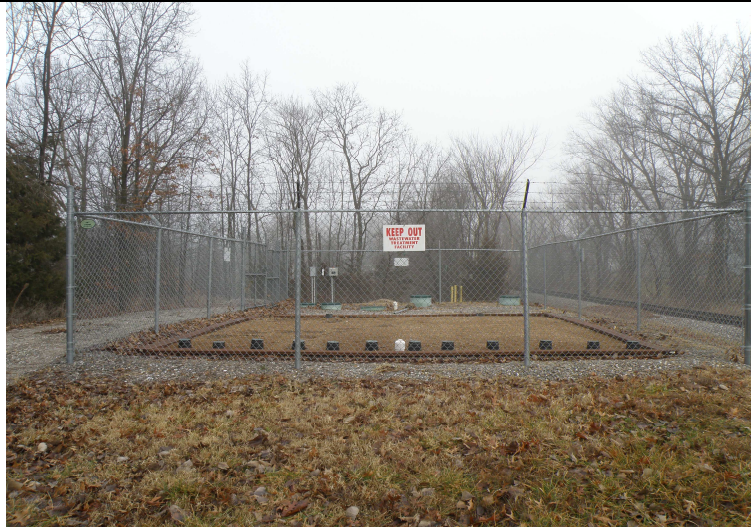
Photograph #: 2  
Taken by: Josh Hufford  
Entity: BCRSD Brown Station WWTP  
Permit: #MO-0135305  
Location: Boone County  
Description: Photo shows the perimeter fence around the facility with warning signs posted on each side of the fence. Taken facing north.  
Date Taken: January 14, 2020  
Program: WPC Unit

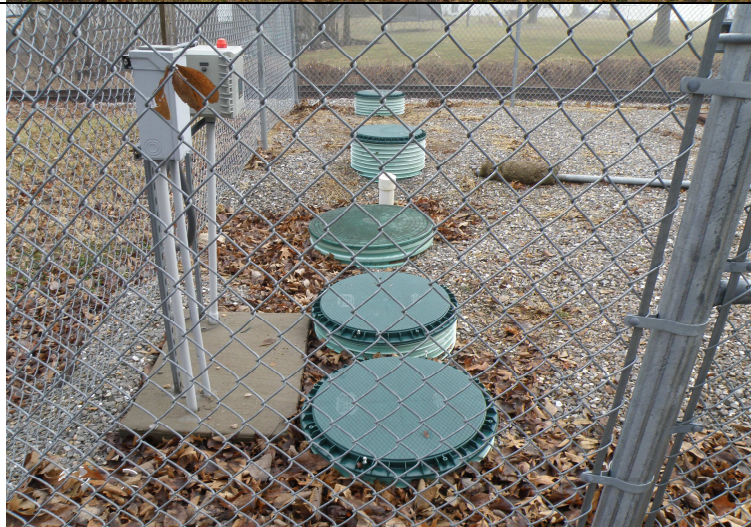
Photograph #: 3  
Taken by: Josh Hufford  
Entity: BCRSD Brown Station WWTP  
Permit: #MO-0135305  
Location: Boone County  
Description: Photo shows the recirculation and septic tanks. Taken facing east.  
Date Taken: January 14, 2020  
Program: WPC Unit

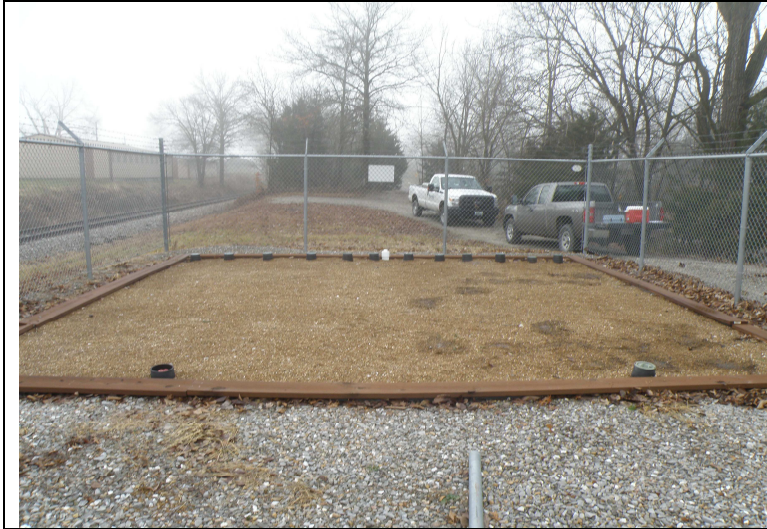
I then entered the facility and made observations of the treatment system. I observed the recirculation and septic tanks. The lids were secured with screws and no evidence of previous overflows were observed (Photo #3). I then observed the sand filter. The filter media bed was free of vegetation, and the rock media appeared evenly distributed. I was informed by Russ Palmer that the recirculation pumps are set to run every eight minutes, so the pumps were running at the time of the inspection. While the pumps were running, I observed pooling on the surface of the media bed (Photos #4, 5). Wastewater was not leaving the filter bed and the pooling receded after the pumps stopped running. I recommended adding gravel to the media bed to ensure the distribution lines are adequately covered. Russ Palmer then tested the alarm, which was working properly.

Photograph #: 4  
Taken by: Josh Hufford  
Entity: BCRSD Brown Station WWTP  
Permit: #MO-0135305  
Location: Boone County  
Description: Photo shows pooling on the surface of the media bed. Taken facing south.  
Date Taken: January 14, 2020  
Program: WPC Unit

1. Ensure the distributors have sufficient gravel cover to prevent the pooling of wastewater on the surface of the media bed.
2. Maintain a sufficient spare parts inventory so that effective maintenance may occur in a timely manner.
3. Routinely examine the stormwater collection system to determine if Inflow and Infiltration is allowing stormwater to enter the system.

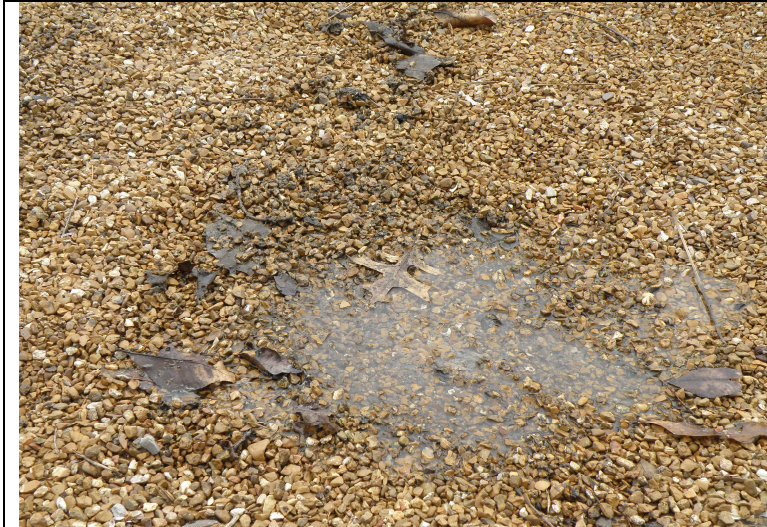
Photograph #: 5  
Taken by: Josh Hufford  
Entity: BCRSD Brown Station WWTP  
Permit: #MO-0135305  
Location: Boone County  
Description: Photo shows a closer view of the wastewater pooling on the surface of the sand filter.  
Date Taken: January 14, 2020  
Program: WPC Unit

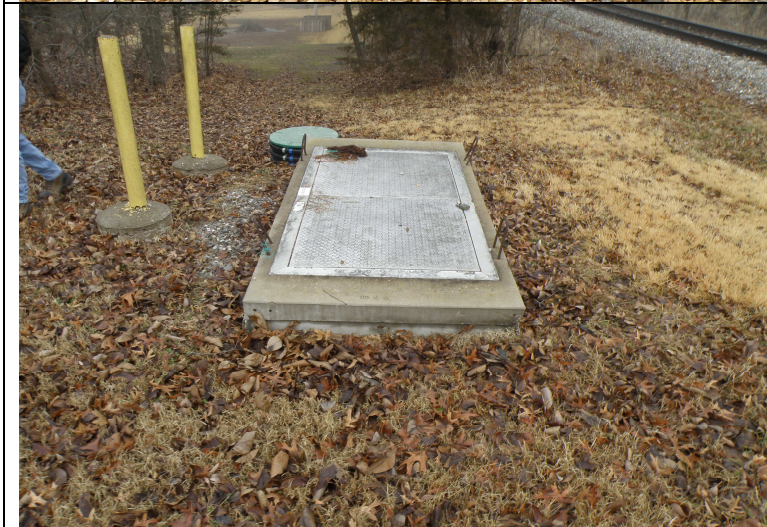
On the north side of the sand filter, I observed a concrete vault (Photo #6). Russ Palmer informed me that the concrete structure was built to accommodate an ultraviolet light disinfection system in the future if needed. On the north side of the concrete vault, I observed the facility's sampling location, which follows the final treatment process. Russ Palmer removed the lid and samples of the effluent were collected for analysis (Samples #190502 and #190503). The effluent appeared clear with a slight musty odor associated with wastewater (Photo #7). Following the sample collection, I traveled to the facility's outfall, which is located approximately 75 yards northwest of the sampling structure. The outfall was clearly marked in the field with a sign (Photo #8). The water in the receiving stream was clear with no evidence of previous impacts from the facility.

Photograph #: 6  
Taken by: Josh Hufford  
Entity: BCRSD Brown Station WWTP  
Permit: #MO-0135305  
Location: Boone County  
Description: Photo shows the concrete structure built to accommodate an ultraviolet light disinfection system in the future if needed. Taken facing north.  
Date Taken: January 14, 2020  
Program: WPC Unit

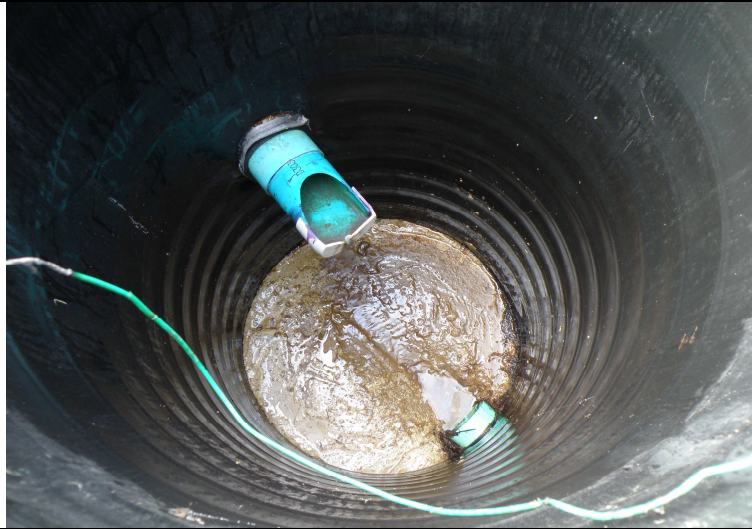
Photograph #: 7  
Taken by: Josh Hufford  
Entity: BCRSD Brown Station WWTP  
Permit: #MO-0135305  
Location: Boone County  
Description: Photo shows the facility's sampling location, which follows the final treatment process. The facility is discharging and samples were collected at this location.  
Date Taken: January 14, 2020  
Program: WPC Unit

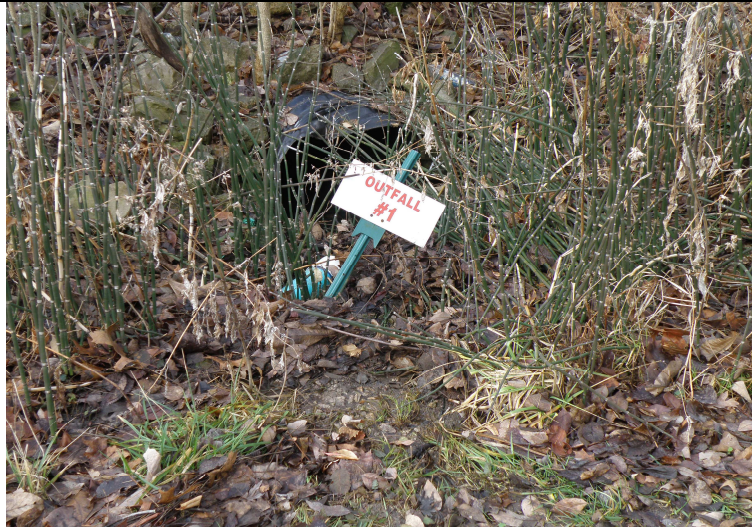
Photograph #: 8  
Taken by: Josh Hufford  
Entity: BCRSD Brown Station WWTP  
Permit: #MO-0135305  
Location: Boone County  
Description: Photo shows the outfall was clearly marked in the field with a sign. Taken facing west.  
Date Taken: January 14, 2020  
Program: WPC Unit
