Hunter's Ridge Subdivision, WSS WWTP

South Walnut Hills/Woodland Lake Estates, WPC WWTP

File No. SR-2016-0200

The Villages at Whiteman WWTP

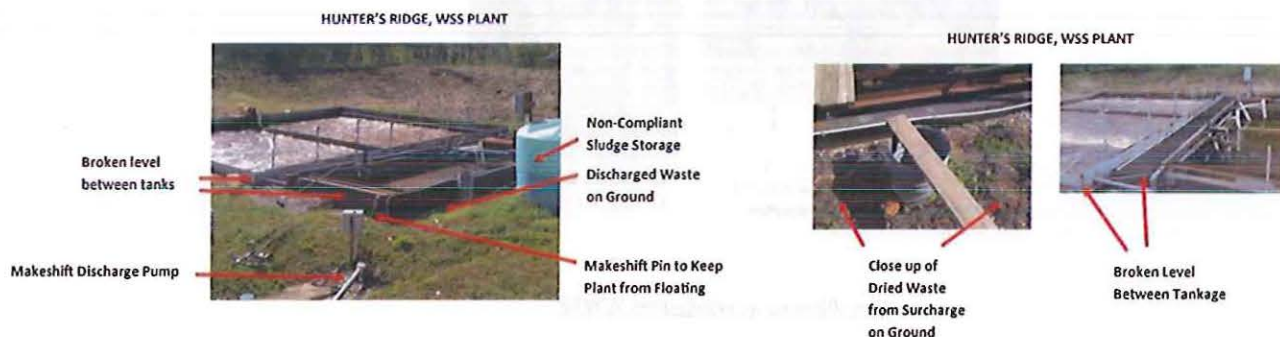
At the time of acquisition, WSS was a distressed extended aeration package plant with internal clarification and no disinfection systems. The plant was built below the floodplain, regularly over-flowing untreated waste into the receiving creek. WSS was covered in dried sludge created by wastewater flushing the entire plant onto the ground. The WSS plant was visibly structurally damaged due to the plant "floating" as a result of hydrostatic pressure from the surrounding groundwater. Half of the blower equipment was not functioning prior to the acquisition and the sludge holding tankage had been abandoned for an improvised out-of-ground plastic farm tankage. Flow monitoring demonstrated the plant was regularly surcharging (overflowing) due to infiltration and inflow (I & I) and WSS was unable to consistently treat for nutrients. Biological Nutrient Removal (BNR) is a process used for nitrogen and phosphorus removal from wastewater before it is discharged into surface or ground water.

To fix the issues at Hunter's Ridge Waste Water Treatment Plant (WWTP), Racoon Creek built a new activated sludge WWTP, converted the old WWTP to I&I storage/treatment, added ultraviolet disinfection, built a pump station to properly process flow between the plants, and performed smoke testing with corresponding fixes to lower I&I.

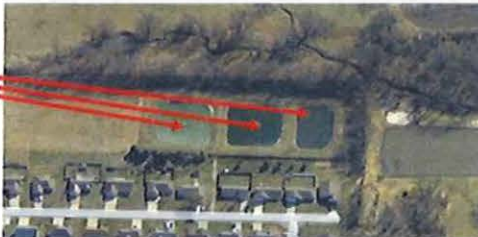
THE VILLAGES AT WHITEMAN, VILLAGES PLANT

The Villages wastewater conveyance and treatment system feeds a three cell aerated lagoon system with a poured-in-place concrete chlorine disinfection system. At the time of acquisition only one cell had functioning aeration; there was build up of sludge deposits above a cell waterline; the plant was unable to treat for ammonia; existing disinfection allowed organic material in the effluent (outflow), and the plant surcharged.

Original Three Cell Aerated Lagoon

To fix issues at The Villages, Raccoon Creek built a moving bed bioreactor plant (MBBR), removed 35 years of lagoon sludge for I&I storage and treatment, improved disinfection, built a pump station to properly feed the MBBR plant, and performed smoke testing with corresponding fixes to lower I&I.
