Exhibit No. _____
Issue: DNR Policy; Technical, Managerial and
Financial Capability of CSWR
Witness: Kristi Savage-Clarke
Type of Exhibit: Surrebuttal Testimony
Sponsoring Party: Confluence Rivers Utility
Operating Company, Inc.
File Nos.: WA-2019-0299
Date: September 23, 2019

Surrebuttal Testimony

Kristi Savage-Clarke

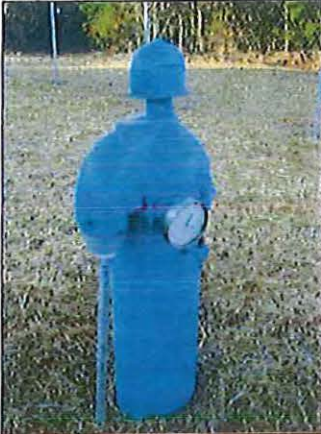
Photo #:001
Date Taken: 10/26/2016
By: Michelle Oglesby
Program: PDWB
File: Crawford County
Location: Indian Hills Utilities Operating Co. Inc.
Description: Well #1

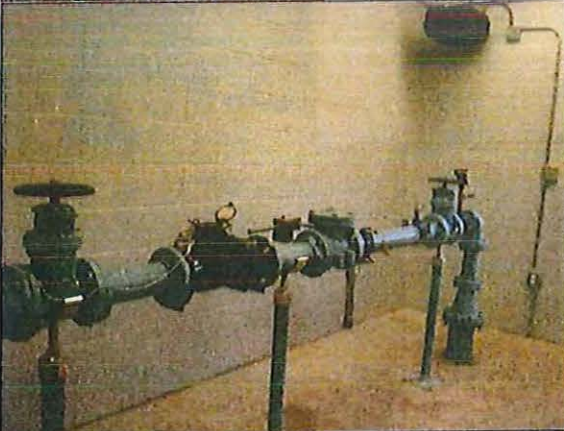
Photo #:002
Date Taken: 10/26/2016
By: Michelle Oglesby
Program: PDWB
File: Crawford County
Location: Indian Hills Utilities Operating Co. Inc.
Description: Well #1 - Piping

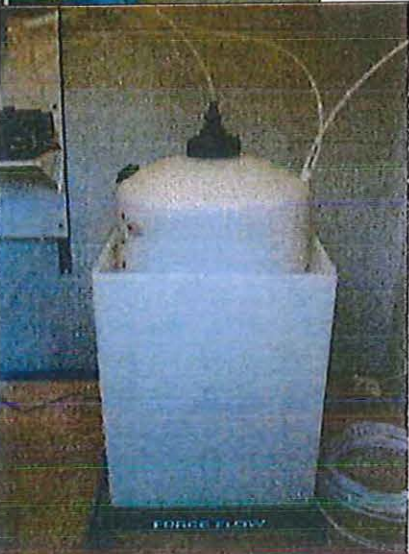
Photo #:004
Date Taken: 10/26/2016
By: Michelle Oglesby
Program: PDWB
File: Crawford County
Location: Indian Hills Utilities Operating Co. Inc.
Description: Well #1 – Chlorine Room with chemical storage.

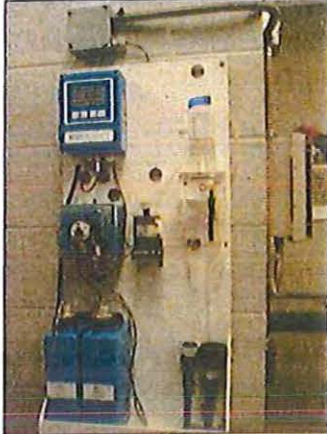
Photo #:005
Date Taken: 10/26/2016
By: Michelle Oglesby
Program: PDWB
File: Crawford County
Location: Indian Hills Utilities Operating Co. Inc.
Description: Well #1 – Continuous chlorine reader.

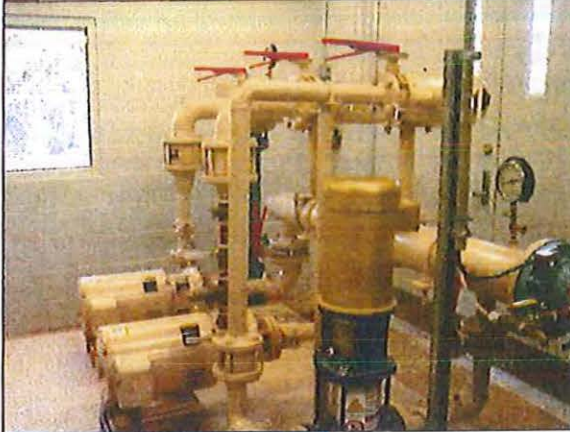
Photo #:006
Date Taken: 10/26/2016
By: Michelle Oglesby
Program: PDWB
File: Crawford County
Location: Indian Hills Utilities Operating Co. Inc.
Description: Well #1 – Booster Pump Station

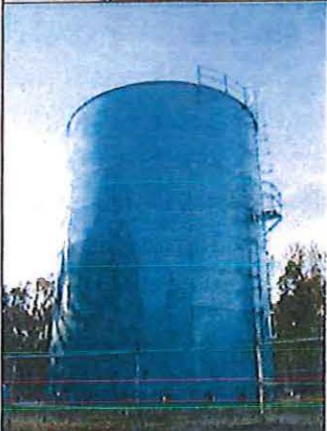
Photo #:007
Date Taken: 10/26/2016
By: Michelle Oglesby
Program: PDWB
File: Crawford County
Location: Indian Hills Utilities Operating Co. Inc.
Description: Well #1 – 263,000 gallon standpipe.

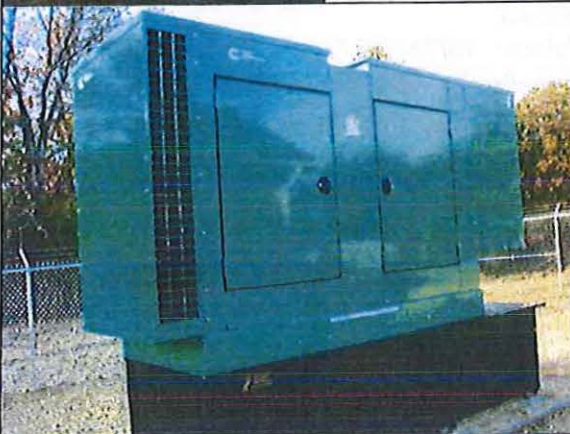
Photo #:008
Date Taken: 10/26/2016
By: Michelle Oglesby
Program: PDWB
File: Crawford County
Location: Indian Hills Utilities Operating Co. Inc.
Description: Well #1 – Generator

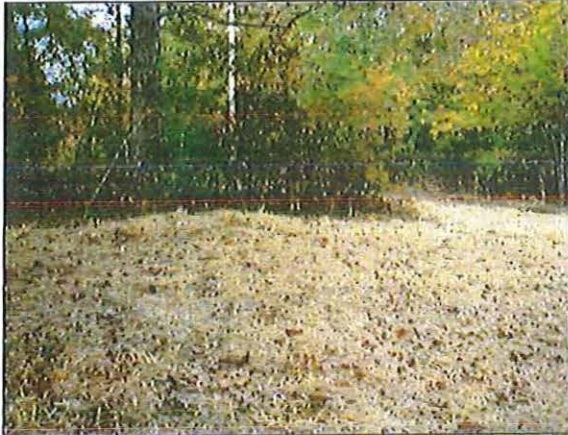
Photo #:009
Date Taken: 10/26/2016
By: Michelle Oglesby
Program: PDWB
File: Crawford County
Location: Indian Hills Utilities Operating Co. Inc.
Description: Location where Well #2 used to be.

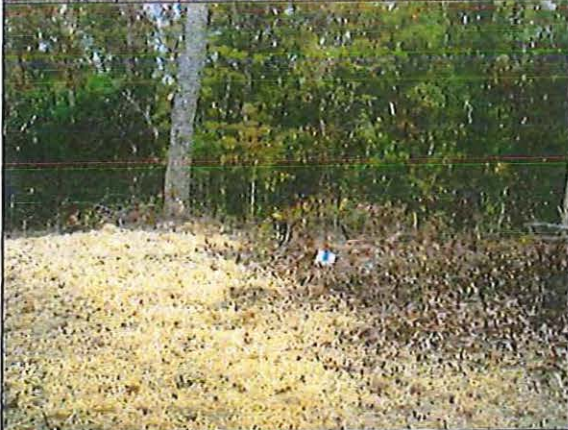
Photo #:010
Date Taken: 10/26/2016
By: Michelle Oglesby
Program: PDWB
File: Crawford County
Location: Indian Hills Utilities Operating Co. Inc.
Description: Location where Well #2 booster pumps station was located.

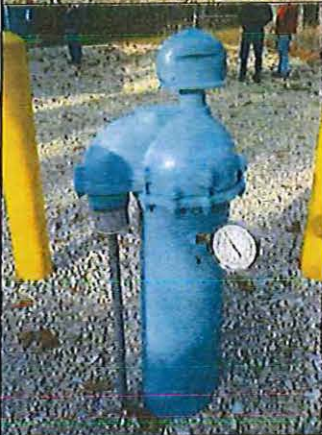
Photo #:011
Date Taken: 10/26/2016
By: Michelle Oglesby
Program: PDWB
File: Crawford County
Location: Indian Hills Utilities Operating Co. Inc.
Description: Well #3

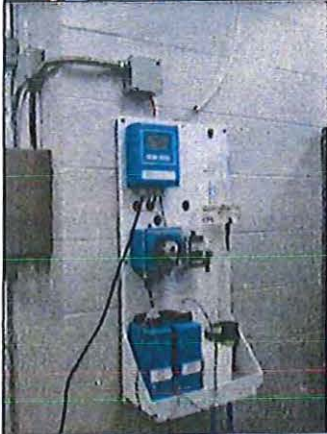
Photo #:015
Date Taken: 10/26/2016
By: Michelle Oglesby
Program: PDWB
File: Crawford County
Location: Indian Hills Utilities Operating Co. Inc.
Description: Well #3 – Continuous chlorine reader.

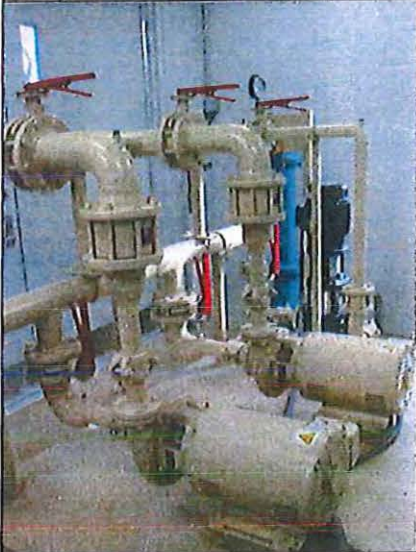
Photo #:016
Date Taken: 10/26/2016
By: Michelle Oglesby
Program: PDWB
File: Crawford County
Location: Indian Hills Utilities Operating Co. Inc.
Description: Well #3 – Booster Pump Station.

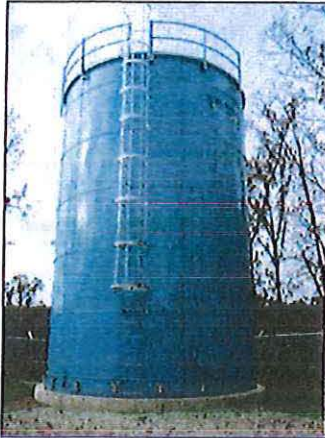
Photo #:017
Date Taken: 10/26/2016
By: Michelle Oglesby
Program: PDWB
File: Crawford County
Location: Indian Hills Utilities Operating Co. Inc.
Description: Well #3 – 53,000 gallon standpipe.

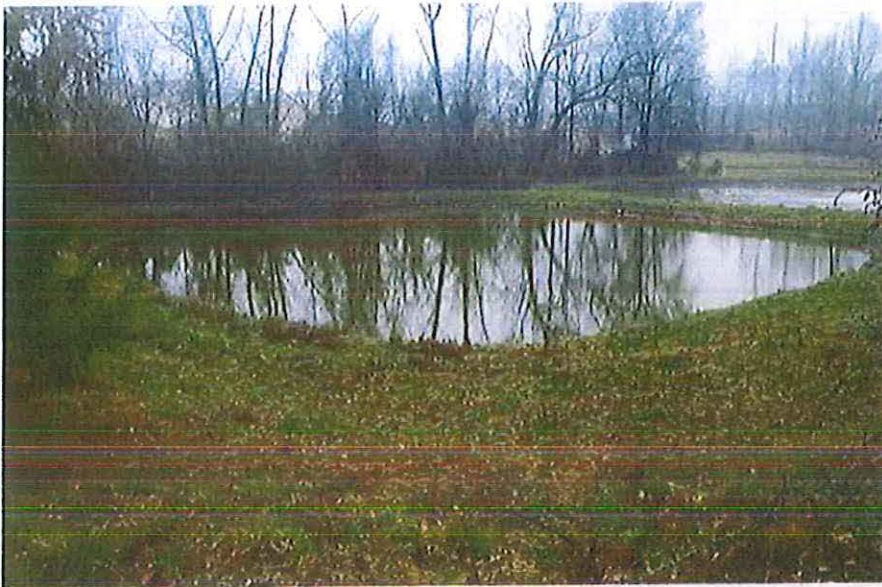
Photo #: 001
By: Tim Mattingly
Facility: Hillcrest Manor
Permit: MO-0088072
Location: Cape Girardeau County

Description: This is a photo of the primary cell of the lagoon system at Hillcrest Manor Subdivision.

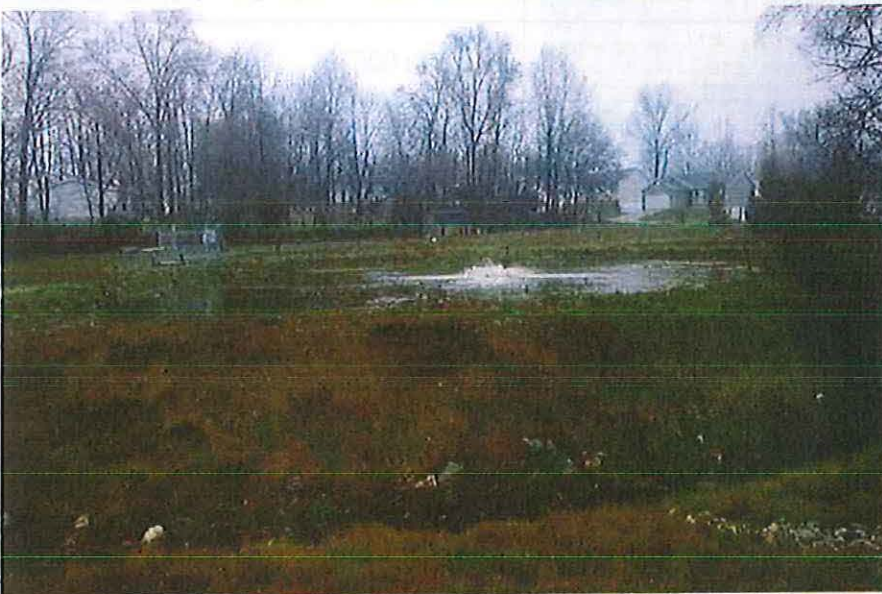
Photo #: 002
By: Tim Mattingly
Facility: Hillcrest Manor
Permit: MO-0088072
Location: Cape Girardeau County

Description: The second cell of the lagoon serving Hillcrest Manor Subdivision. The aerator was fully functional.

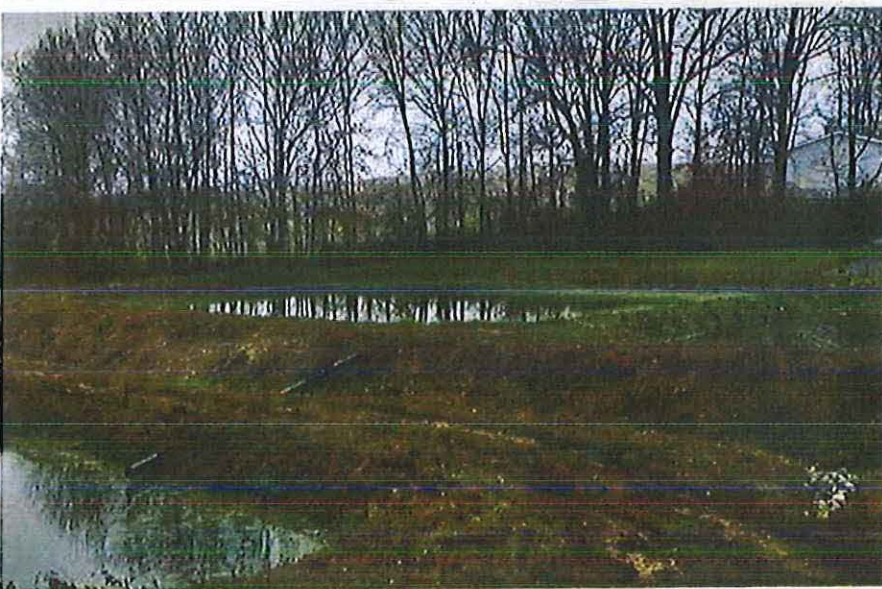
Photo #: 003
By: Tim Mattingly
Facility: Hillcrest Manor
Permit: MO-0088072
Location: Cape Girardeau County

Description: A photograph of the third cell of the Hillcrest Manor Subdivision. The pipe seen is for emergency maintenance on the second or third cells.

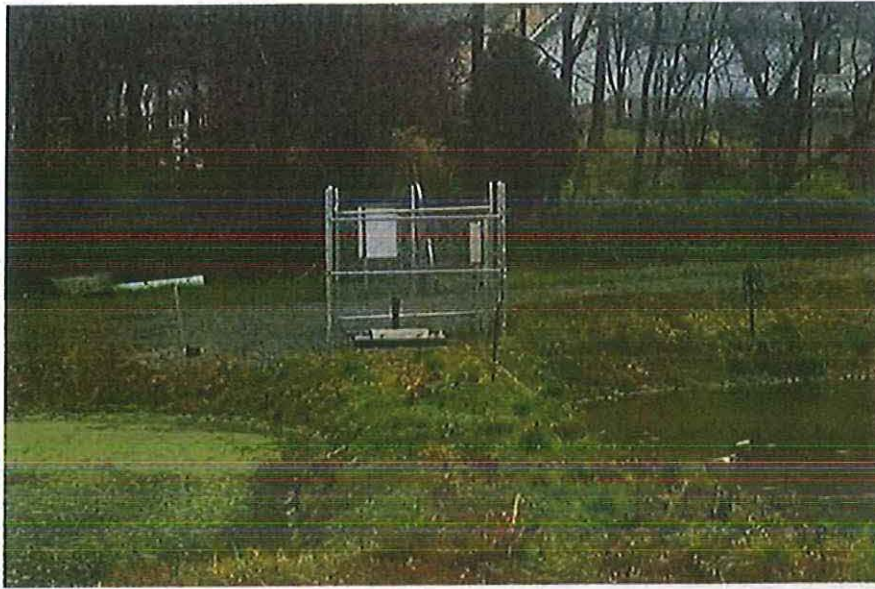
Photo #: 004
By: Tim Mattingly
Facility: Hillcrest Manor
Permit: MO-0088072
Location: Cape Girardeau County

Description: This small lift station is located between cells two and three and pumps wastewater from cell three to the moving bed biofilm reactor.

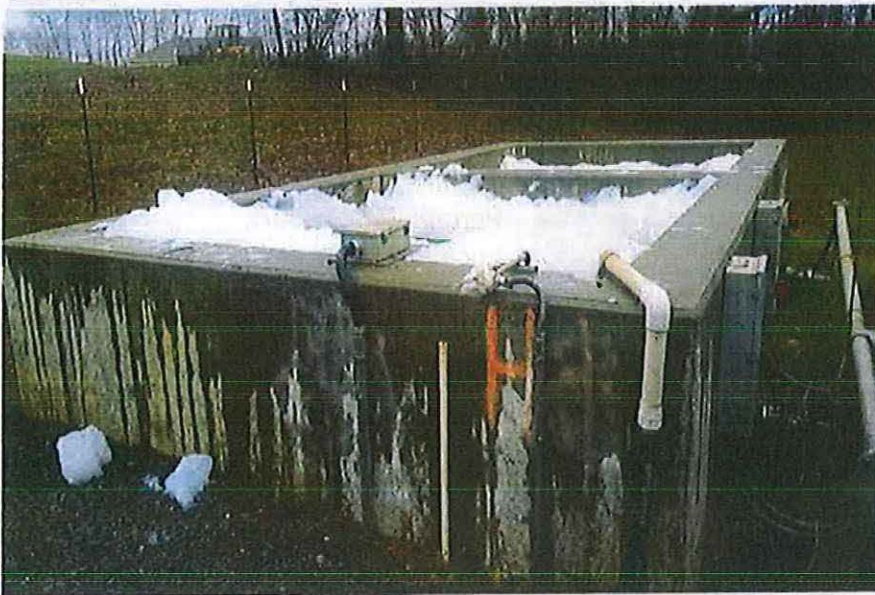
Photo #: 005
By: Tim Mattingly
Facility: Hillcrest Manor
Permit: MO-0088072
Location: Cape Girardeau County

Description: This is a photo of the moving bed biofilm reactor. The foam seen here is minimal, only occurring during extreme temperature fluctuations or periods of rain.

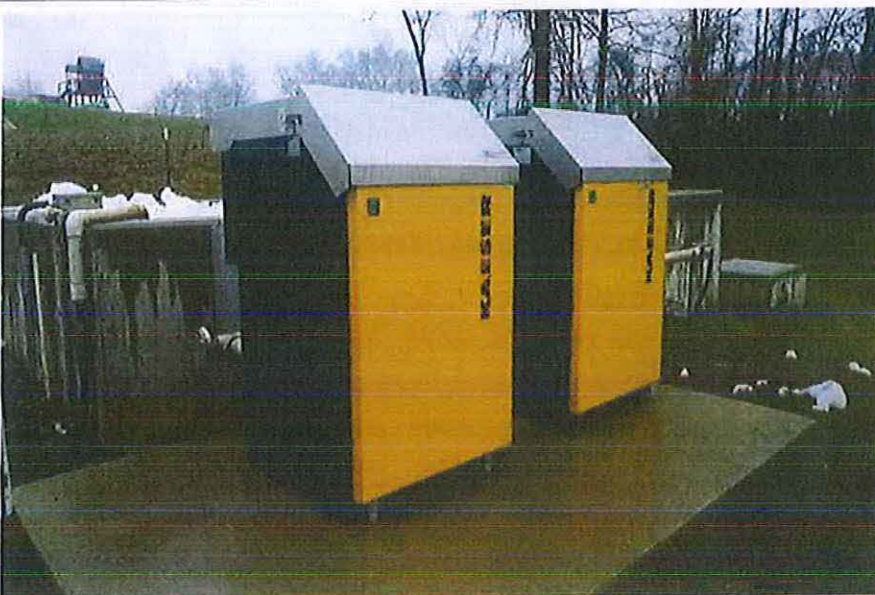
Photo #: 006
By: Tim Mattingly
Facility: Hillcrest Manor
Permit: MO-0088072
Location: Cape Girardeau County

Description: These are the two blowers that provide the air for the moving bed biofilm reactor. Their usage alternates between the two.

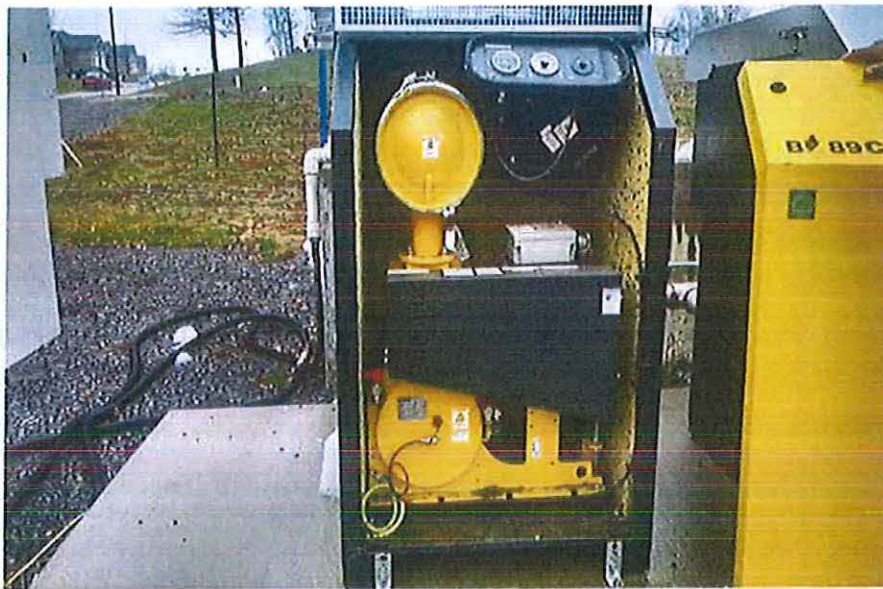
Photo #: 007
By: Tim Mattingly
Facility: Hillcrest Manor
Permit: MO-0088072
Location: Cape Girardeau County

Description: A picture of the internal components of the individual blowers.

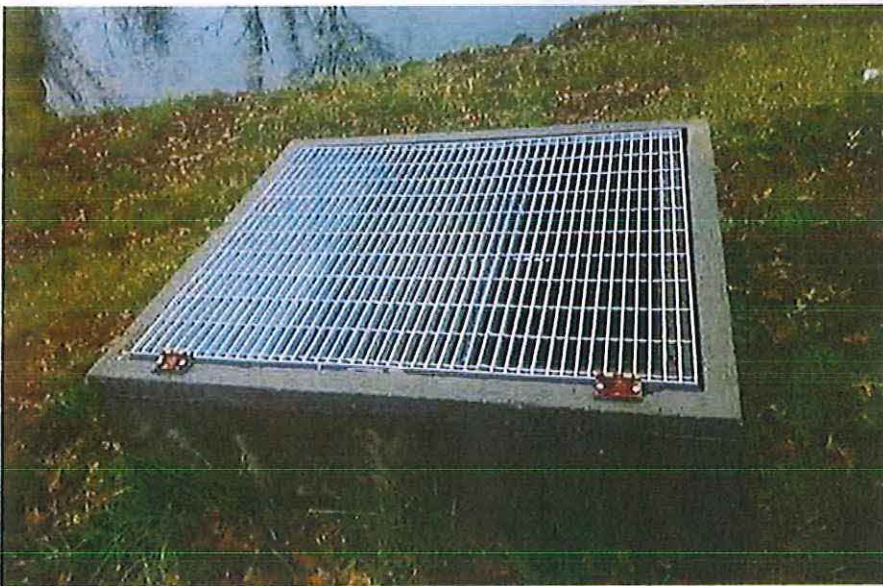
Photo #: 008
By: Tim Mattingly
Facility: Hillcrest Manor
Permit: MO-0088072
Location: Cape Girardeau County

Description: This is a photograph of the exterior of the weir box. The wastewater travels from the moving bed biofilm reactor to this structure.

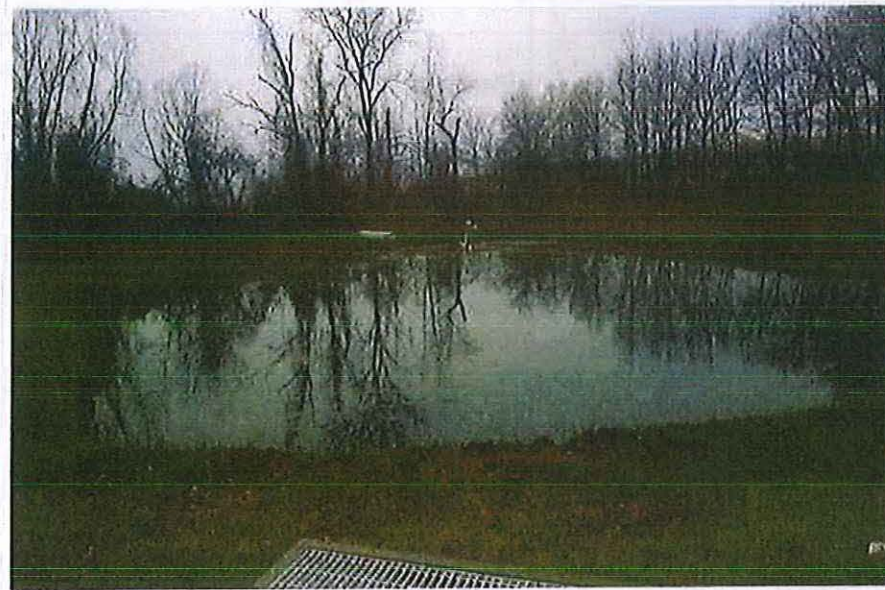
Photo #: 011
By: Tim Mattingly
Facility: Hillcrest Manor
Permit: MO-0088072
Location: Cape Girardeau County

Description: This photo is a view of the polishing cell.

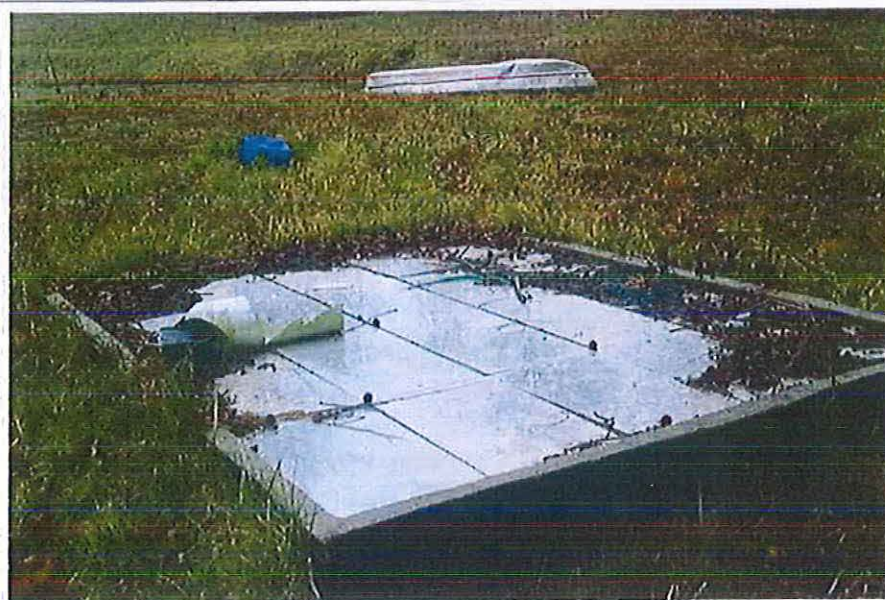
Photo #: 012
By: Tim Mattingly
Facility: Hillcrest Manor
Permit: MO-0088072
Location: Cape Girardeau County

Description: This is a photograph of the chlorine contact chamber. The blue box at the top of the picture is the tablet chlorinator.

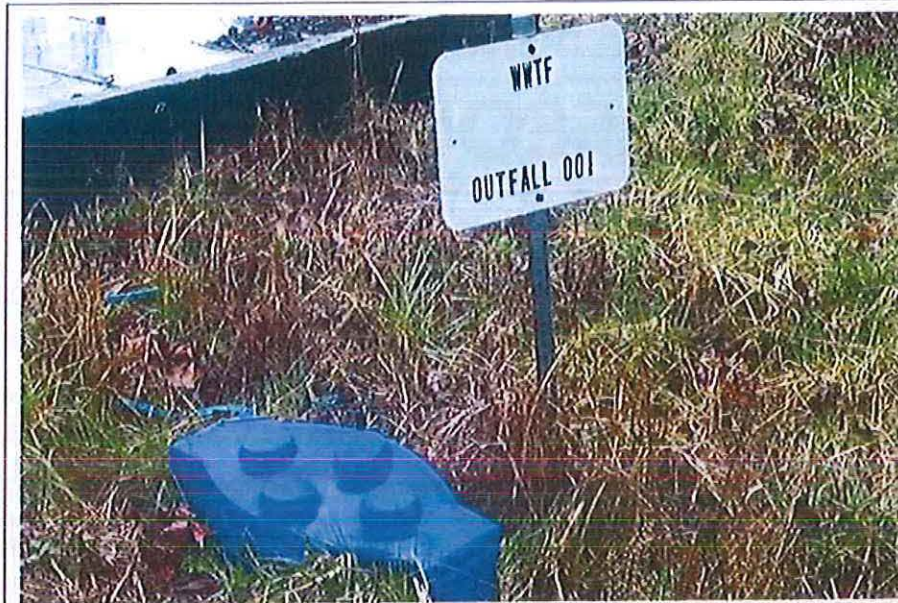
Photo #: 013
By: Tim Mattingly
Facility: Hillcrest Manor
Permit: MO-0088072
Location: Cape Girardeau County

Description: The blue box in this picture is the tablet de-chlorination unit. Obviously, the facility's outfall sign is also seen.

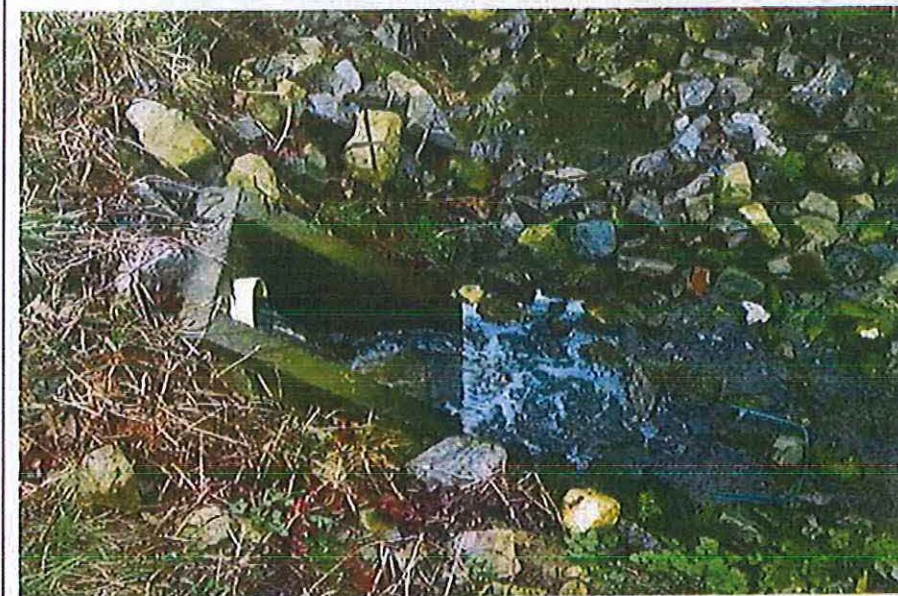
Photo #: 014
By: Tim Mattingly
Facility: Hillcrest Manor
Permit: MO-0088072
Location: Cape Girardeau County

Description: This photo show outfall #001 for the facility. The effluent was clear with no odor.

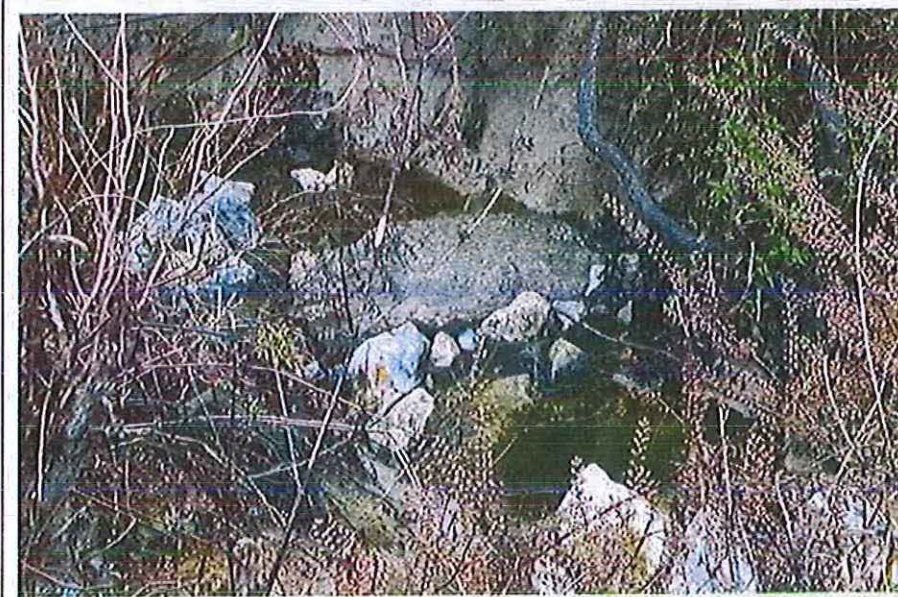
Photo #: 015
By: Tim Mattingly
Facility: Hillcrest Manor
Permit: MO-0088072
Location: Cape Girardeau County

Description: This is a picture of the receiving stream downstream of the WWTF. It had a low flow with a little algae growth. This stream also receives drainage for the subdivision just prior to the area where this photo was taken.

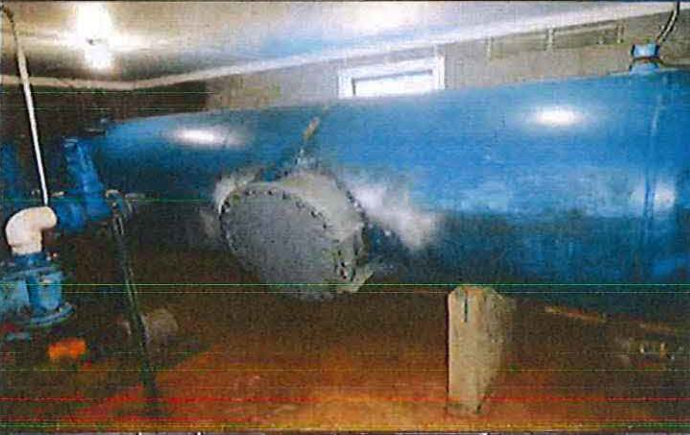
Photo #: 003
Date Taken: 01/24/2018
By: Michael Wyatt
Program: PDWB
File: Hillcrest Utility Operating Co., Inc. – General
Location: Well house
Description: ~2,100 gallon hydro-pneumatic pressure tank.

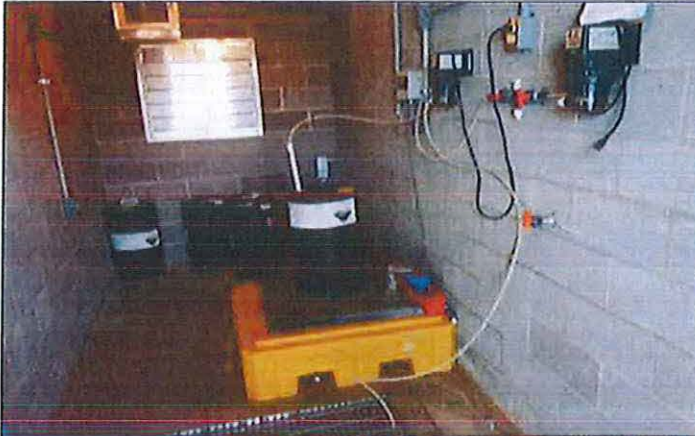
Photo #: 005
Date Taken: 01/24/2018
By: Michael Wyatt
Program: PDWB
File: Hillcrest Utility Operating Co., Inc. – General
Location: Chlorine feed room
Description: Chlorine feed system.

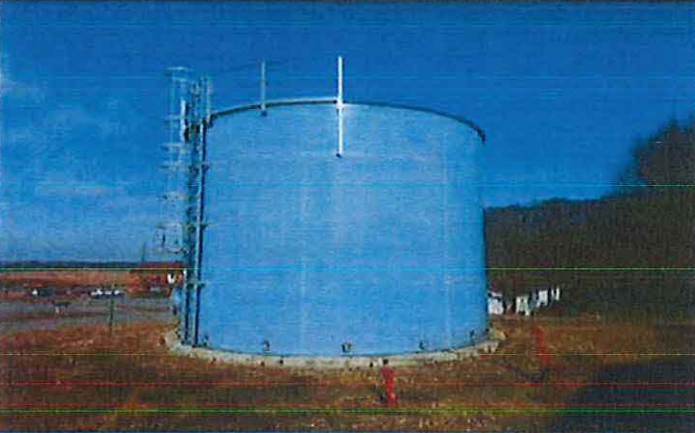
Photo #: 007
Date Taken: 01/24/2018
By: Michael Wyatt
Program: PDWB
File: Hillcrest Utility Operating Co., Inc. – General
Location: Tank site
Description: 58,000 gallon ground storage tank.

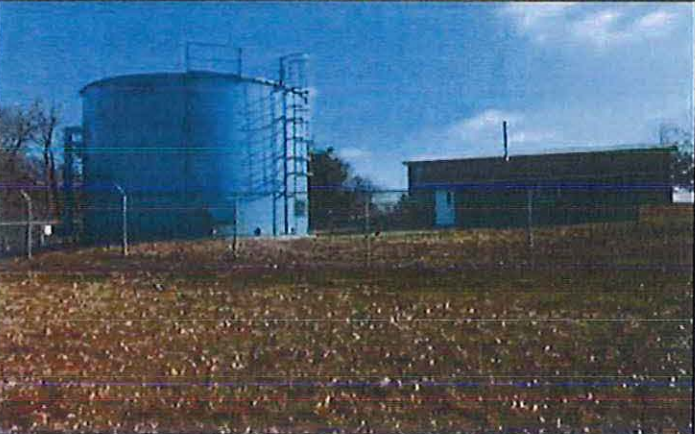
Photo #: 008
Date Taken: 01/24/2018
By: Michael Wyatt
Program: PDWB
File: Hillcrest Utility Operating Co., Inc. – General
Location: Well/tank site
Description: Fenced well house and storage tank.
