Exhibit No.:
Issues: Eureka Acquisition
Witness: Brian W. Eisenloeffel
Exhibit Type: Surrebuttal
Sponsoring Party: Missouri-American Water Company
Case No.: WA-2021-0376
Date: December 17, 2021

SURREBUTTAL TESTIMONY

MISSOURI-AMERICAN WATER COMPANY

**REFERRAL NOTICE OF VIOLATION
WATER POLLUTION CONTROL BRANCH RNOV SL190028**

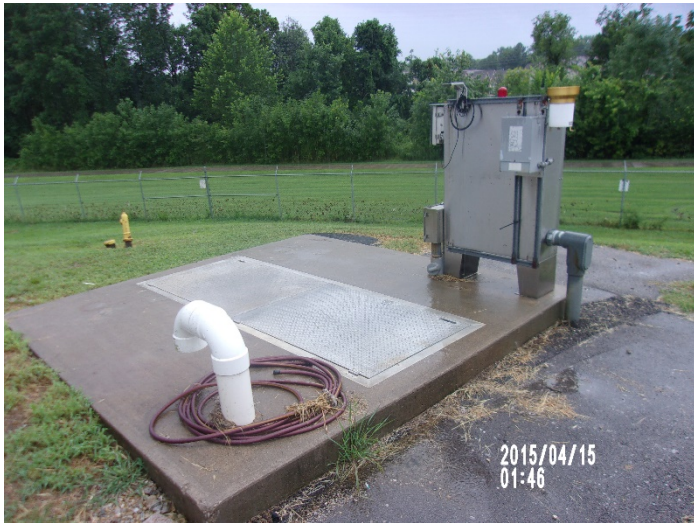
Photograph: # 1.
Taken By: Oscar Vazquez
Date Taken: July 29, 2019
Program: ECA Unit
Entity: Eureka WWTF
Permit: MO-0039569
Location: Influent Lift Station
Description: Wet well and pump control panel.

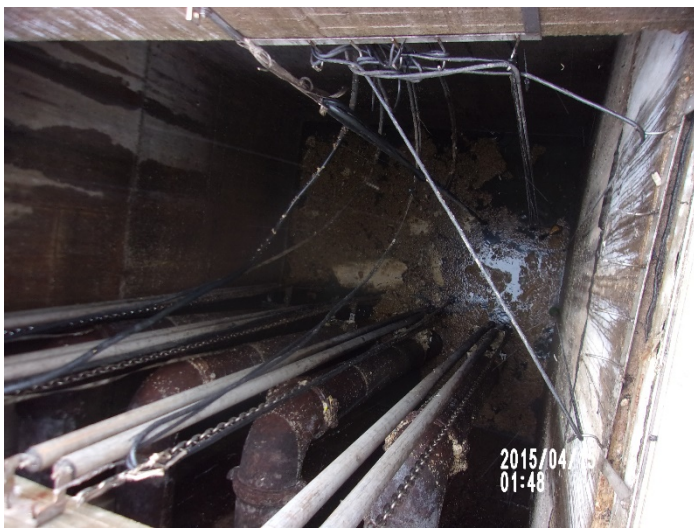
Photograph: # 2.
Taken By: Oscar Vazquez
Date Taken: July 29, 2019
Program: ECA Unit
Entity: Eureka WWTF
Permit: MO-0039569
Location: Influent Lift Station
Description: Wet well with four pump discharge lines.

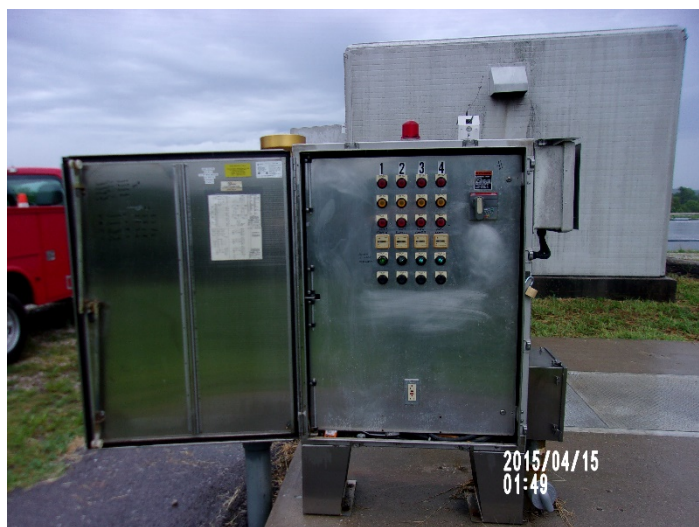
Photograph: # 3.
Taken By: Oscar Vazquez
Date Taken: July 29, 2019
Program: ECA Unit

Entity: Eureka WWTF
Permit: MO-0039569
Location: Influent Lift Station
Description: LS control panel features include pump run indicator lights, hand-off-auto selector switches, and elapse time meters.

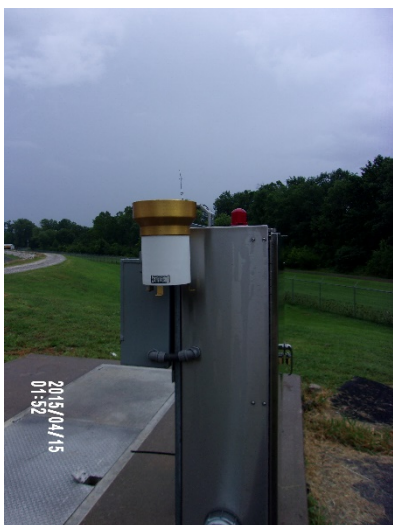
Photograph: # 4.
Taken By: Oscar Vazquez
Date Taken: July 29, 2019
Program: ECA Unit

Entity: Eureka WWTF
Permit: MO-0039569
Location: Influent Lift Station
Description: Rain gauge attached to LS control panel is integrated into a SCADA system.

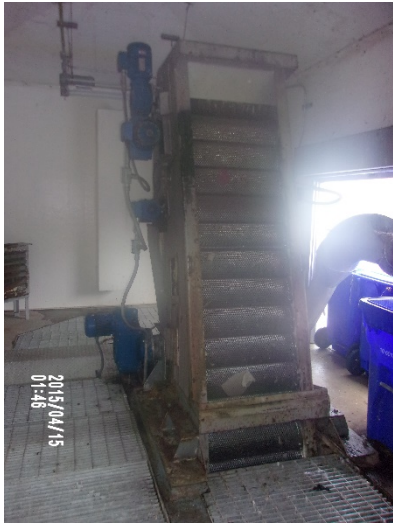
Photograph: # 5.
Taken By: Oscar Vazquez
Date Taken: July 29, 2019
Program: ECA Unit

Entity: Eureka WWTF
Permit: MO-0039569
Location: Fine Screen Building
Description: Fine Screen.

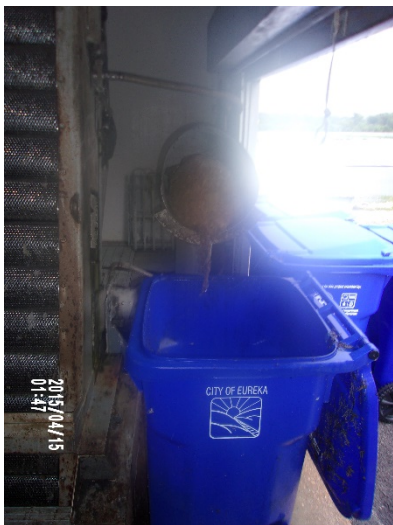
Photograph: # 6.
Taken By: Oscar Vazquez
Date Taken: July 29, 2019
Program: ECA Unit

Entity: Eureka WWTF
Permit: MO-0039569
Location: Fine Screen Building
Description: Compacted and dewatered screenings are dumped into 300-pound trash containers.

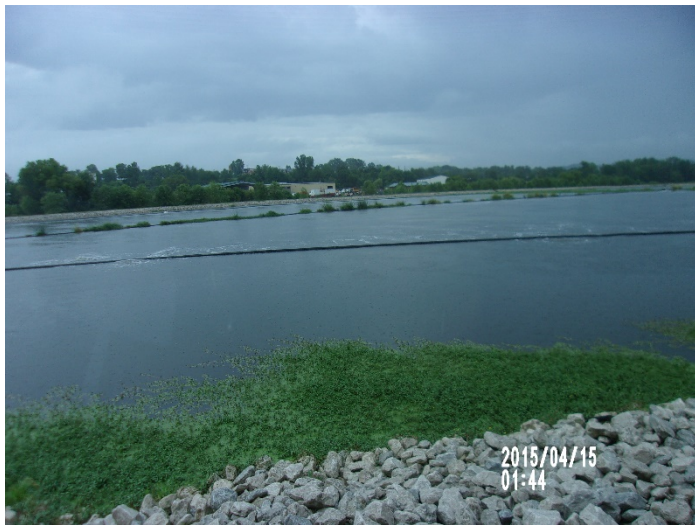
Photograph: # 7.
Taken By: Oscar Vazquez
Date Taken: July 29, 2019
Program: ECA Unit

Entity: Eureka WWTF
Permit: MO-0039569
Location: Three-Cell Aerated Lagoon
Description: Looking northeast from the southern shore of lagoon cell #1, near the bar screen building.

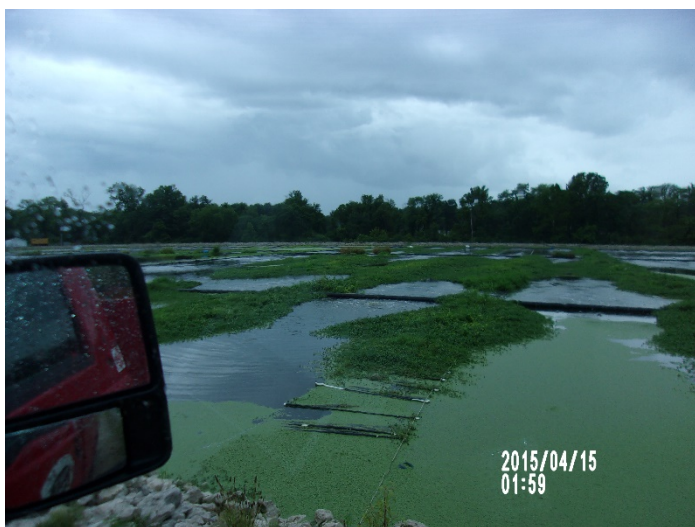
Photograph: # 8.
Taken By: Oscar Vazquez
Date Taken: July 29, 2019
Program: ECA Unit

The presence of different varieties of floating plants were observed mainly in lagoon cell #s 1 and 2 as shown in Photo #s 8 and 9. Mr. Ricks identified the prevalent floating plants in the lagoon as duckweed and water primrose. He further indicated that floating plants are physically removed or controlled (in the case of duckweed) with environment-friendly herbicides routinely. More frequent removal and/or control of floating plants is recommended (**Recommendation #2**). Mr. Ricks indicated that no sludge has been removed from the lagoon since it became operational. He explained that the facility applies a bio-augmentation product to the lagoon to promote degradation of accumulated sludge and optimize lagoon treatment to some extent. Mr. Ricks pointed out the fine bubbles widespread on the lagoon water surface, clarifying that this is nitrogen gas being removed as a product of the bio-augmentation process. He further indicated that the facility conducts sludge profile surveys routinely to monitor reduction efforts.

Entity: Eureka WWTF
Permit: MO-0039569
Location: Three-Cell Aerated Lagoon
Description: Looking south from the northern shore of lagoon. A line of Aquamats® is shown here.

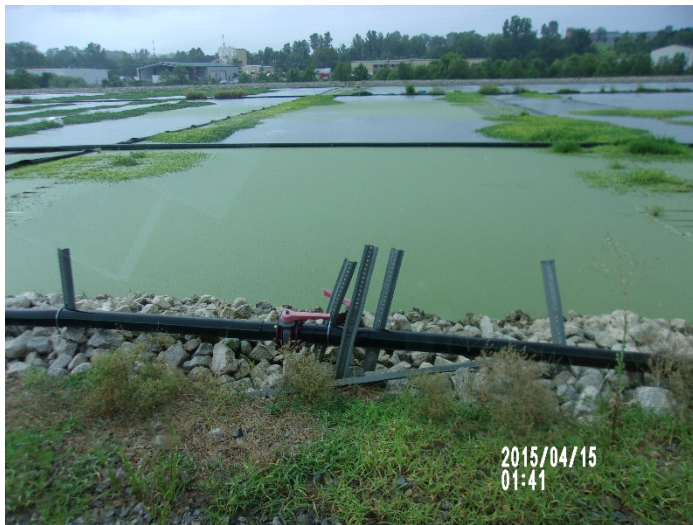
Photograph: # 9.
Taken By: Oscar Vazquez
Date Taken: July 29, 2019
Program: ECA Unit

Entity: Eureka WWTF
Permit: MO-0039569
Location: Three-Cell Aerated Lagoon
Description: Looking north from the southern shore of lagoon cell #2. The photo shows the valve operated to control the discharge of return wastewater into cell #2.

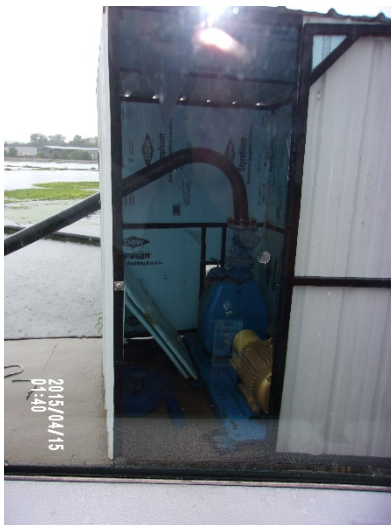
Photograph: # 10.
Taken By: Oscar Vazquez
Date Taken: July 29, 2019
Program: ECA Unit

Entity: Eureka WWTF
Permit: MO-0039569
Location: Recirculation Pump Shed
Description: The recirculation pump shown here is operated manually to recirculate approximately 6.5 MGD of wastewater from lagoon cell #3 back to lagoon cell #s 1 and 2.

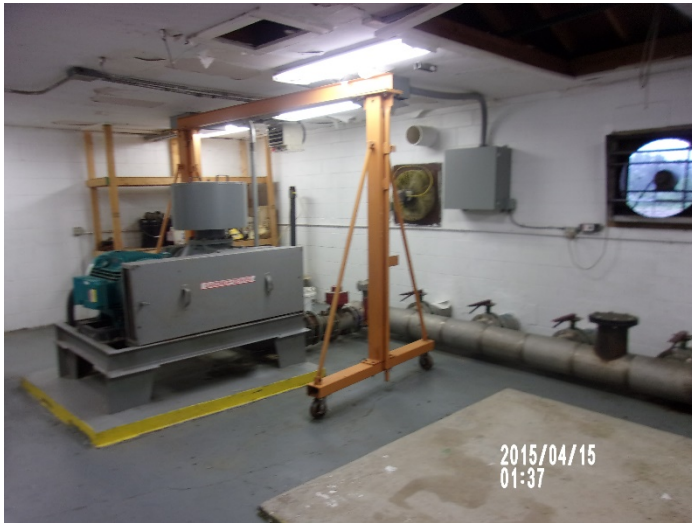
Photograph: # 11.
Taken By: Oscar Vazquez
Date Taken: July 29, 2019
Program: ECA Unit

Entity: Eureka WWTF
Permit: MO-0039569
Location: Blowers Building
Description: Old aeration pump used as backup.

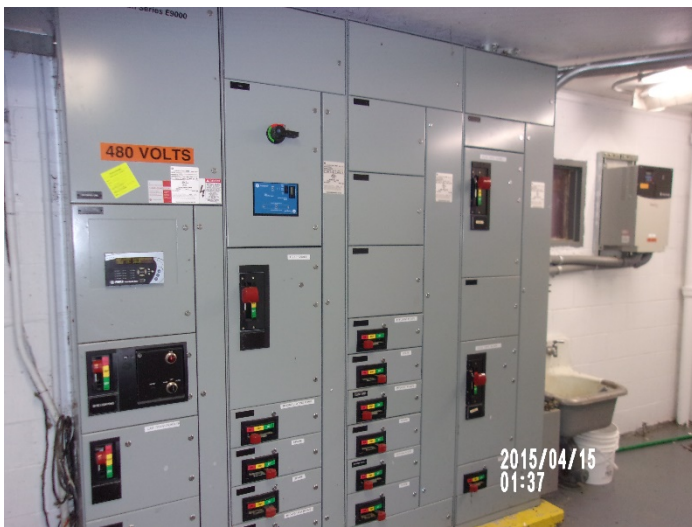
Photograph: # 12.
Taken By: Oscar Vazquez
Date Taken: July 29, 2019
Program: ECA Unit

Entity: Eureka WWTF
Permit: MO-0039569
Location: Blowers Building
Description: Aeration pump panels.

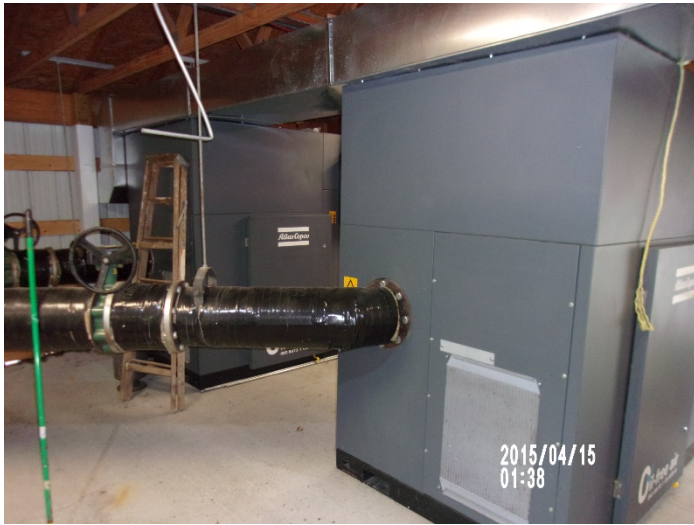
Photograph: # 13.
Taken By: Oscar Vazquez
Date Taken: July 29, 2019
Program: ECA Unit

Entity: Eureka WWTF
Permit: MO-0039569
Location: Blowers Building
Description: Turbo blowers.

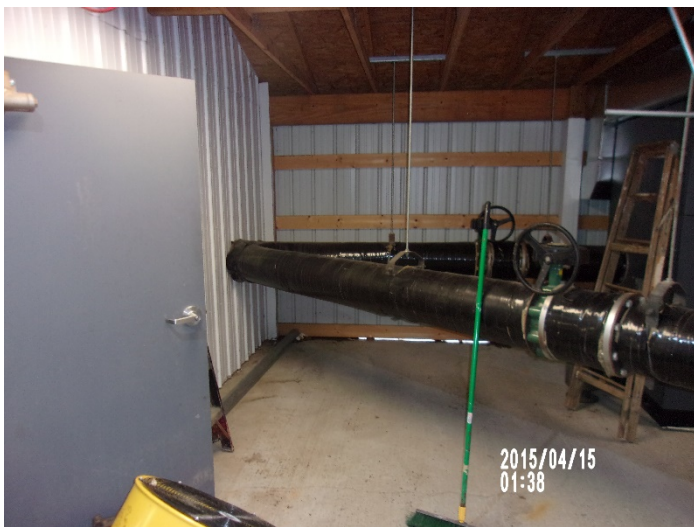
Photograph: # 14.
Taken By: Oscar Vazquez
Date Taken: July 29, 2019
Program: ECA Unit

Entity: Eureka WWTF
Permit: MO-0039569
Location: Blowers Building
Description: Turbo blower ducts system.

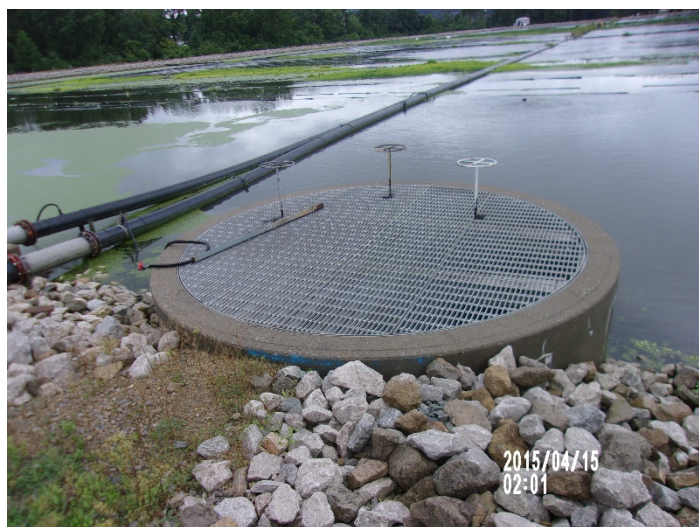
Photograph: # 15.
Taken By: Oscar Vazquez
Date Taken: July 29, 2019
Program: ECA Unit

Entity: Eureka WWTF
Permit: MO-0039569
Location: Effluent Structure
Description: The three valves are manually operated to draw and control lagoon cell #3 outflows at three different depths. To some extent, the effluent structure design allows the operator to control the lagoon effluent blend.

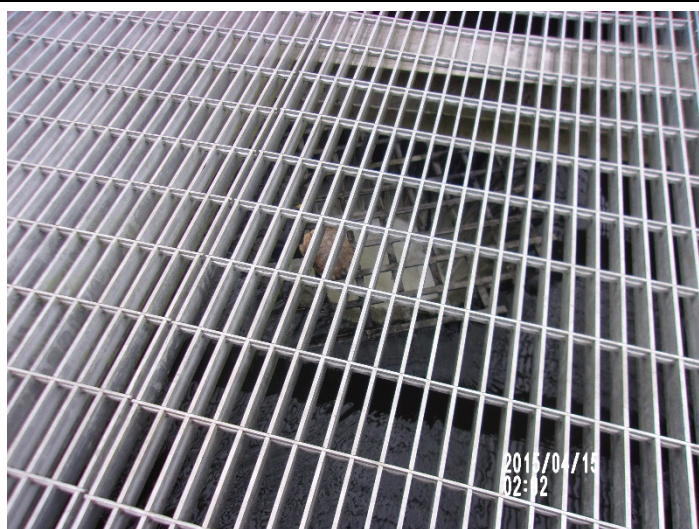
Photograph: # 16.
Taken By: Oscar Vazquez
Date Taken: July 29, 2019
Program: ECA Unit

Entity: Eureka WWTF
Permit: MO-0039569
Location: Effluent Structure
Description: The effluent blend overflows and is conveyed by gravity to the UV disinfection unit.

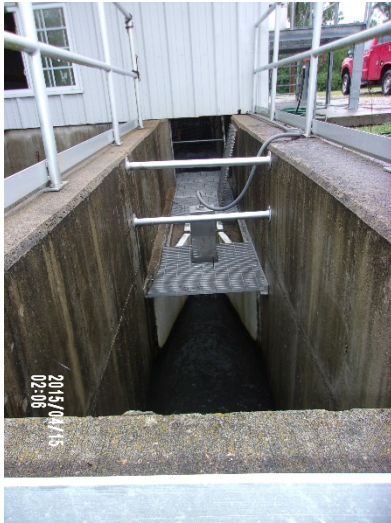
Photograph: # 17.
Taken By: Oscar Vazquez
Date Taken: July 29, 2019
Program: ECA Unit

Entity: Eureka WWTF
Permit: MO-0039569
Location: UV Disinfection System Building
Description: Looking downstream: Parshall channel with mounted ultrasonic flow meter.

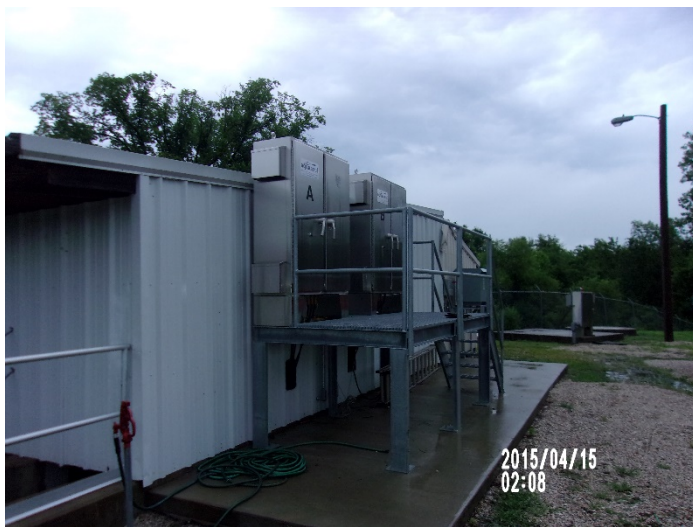
Photograph: # 18.
Taken By: Oscar Vazquez
Date Taken: July 29, 2019
Program: ECA Unit

Entity: Eureka WWTF
Permit: MO-0039569
Location: UV Disinfection System Building
Description: UV Disinfection Unit Control Panels are raised to the 100-year floodplain.

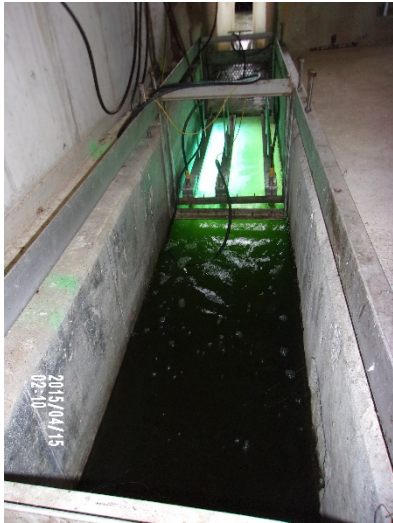
Photograph: # 19.
Taken By: Oscar Vazquez
Date Taken: July 29, 2019
Program: ECA Unit

Entity: Eureka WWTF
Permit: MO-0039569
Location: UV Disinfection System Building
Description: Looking upstream, after the Parshall channel, it can be observed that one of the UV disinfection banks and some modules were out of service at the time of inspection.

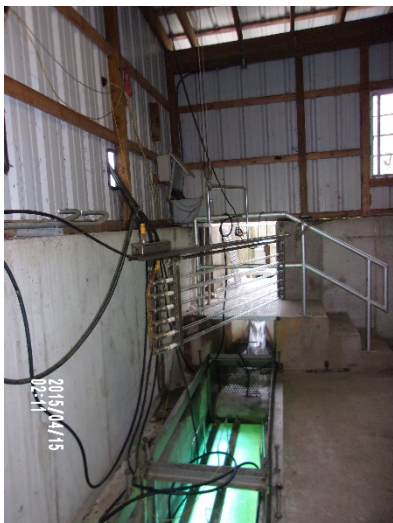
Photograph: # 20.
Taken By: Oscar Vazquez
Date Taken: July 29, 2019
Program: ECA Unit

Entity: Eureka WWTF
Permit: MO-0039569
Location: UV Disinfection System Building
Description: Out-of-service bulb module is shown in the photo.

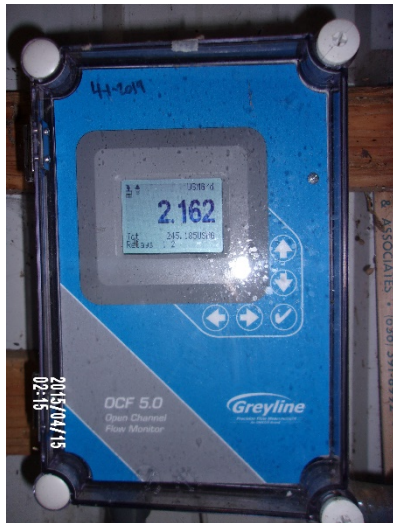
Photograph: # 21.
Taken By: Oscar Vazquez
Date Taken: July 29, 2019
Program: ECA Unit

Entity: Eureka WWTF
Permit: MO-0039569
Location: UV Disinfection System Building
Description: Flow meter controller.

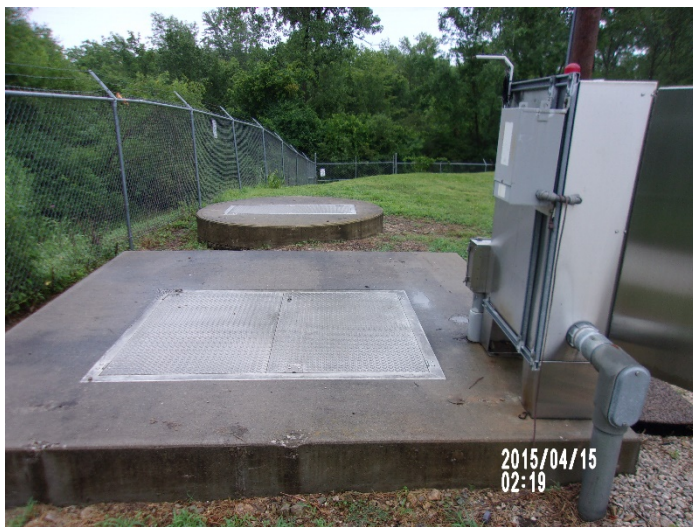
Photograph: # 22.
Taken By: Oscar Vazquez
Date Taken: July 29, 2019
Program: ECA Unit

Entity: Eureka WWTF
Permit: MO-0039569
Location: Effluent Lift Station (LS)
Description: In the foreground, the effluent LS and LS control panel. In the background, effluent check valves vault.

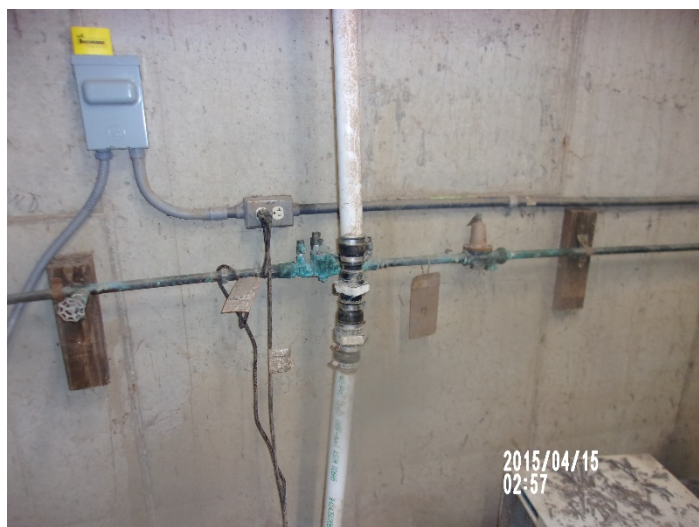
Photograph: # 23.
Taken By: Oscar Vazquez
Date Taken: July 29, 2019
Program: ECA Unit

When inquired about the use of backflow preventers to protect potable water supplies, Mr. Ricks explained that the facility has three backflow preventers installed. We observed one of the plant's

Entity: Eureka WWTF
Permit: MO-0039569
Location: WWTF Office/Lab Building
Description: Backflow preventer.

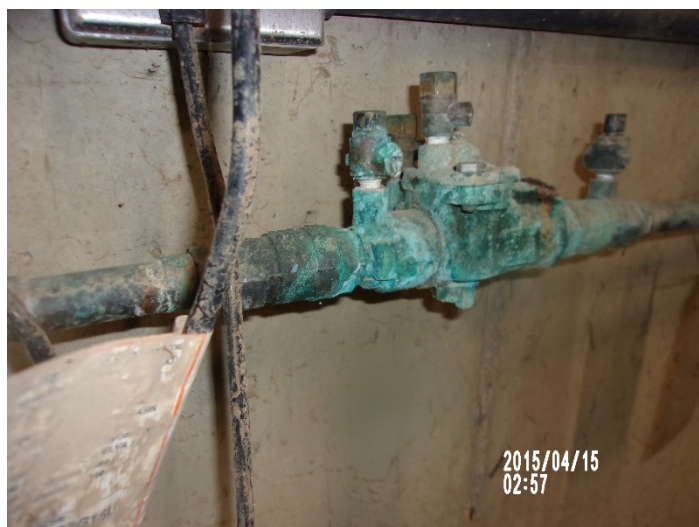
Photograph: # 24.
Taken By: Oscar Vazquez
Date Taken: July 29, 2019
Program: ECA Unit

Entity: Eureka WWTF
Permit: MO-0039569
Location: WWTF Office/Lab Building
Description: Backflow preventer.
