**Missouri Public Service Commission
Staff Report on Restoration Efforts of
AmerenUE Following Severe
Thunderstorms on July 5th, 2004**

Issued: August 31, 2004

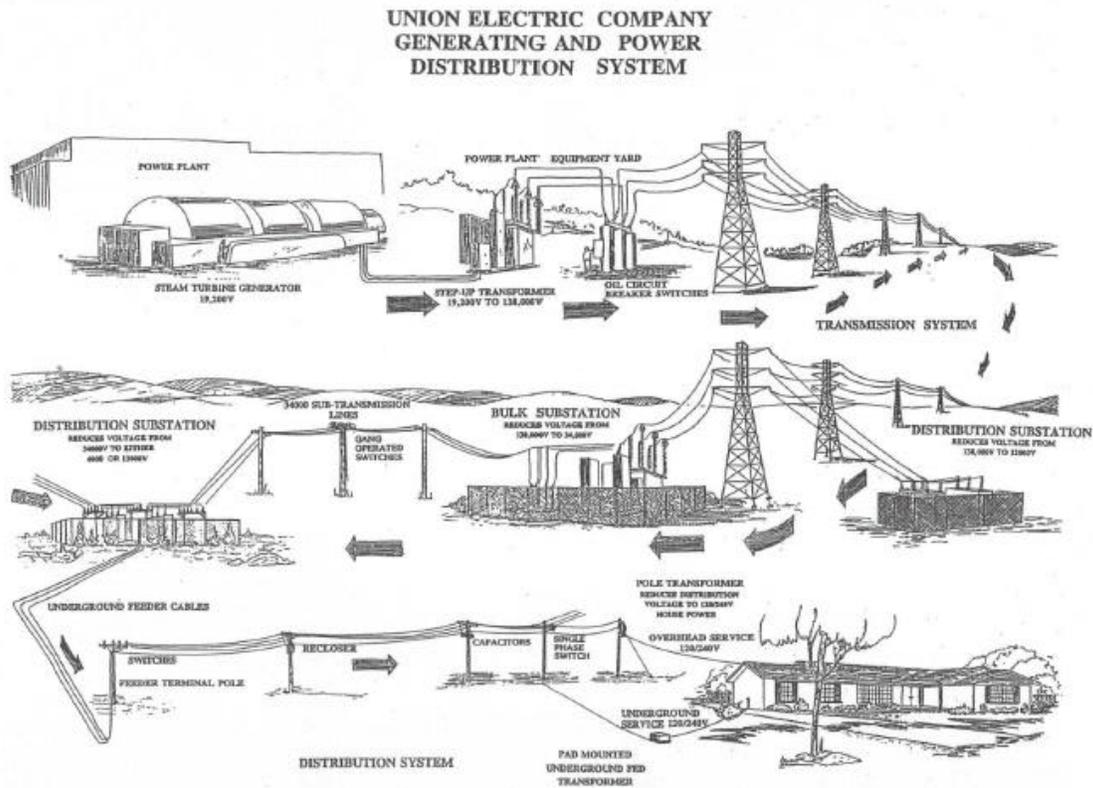
The primary conductors (typically 7,200 volts) of the distribution system are not insulated and contact with tree limbs can cause arcing or electrical short circuits to ground. This contact may cause quality of service problems for sensitive electrical equipment. Service lines (typically 240 volts) are insulated and can tolerate incidental tree contact. Much of the damage to AmerenUE’s system from these thunderstorms was to its distribution system. The following diagram illustrates the major elements of the infrastructure that AmerenUE depends on to deliver electricity to its customers:

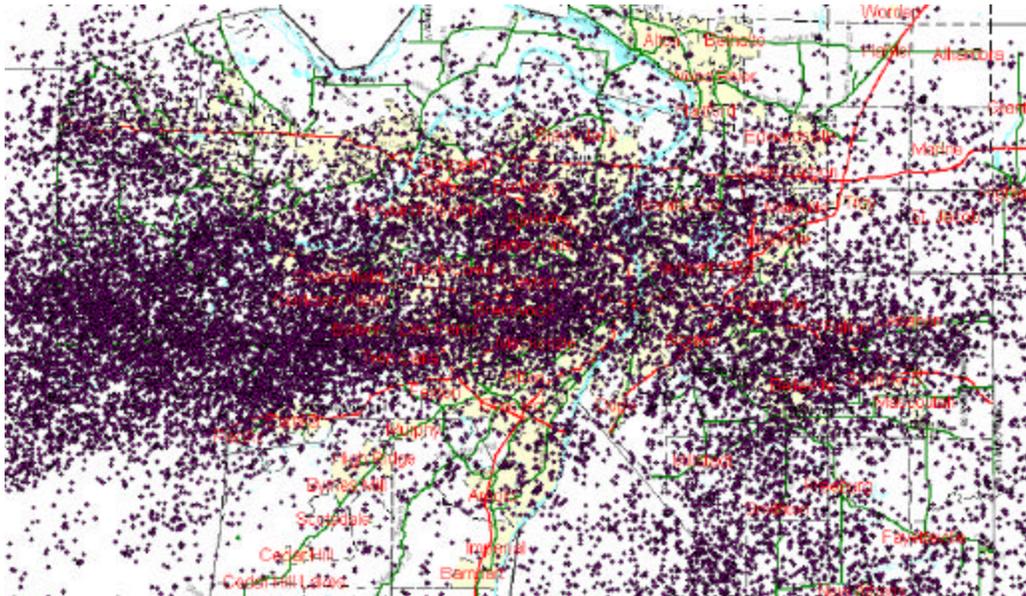
This storm delivered in excess of 25,000 lighting strokes with a peak hour of almost 10,000 strokes.

This map shows lighting stroke locations associated with this storm in the St. Louis area (provided by AmerenUE):

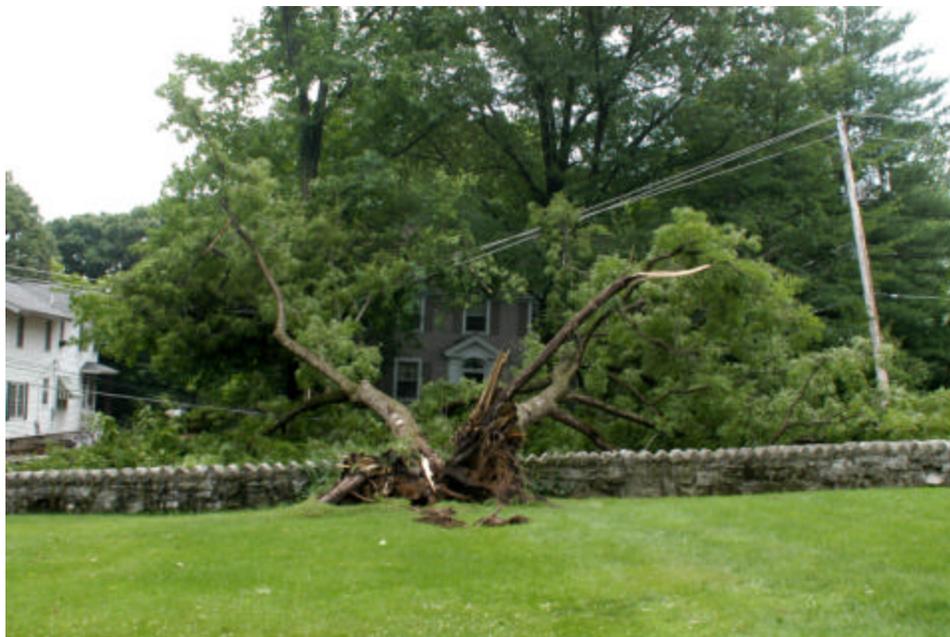
A picture of one of the trees that was toppled by the winds associated with this storm (provided by AmerenUE):

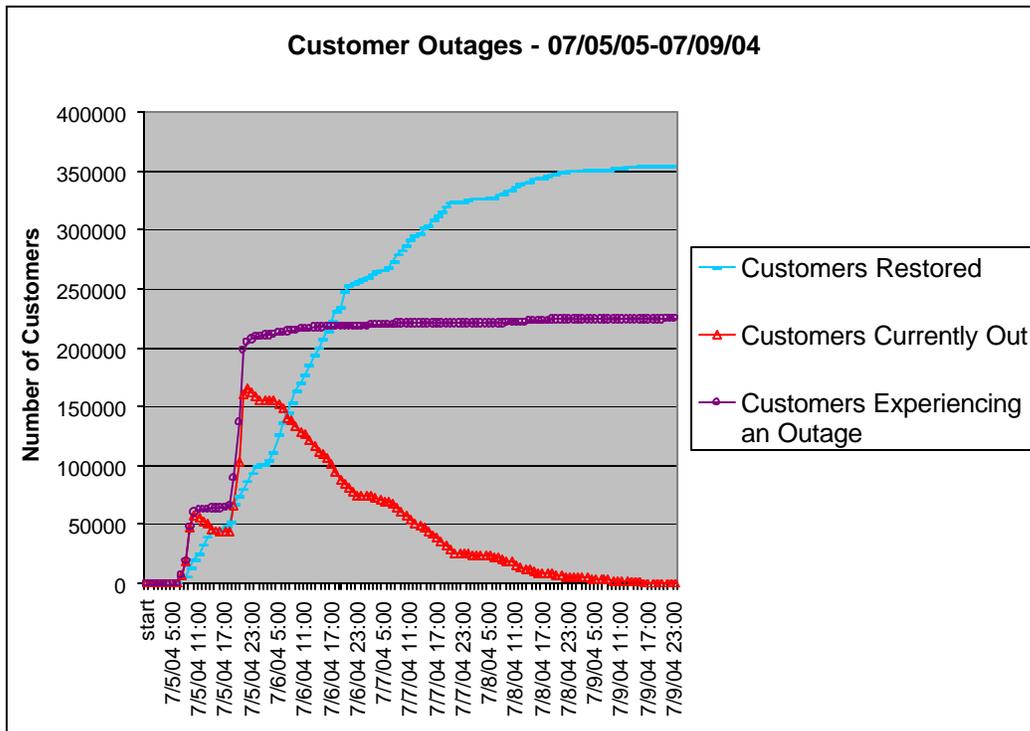
Typical utility service restoration efforts after a major outage event such as this one focus on bringing as many customers back on as quickly as possible. This approach is advantageous to the greatest possible number of customers. This approach is not however advantageous to the individual customer who may have extensive damage to the distribution system that serves only their home or a small group of homes. This approach may also not be advantageous to the individual who may be a registered medical-need customer but has several items that need to be repaired in order for their service to be restored. This procedure must however recognize that certain critical facilities like water pumping stations, sewage pumping stations, hospitals, fire stations, police stations, and identified shelters necessary for life and safety must have their service restored as quickly as reasonably possible. These priority exceptions for life and safety related reasons do not currently extend to care facilities for the elderly or disabled. It is Staff's understanding that AmerenUE follows this policy in its allocation of resources to respond to major outage events. Staff believes this is an appropriate policy for allocation of personnel and equipment resources during major restoration efforts as it results in the greatest number of customers being brought back on in the shortest period of time. The efforts of the personnel and equipment that were allocated to repair AmerenUE's distribution system after these storms resulted in the following restoration rate information (data from AmerenUE).

At first glance it is difficult to understand how the “Customers Restored” line in the previous graph could be higher than the “Customers Experiencing an Outage” line. What this difference in lines is primarily showing is the number of customers that were out as a result of more than 1 fault between their residence and the operating portions of AmerenUE’s system. These customers are counted two or more times when their outage is partially repaired by one system repair but one or more additional system repairs are necessary to actually get power to their residence.

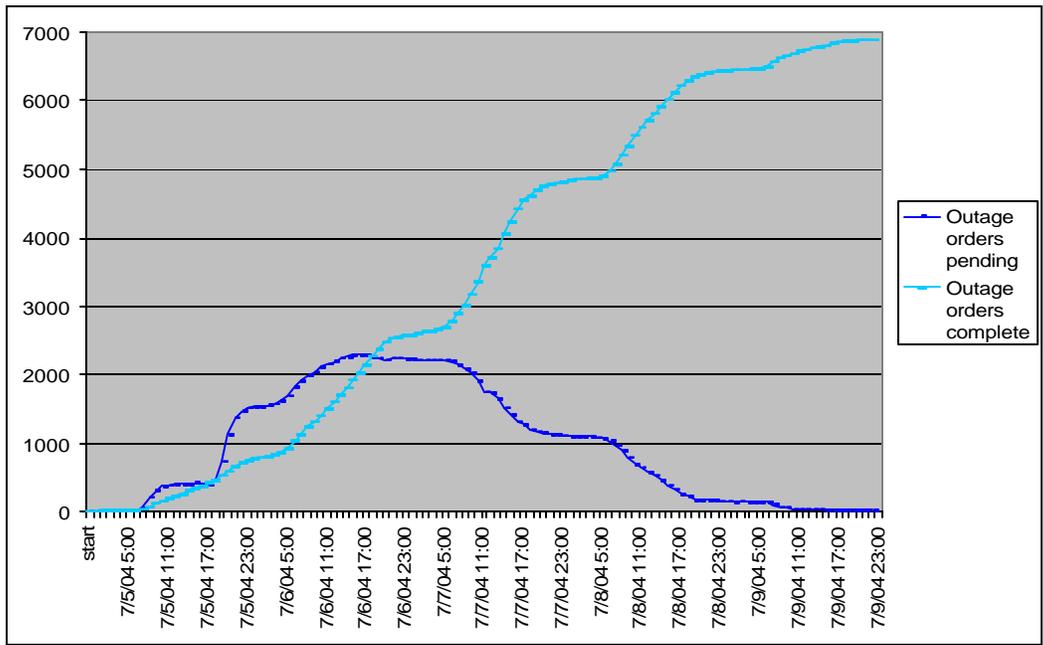
Another way to look at this data is to look at the outage orders complete at any given time versus the outage orders pending as shown in the following graph (data from AmerenUE). This graph clearly shows that the greatest productivity rates for the crews were observed July 6th and July 7th with a declining productivity on July 8th and especially on July 9th. This is a normal trend in productivity with major restoration efforts if the utility is focusing on the repair items that impact a large number of customers first and moving on to more individual house-by-house outage situations toward the end of the restoration effort. The arrival of additional crews and time required for them to become effective is also shown in this data in the difference in productivity rates between July 7th (the most productive day in terms of orders completed) and July 6th (the first full day of work after the storms and the second most productive day). This may also be an illustration of the level of tree related damage from these storms and how long it took to make progress clearing the debris.

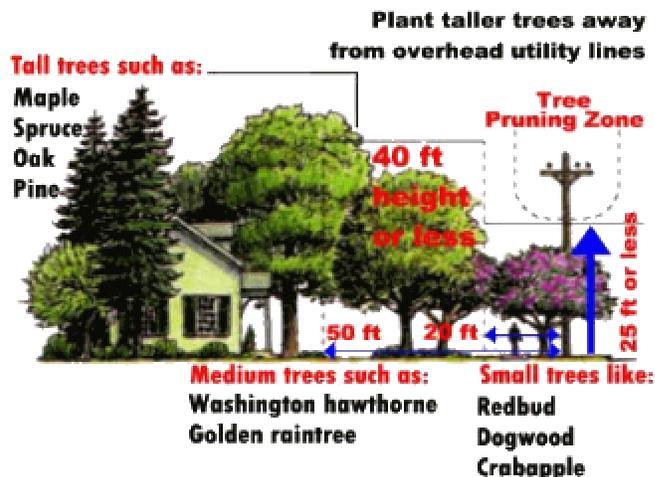
AmerenUE's website also provides the following diagram to assist customers in determining where and what kind of trees they can plant in the portions of their property that are near power lines:

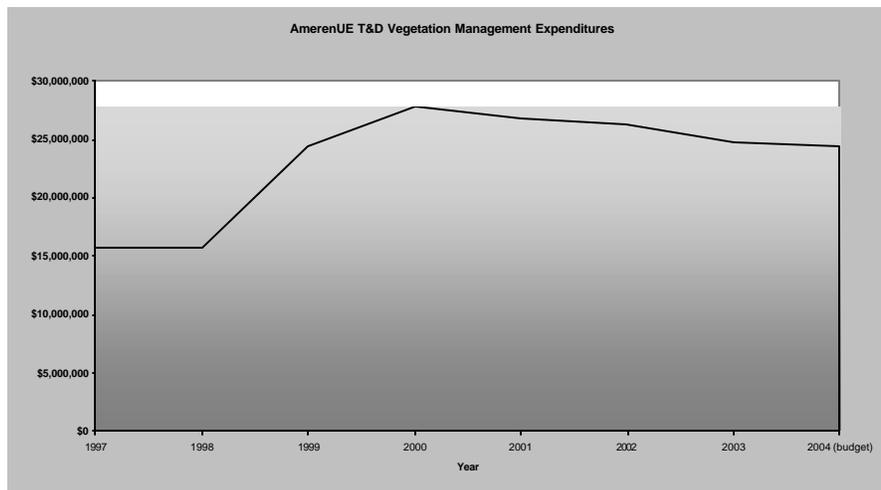
Staff's concerns with AmerenUE's tree trimming cycle situation resulted in several questions regarding recent and projected budgets to support vegetation management. In Staff's informal investigation following the ice storm in January of 2002 it was observed that AmerenUE had generally increased its expenditures on vegetation management from 1998 to 2001 with a slight decrease in 2001 vs. 2000. It was anticipated in 2002 that AmerenUE would be able to make some progress on its vegetation management schedules with these increases in expenditures. At this time, Staff's view of AmerenUE's vegetation management trim cycles is that this situation has not improved. The following chart shows that AmerenUE has not increased its vegetation management expenditures since 2000 and has in fact been spending less each year since 2000.

As a result of the observations in this report regarding vegetation management practices at AmerenUE and their current status, Staff strongly recommends that AmerenUE immediately implement programs to begin addressing the existing backlog in tree trimming cycles of its distribution systems in rural and suburban areas. AmerenUE’s efforts to address this current backlog in distribution system trimming should not be implemented through any types of reductions in current efforts to adequately control vegetation along their transmission system corridors or in reductions in efforts in other areas that could impact system reliability or safety. Staff notes that AmerenUE has policies currently in place regarding vegetation management, working with impacted landowners and public relations. AmerenUE should not diminish or stop applying any of these customer relation policies or practices in its efforts to address this current backlog in tree trimming work.

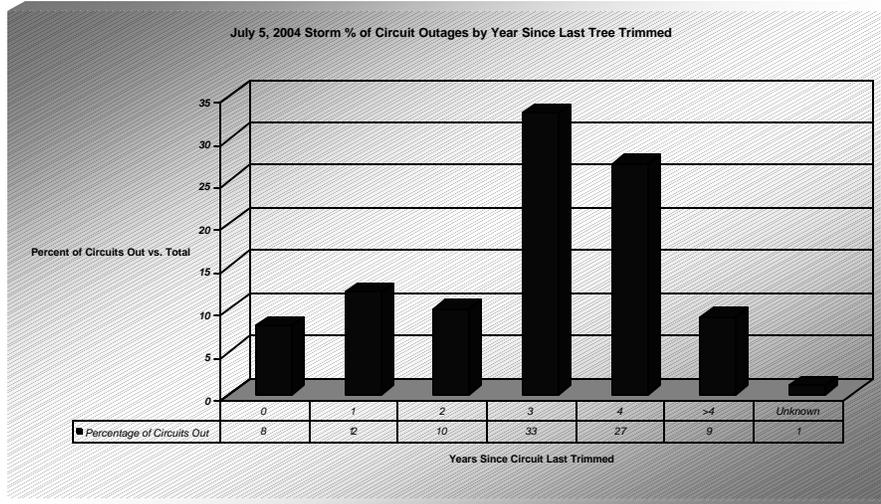
Staff also looked at circuit outages versus tree trim cycles and was provided with the following information by AmerenUE on the circuit outages from the storms on July 5, 2004:

This chart illustrates that the circuits that had been trimmed 3 or 4 years ago made up 60% of the circuits that were out as a result of these storms. Circuits that had last been trimmed less than 3 years ago made up 30% of the total. It should be noted that all of this data might reflect differences in storm damage density versus circuit trim cycles in particular areas and therefore may reflect some circumstances beyond just how recently the circuit was trimmed. An anomaly in the data was observed in circuits that were trimmed 5, 6 or more years ago. As noted, this may be an issue with the distribution of these circuits versus where the greatest density of storm damage was observed.

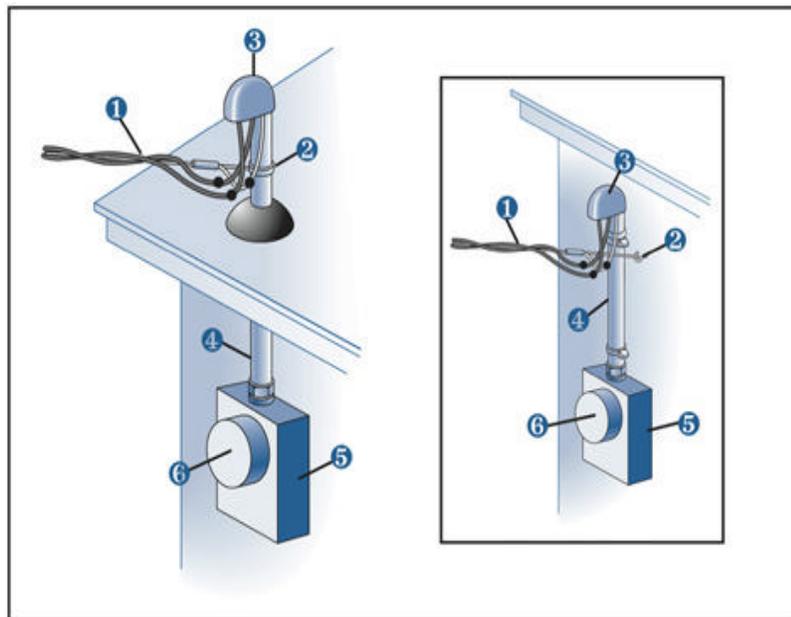
It should be noted that a significant number of customers had the service line to their home damaged by trees and/or tree limbs and this caused their outage. AmerenUE has limited responsibilities in returning customers to service who have facilities damaged that are not AmerenUE’s responsibility to maintain or repair. AmerenUE is not responsible for vegetation management along the service line where it drops from AmerenUE’s distribution line to the customer’s connection on their residence. AmerenUE will disconnect power from a service drop for no charge if a customer wishes to trim the vegetation along these service drops safely. AmerenUE recommends that customers hire a professional tree service to do this trimming. The following diagram helps to illustrate which portions of the connection to the customer’s house AmerenUE installs and maintains (diagram from Kansas City Power & Light website):

Typical overhead service drop connection elements to home & their descriptions:

- 1) **Service Line (Service Drop)**
- 2) Service Bracket
- 3) Weatherhead
- 4) Pipe Riser
- 5) Meter Can
- 6) **Electric Meter**

The items identified above that are not AmerenUE’s responsibility to install or maintain are the customer’s responsibility to have repaired if they are damaged. If a meter box is pulled away from the home and a customer has no power the utility may perform a temporary fix to provide power. A qualified electrician should do any of the work required to restore service that is not provided by AmerenUE.
