Exhibit No. \_\_\_\_\_  
Issue: DNR Policy; Technical, Managerial and  
Financial Capability of CSWR  
Witness: Kristi Savage-Clarke  
Type of Exhibit: Surrebuttal Testimony  
Sponsoring Party: Confluence Rivers Utility  
Operating Company, Inc.  
File Nos.: WA-2019-0299  
Date: September 23, 2019

**Missouri Public Service Commission**

**Surrebuttal Testimony**

**Kristi Savage-Clarke**

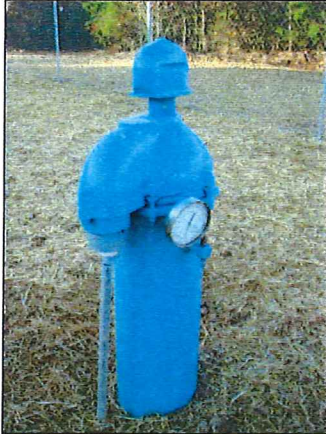
**Photo #:001**  
**Date Taken:** 10/26/2016  
**By:** Michelle Oglesby  
**Program:** PDWB  
**File:** Crawford County  
**Location:** Indian Hills Utilities Operating Co. Inc.  
**Description:** Well #1

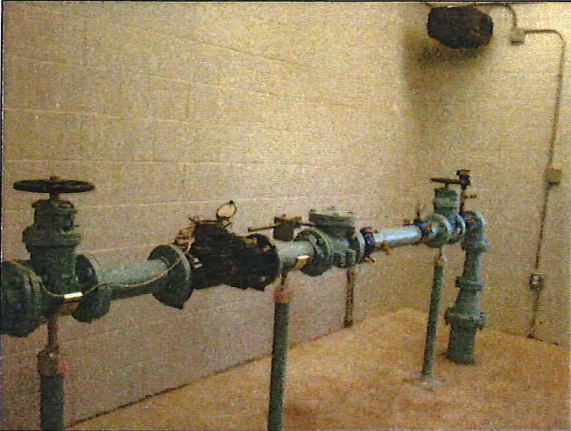
**Photo #:002**  
**Date Taken:** 10/26/2016  
**By:** Michelle Oglesby  
**Program:** PDWB  
**File:** Crawford County  
**Location:** Indian Hills Utilities Operating Co. Inc.  
**Description:** Well #1 - Piping

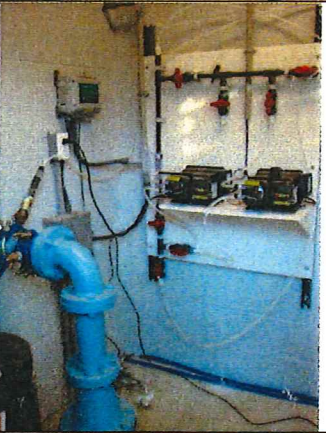
**Photo #:003**  
**Date Taken:** 10/26/2016  
**By:** Michelle Oglesby  
**Program:** PDWB  
**File:** Crawford County  
**Location:** Indian Hills Utilities Operating Co. Inc.  
**Description:** Well #1 – Chlorine Room with chlorine pumps.

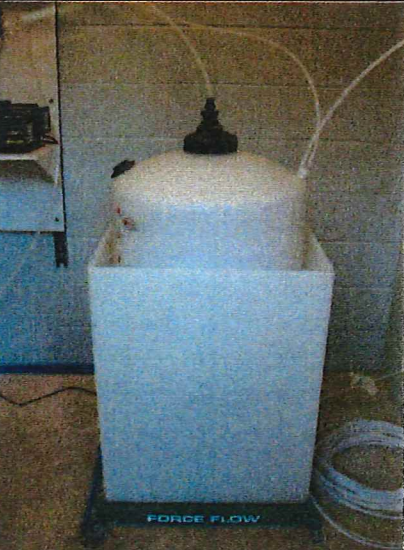
**Photo #:004**  
**Date Taken:** 10/26/2016  
**By:** Michelle Oglesby  
**Program:** PDWB  
**File:** Crawford County  
**Location:** Indian Hills Utilities Operating Co. Inc.  
**Description:** Well #1 – Chlorine Room with chemical storage.

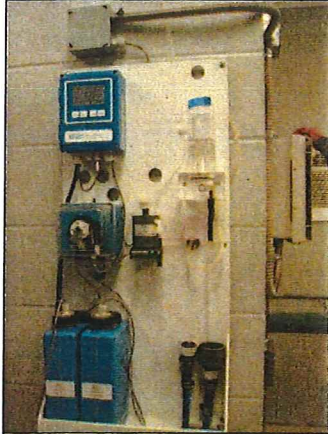
**Photo #:005**  
**Date Taken:** 10/26/2016  
**By:** Michelle Oglesby  
**Program:** PDWB  
**File:** Crawford County  
**Location:** Indian Hills Utilities Operating Co. Inc.  
**Description:** Well #1 – Continuous chlorine reader.

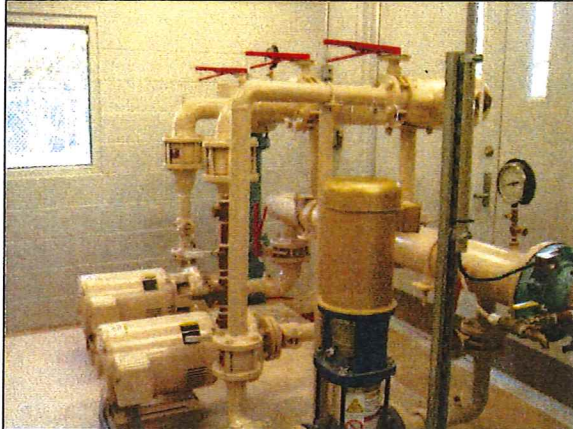
**Photo #:006**  
**Date Taken:** 10/26/2016  
**By:** Michelle Oglesby  
**Program:** PDWB  
**File:** Crawford County  
**Location:** Indian Hills Utilities Operating Co. Inc.  
**Description:** Well #1 – Booster Pump Station

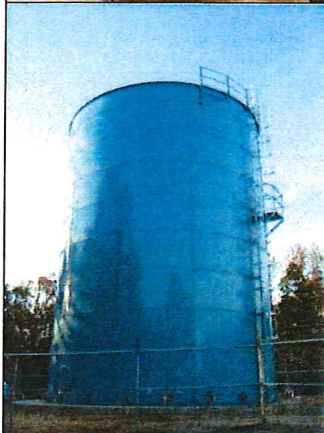
**Photo #:007**  
**Date Taken:** 10/26/2016  
**By:** Michelle Oglesby  
**Program:** PDWB  
**File:** Crawford County  
**Location:** Indian Hills Utilities Operating Co. Inc.  
**Description:** Well #1 – 263,000 gallon standpipe.

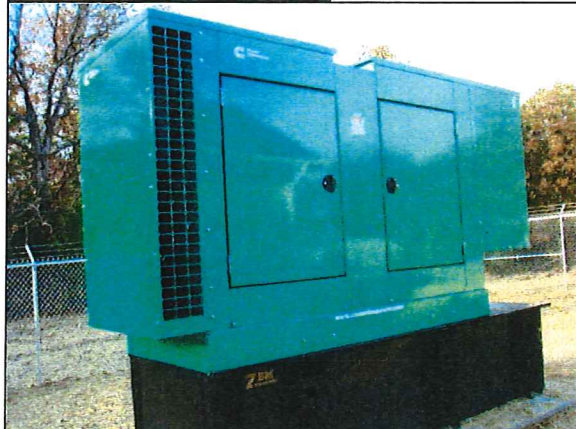
**Photo #:008**  
**Date Taken:** 10/26/2016  
**By:** Michelle Oglesby  
**Program:** PDWB  
**File:** Crawford County  
**Location:** Indian Hills Utilities Operating Co. Inc.  
**Description:** Well #1 – Generator

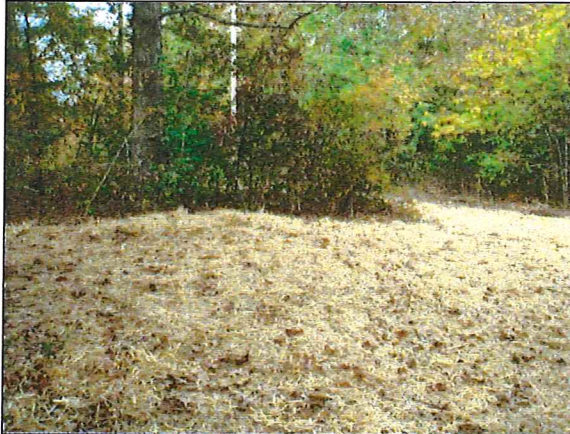
**Photo #:009**  
**Date Taken:** 10/26/2016  
**By:** Michelle Oglesby  
**Program:** PDWB  
**File:** Crawford County  
**Location:** Indian Hills Utilities Operating Co. Inc.  
**Description:** Location where Well #2 used to be.

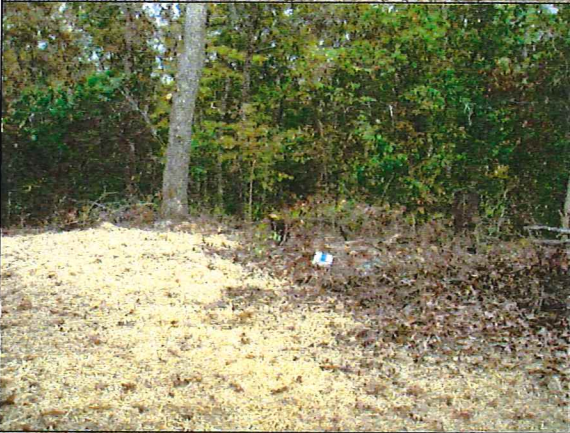
**Photo #:010**  
**Date Taken:** 10/26/2016  
**By:** Michelle Oglesby  
**Program:** PDWB  
**File:** Crawford County  
**Location:** Indian Hills Utilities Operating Co. Inc.  
**Description:** Location where Well #2 booster pumps station was located.

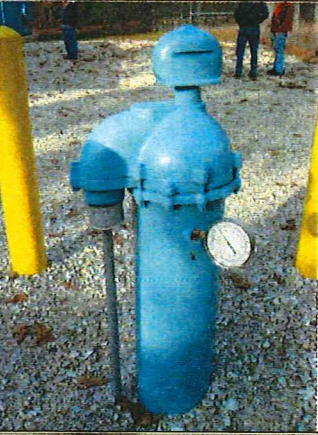
**Photo #:011**  
**Date Taken:** 10/26/2016  
**By:** Michelle Oglesby  
**Program:** PDWB  
**File:** Crawford County  
**Location:** Indian Hills Utilities Operating Co. Inc.  
**Description:** Well #3

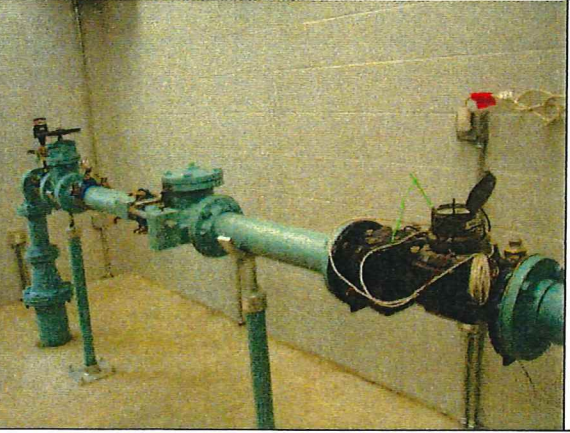
**Photo #:012**  
**Date Taken:** 10/26/2016  
**By:** Michelle Oglesby  
**Program:** PDWB  
**File:** Crawford County  
**Location:** Indian Hills Utilities Operating Co. Inc.  
**Description:** Well #3 - Piping

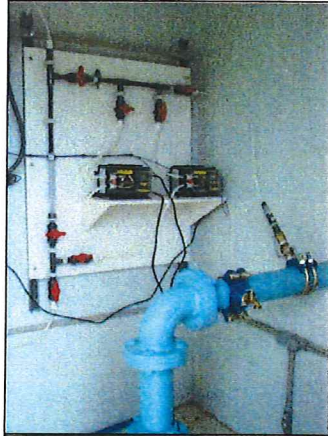
**Photo #:013**  
**Date Taken:** 10/26/2016  
**By:** Michelle Oglesby  
**Program:** PDWB  
**File:** Crawford County  
**Location:** Indian Hills Utilities Operating Co. Inc.  
**Description:** Well #3 – Chlorine Room with chlorine pumps.

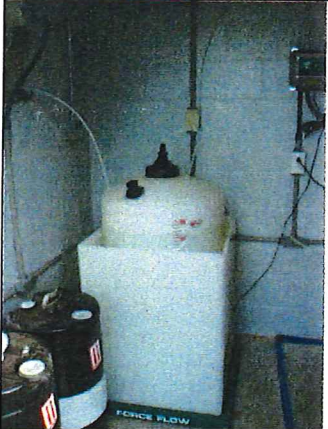
**Photo #:014**  
**Date Taken:** 10/26/2016  
**By:** Michelle Oglesby  
**Program:** PDWB  
**File:** Crawford County  
**Location:** Indian Hills Utilities Operating Co. Inc.  
**Description:** Well #3 – Chlorine Room with chemical storage.

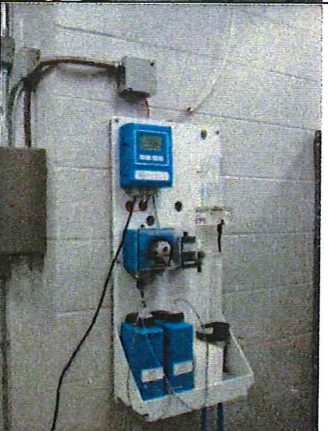
**Photo #:015**  
**Date Taken:** 10/26/2016  
**By:** Michelle Oglesby  
**Program:** PDWB  
**File:** Crawford County  
**Location:** Indian Hills Utilities Operating Co. Inc.  
**Description:** Well #3 – Continuous chlorine reader.

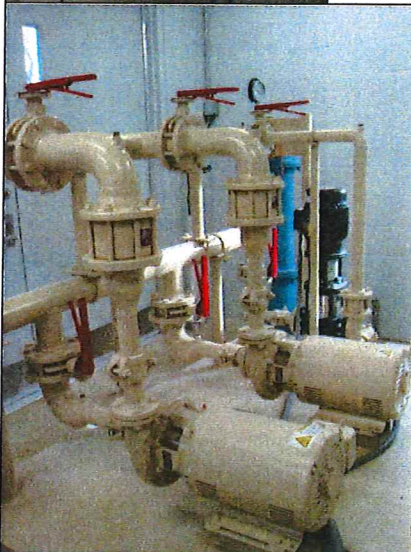
**Photo #:016**  
**Date Taken:** 10/26/2016  
**By:** Michelle Oglesby  
**Program:** PDWB  
**File:** Crawford County  
**Location:** Indian Hills Utilities Operating Co. Inc.  
**Description:** Well #3 – Booster Pump Station.

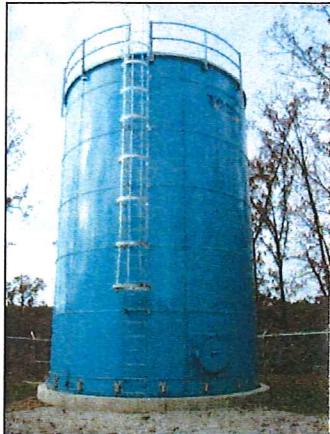
**Photo #:017**  
**Date Taken:** 10/26/2016  
**By:** Michelle Oglesby  
**Program:** PDWB  
**File:** Crawford County  
**Location:** Indian Hills Utilities Operating Co. Inc.  
**Description:** Well #3 – 53,000 gallon standpipe.

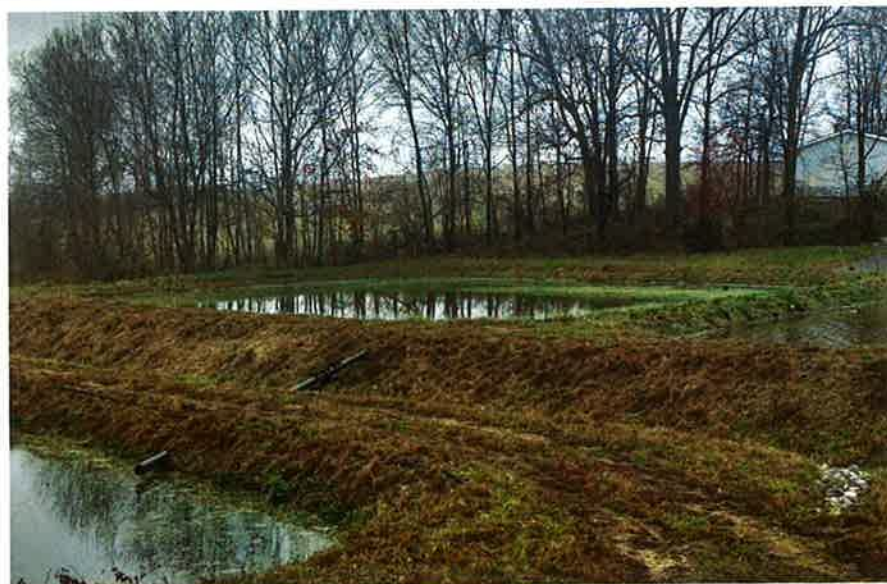
**Photo #:** 003  
**By:** Tim Mattingly  
**Facility:** Hillcrest Manor  
**Permit:** MO-0088072  
**Location:** Cape Girardeau County

**Description:** A photograph of the third cell of the Hillcrest Manor Subdivision. The pipe seen is for emergency maintenance on the second or third cells.

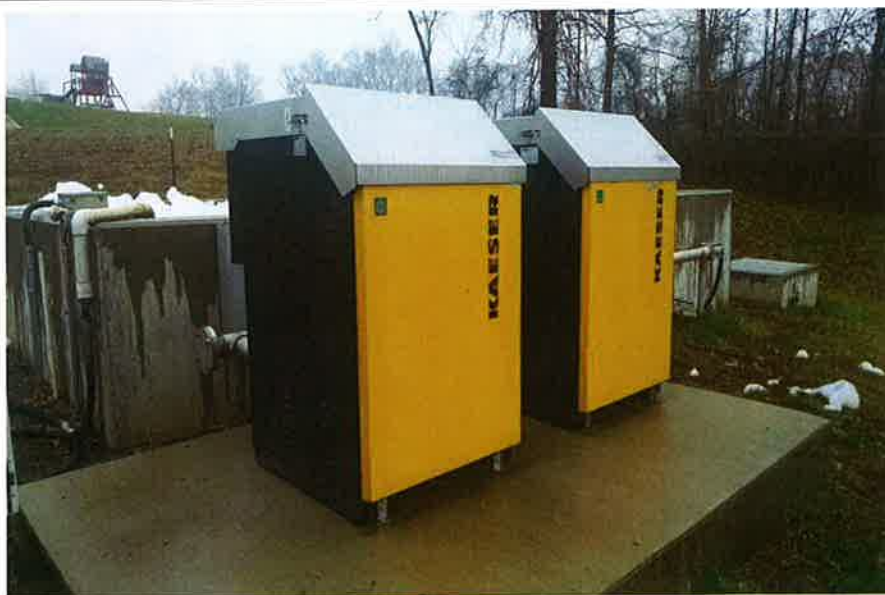
**Photo #:** 006  
**By:** Tim Mattingly  
**Facility:** Hillcrest Manor  
**Permit:** MO-0088072  
**Location:** Cape Girardeau County

**Description:** These are the two blowers that provide the air for the moving bed biofilm reactor. Their usage alternates between the two.

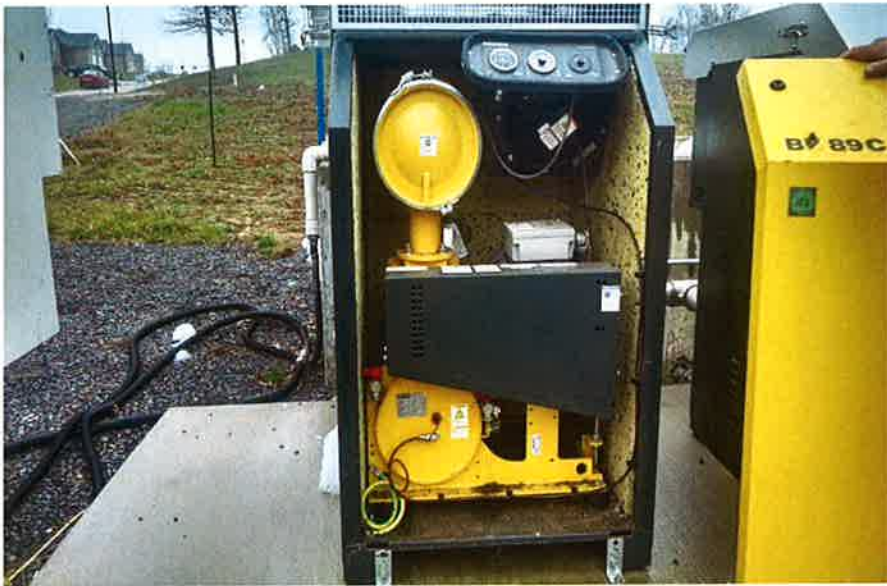
**Photo #:** 007  
**By:** Tim Mattingly  
**Facility:** Hillcrest Manor  
**Permit:** MO-0088072  
**Location:** Cape Girardeau County

**Description:** A picture of the internal components of the individual blowers.

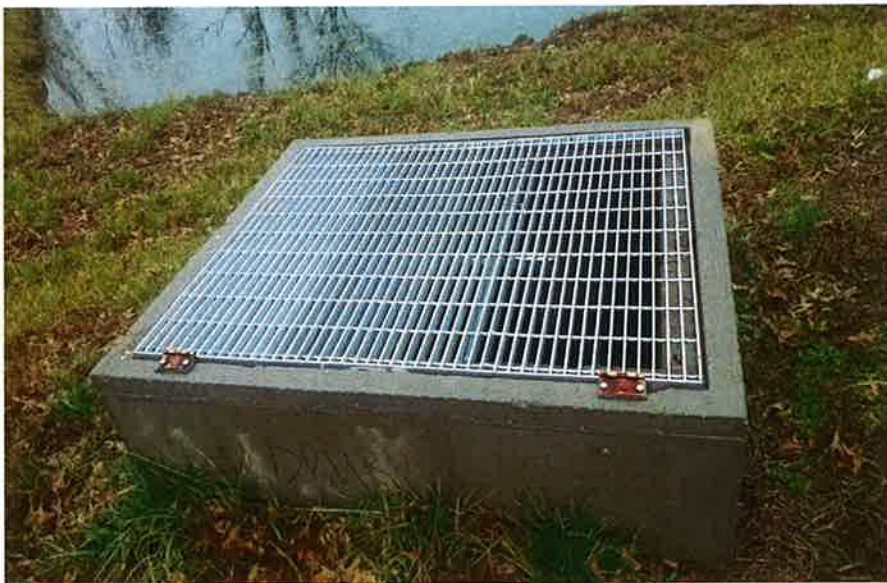
**Photo #:** 008  
**By:** Tim Mattingly  
**Facility:** Hillcrest Manor  
**Permit:** MO-0088072  
**Location:** Cape Girardeau County

**Description:** This is a photograph of the exterior of the weir box. The wastewater travels from the moving bed biofilm reactor to this structure.

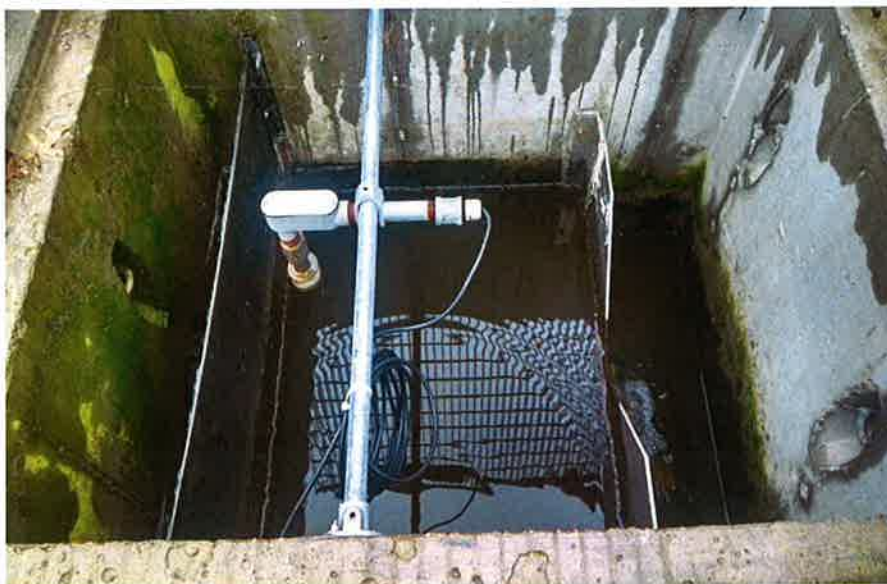
**Photo #:** 009  
**By:** Tim Mattingly  
**Facility:** Hillcrest Manor  
**Permit:** MO-0088072  
**Location:** Cape Girardeau County

**Description:** This is the interior of the weir box.

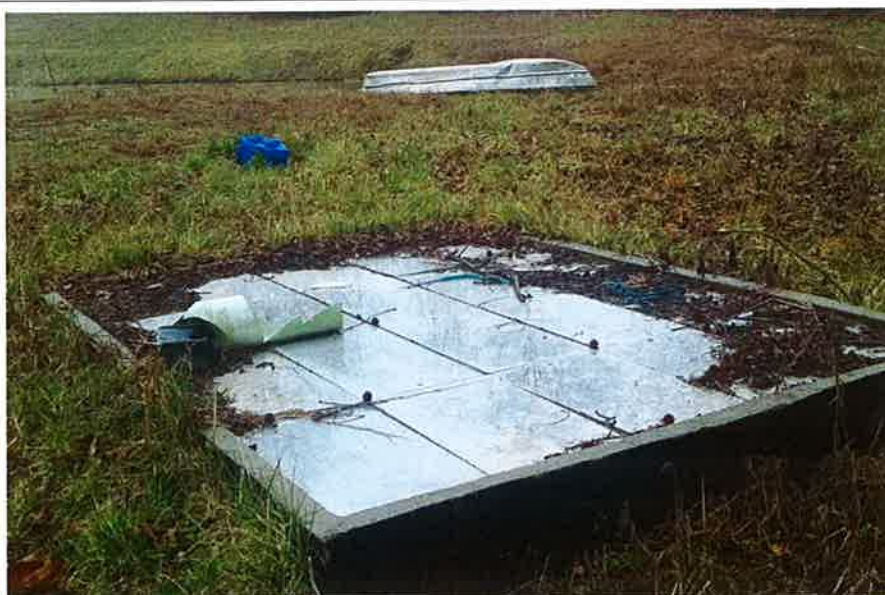
**Photo #:** 012  
**By:** Tim Mattingly  
**Facility:** Hillcrest Manor  
**Permit:** MO-0088072  
**Location:** Cape Girardeau County

**Description:** This is a photograph of the chlorine contact chamber. The blue box at the top of the picture is the tablet chlorinator.

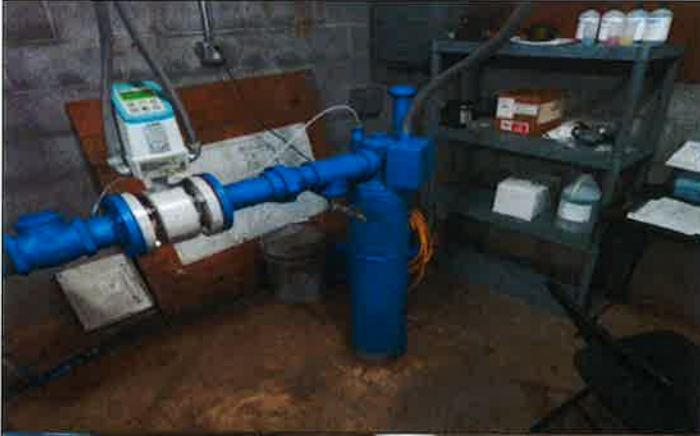
**Photo #: 001**  
**Date Taken:** 01/24/2018  
**By:** Michael Wyatt  
**Program:** PDWB  
**File:** Hillcrest Utility Operating Co., Inc. – General  
**Location:** Well house  
**Description:** Well.

Drawdown measurement tests performed on a monthly basis are recommended and can warn the operator of impending issues such as a screen blockage, low water table and/or excessive pump wear.

The Department recommends that the supply conduct monthly drawdown measurement tests and record the results for review.

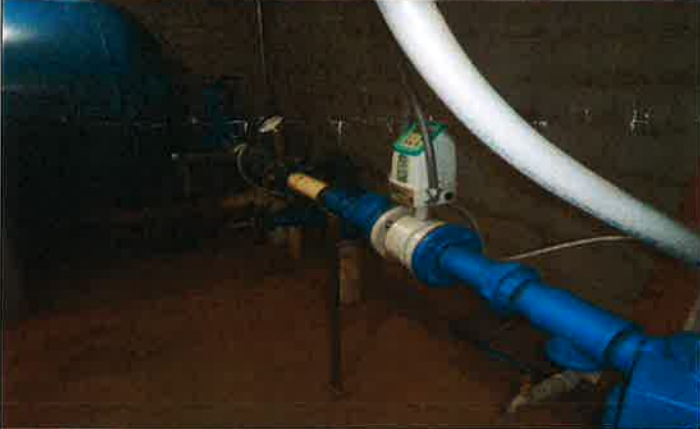
**Photo #: 002**  
**Date Taken:** 01/24/2018  
**By:** Michael Wyatt  
**Program:** PDWB  
**File:** Hillcrest Utility Operating Co., Inc. – General  
**Location:** Well house  
**Description:** Discharge piping.

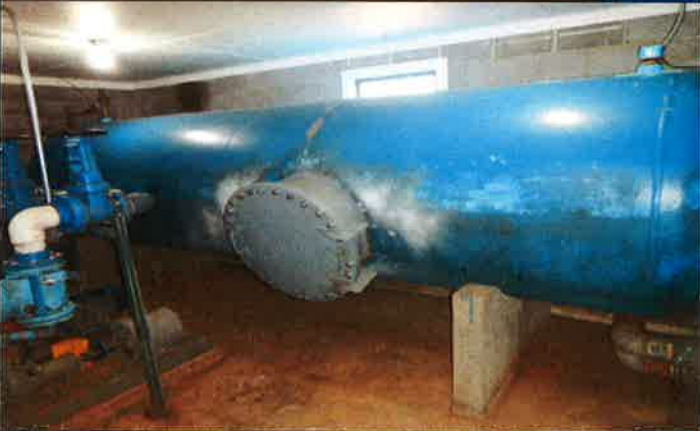
**Photo #: 003**  
**Date Taken:** 01/24/2018  
**By:** Michael Wyatt  
**Program:** PDWB  
**File:** Hillcrest Utility Operating Co., Inc. – General  
**Location:** Well house  
**Description:** ~2,100 gallon hydro-pneumatic pressure tank.

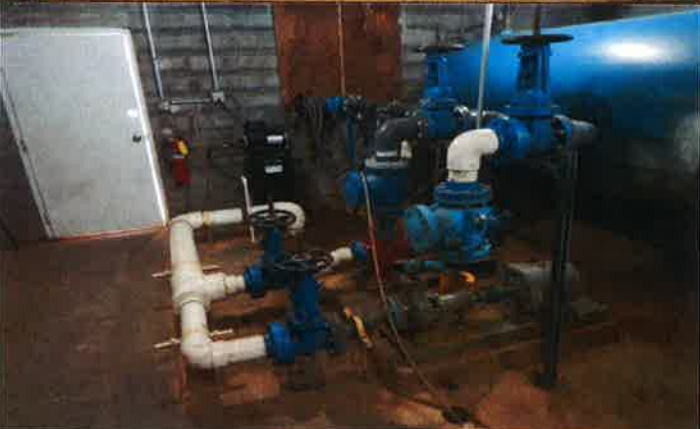
**Photo #: 004**  
**Date Taken:** 01/24/2018  
**By:** Michael Wyatt  
**Program:** PDWB  
**File:** Hillcrest Utility Operating Co., Inc. – General  
**Location:** Well house  
**Description:** High service pumps.

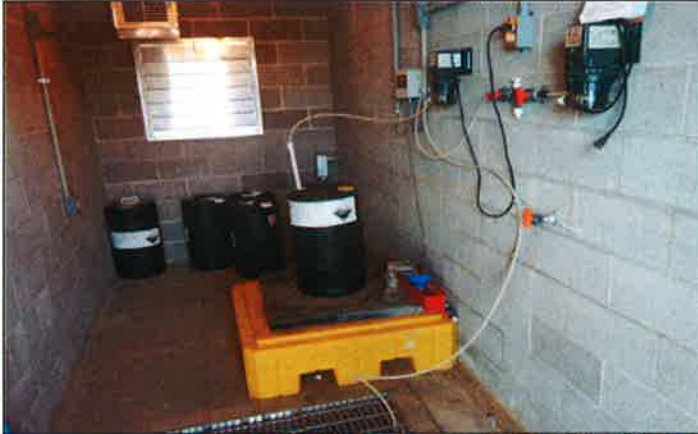
**Photo #: 005**  
**Date Taken:** 01/24/2018  
**By:** Michael Wyatt  
**Program:** PDWB  
**File:** Hillcrest Utility Operating Co., Inc. – General  
**Location:** Chlorine feed room  
**Description:** Chlorine feed system.

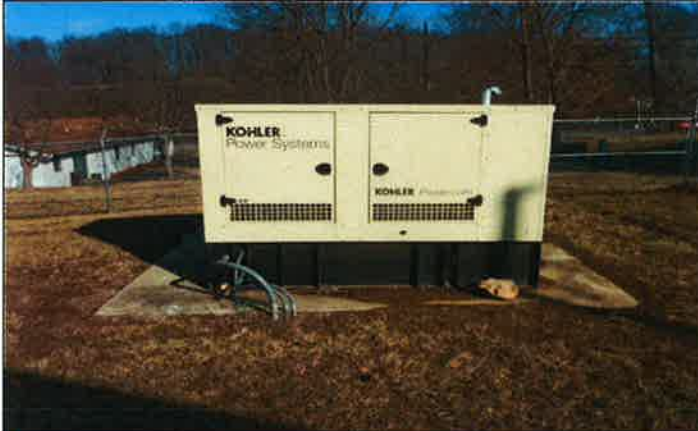
**Photo #: 006**  
**Date Taken:** 01/24/2018  
**By:** Michael Wyatt  
**Program:** PDWB  
**File:** Hillcrest Utility Operating Co., Inc. – General  
**Location:** Back of well house building  
**Description:** Stationary generator.

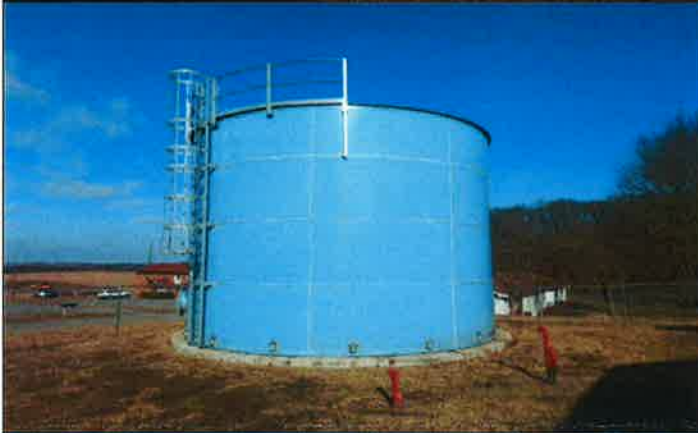
**Photo #: 007**  
**Date Taken:** 01/24/2018  
**By:** Michael Wyatt  
**Program:** PDWB  
**File:** Hillcrest Utility Operating Co., Inc. – General  
**Location:** Tank site  
**Description:** 58,000 gallon ground storage tank.

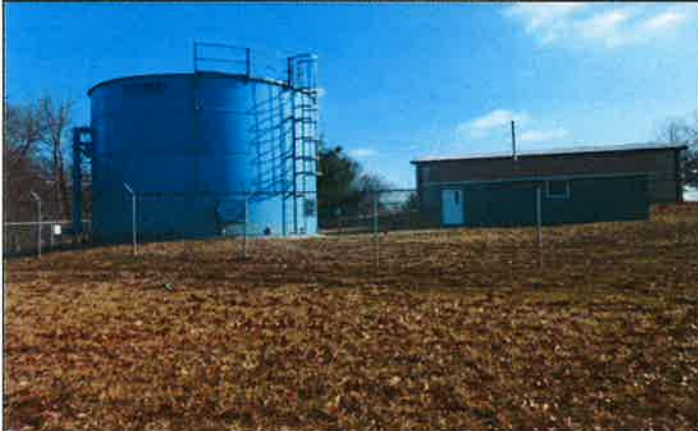
**Photo #: 008**  
**Date Taken:** 01/24/2018  
**By:** Michael Wyatt  
**Program:** PDWB  
**File:** Hillcrest Utility Operating Co., Inc. – General  
**Location:** Well/tank site  
**Description:** Fenced well house and storage tank.
