Exhibit No. _____
Issue: Company Background, Improvements,
Auditing and Tax Preparation Fees, Capital
Structure, Cost of Capital, Rate Case Expense
Witness: Josiah Cox
Type of Exhibit: Direct Testimony
Sponsoring Party: Indian Hills
Case No.: WR-2017-0259
Date: October 13, 2017

Direct Testimony

Josiah Cox

Indian Hills Utility Operating Company, Inc.

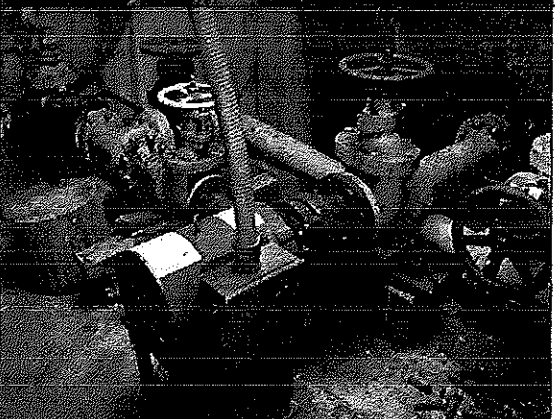
Photo #:8
Date Taken: 08/20/2014
By: Michelle Oglesby
Program: PDWB
File: Crawford County
Location: Indian Hills Utilities
Description: Pump and piping within the well house for Well #1.

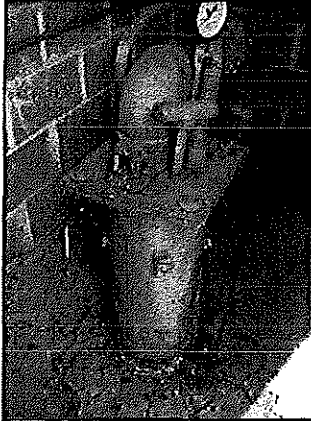
Photo #:9
Date Taken: 08/20/2014
By: Michelle Oglesby
Program: PDWB
File: Crawford County
Location: Indian Hills Utilities
Description: Well head and casing for Well #2.

This can be eliminated by repairing Well #2 and bringing it back on line. In addition to an emergency supply, Well #2 could also relieve Well #1 by alternating run times, giving the ground water recharge area around Well #1 additional time to replenish.

The department recommends that the public water system repair all components for Well #2, to have an additional source of water for the water system.

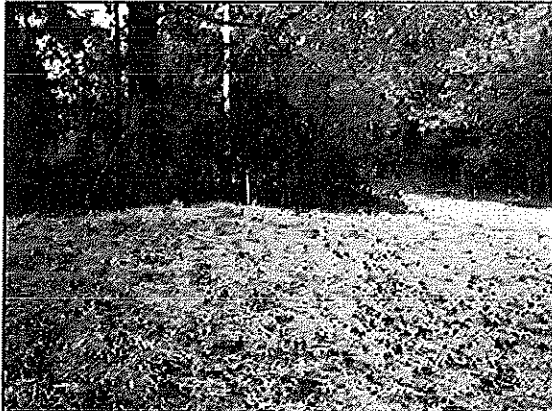
Photo #:009
Date Taken: 10/26/2016
By: Michelle Oglesby
Program: PDWB
File: Crawford County
Location: Indian Hills Utilities Operating Co. Inc.
Description: Location where Well #2 used to be.

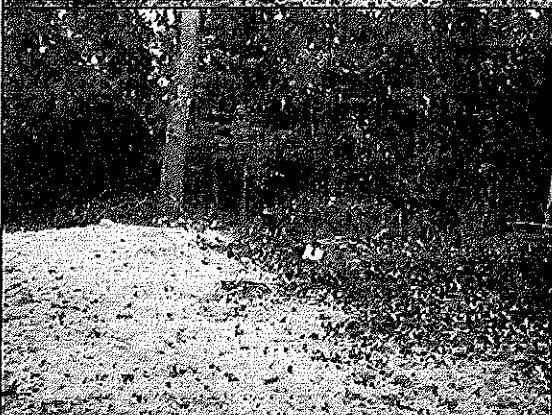
Photo #:010
Date Taken: 10/26/2016
By: Michelle Oglesby
Program: PDWB
File: Crawford County
Location: Indian Hills Utilities Operating Co. Inc.
Description: Location where Well #2 booster pumps station was located.

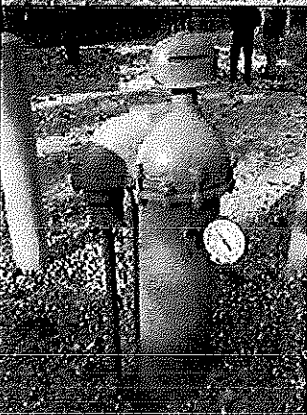
Photo #:011
Date Taken: 10/26/2016
By: Michelle Oglesby
Program: PDWB
File: Crawford County
Location: Indian Hills Utilities Operating Co. Inc.
Description: Well #3

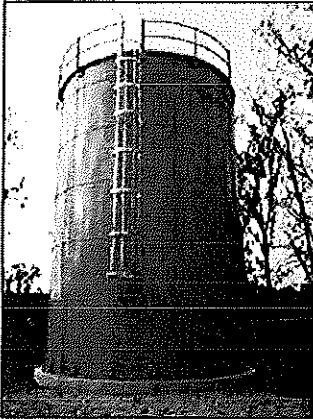
Photo #:017
Date Taken: 10/26/2016
By: Michelle Oglesby
Program: PDWB
File: Crawford County
Location: Indian Hills Utilities Operating Co. Inc.
Description: Well #3 – 53,000 gallon standpipe.
