**WATERS DELINEATION REPORT**

**MILLCREEK BESS PROJECT**  
**SILEX, LINCOLN COUNTY, MISSOURI**

**AMEREN MISSOURI**  
**1901 CHOUTEAU AVENUE**  
**ST. LOUIS, MO 63166**

**CIVIL & ENVIRONMENTAL CONSULTANTS, INC.**  
**ST. LOUIS, MO**

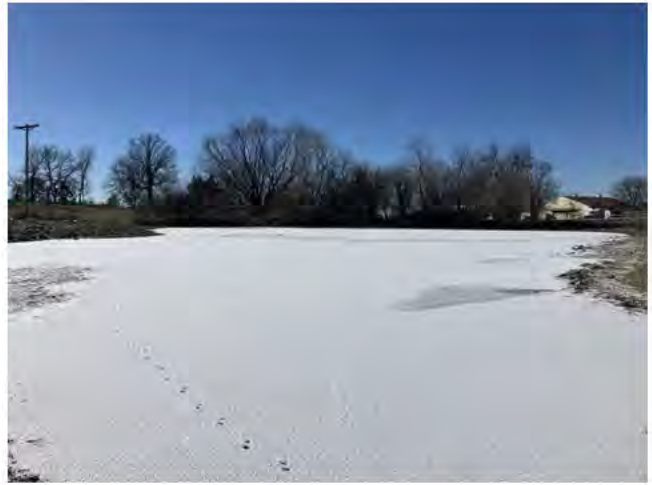
**Photo Number:** 82  
**Description:** Open Water 18. DOV is southwest.  
**Date Taken:** 12/15/2025

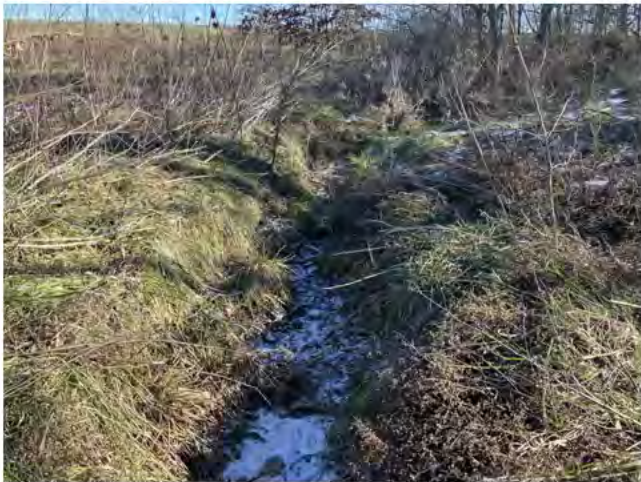
**Photo Number:** 83  
**Description:** Ephemeral Stream 36 looking upstream. DOV is northwest.  
**Date Taken:** 12/15/2025

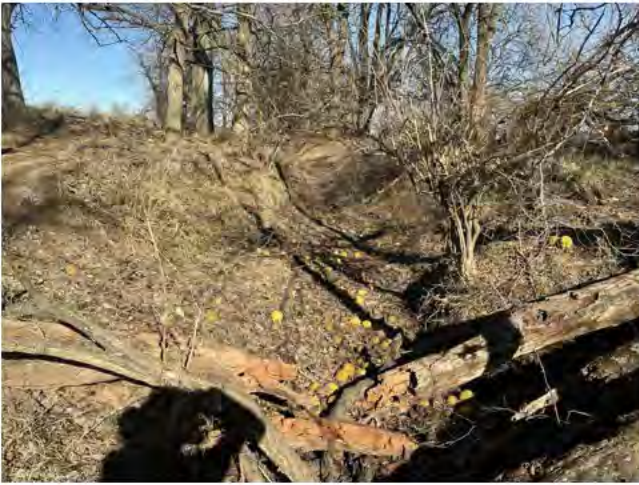
**Photo Number:** 96  
**Description:** Ephemeral Stream 26A looking upstream. DOV is northeast.  
**Date Taken:** 12/15/2025

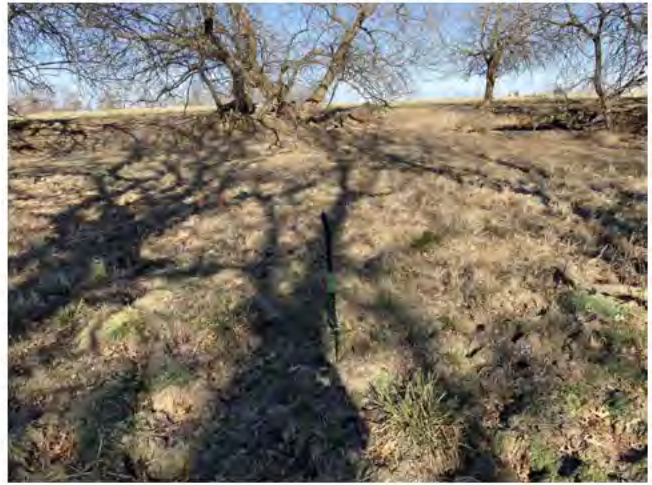
**Photo Number:** 97  
**Description:** SP-29 and PEM Wetland 18. DOV is northwest.  
**Date Taken:** 12/16/2025

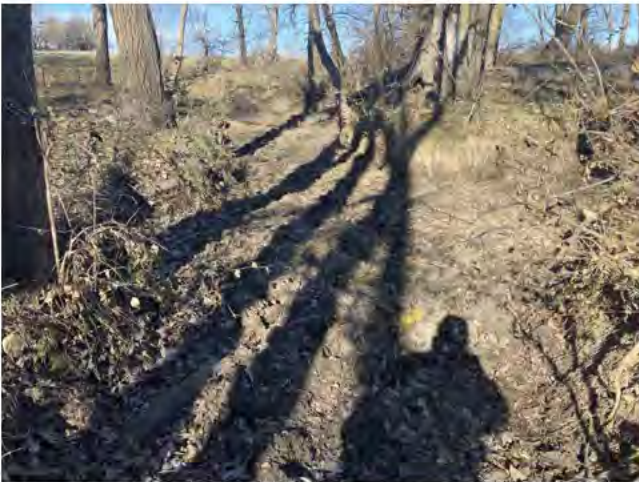
**Photo Number:** 98  
**Description:** Ephemeral Stream 28 looking upstream. DOV is northwest.  
**Date Taken:** 12/15/2025

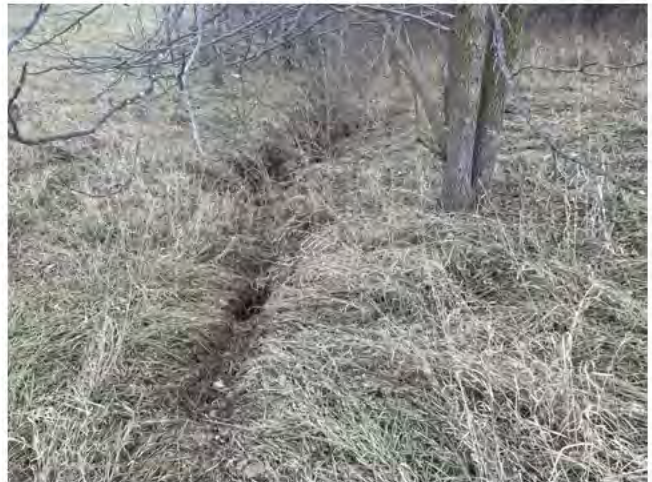
**Photo Number:** 99  
**Description:** Ephemeral Stream 29 looking downstream. DOV is southeast.  
**Date Taken:** 12/22/2025

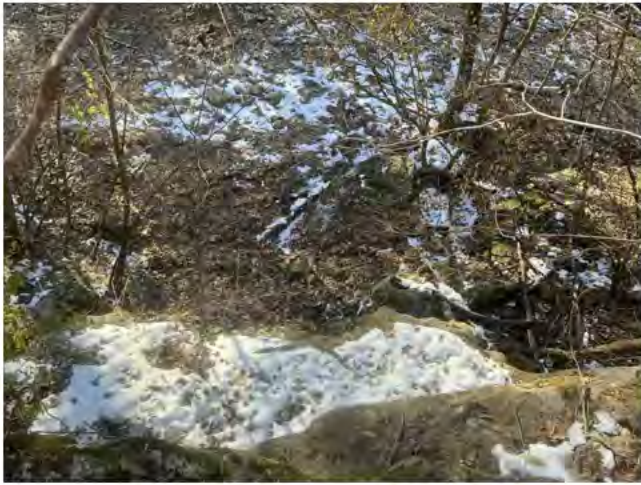
**Photo Number:** 115  
**Description:** Ephemeral Stream 35. DOV is southeast.  
**Date Taken:** 12/15/2025

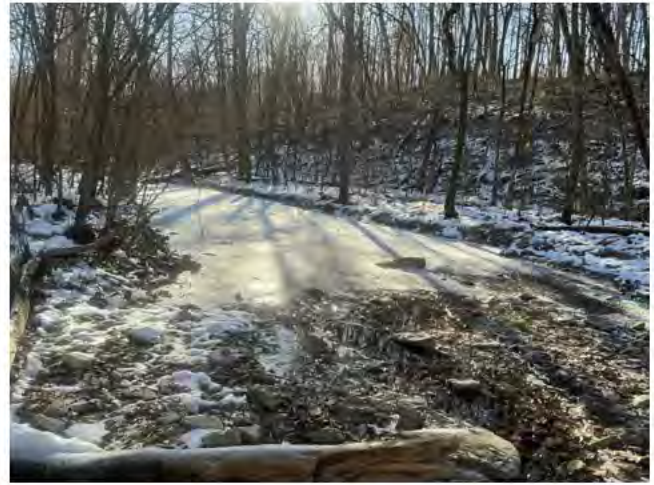
**Photo Number:** 116  
**Description:** Intermittent Stream 30F looking downstream. DOV is southeast.  
**Date Taken:** 12/15/2025

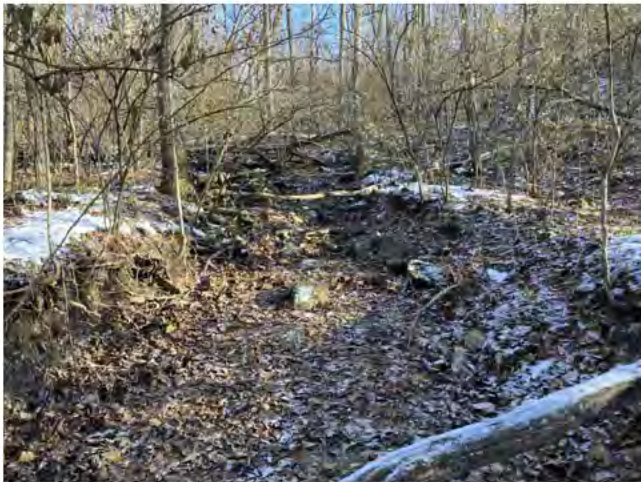
**Photo Number:** 117  
**Description:** Intermittent Stream 34B (backchannel) looking upstream. DOV is northeast.  
**Date Taken:** 12/15/2025

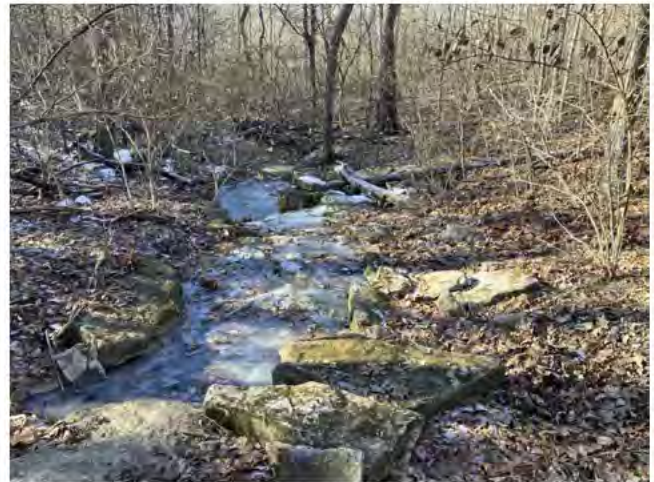
**Photo Number:** 118  
**Description:** Intermittent Stream 34A looking upstream. DOV is northeast.  
**Date Taken:** 12/15/2025

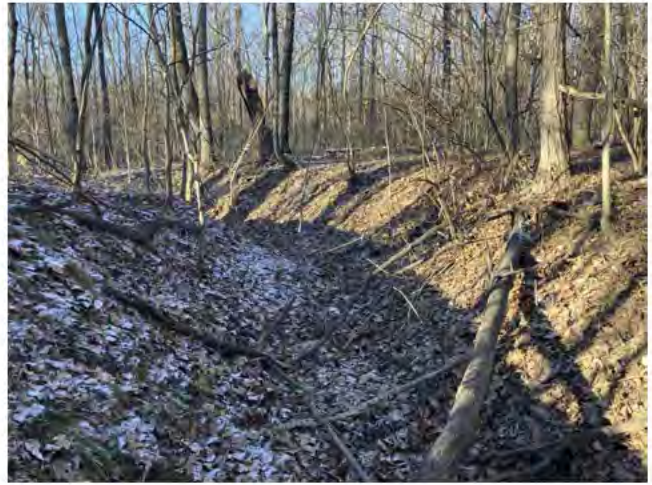
**Photo Number:** 120  
**Description:** Upland drainage looking downslope. DOV is west.  
**Date Taken:** 12/15/2025

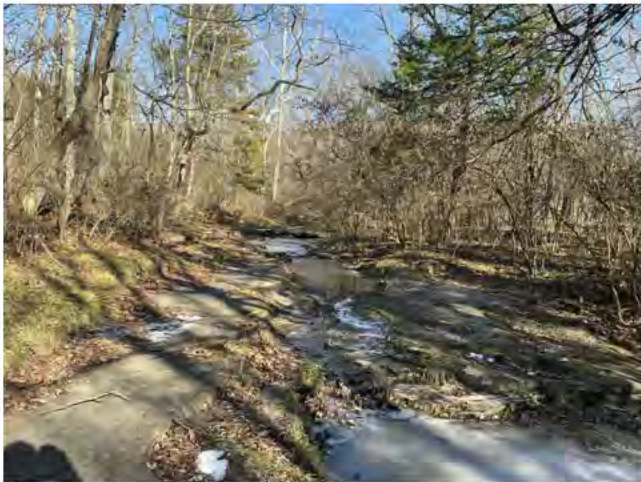
**Photo Number:** 121  
**Description:** Intermittent Stream 19D looking downstream. DOV is southwest.  
**Date Taken:** 12/15/2025

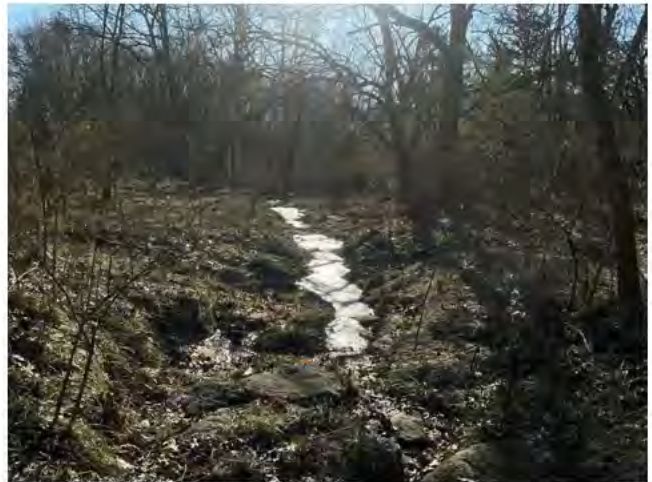
**Photo Number:** 122  
**Description:** Intermittent Stream 26C looking downstream. DOV is southwest.  
**Date Taken:** 12/15/2025

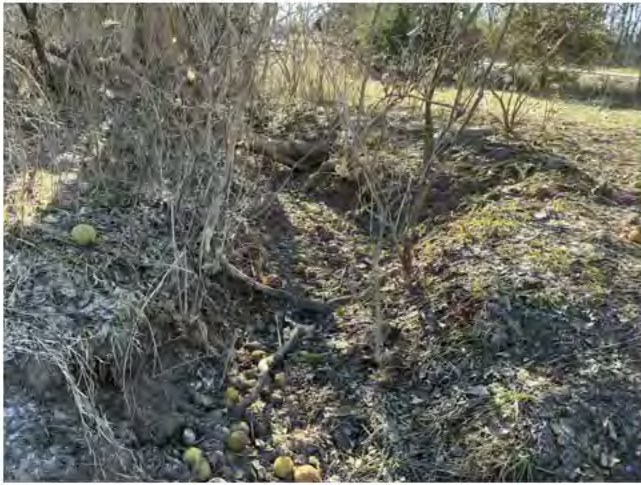
**Photo Number:** 123  
**Description:** Ephemeral Stream 27 looking downstream. DOV is southwest.  
**Date Taken:** 12/15/2025

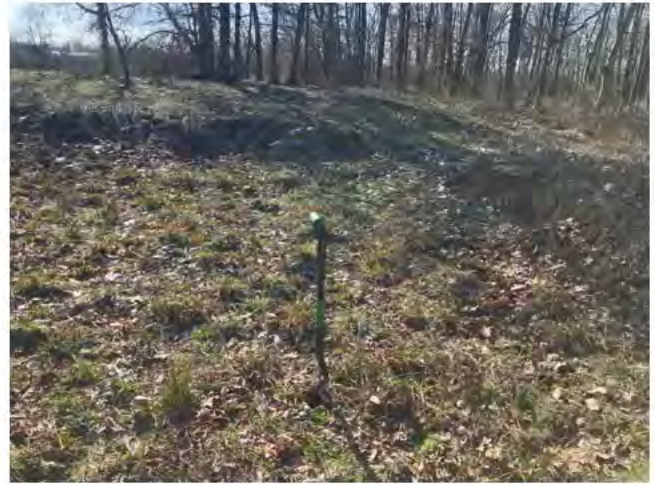
**Photo Number:** 124  
**Description:** SP-31 and PEM Wetland 17. DOV is south.  
**Date Taken:** 12/16/2025

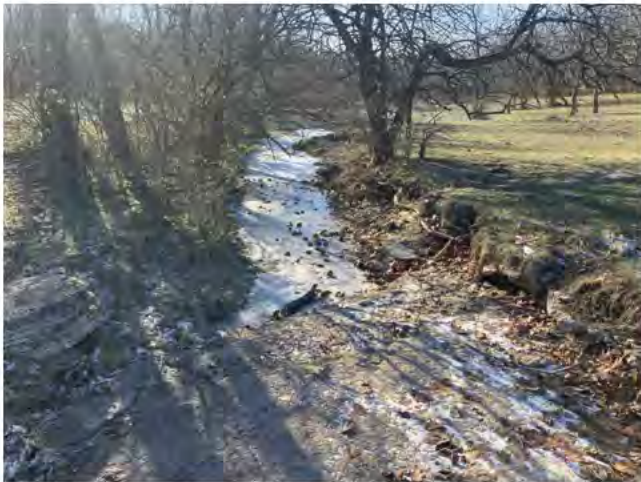
**Photo Number:** 125  
**Description:** Intermittent Stream 19D looking downstream. DOV is southwest.  
**Date Taken:** 12/15/2025

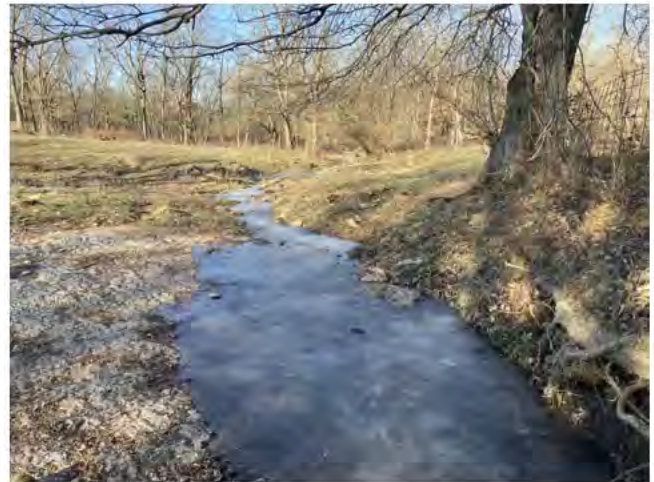
**Photo Number:** 126  
**Description:** Intermittent Stream 25B looking downstream. DOV is northwest.  
**Date Taken:** 12/16/2025

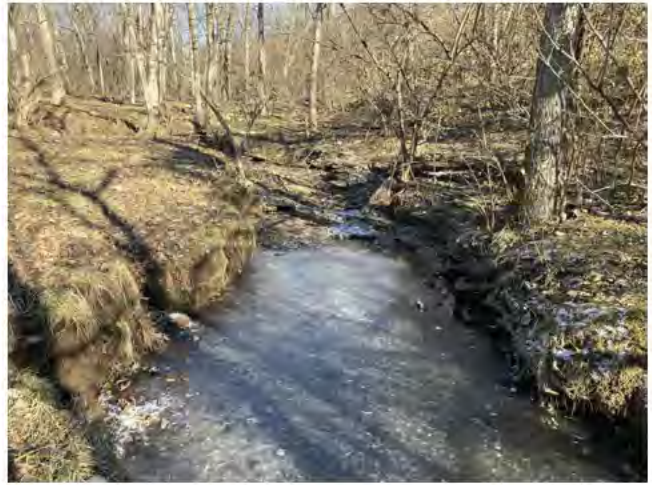
**Photo Number:** 128  
**Description:** Intermittent Stream 19D looking upstream. DOV is northeast.  
**Date Taken:** 12/15/2025

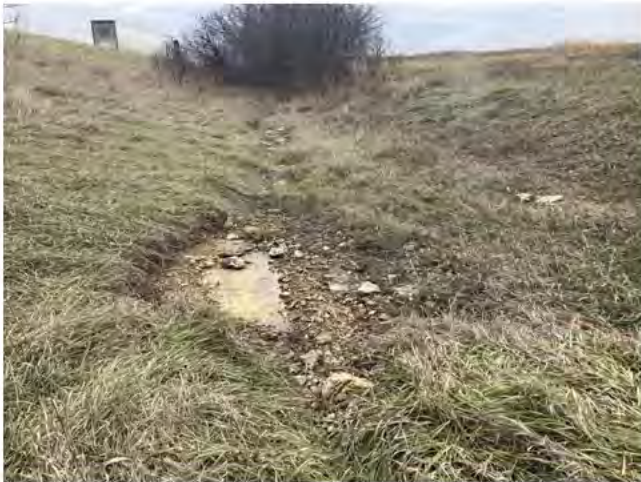
**Photo Number:** 129  
**Description:** Upland drainage looking upslope. DOV is southeast.  
**Date Taken:** 12/22/2025

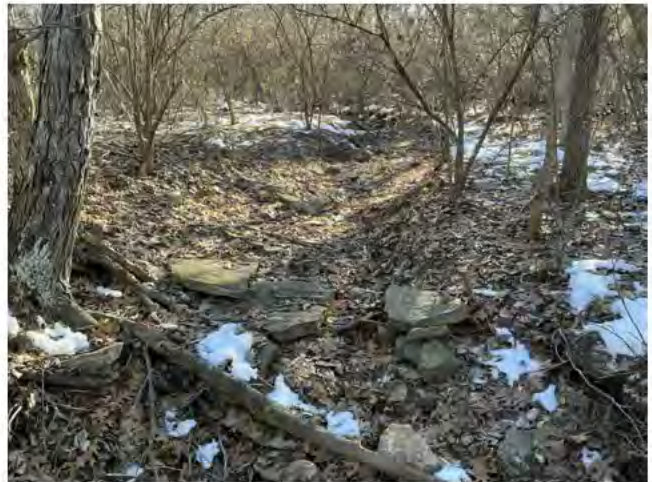
**Photo Number:** 141  
**Description:** Ephemeral Stream 33 looking upstream. DOV is southeast.  
**Date Taken:** 12/15/2025

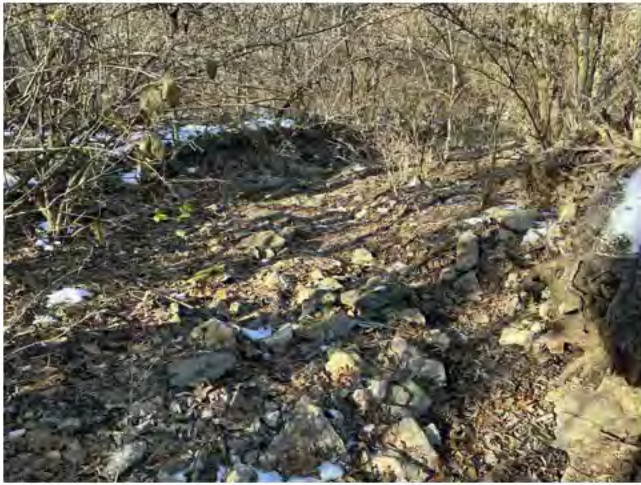
**Photo Number:** 142  
**Description:** Ephemeral Stream 37 looking upstream. DOV is southwest.  
**Date Taken:** 12/15/2025

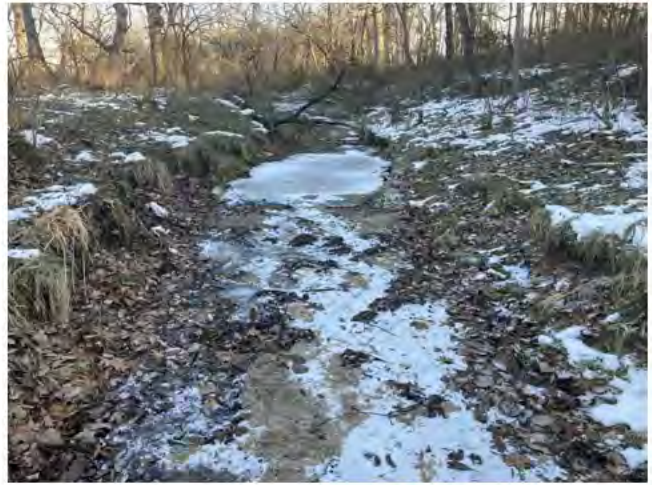
**Photo Number:** 143  
**Description:** Intermittent Stream 30B looking upstream. DOV is east.  
**Date Taken:** 12/15/2025

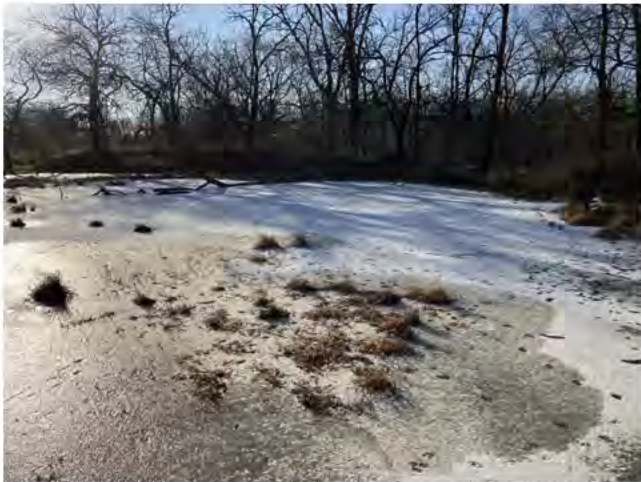
**Photo Number:** 144  
**Description:** Open Water 17. DOV is southeast.  
**Date Taken:** 12/16/2025

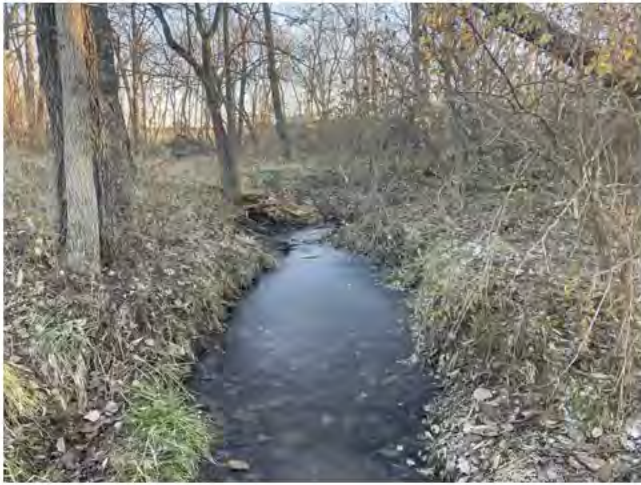
**Photo Number:** 146  
**Description:** Intermittent Stream 31F looking upstream. DOV is southeast.  
**Date Taken:** 12/15/2025

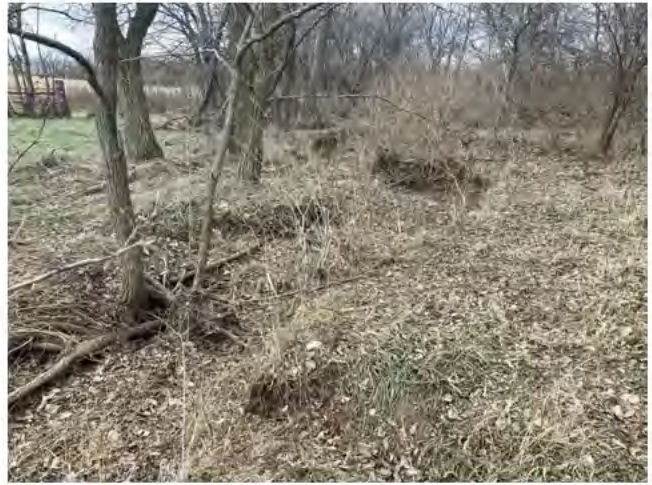
**Photo Number:** 147  
**Description:** Ephemeral Stream 30A looking downstream. DOV is west.  
**Date Taken:** 12/22/2025

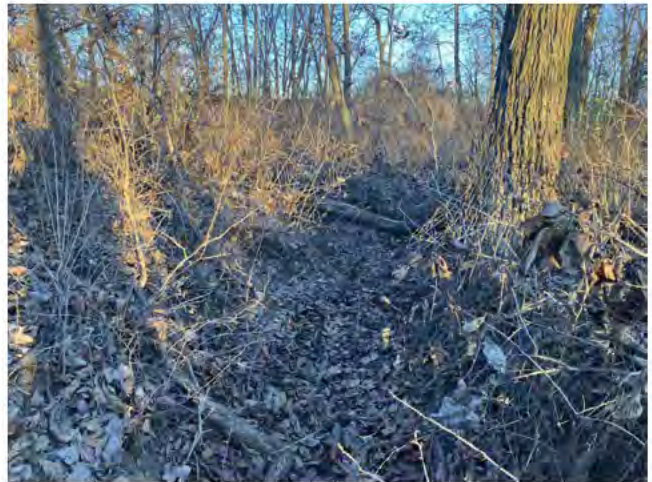
**Photo Number:** 152  
**Description:** Ephemeral Stream 32 looking downstream. DOV is southwest.  
**Date Taken:** 12/15/2025

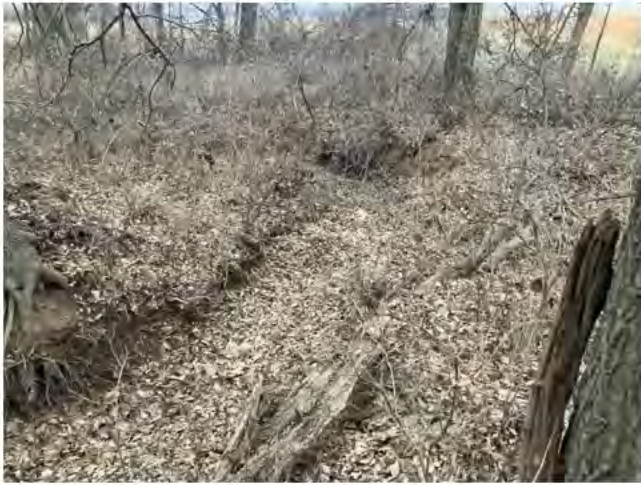
**Photo Number:** 153  
**Description:** Ephemeral Stream 31A looking downstream. DOV is northwest.  
**Date Taken:** 12/22/2025
