**BEFORE THE PUBLIC SERVICE COMMISSION
OF THE STATE OF MISSOURI**

In the Matter of Laclede Gas Company)	
Concerning a Natural Gas Incident at)	
7527 Michigan Avenue, St. Louis,)	Case No. GS-2009-0270
Missouri.)

STAFF'S FINAL STATUS REPORT

Gas Incident Report

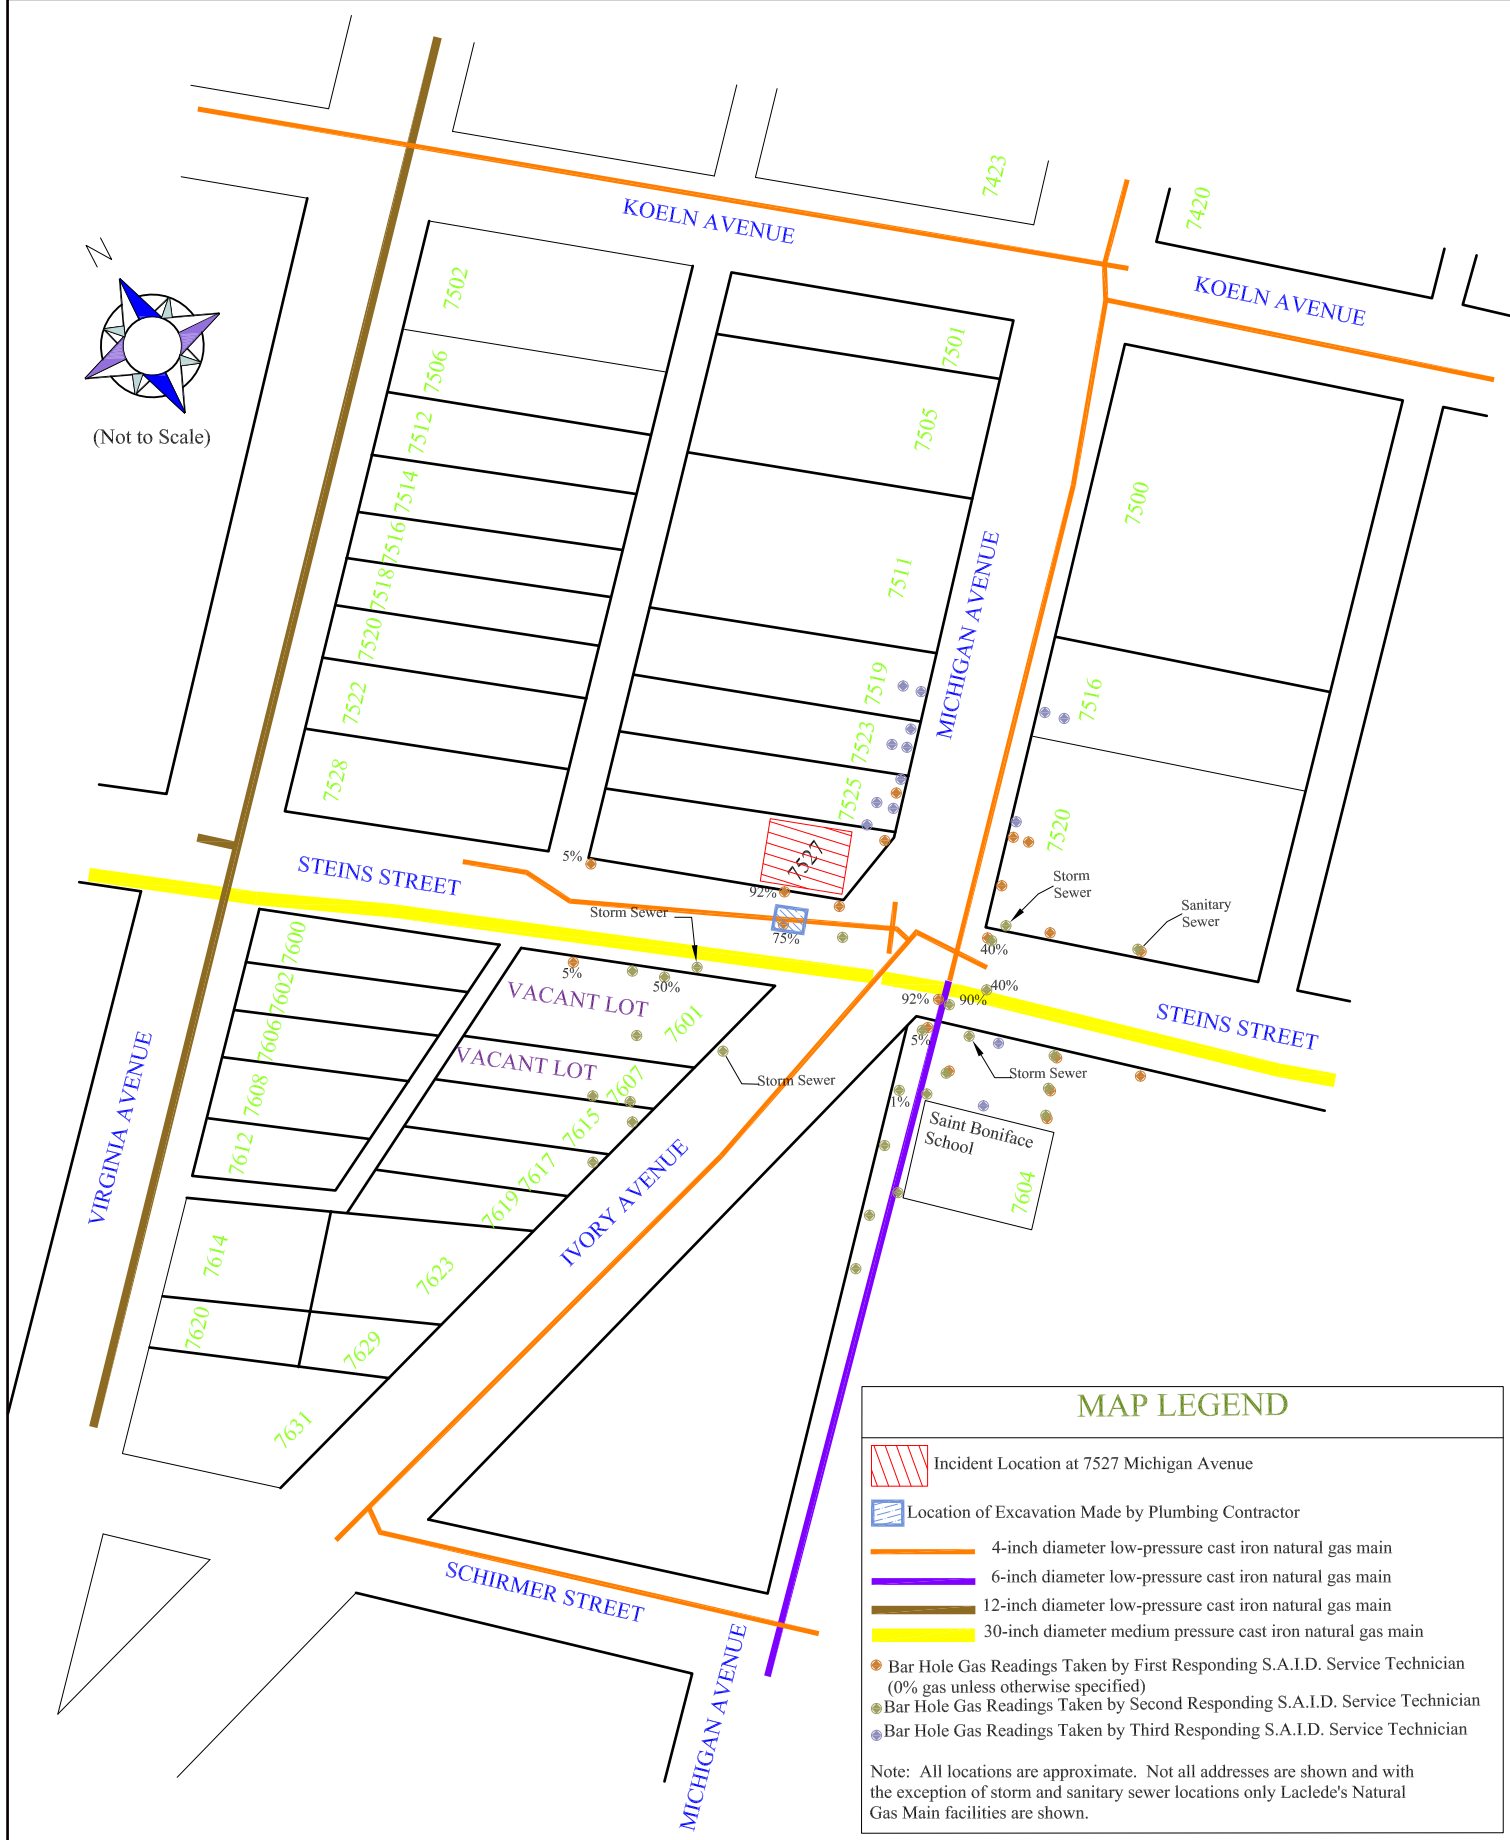
Figure 2
Plan View of the Incident Area
Appendix B-2

Numerous natural gas facilities are located along Steins Street, Michigan Avenue, Ivory Avenue and Virginia Avenue (see Appendix B-2, Figure 2). The involved 4-inch cast iron (CI) natural gas main (just south of 7527 Michigan Avenue) was located approximately 8 feet south of the north curb line of Steins Street. This segment of 4-inch CI main was approximately 400 feet in length and it connected to another section of 4-inch CI main near the intersection of Steins Street, Michigan and Ivory Avenues. The involved 4-inch CI gas main was installed during the period of November 28, 1904 through December 3, 1904.

The Staff interviewed three Laclede Service Technicians who responded to the incident and took gas-in-air readings, identified on Figure 2 of Appendix B as “First Responding S.A.I.D. Service Technician” (First Technician), “Second Responding S.A.I.D. Service Technician” (Second Technician) and “Third Responding S.A.I.D. Service Technician (Third Technician) based on arrival times at the incident. The Staff provided the Technicians with a draft drawing of Figure 2 from Appendix B, titled Plan View of the Incident Area for review.
