# FERC TAUM SAUK INVESTIGATION TEAM

April 28, 2006

Report of Findings on the Overtopping and Embankment  
Breach of the Upper Dam - Taum Sauk Pumped Storage  
Project, FERC No. 2277

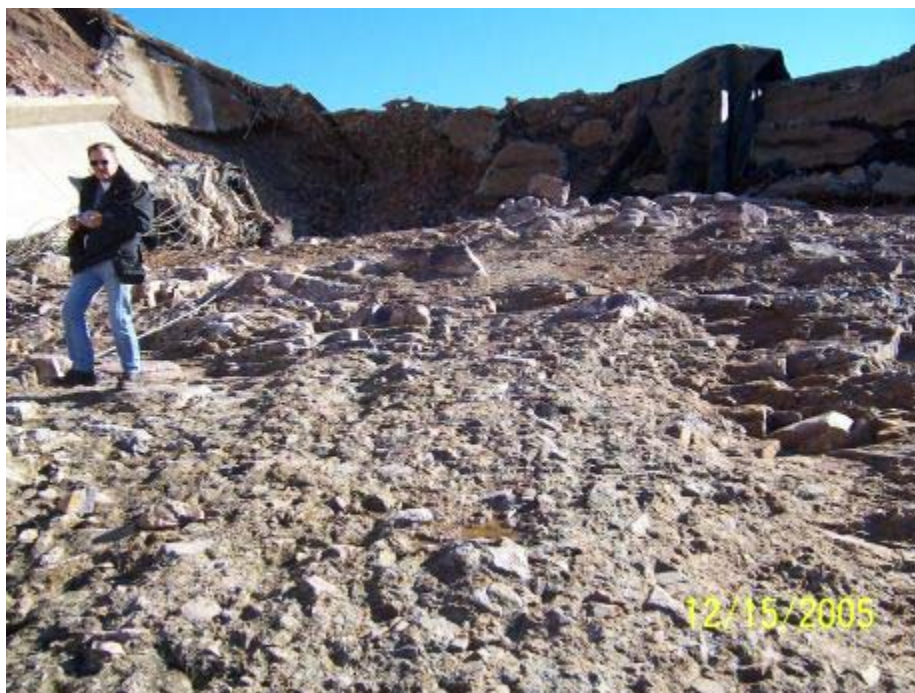
**Figure 2.9 - Overview of area to the right of that shown in previous photograph. (See also Figure 2.4.) Note breach in background and toe of breach slope on left edge of photograph.**

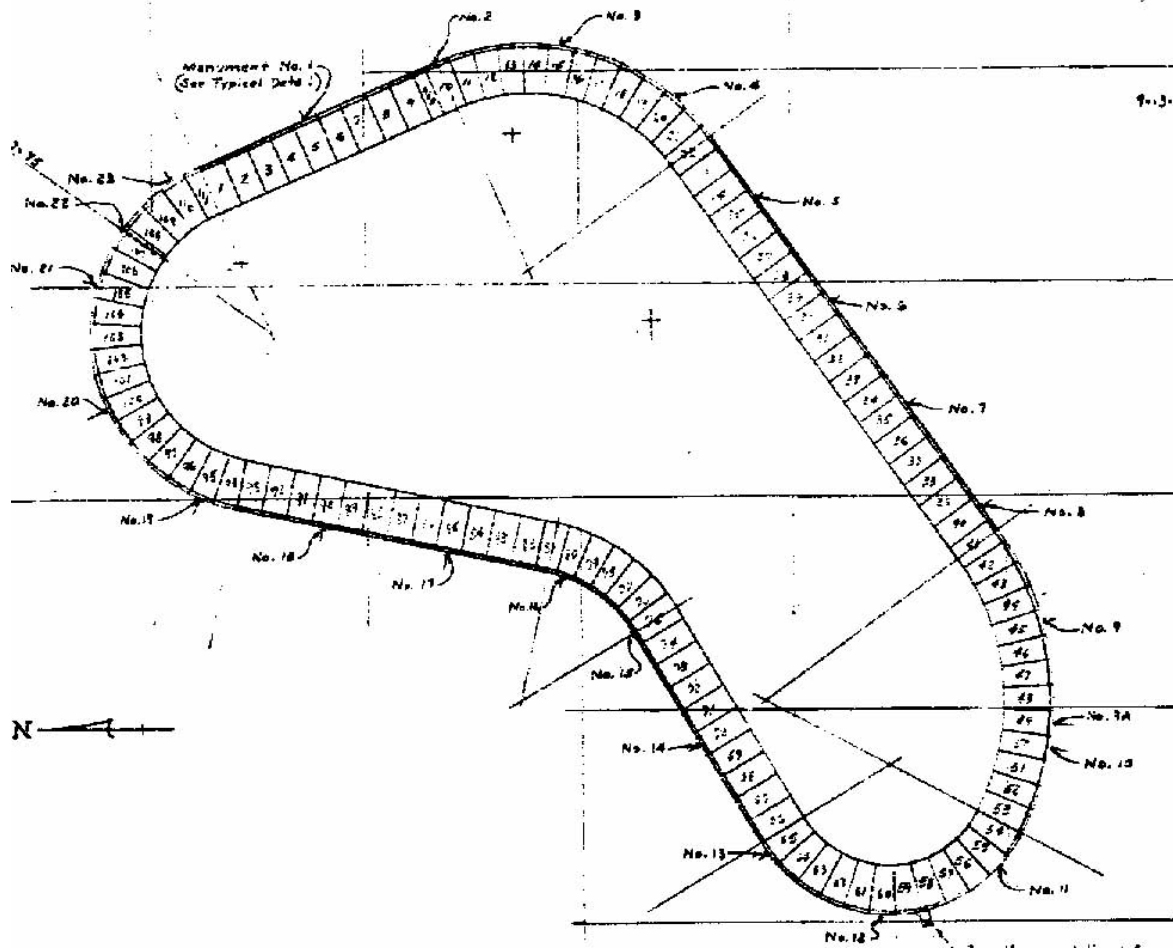
A correction was made early in the history of the monitoring to account for a number of pins that were damaged, reducing the elevations from the original survey. It appears that the correction that was applied may have been to add the difference rather than subtract the difference. Hence, some of the settlements shown may be slightly more than the actual settlement. Figure 3.2 shows that the primary settlement occurred prior to August 1976. Apparent movements following this time were very small from year to year and generally fall within the accuracy of the surveys. Figure 3.3 shows a more detailed view of settlement that has occurred during the past 24 years. For reference, Point 19 is within the breach area.

Figure 3.1 - Location of Settlement Survey Pins in Parapet Wall Footer

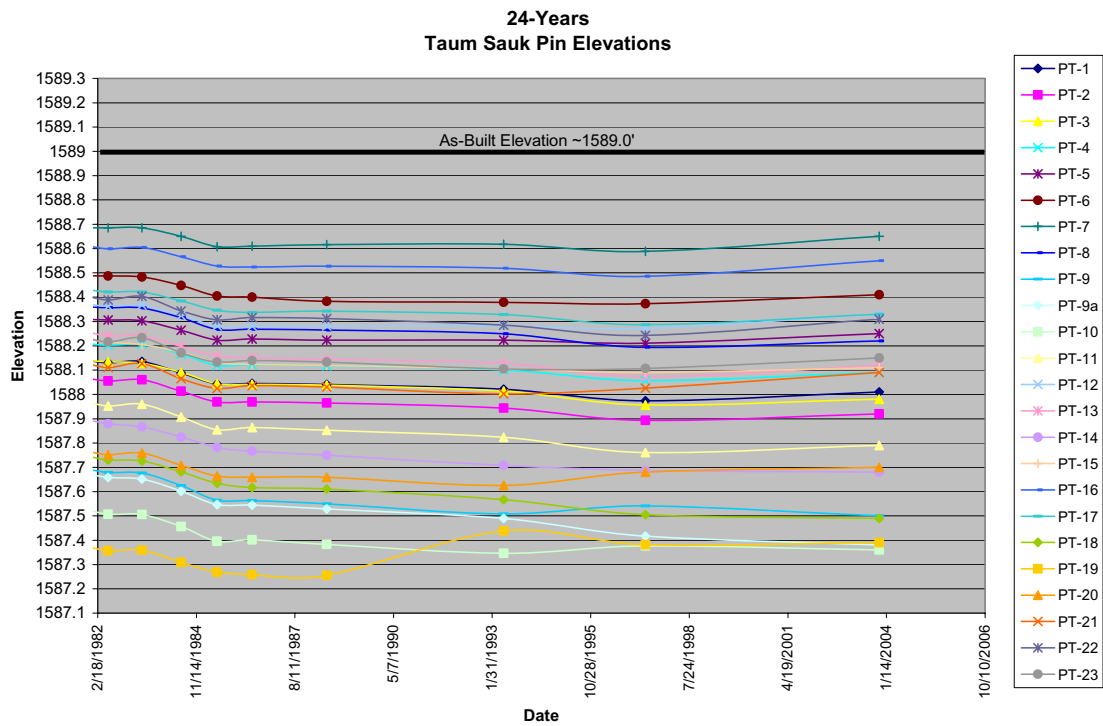
**Figure 3.3 - Settlement Data 1983-2006**

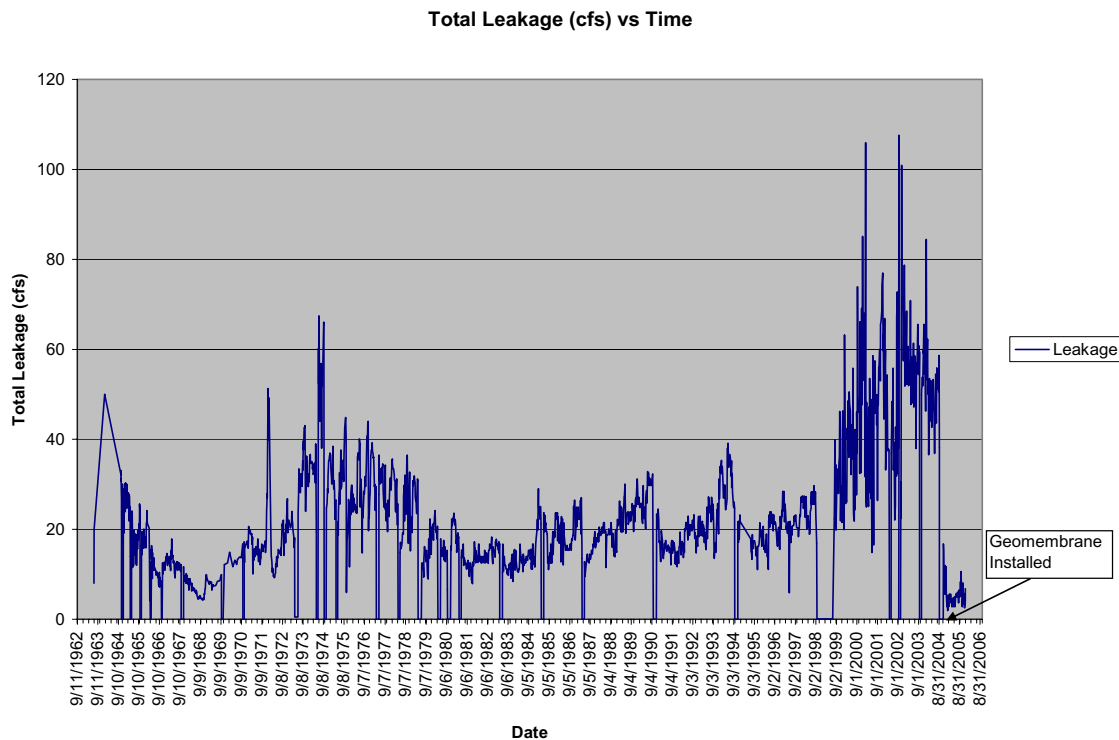
Higher rates of leakage began in 1999 following an extended outage. A geomembrane liner was subsequently installed in 2004, which significantly reduced the leakage for the 12 months prior to the breach. Figure 3.5 shows the history of leakage and the periods of repairs (illustrated by periods of zero leakage).

**Figure 3.5- Historical leakage Rates**

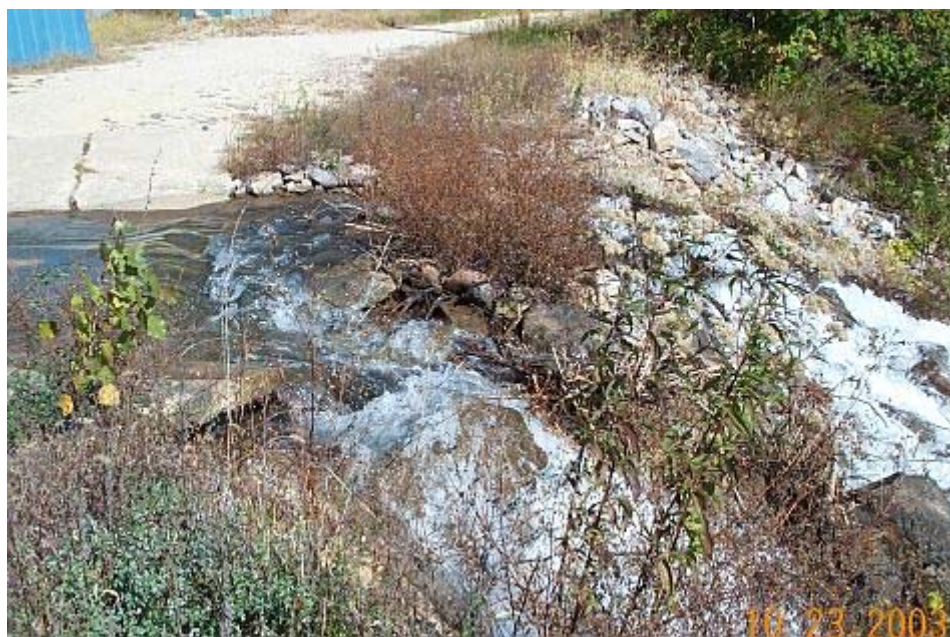
**Figure 3.8 - Overflow of the seepage collection Pond before liner installation  
(2003 FERC Operation Inspection Report)**

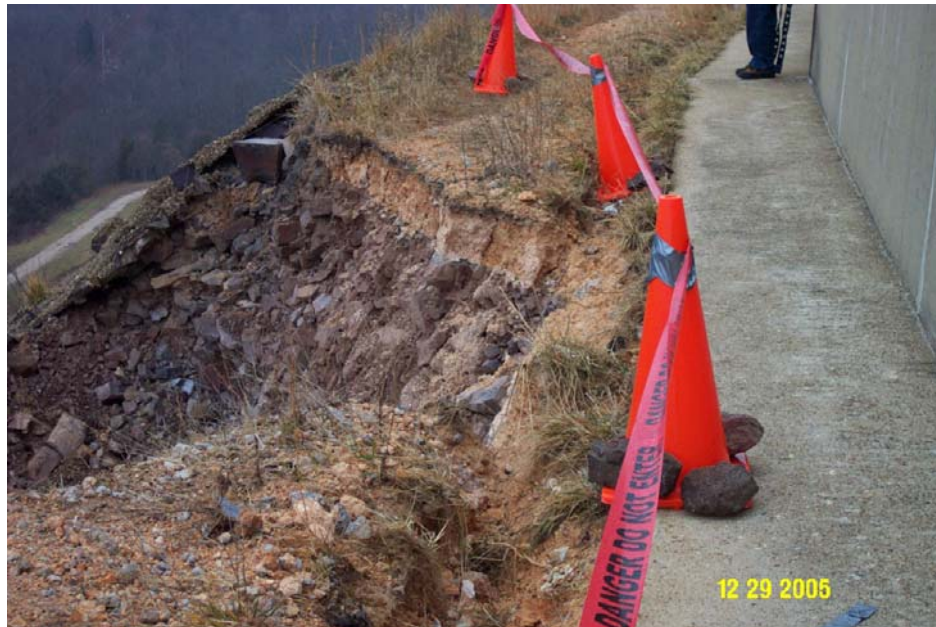
**Figure 4.6 - Panels 48 and 49**  
**Scarp near toe of parapet wall footing**  
**Note erosion rut adjacent to the footing**

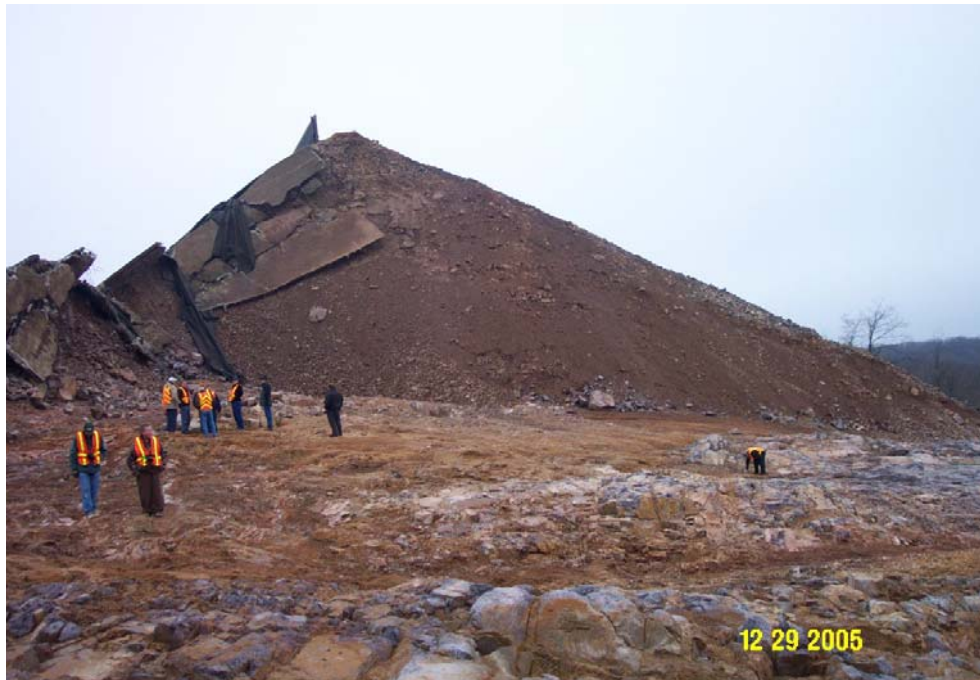
Figures 4.2-4.12 document the different levels of damage that occurred on the embankment. The photos indicate the progression of how the embankment behaved as overtopping began and how erosion progressed with time and higher levels of flow. Damage assessments are those shown on KdG drawing S1 dated December 20, 2005 (Figure 4.1)

**Figure 4.11 - Left side of breach**

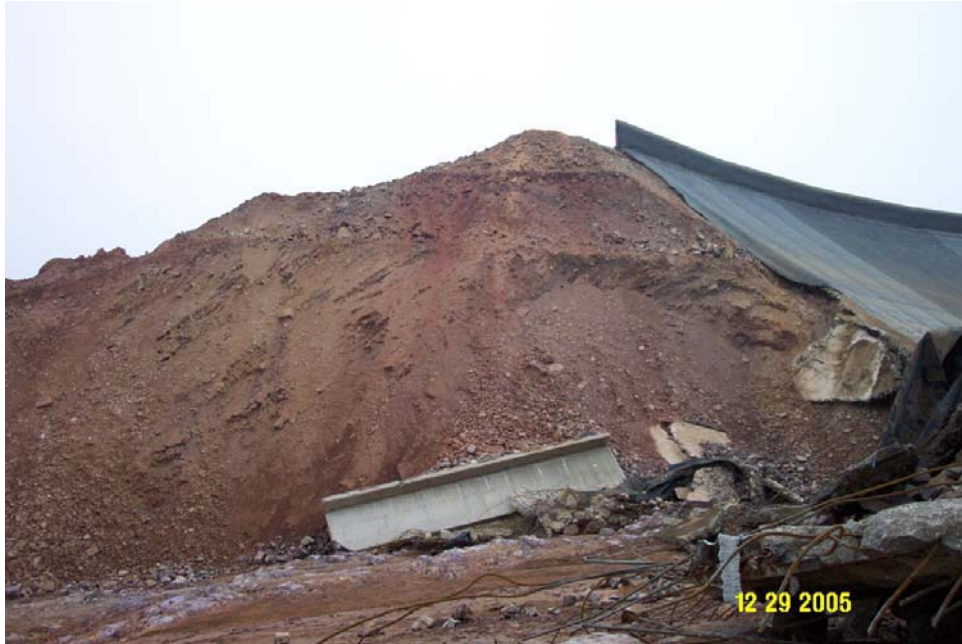
**Figure 4.12 - Right side of breach  
Note layering of embankment**

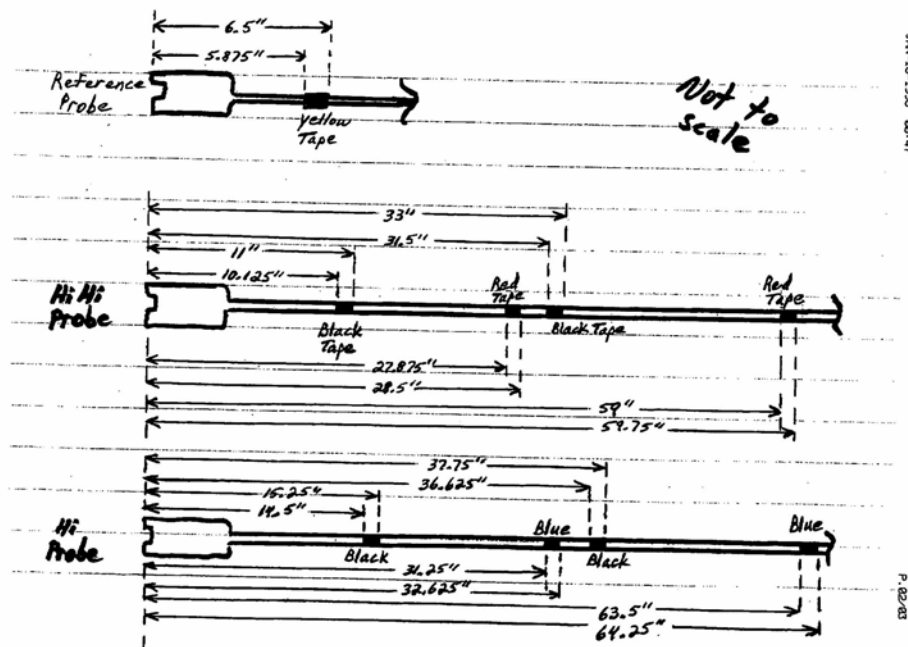
Figures 5.2 show the configuration of the sensors within the instrument cabinet. The cabinet is located on the dam crest at the southwest end of the reservoir. Figure 5.3 shows distances from the Warrick Conductivity sensor tips to reference tapes placed on the wiring by AmerenUE staff. The tapes were used to place the sensors at the original design elevation (November 2004) and the as-found elevation on December 14, 2005.

**Figure 5.3 - Tape reference points on leads to the HIGH and HIGH-HIGH Warrick Conductivity Sensors (as Provided by AmerenUE)**

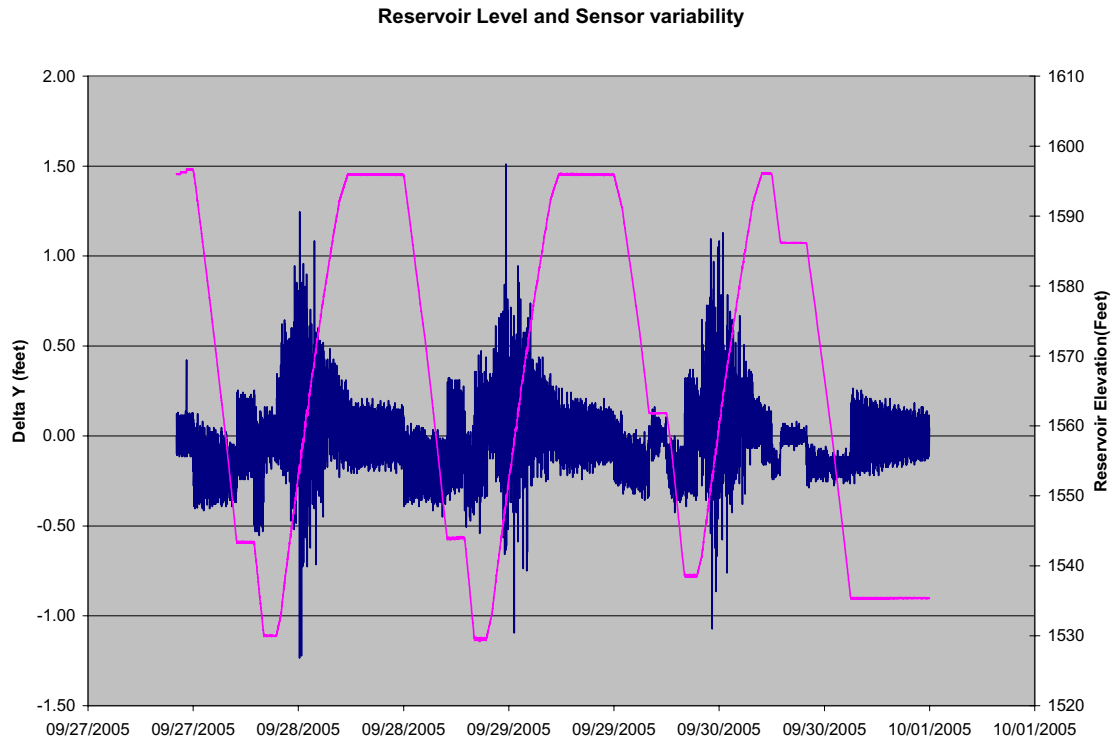
1. The variability in the system output when the reservoir was in pump mode appeared to be within the specification after initial installation.
2. Increases in variability of the Druck pressure transducer signals and output appear to increase from September 2005 through December 2005.
3. Variability appears to be greater than the sum of the electronic error and the rate of reservoir rise. Variability up to  $\pm 1.75$  feet occurred December 13, 2005.
4. The greatest fluctuation in the output occurs during the pump cycle when the reservoir elevation is between 1545 ft and 1565 ft.
5. It is possible there is a relationship between the movement of the instrumentation pipes and the turbulence caused by the pumping cycle (Figure 5.16 – shows turbulence on first filling. Figure 5.5 shows proximity of pipes to the intake shaft.)

**Figure 5.13 - System Variability September 27-October 1, 2005**

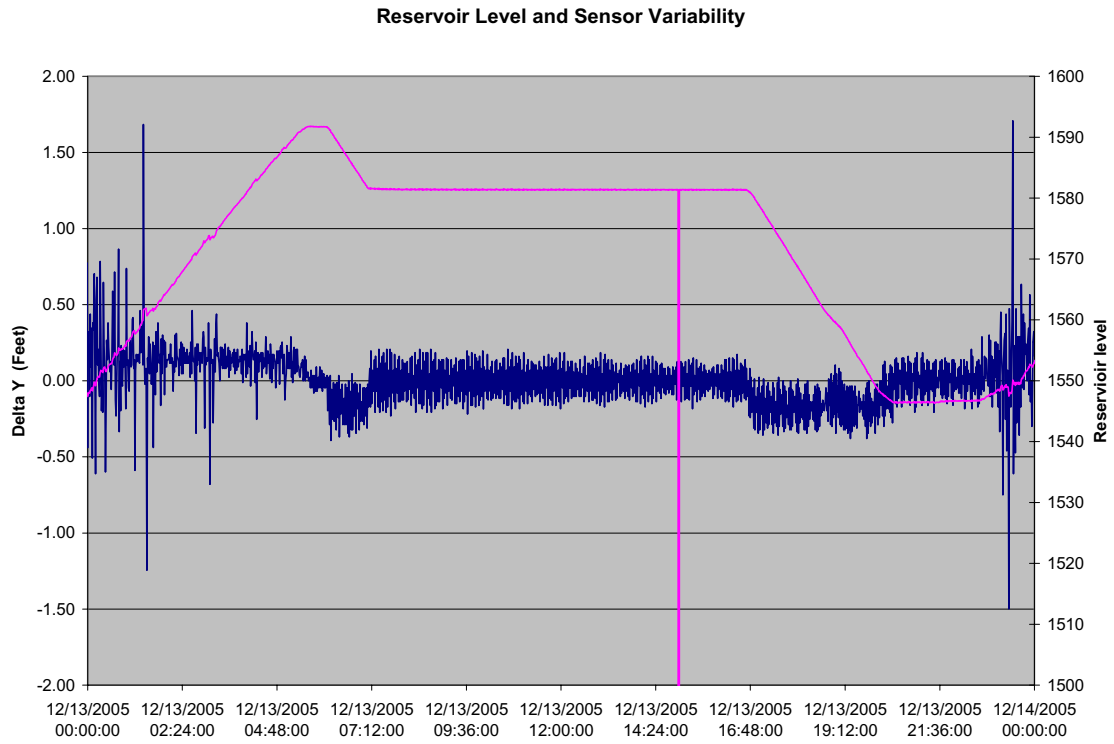
**Figure 5.14 - System Variability December 13, 2005**

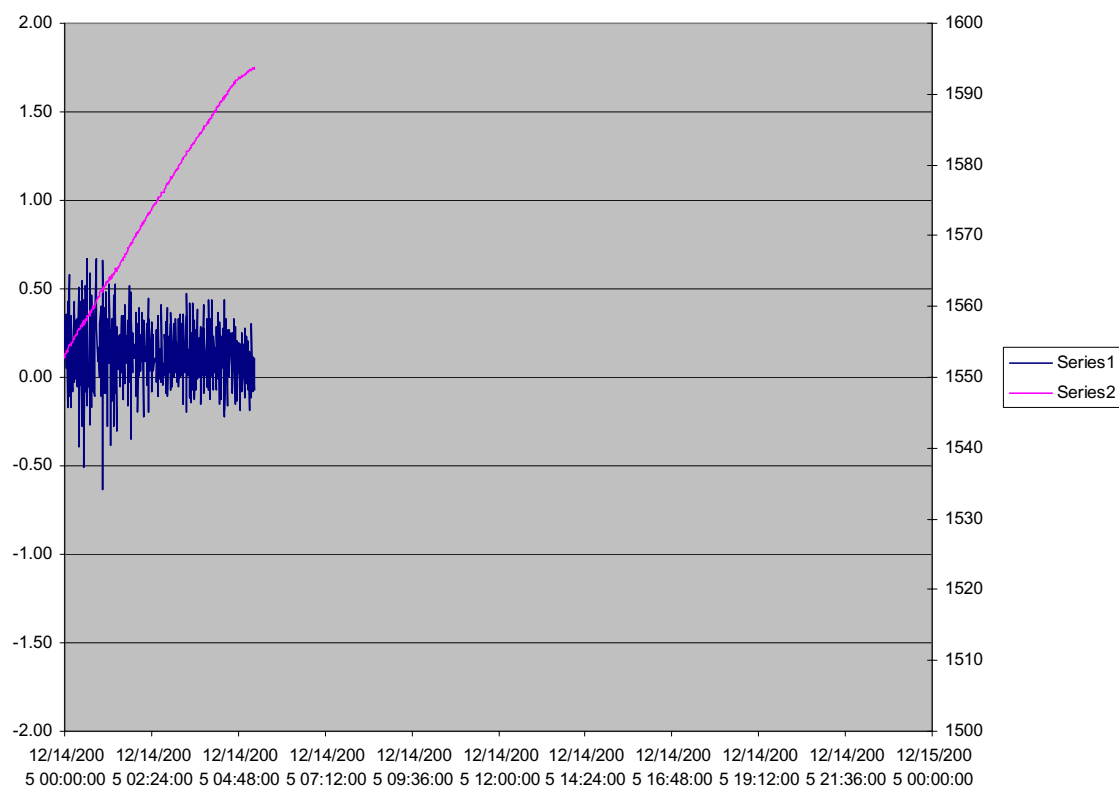
**Figure 5.15 - System Variability December 14, 2005**

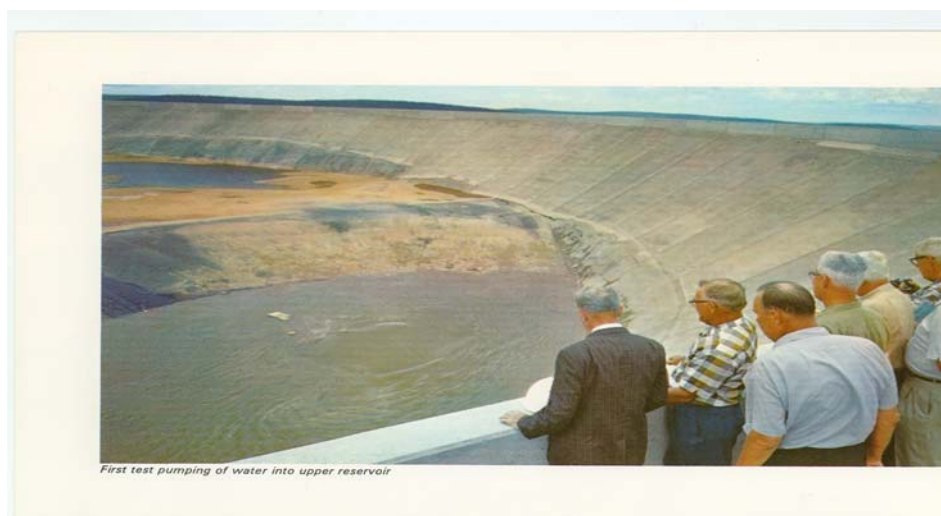
**Figure 5.16 - Turbulence on first filling (from AmerenUE)**

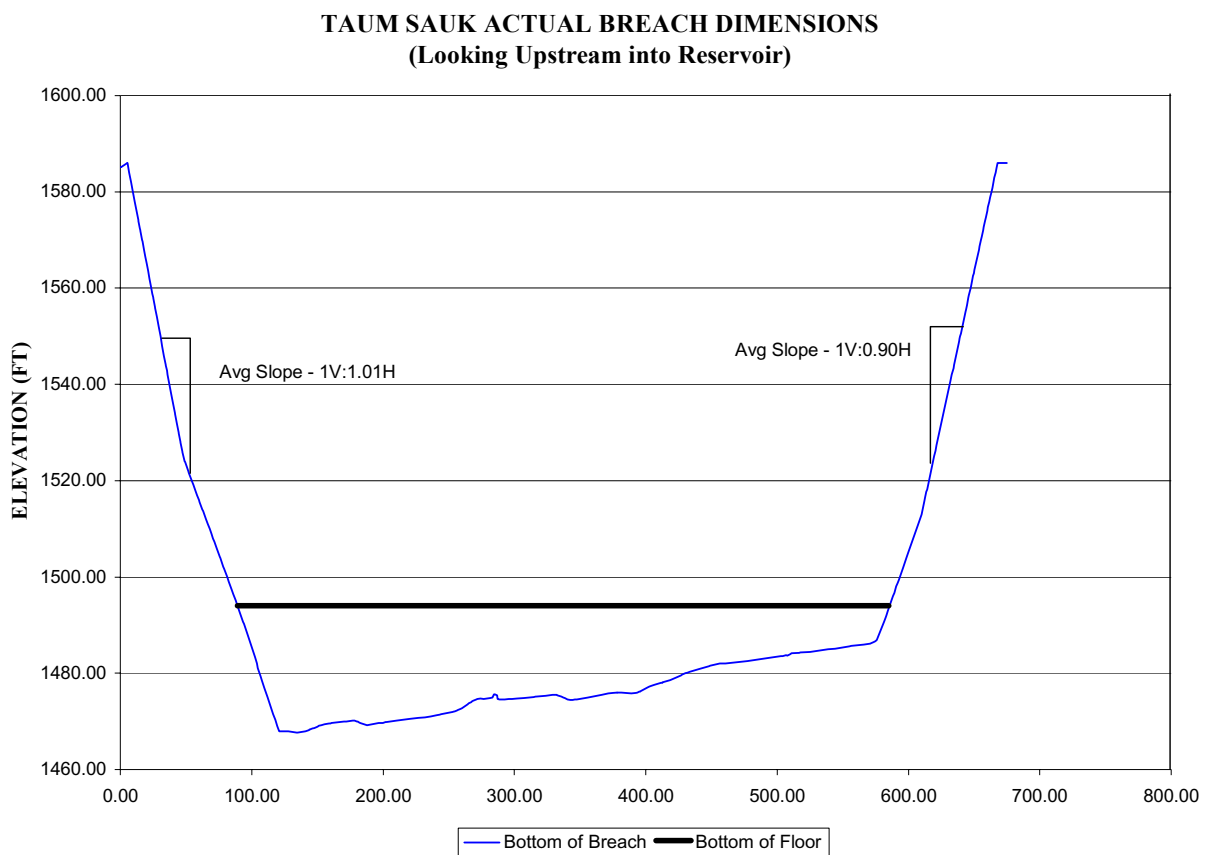
**Figure 8.3— Breach Cross Section**

Breach depth = 103 feet. This is based on the floor of the reservoir at elevation 1494 ft and the low point of the parapet wall at about elevation 1597 ft.

An elevation view of the breach based on the aerial survey is in Figure 8.3.

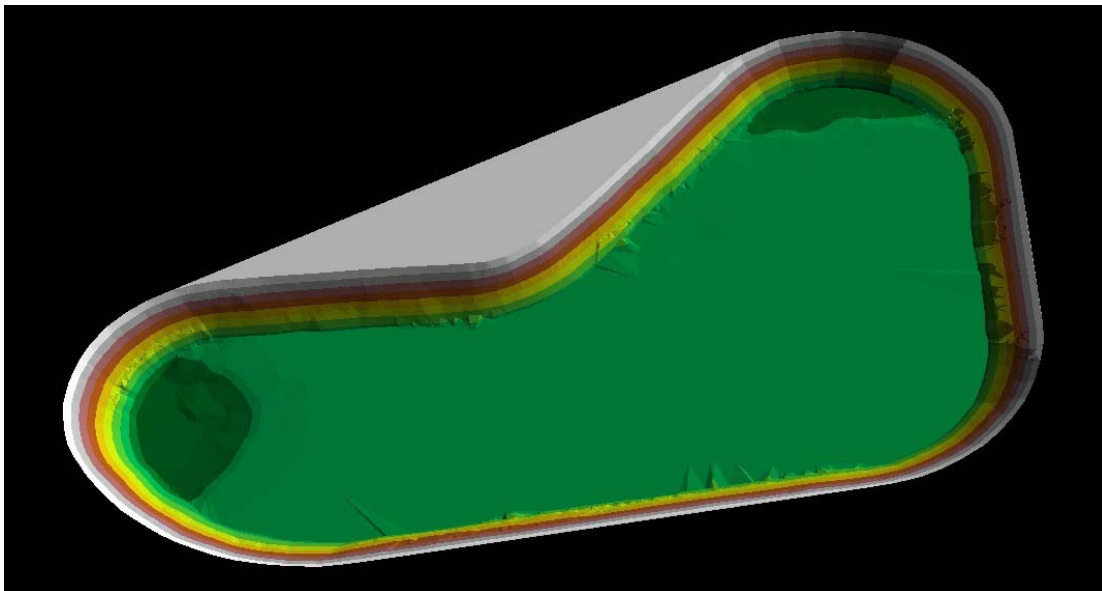
**Figure 8.4 – Aerial Survey of empty upper reservoir**

time for the day of the event. The stage-storage curve was calculated in 1-foot increments using the post-breach aerial survey data (Figure 8.4) and a geographic information system (GIS). The stage-storage data was verified with the stage storage curve for the upper reservoir provided in AmerenUE's February 7, 2006 filing. As shown in Figure 8.5 the stage storage information from the two sources matches well.

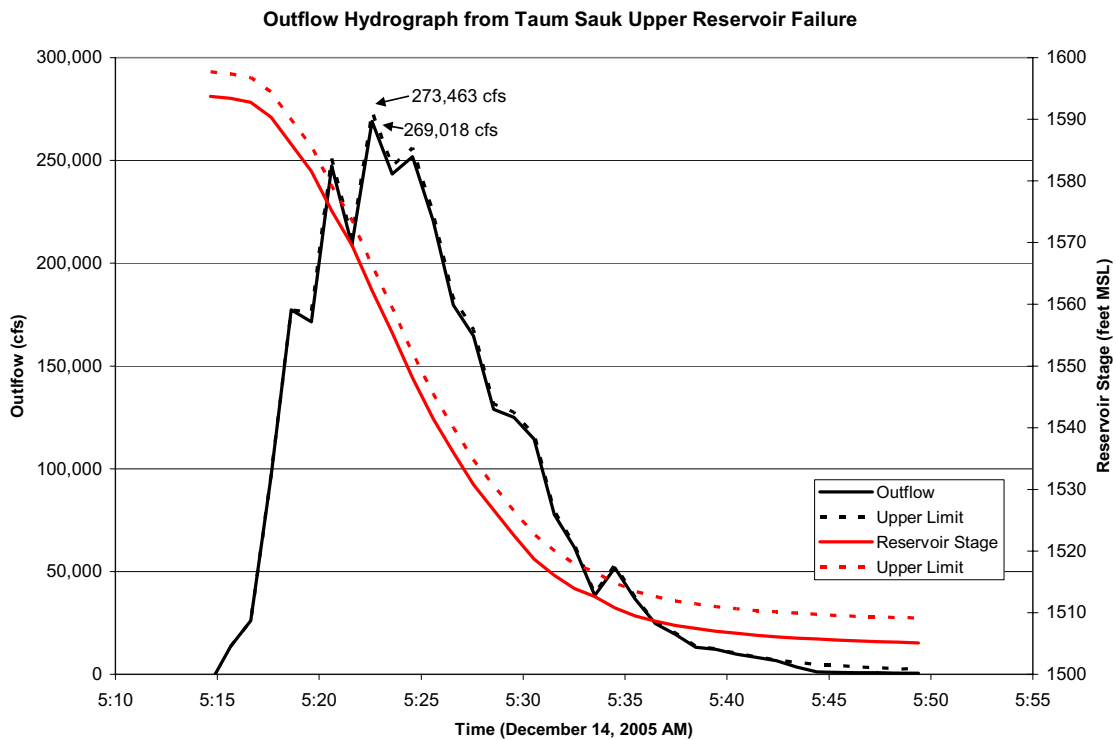
**Figure 8.6 - Calculated Outflow Hydrograph for Taum Sauk Breach**

Outflow was computed in one-minute intervals on December 14, 2005 from 5:15 am until the reservoir was mostly empty at 5:50 am. The change in stage for each one minute interval was interpolated on the stage-storage curve to a volume in acre-ft per minute, which was then converted to cfs. The outflow hydrograph is shown in Figure 8.6.

Assuming that the pressure transducer readings were off by 4 feet, the calculated peak flow out of the breach was about 273,450 cfs. If the actual pressure transducer readings are used, the resulting peak outflow from the reservoir was about 269,000 cfs. Time to peak for the outflow hydrograph was approximately 8 minutes after the breach initiated.

The outflow hydrograph indicates initial flows may have been due to the loss of one and then two sections of the parapet wall. At 5:16 and 5:17 AM outflows were about 10,000 and 25,000 cfs, respectively. This corresponds with the outflow expected from the loss of one and then two sections of the parapet wall (see Section 8.1.9). After 5:17 AM flows increased rapidly peaking at 273,000 cfs at about 5:23 AM. This zig-zag shape of the outflow resembles somewhat the shape of the outflow estimated in the Emergency Action Plan (EAP), see Figure 8.2.

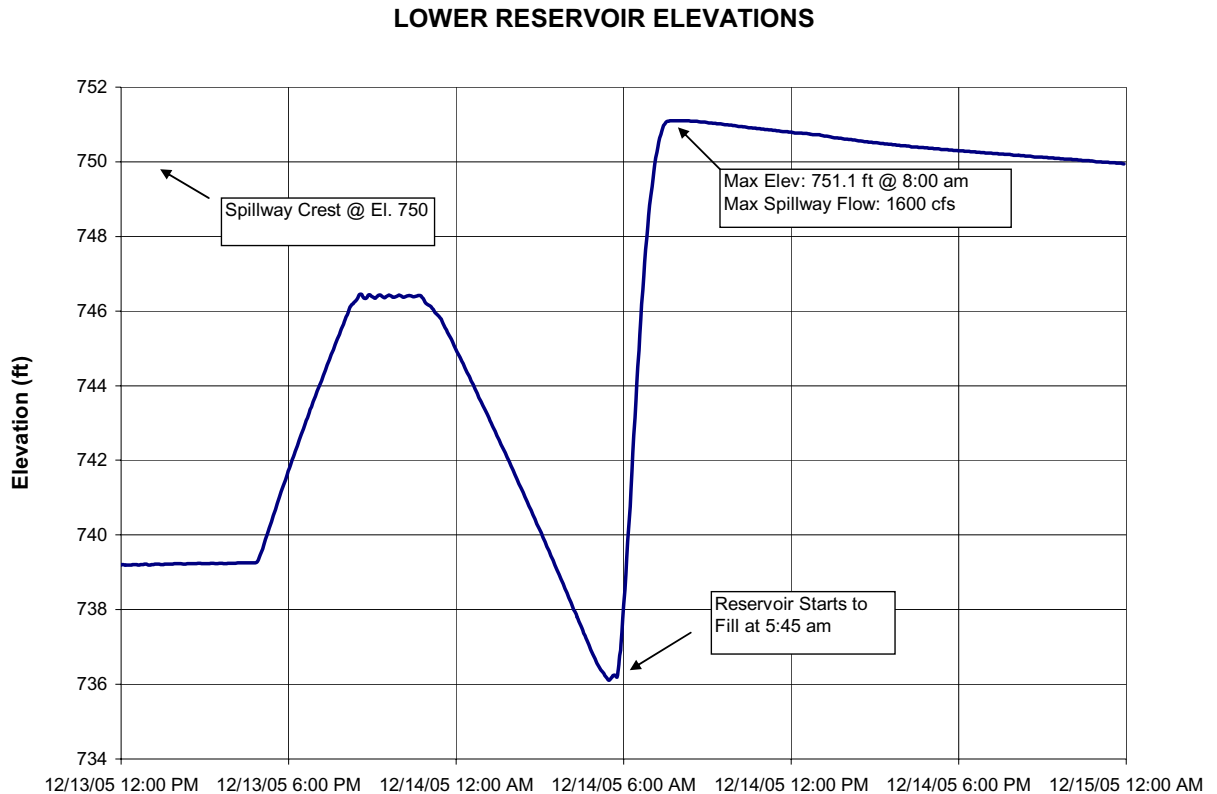
**Figure 8.10 - Lower Reservoir Elevation December 13 and 14 2005**

Figure 8.10 shows water levels at the Lower Reservoir on December 13 and 14, 2005. The Lower Reservoir was able to store the majority of inflows from the Upper Reservoir breach. According to the reservoir level information provided by AmerenUE's letter dated December 27, 2006, the lower reservoir was drawn down to elevation 736.1 ft prior to the breach. This provided about 3,920 acre-feet of

storage up to elevation 750 ft. The maximum recorded elevation in the lower reservoir following the breach was 751.1 ft, which occurred at about 8:00 am. This was approximately 1.1 feet of overtopping and resulted in a maximum outflow from the spillway of about 1,600 cfs (excluding flows through the sluice). The maximum reservoir level on December 14, 2005 was well below the flood of record.

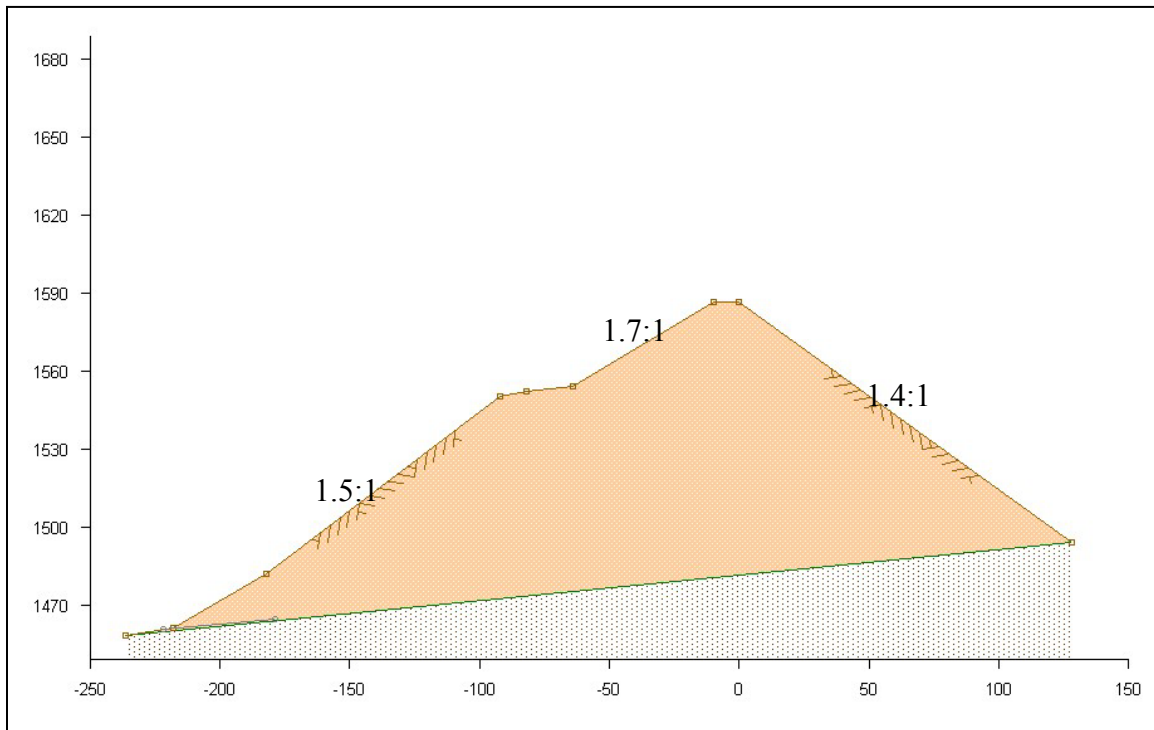
**Figure 9.1– Embankment Cross Section**

Questions were raised about the steepness of the downstream slope in the area of the breach. A second topographic section was made at the north end of the breach to assess the steepness of the slope in that area. Due to slope failures immediately adjacent to the breach, the section was taken 80 feet northeast of the breach edge (refer to Line 2 in Appendix D – Figure D.1). Figure 9.1 shows the cross section which represents the as-built configuration of the breach section.

The upstream slope (right side of above drawing) is 1.4H:1.0V. The portion of the downstream slope that is above the access road is 1.7H:1.0V, and the portion of the downstream slope below the access road is 1.5H:1.0V. The downstream slope used in the stability analyses for the section taken at the center of the breach was 1.5H:1.0V. Rather than cutting into the original embankment to construct the access road, it appears the access road was placed with material dumped on top of the original embankment. The slope of the road fill material is slightly steeper than the original downstream embankment slope (1.5H:1.0V versus 1.7H:1.0V, respectively). The steeper slope of 1.5H:1.0V was used to represent of the downstream slope in the area of the breach.

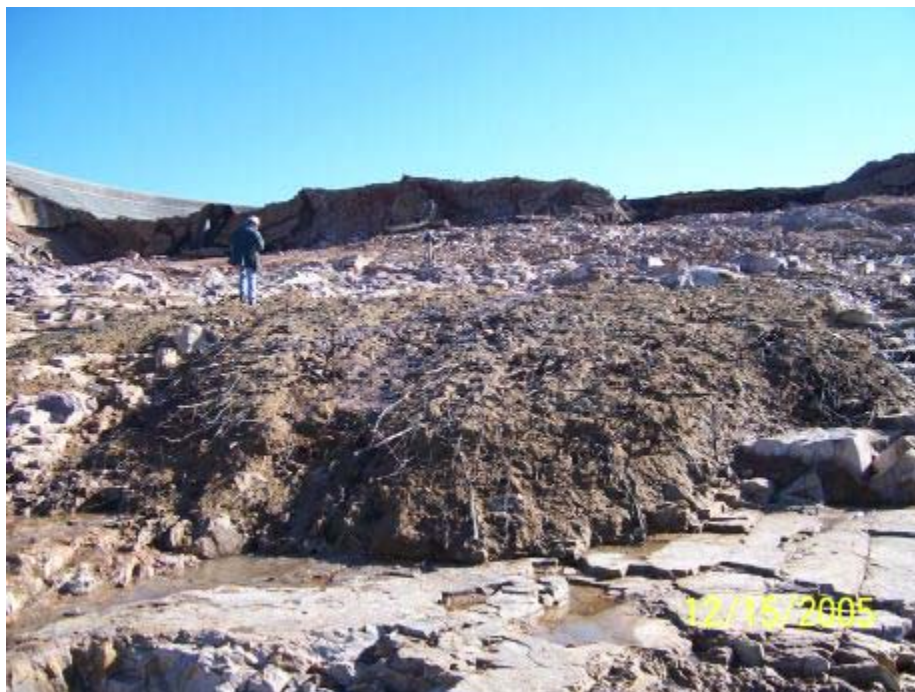
**Figure 9.3 - Residual topsoil on top of fresh rhyolite.**

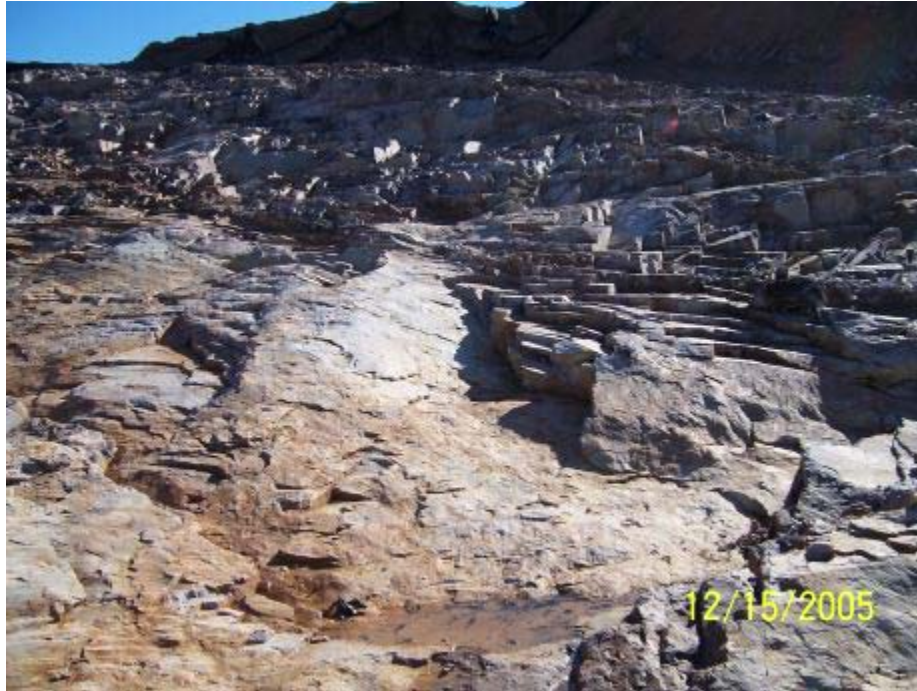
Paul C. Rizzo Consultants prepared a geologic map of the foundation area, which was used to evaluate the engineering behavior of the various materials present. The bedrock is a jointed rhyolite that is considered competent rock. No singular, continuous planes of weakness were observed within the bedrock that could be modeled as a failure plane. However, there is an area in the south side of the breach, that trends along the centerline of the low pond in the northwest corner of the reservoir floor, which contains weathered rhyolite (Figure 9.2). The material is slightly cohesive in some areas and granular in others and still contains some of the original rock fabric. Along the north side of the breach, near the road that ran along the toe of the dam, there is an area with about 6 to 18-inches of a clay rich soil with roots and organics, resting directly on fresh rhyolite (Figure 9.3). Most of the area of the breach is fresh competent rock with no traces of soil or weathered rock (Figure 9.4).

**Figure 9.4 - Fresh rhyolite bedrock surface.**

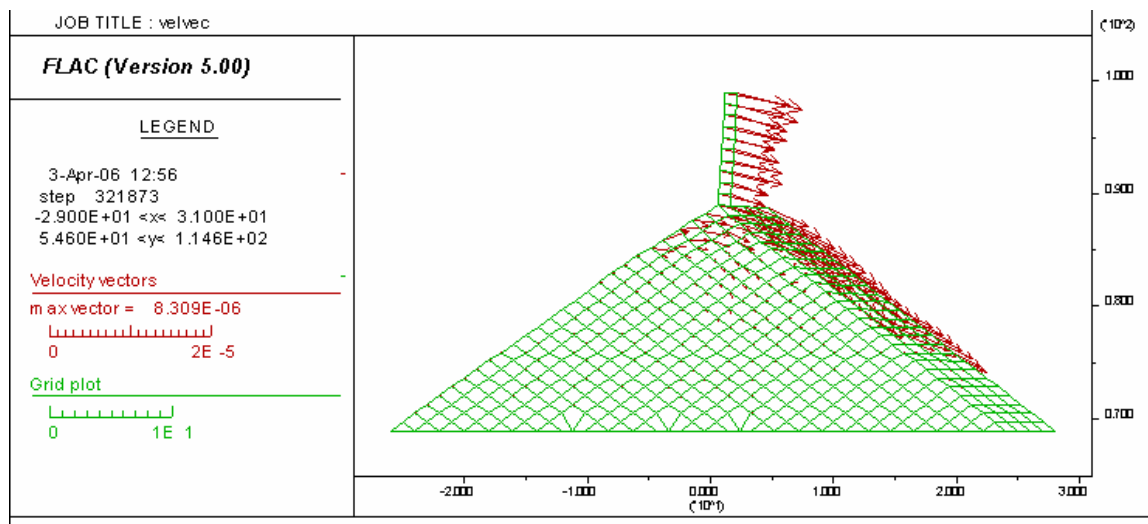
Figure 9.5 – FLAC Analysis

The analysis was stopped when the top of the parapet wall deflected more than 1 foot, which occurred when embankment erosion approached the toe of the wall. This deflection would cause significantly more overtopping to occur, further undermining the wall. Also, it is possible the geomembrane and concrete liner would have ruptured due to the significant wall movement allowing substantial leakage through the open joint, accelerating the loss of embankment material beneath the wall. (See Figures 9.5 and 9.6)

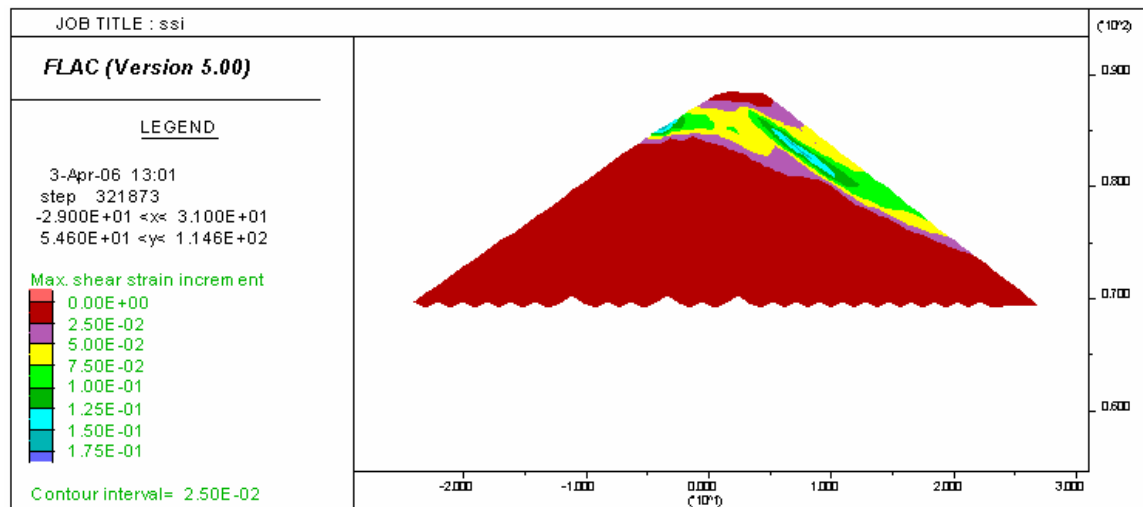
Figure 9.6 - Shear strain from the final FLAC iteration.

Note the band of high shear strain parallel to the slope

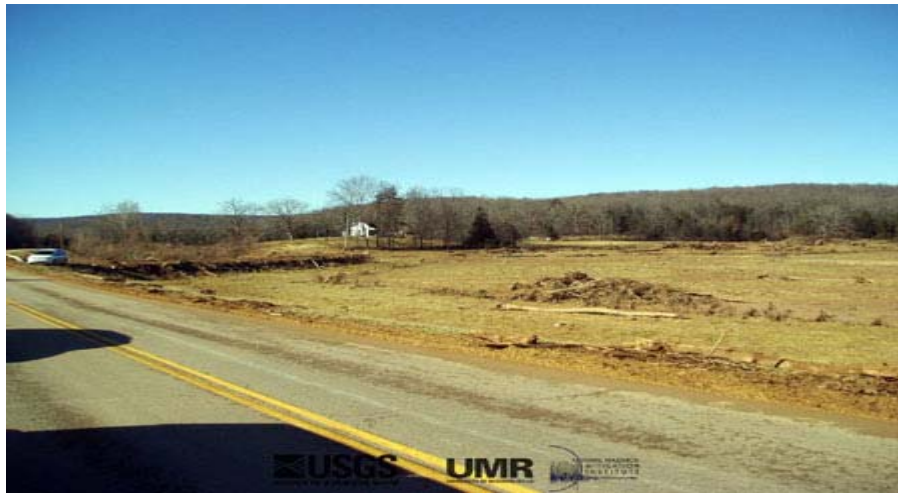
One home approximately 200 hundred yards from the Superintendent's residence (located off Route N) was surrounded by flood waters but, because it is located on a small hill, the flood waters encircled the residence but did not flood it. The surrounding farmland however, was flooded and debris and sediment was deposited in the fields. Additionally, some of the farmland fencing was destroyed (Figure 11.2).

**Figure 11.2 - Farmland with debris on north side of Route N. Note home on small hill. (Source: U.S. Geological Survey)**

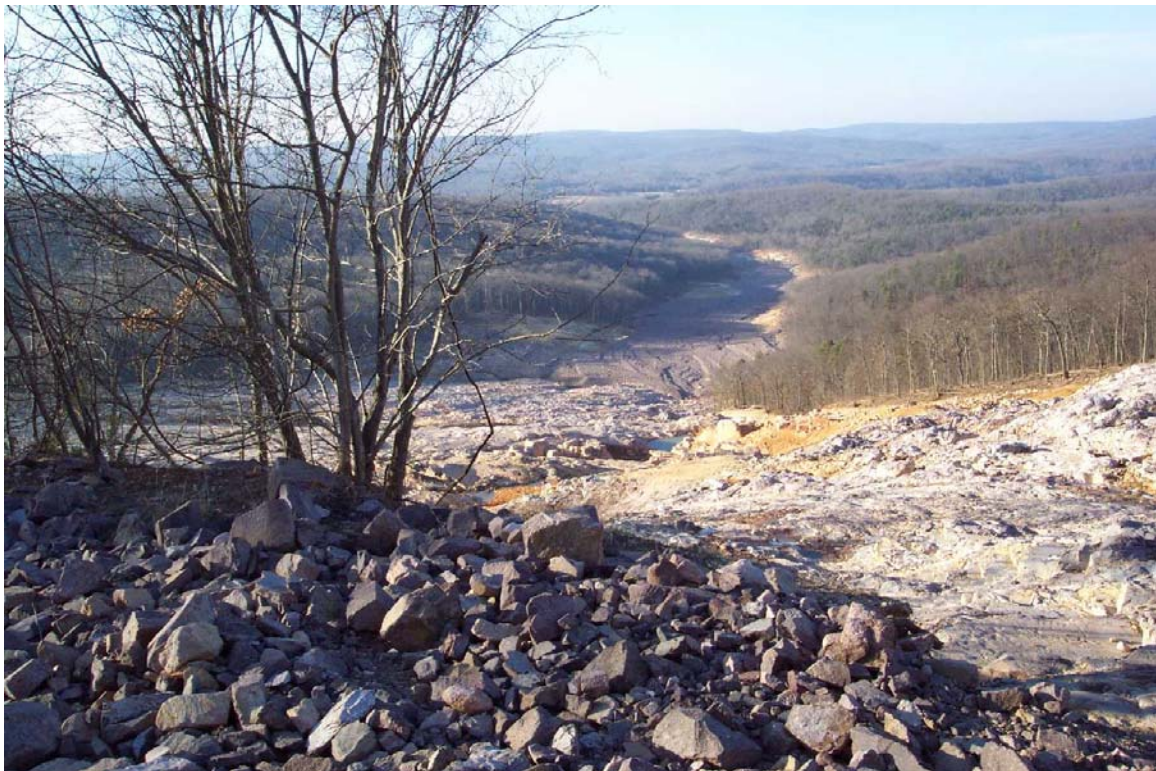
Approximately 317 acres, between the upper and lower reservoir, were directly impacted by the release of water immediately following the dam breach. A map and description of the land uses and soils of this impacted area can be found in Appendix E in the back of this report. The erosive force of the water from the breach removed all topsoil to bedrock in an approximate 200-yard swath, down the face of the Proffit Mountain (Figure 11.3) along the course of an intermittent unnamed tributary. Also, seen in Figure 11.3 is the shallowness of the topsoil along the tree line.

**Figure 11.3– Downstream view from breach (Source: Staff, 12/22/05)**

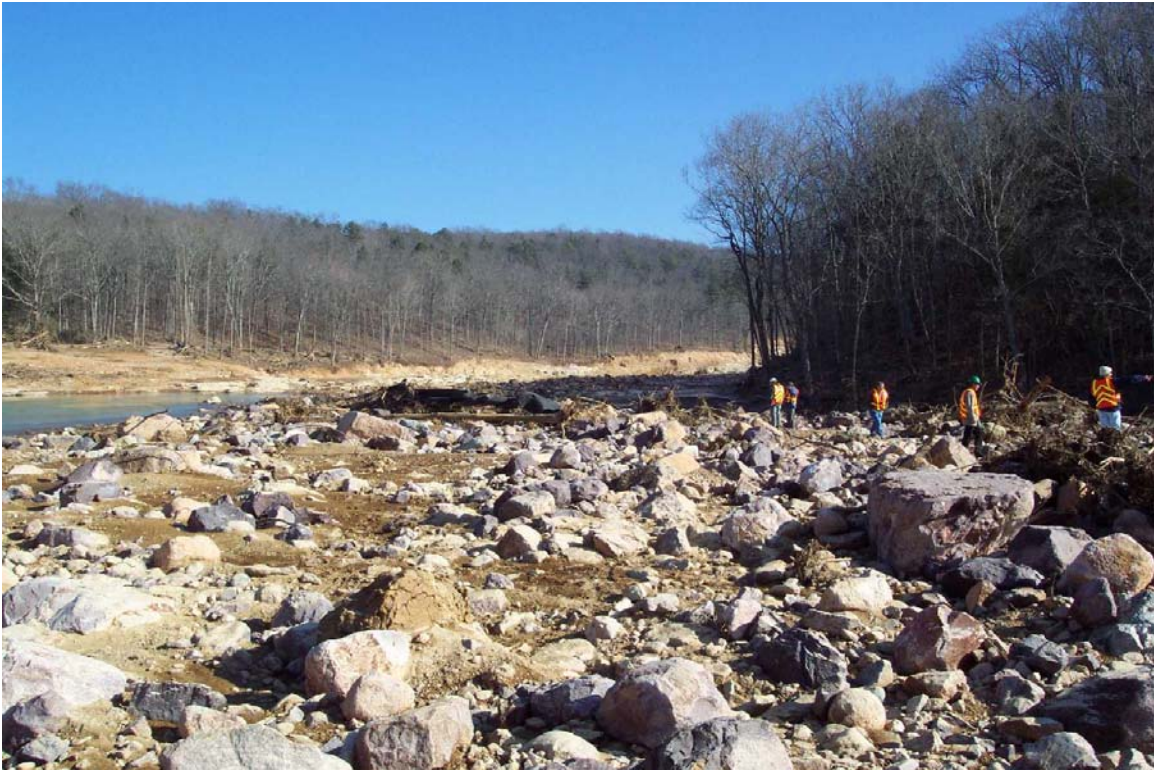
A break in the slope of the terrain is located where the unnamed tributary joins the East Fork Black River at the lower portion of the mountain. Most of the deposition of eroded sediments and rock fill from the dam embankment occurred at this point, forming a debris dam (Figure 11.4) and pond at the approximate location of U.S. Geological Survey gage station (No. 070661270) which was severely damaged during the event. The material deposited at this point ranged from boulders several feet in diameter to sand and fine silts. Concrete, rebar, and

sections of the geomembrane lining from the Upper reservoir were also present in the debris field.

**Figure 11.4 – Looking upstream from debris dam (Source: Staff, 12/22/05)**

It is expected that there will be continued soil erosion and transport of material of varying sizes from the slope of Proffit Mountain and the associated debris field. The licensee has proposed a series of temporary sediment retention structures along the affected area to prevent further transport of the sediments, until they can be stabilized.

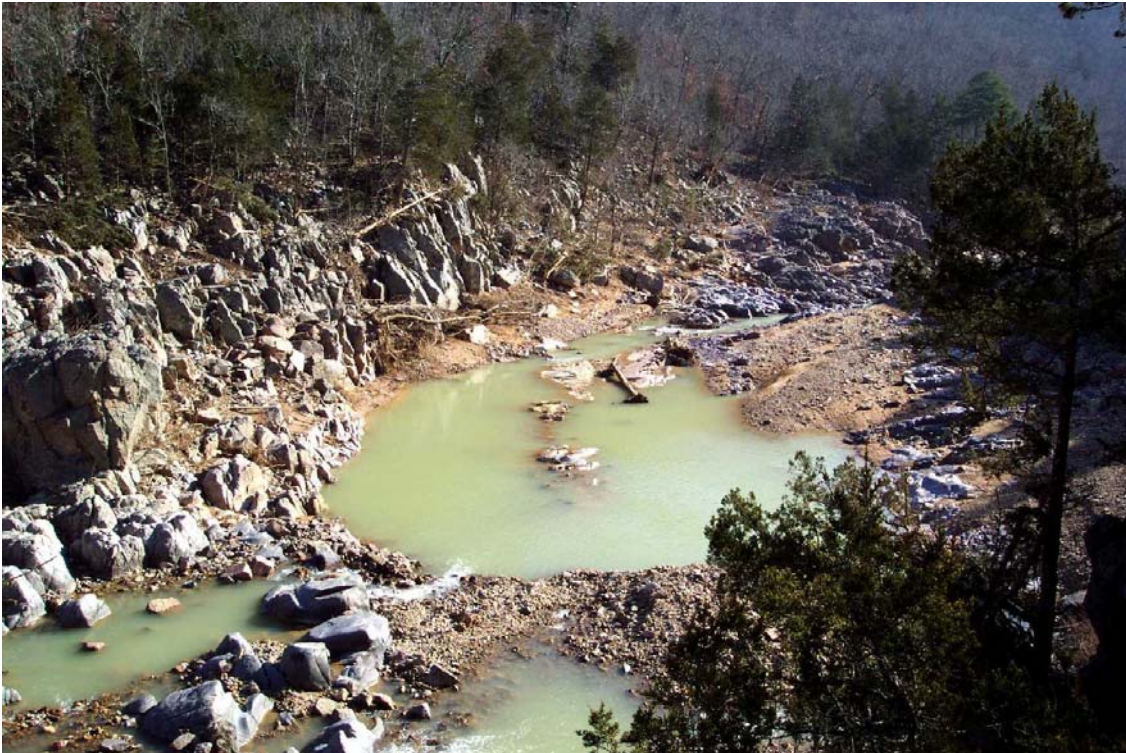
**Figure 11.5 – Turbidity at Johnson’s Shut-ins (Source: Staff, 12/22/05)**

In order to reduce turbidity in the lower reservoir, AmerenUE, with the approval of the Missouri DNR and Commission, used common alum based flocculants (used primarily for drinking water treatment) to remove the charge on

the particles and allow them to settle. Flocculation is a process by which the electrostatic charge of suspended particles is neutralized by a flocculent, allowing the particles to stick to one another and form flocs. Once the flocs are large enough they fall from suspension. After receiving state approval of the plan on January 20, 2006, and Commission approval on January 25, 2006, the licensee applied the flocculent to the lower reservoir on January 25-27, 2006. Without use of a flocculent the particles would have stayed in suspension, and the water in the lower reservoir would have cleared much more slowly. In addition, turbidity caused by suspended clay particles would have remained in the river downstream over a longer period and likely extended further downstream.
