# FERC TAUM SAUK INVESTIGATION TEAM

April 28, 2006

Report of Findings on the Overtopping and Embankment  
Breach of the Upper Dam - Taum Sauk Pumped Storage  
Project, FERC No. 2277

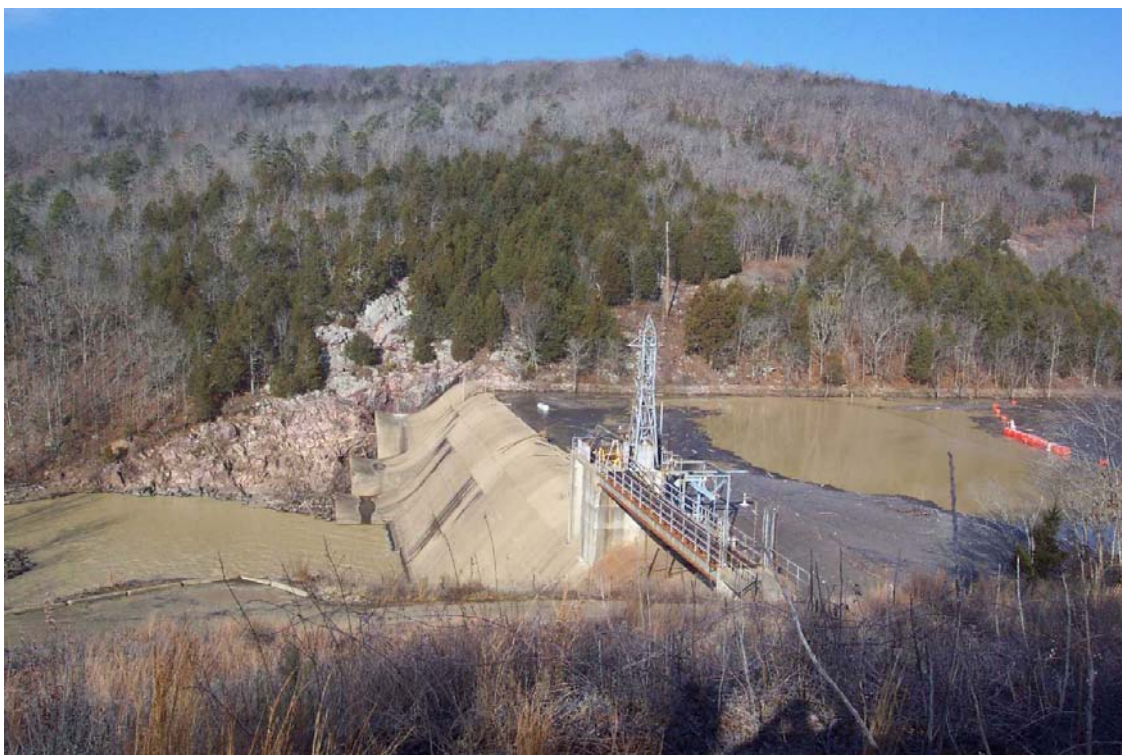
**Figure 11.6 – Turbidity at Lower Dam (Source: Staff, 12/22/05)**

In order to reduce turbidity in the lower reservoir, AmerenUE, with the approval of the Missouri DNR and Commission, used common alum based flocculants (used primarily for drinking water treatment) to remove the charge on

the particles and allow them to settle. Flocculation is a process by which the electrostatic charge of suspended particles is neutralized by a flocculent, allowing the particles to stick to one another and form flocs. Once the flocs are large enough they fall from suspension. After receiving state approval of the plan on January 20, 2006, and Commission approval on January 25, 2006, the licensee applied the flocculent to the lower reservoir on January 25-27, 2006. Without use of a flocculent the particles would have stayed in suspension, and the water in the lower reservoir would have cleared much more slowly. In addition, turbidity caused by suspended clay particles would have remained in the river downstream over a longer period and likely extended further downstream.

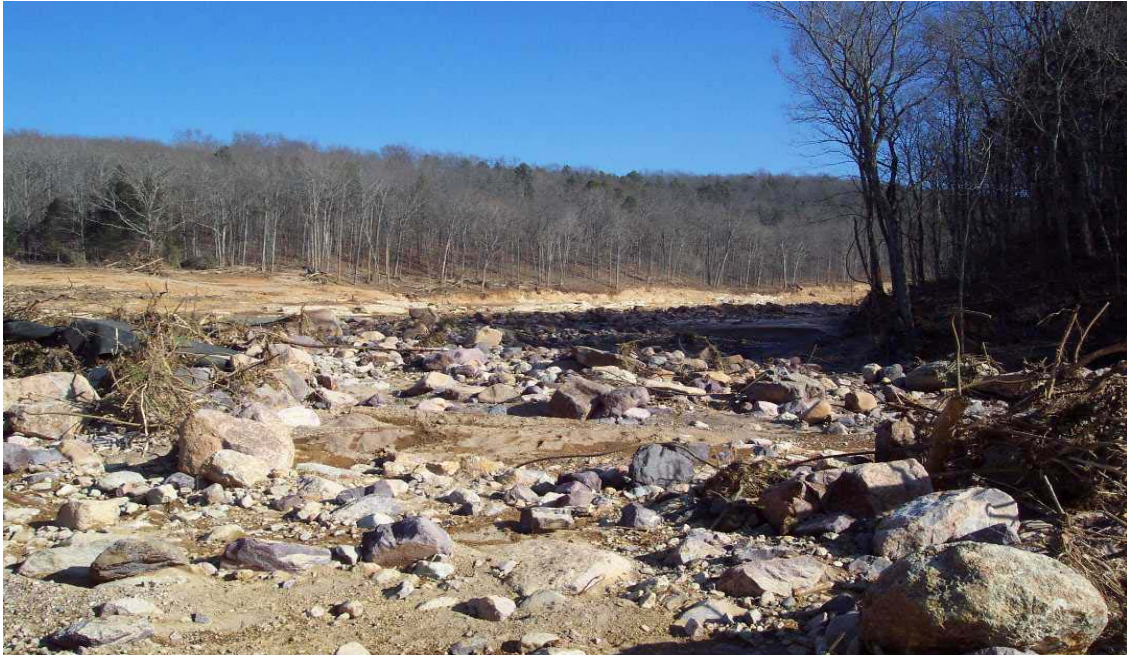
The high flows immediately following the rim dike breach, carried a tremendous amount of sediment and boulders into the river from the upper dam's embankment, in addition to the scour created down the side of the mountain. Vegetative debris and earthen sediment was deposited on the valley floor and in the East Fork Black River (Figure 11.7). The volume of the debris and sediment altered the configuration of the river from the point of entry to the Shut-Ins area of the park and destroyed riparian habitat (Figure 11.8). It also reduced aquatic habitat and adversely affected the river channel by creating pools, barrier dams and disjoining habitats.

**Figure 11.7 - Modified channel of the East Fork Black River (Source: Staff)**

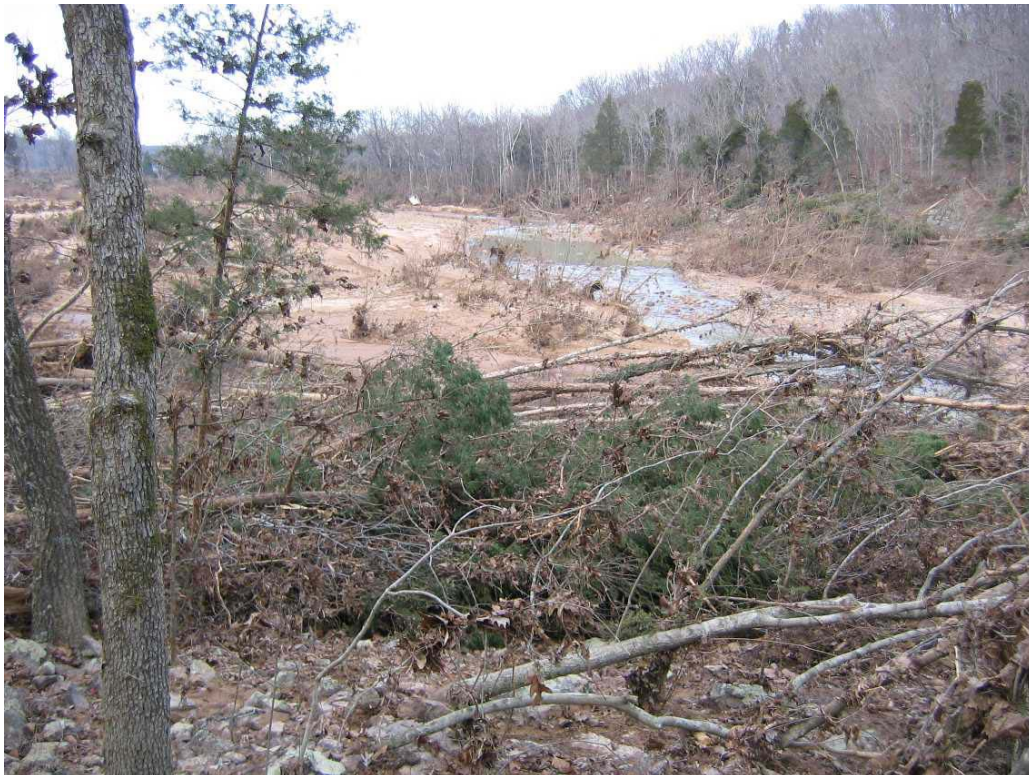
**Figure 11.8 - East Fork Black River within State Park. (Source: Missouri Department of Conservation)**

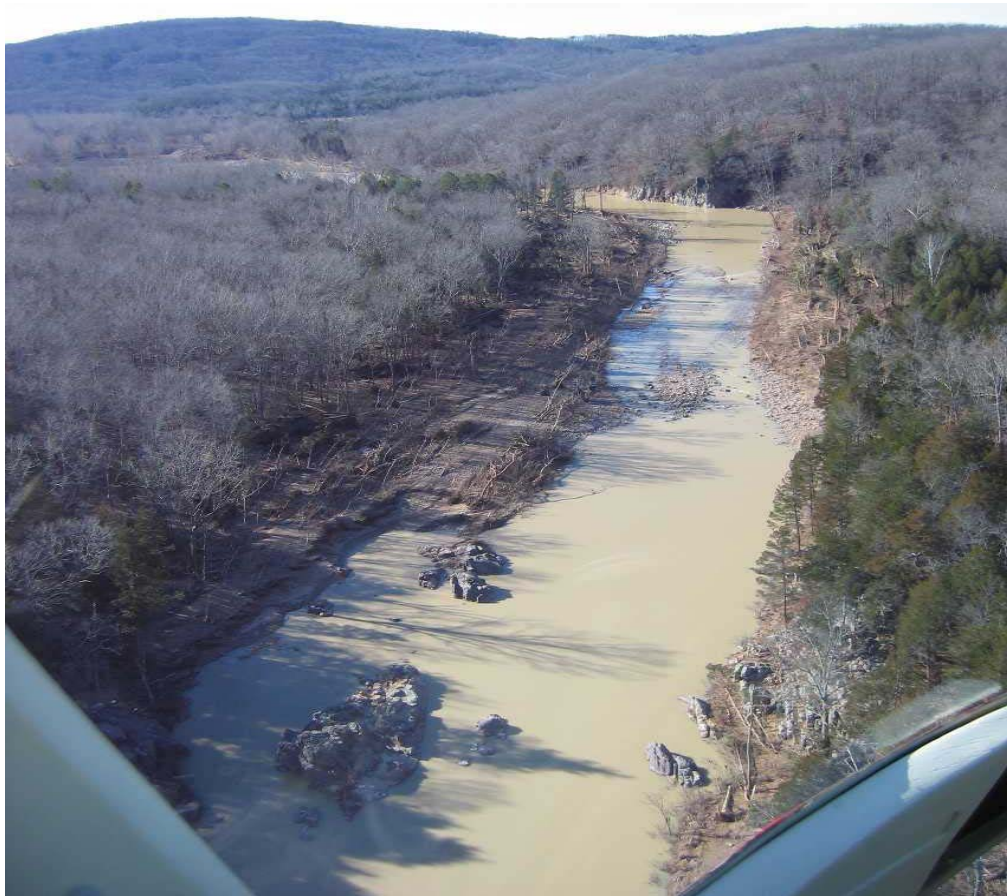
The channel modification was most extensive upstream from the Shut-Ins at the entrance to the State Park. The natural boulder and bedrock area of the Shut-Ins helped prevent excessive scour and the reconfiguration of the channel in that area; however, below the Shut-Ins area and upstream of the lower reservoir, significant loss of riparian habitat, flooding, scour, and turbidity were sustained (Figure 11.9).

**Figure 11.9 - Scour and loss of riparian habitat below the Shut-Ins. (Source: Missouri Department of Conservation)**

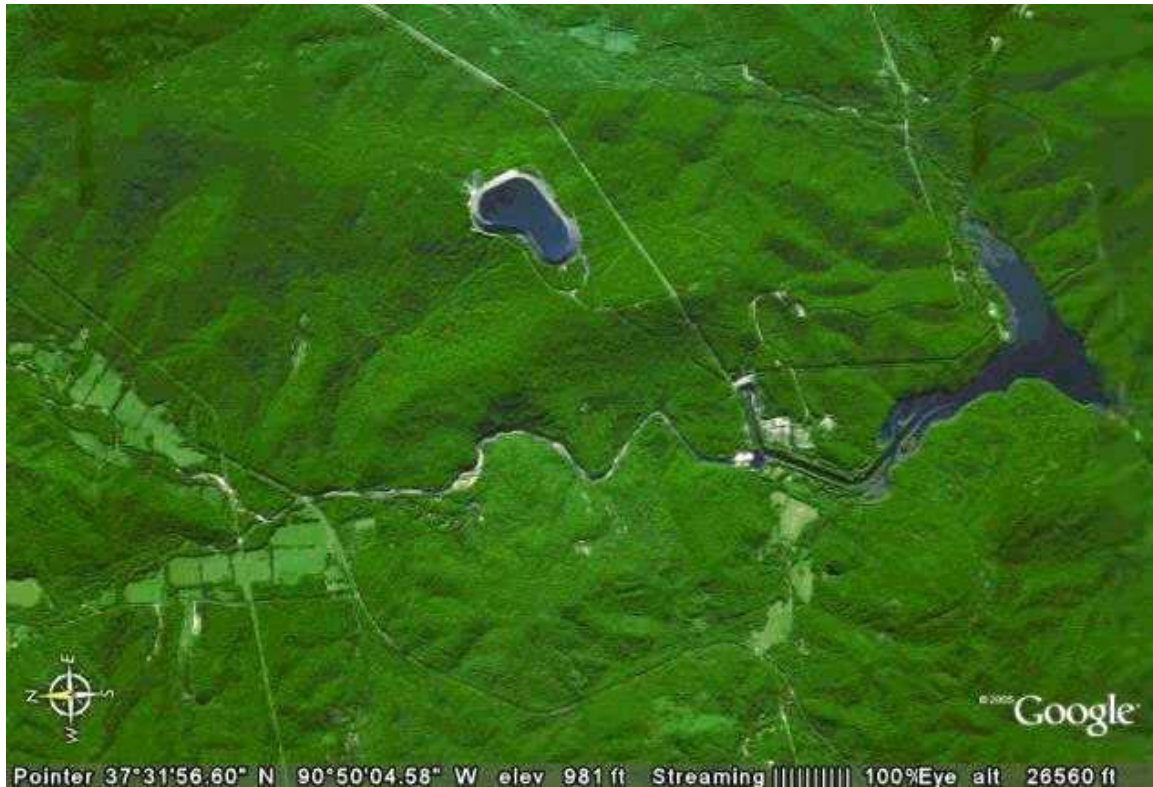
Prior to the December 14 event, Proffit Mountain was heavily forested as seen in the satellite photograph (Figure 11.13). From the base of the upper reservoir in the northwest corner, where the breach occurred, to the valley floor and state park, over 250 acres of forest vegetation was denuded. Compounding the problem of deforestation is the fact that all soil in a 200 yard swath down Proffit Mountain was removed down to bedrock. Therefore, the ability to reforest this area is highly

problematic. It is expected that due to the absence of topsoil, this area will remain deforested.

**Figure 11.13 - Pre-event satellite photograph of the forested area surrounding Proffit Mountain. (Source: Google Earth, 2005)**

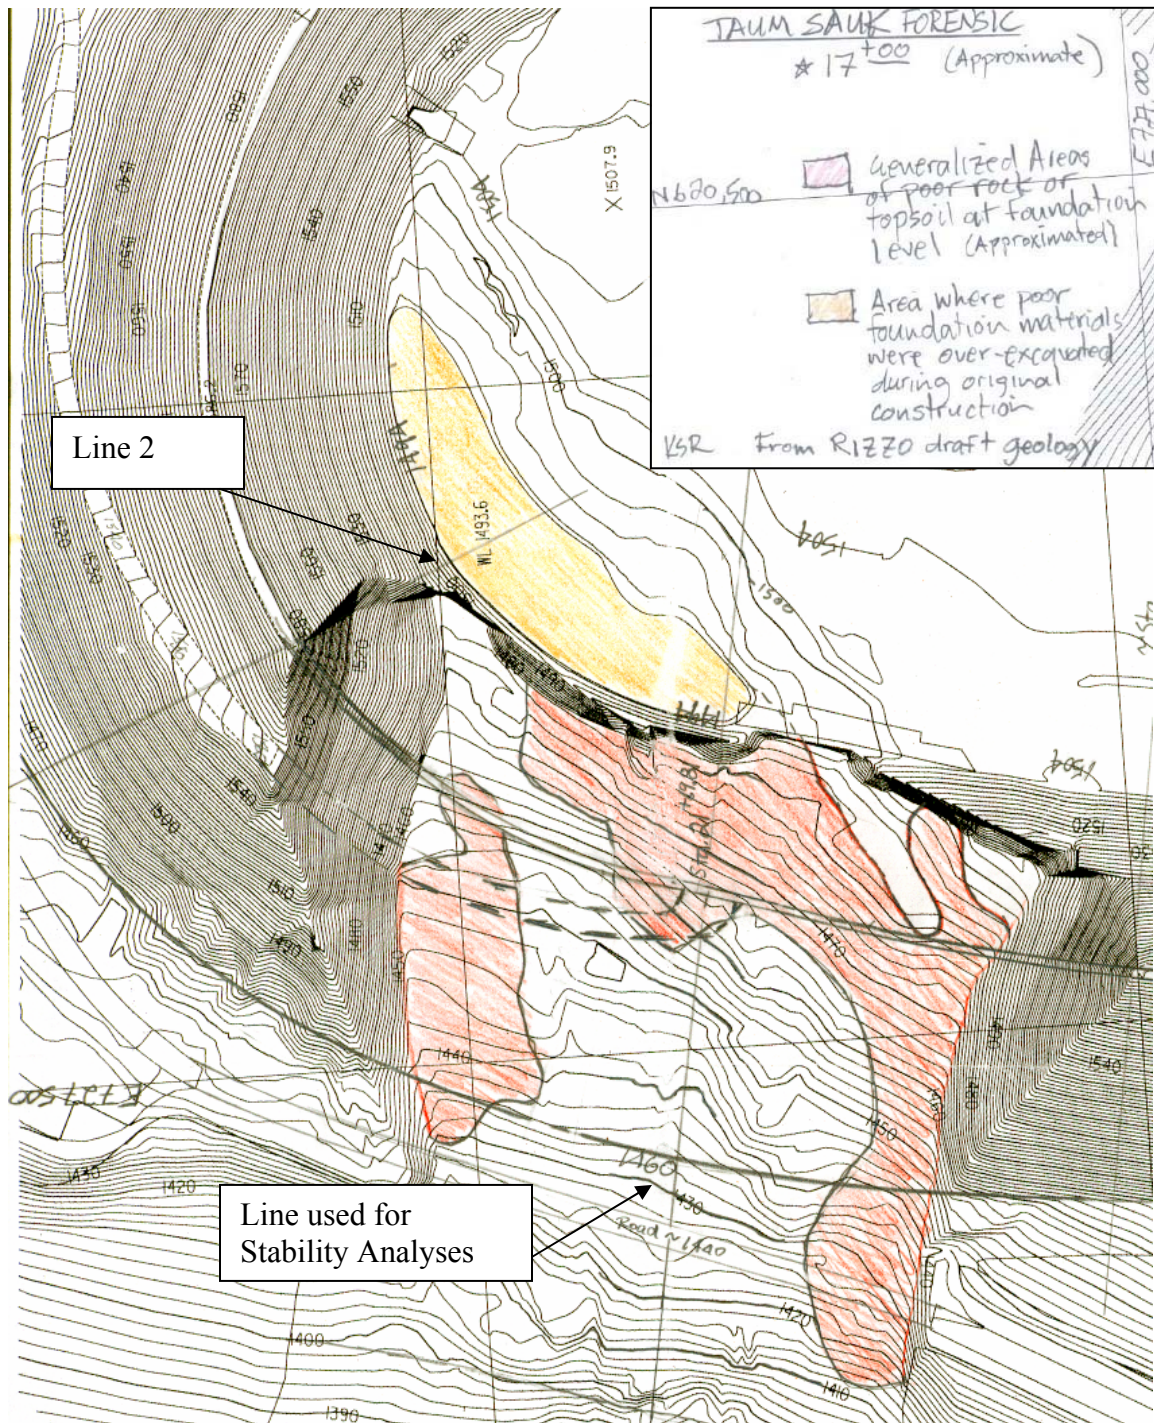
Figure D.1- Taum Sauk Forensic Reconstruction

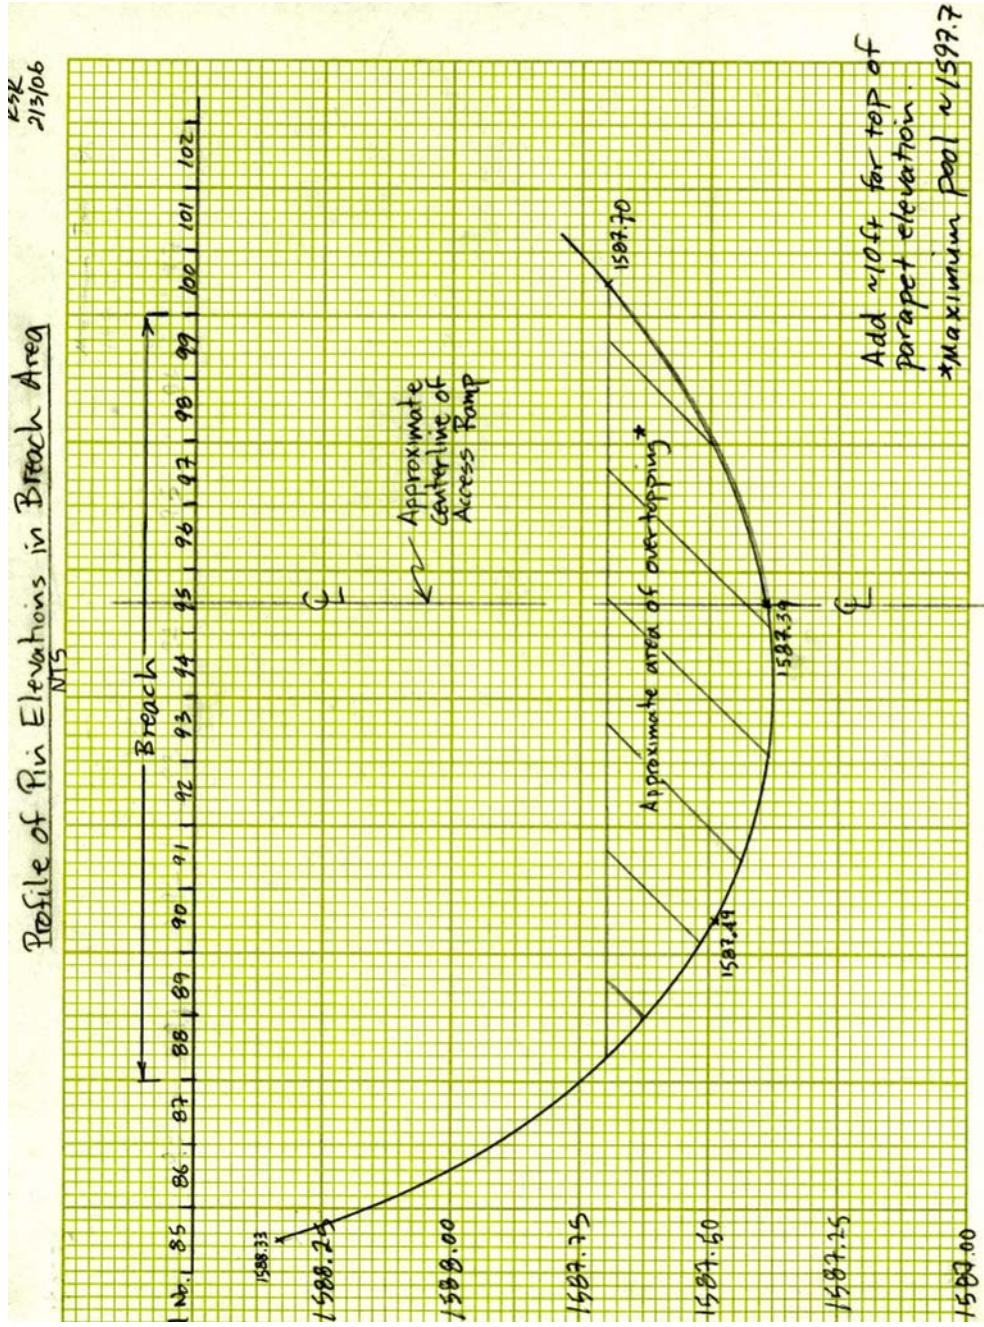
Figure D.2 - Vertical curve in the area of the breach. Approximate extent of overtopping is hatched.
