**SIEMENS' REPORT**  
**MARCH 24, 2006**  
**AmerenUE**

## AmerenUE Taum Sauk Incident Instrumentation and Controls Root Cause Investigation Report

March 24, 2006

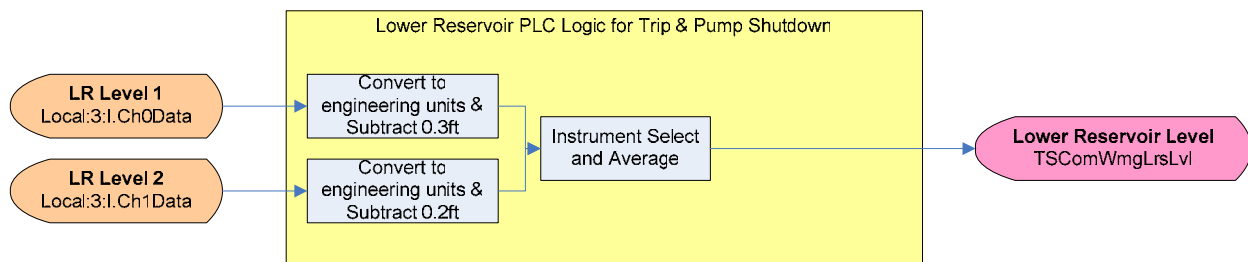
Figure 8: Lower Reservoir PLC Logic Diagram

The lower reservoir PLC is to read the LR level transmitters and converts the values into engineering units. Then it performs an average calculation of these two values. The operators can also choose to use either one of the two values instead of the average. According to the operator logs, transmitter #2 was not operational on 12-Dec-05, so transmitter #1 was selected as the sole source.

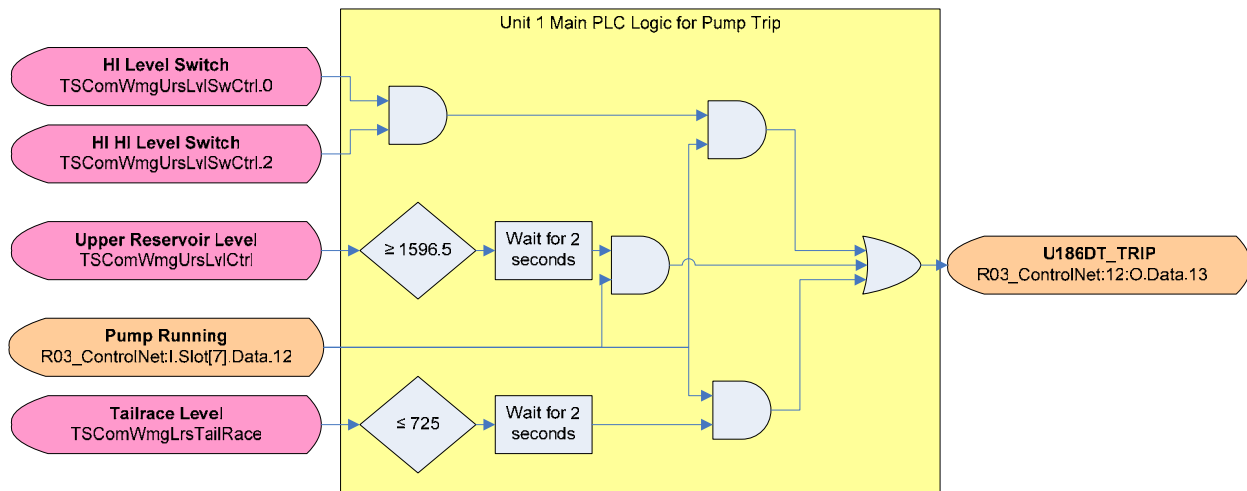
**Figure 9: Unit 1 Main PLC Logic for Pump Trip**

The Unit 1 main PLC performs the trip logic as outlined in the above sketch. Either a combination of the HI and HI-HI level switch, an indicated upper reservoir level of greater or equal than 1596.5 feet or a tailrace level of less or equal than 725 feet for more than 2 seconds is to trip the pump. The trip levels for the tailrace level (725 feet) and for the upper reservoir level (1596.5 feet) are coded into the PLC program and therefore not changeable by the operator.

The trip is performed by energizing the coil of relay 186DT which triggers an input signal of the governor PLC. This is to cause the governor PLC to trip the pump and to close the wicket gates. Since the historical process data indicates that the inputs for the trip signals were never satisfied (e.g. HI-HI alarm was never present, the maximum indicated upper reservoir level was 1593.72 which is below 1596.5 feet and the lowest tailrace level logged in the process data archive was 730.0 which is above 725.0 feet) during the incident, it is likely that relay 186DT was never energized and the trip circuit was therefore not further analyzed.

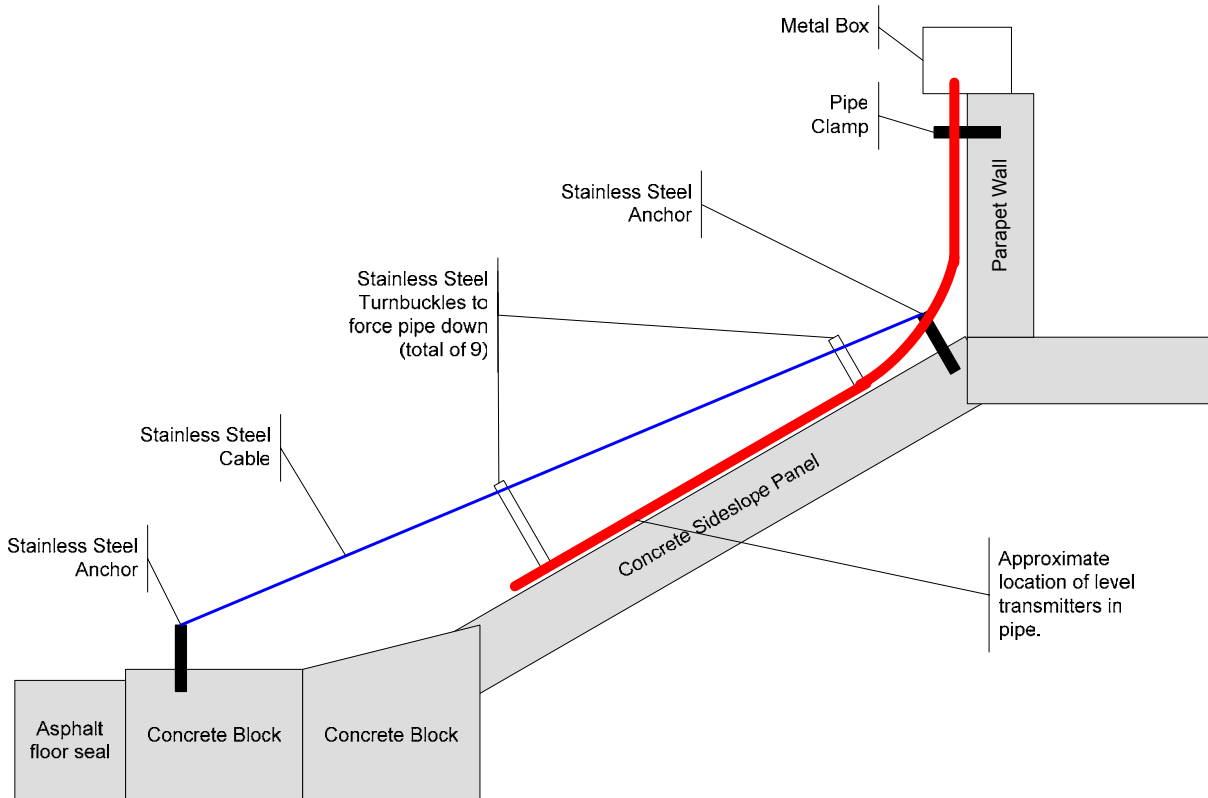
**Figure 13: Instrumentation Pipe Installation Sketch**

Two HDPE pipes are utilized to hold in place and protect all of these instruments. Four pipes are installed (two are spares) into the upper reservoir and held against the liner per IMG121866 - Sketch SB1306-3 "Gage Pipe Supports As Constructed". Also see the sidewall riser pipe cross-section detail on IMG013196 - Side Slope Relining Details III drawing 8304-X-155099 r5 for specifications of where holes were drilled into pipes. Also see the 15-Nov-04 photo of the pipe installation.

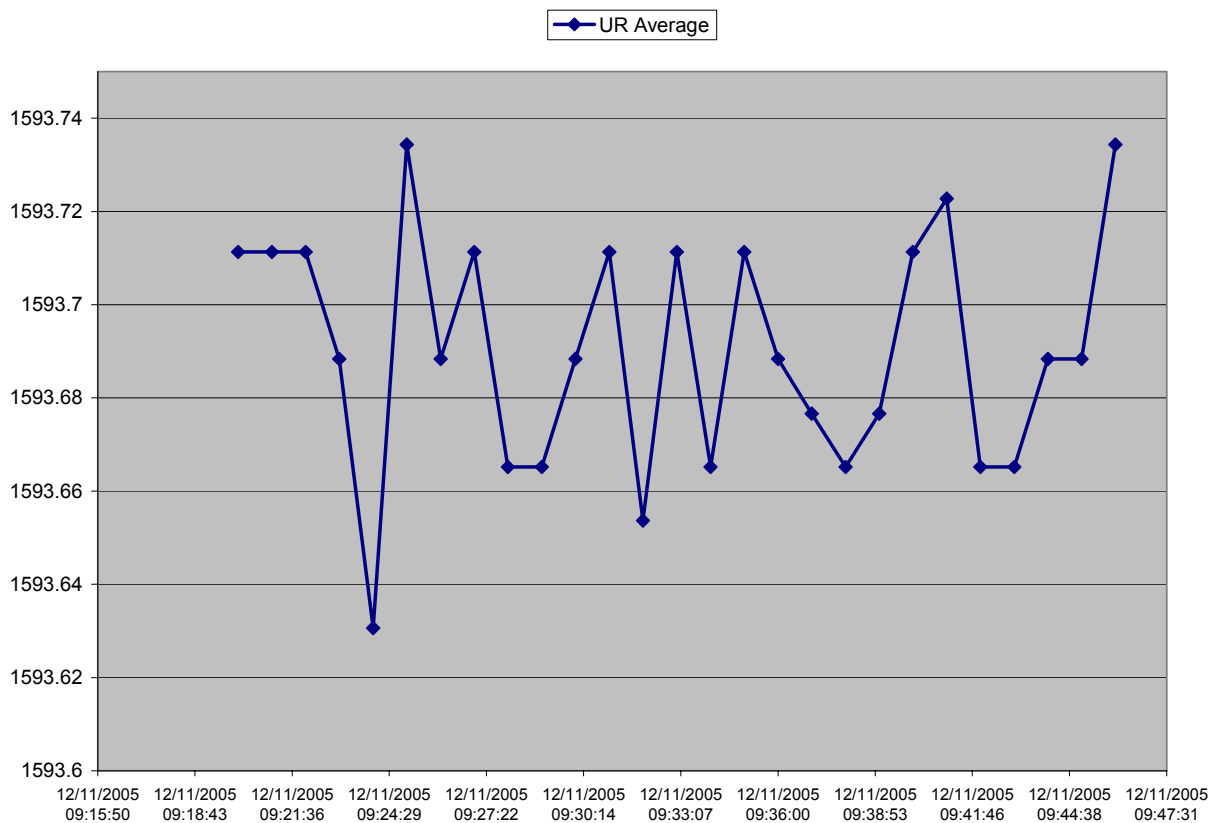
Figure 22: Average UR Transmitter Reading on 11-Dec-05 between 09:20 and 09:46

The following chart shows the average transmitter reading (calculated in the PLC as the average of TX2 and TX3) on 11-Dec-05 between 09:20 and 09:46. The maximum variation is 0.1 feet. The last pump stopped at 07:50am on this morning. The data sample started 90 minutes after the last stop. It should be expected that there was no movement of the reservoir level.

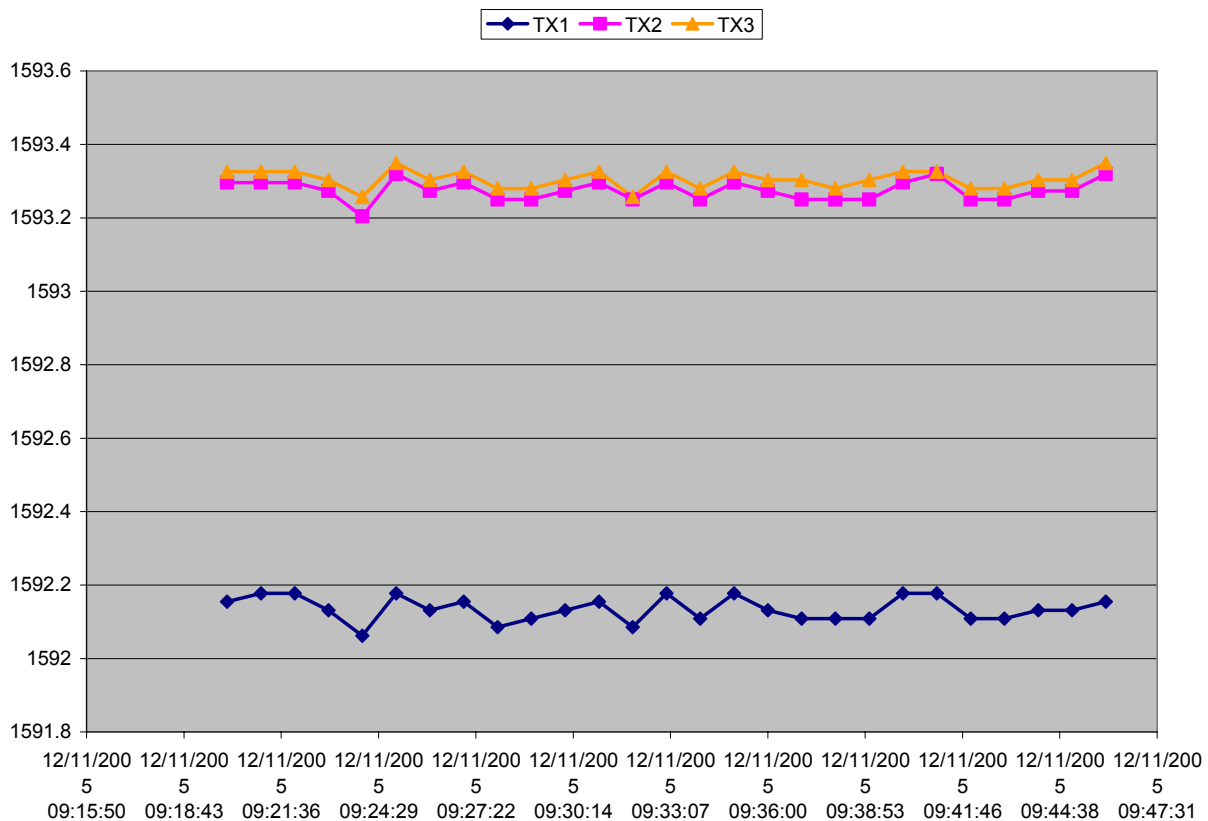
**Figure 23: Individual UR Transmitter Reading on 11-Dec-05 between 09:20 and 09:46**

This data indicates that all three transmitter readings are moving in parallel. This becomes more evident if the one minute value changes are plotted (here for TX2 and TX3 which were actually used for level control):

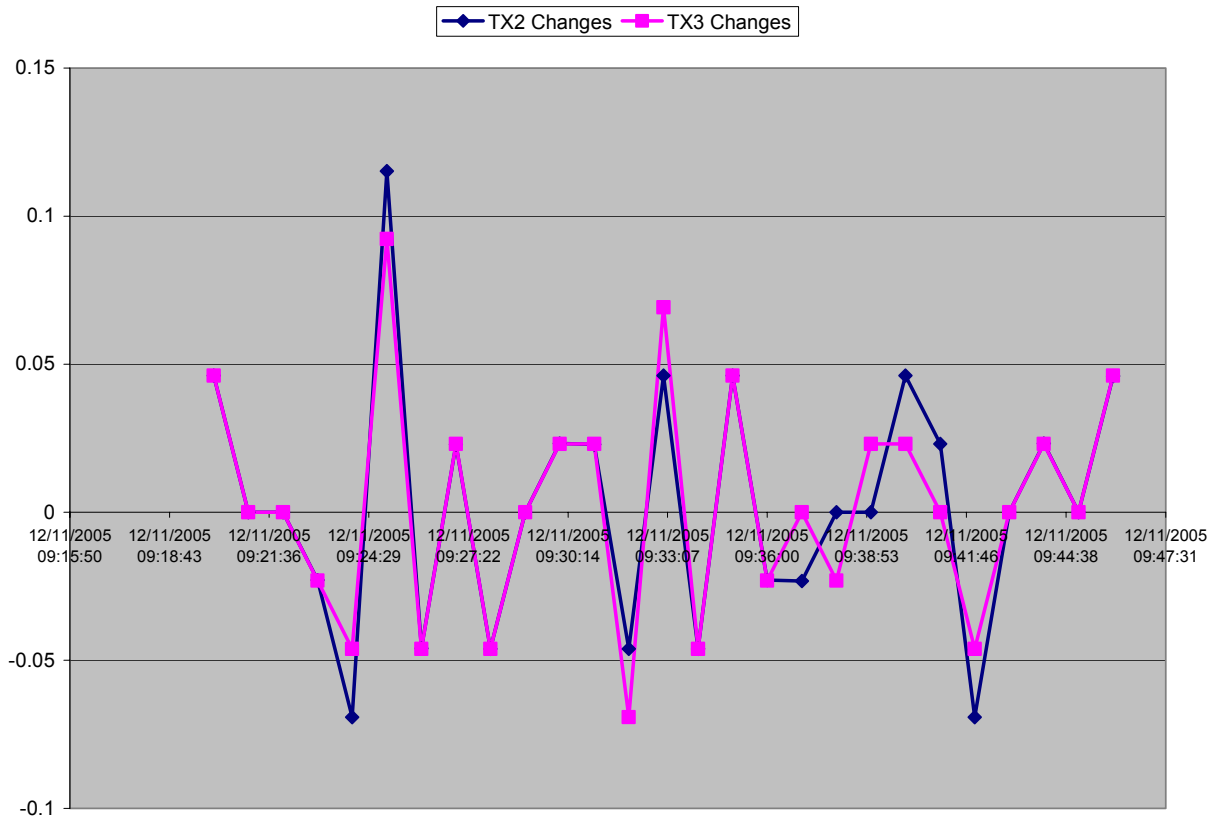
**Figure 24: Individual UR Transmitter Reading Changes on 11-Dec-05**

Several time intervals with different reservoir levels were reviewed. In all cases, a signal variation of  $\pm 0.1 - 0.15$  feet was observed.

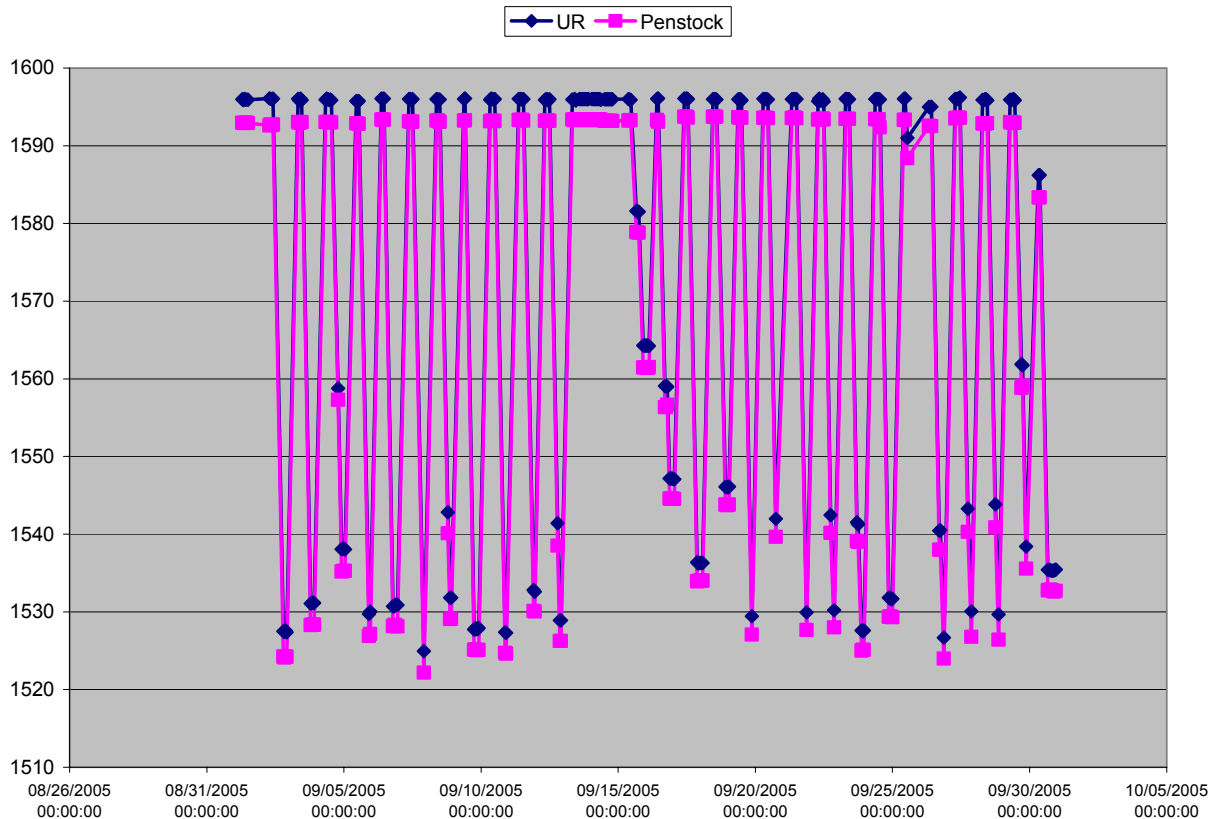
**Figure 25: Comparison between UR Average and PS Level Transmitter Readings**

The following chart shows the UR level compared to the Penstock head during calm plant conditions (no generation or pumping) for the month of September 2005. The chart indicates that the head measured by the Penstock transmitter is closely correlated to upper reservoir level:

The head measured by the penstock transmitter is not suitable for use as a level measurement while the Unit is operating as the measured pressure includes water flow and penstock loss affects that make an upper reservoir level correlation difficult.

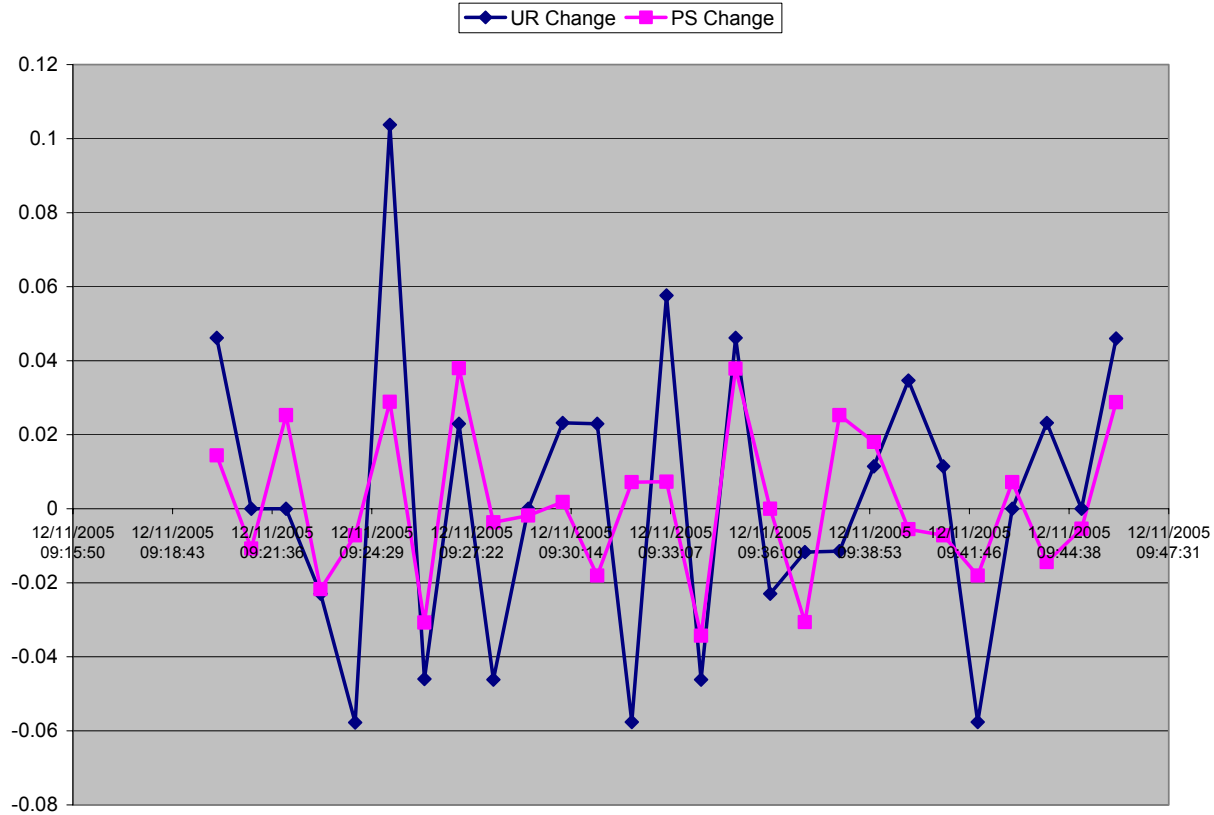
**Figure 27: UR vs. PS Transmitter Reading Changes**

Again, this chart indicates that the PS level transmitter shows less signal noise than the UR level transmitter average. The standard deviation for the UR series is 0.00399, the standard deviation of the PS series is 0.00204.

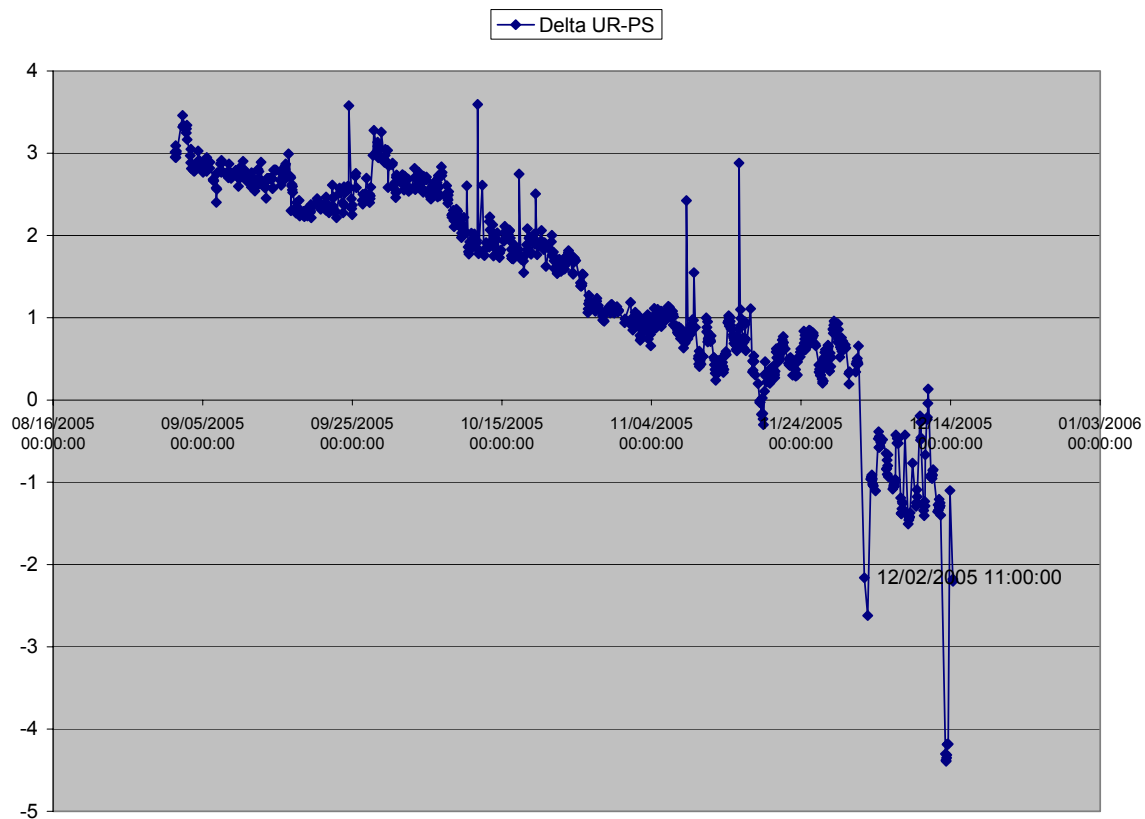
**Figure 28: Difference between UR Transmitter Average and PS Transmitter**

The gradual decrease of the difference may be explained with a gradual movement of the upper reservoir level transmitter locations. The step changes at the beginning and in the middle of December are discussed below.

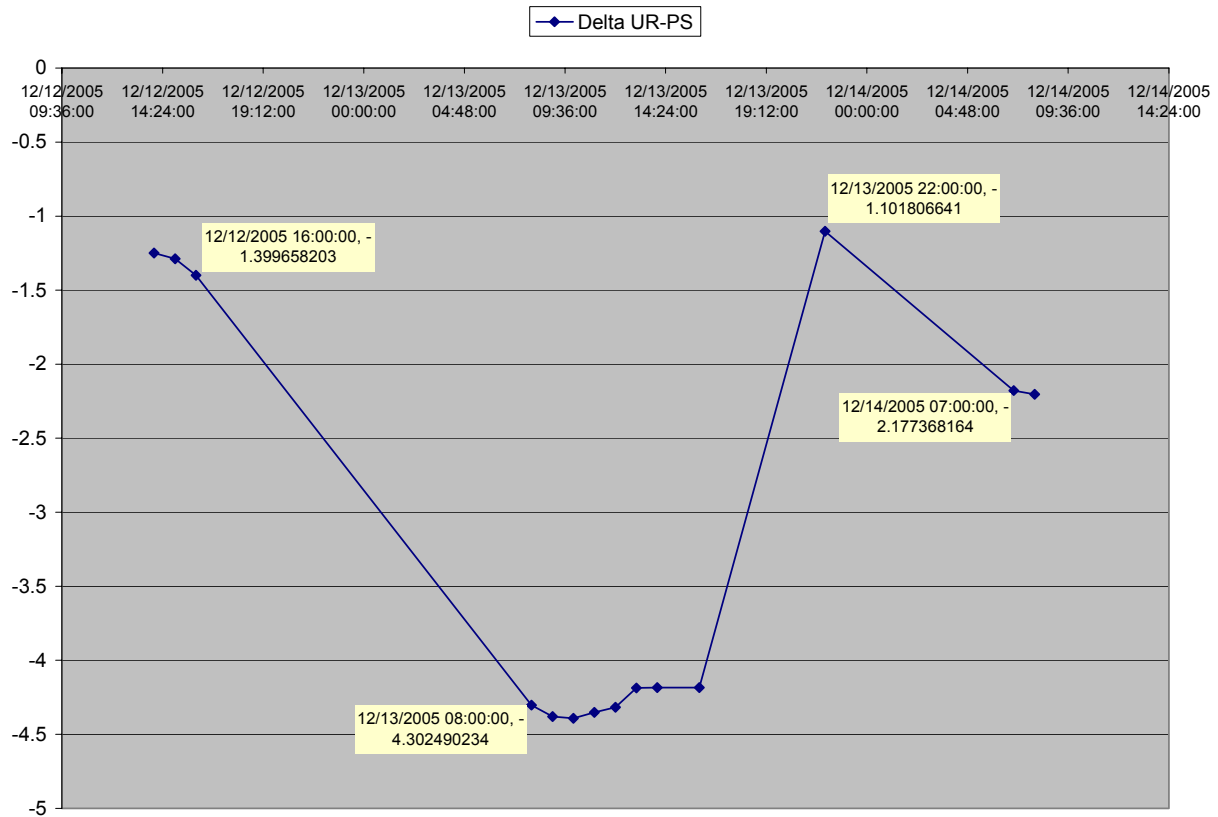
**Figure 32: Difference between UR Transmitter Average and PS Transmitter between 12-Dec-05 and 13-Dec-05**

A similar sudden change of the transmitter readings can be observed between 12-Dec-05 and 13-Dec-05. This change is also likely to be caused by a shift of the instrument elevation.

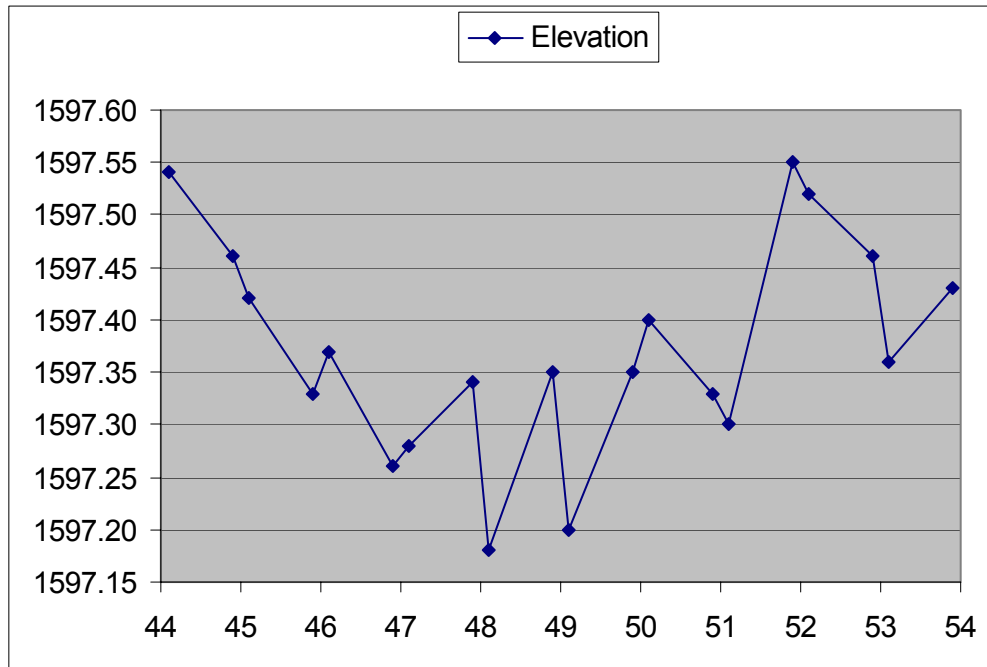
**Figure 33: Surveyed Wall Elevations between Panel 44 and 53**

The average elevation in this area is 1597.37 feet.

Based on this information, it can be assumed that the upper reservoir level measurement which was used to control the automatic stop of the last pump was reading at least 3.65 feet (1597.37 – 1593.72) too low.

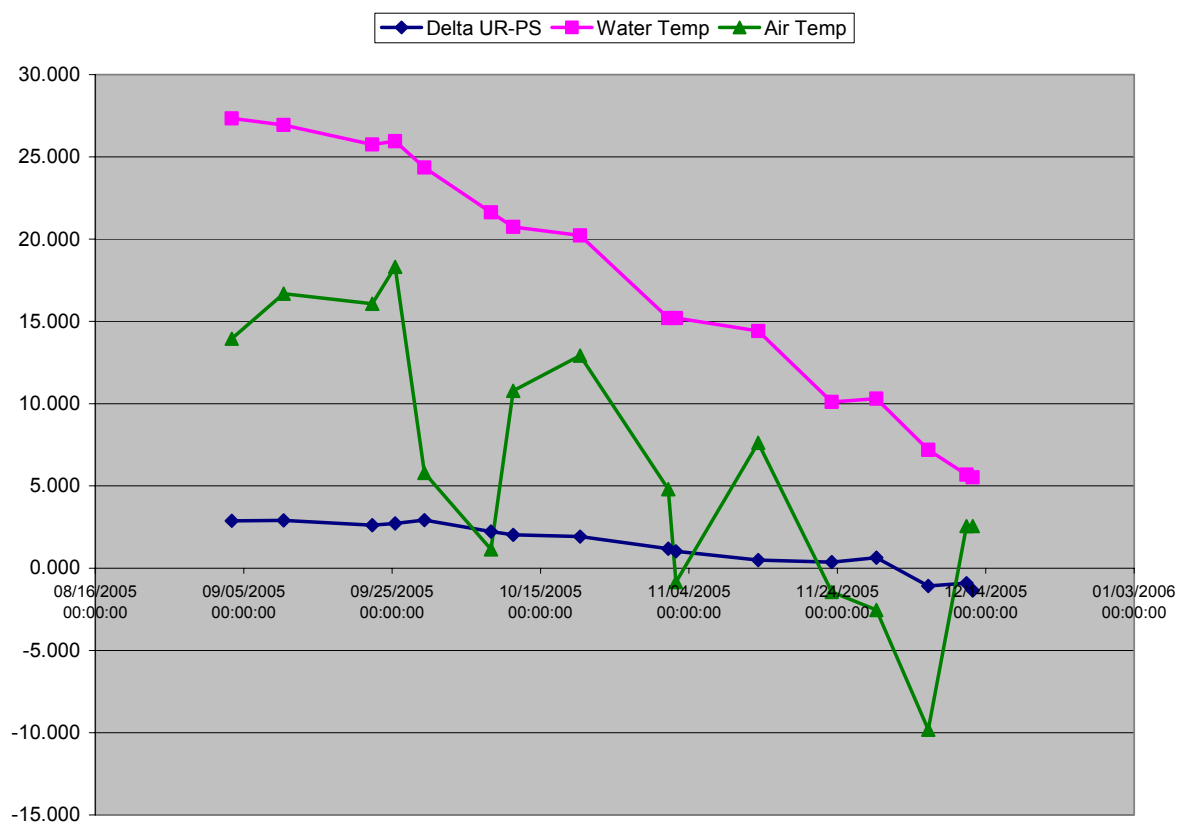
Figure 30: Transmitter Difference and Temperatures

As discussed in chapter 5.2.3, the average upper reservoir level reading was off by at least 3.65 feet low. The estimated minimum instrument lift was at least 2.54 feet. The difference of 1.11 feet ( $3.65 - 2.54$ ) is most likely attributable to additional lift. As indicated in chapter 4.6.2.3 temperature effects are unlikely.

The following chart shows the difference between the UR and PS transmitter readings in calm conditions (after an auto pump stop), the ambient air temperature and the water temperature between 3-Sep-05 and 12-Dec-05:

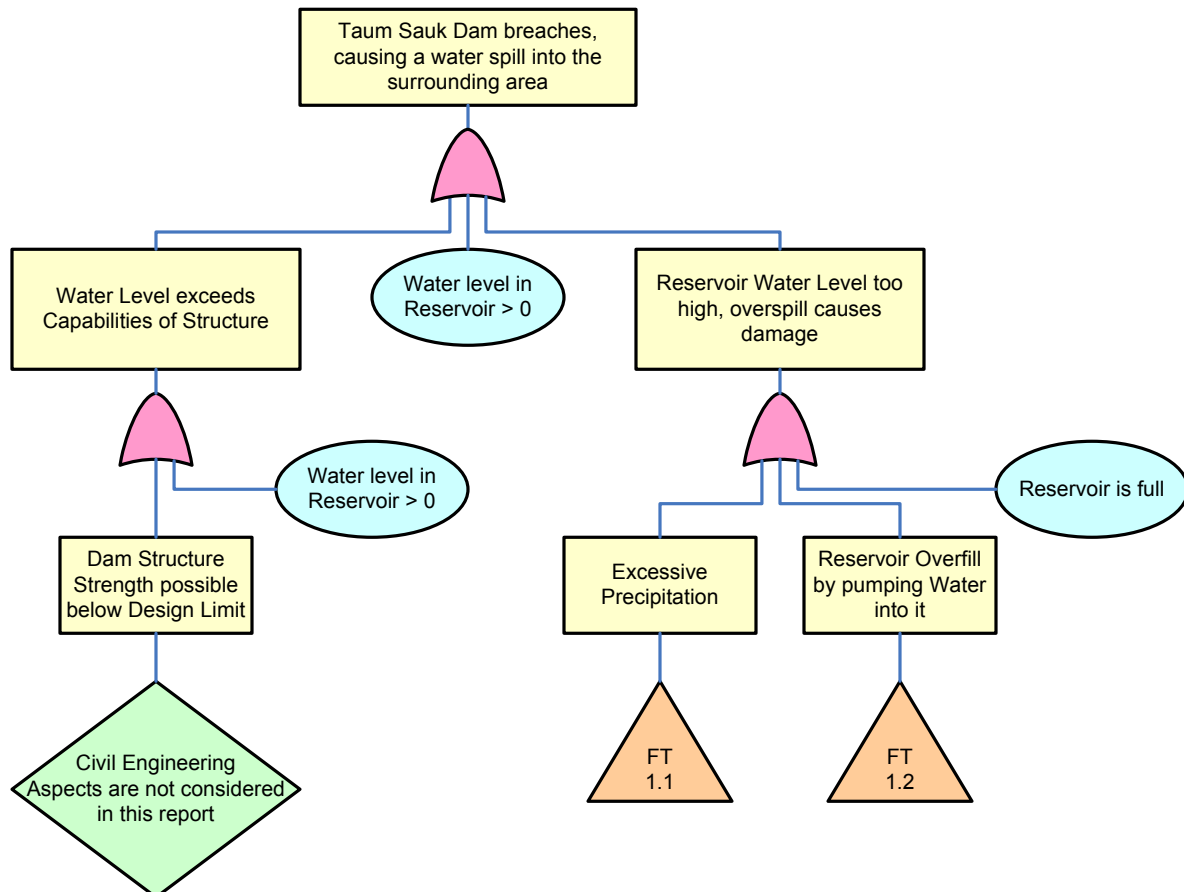
**Figure 31: Fault Tree 1: Possible Causes for Dam Breach**

The dam breach could have been caused either by a normal water level and a weakened dam structure or by water overspill which subsequently caused damage to the dam structure. The overspill could have been caused by precipitation or by pumping water into the reservoir. Since the dam structure analysis is covered by a separate report, this possibility is not explored further.

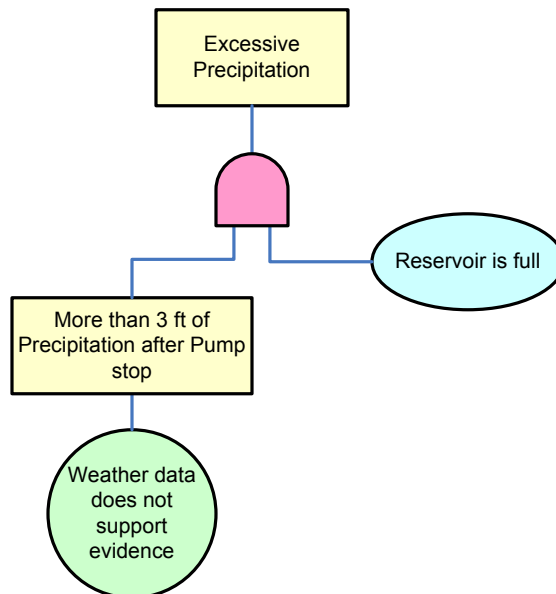
**Figure 32: Fault Tree 1.1: Excessive Precipitation**

Excessive precipitation may cause an overflow if it amounts to 3 feet after the auto-stop of the last pump which occurs at 1594<sup>7</sup> feet (the lowest wall elevation is 1597 feet). However, the weather data reviewed by Siemens does not support this possible cause.

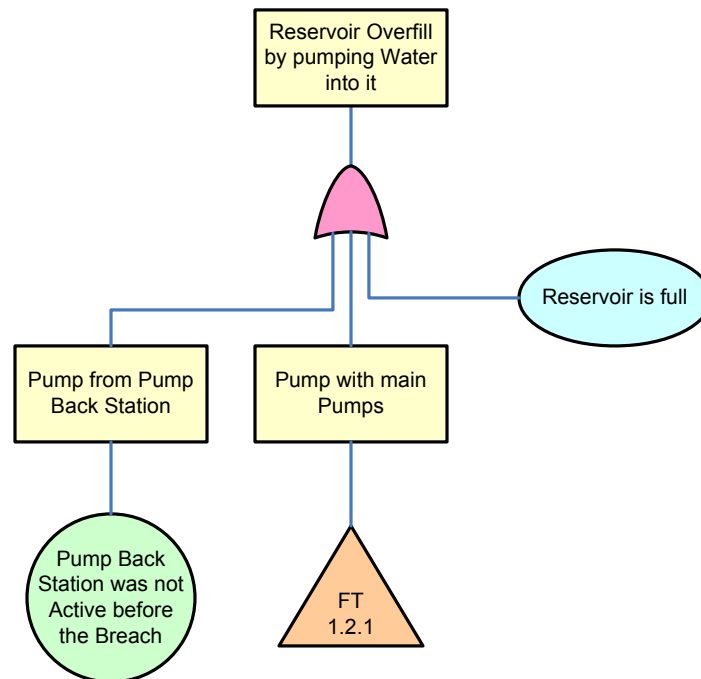
**Figure 33: Fault Tree 1.2: Reservoir Overfill by Pumping Water**

Since the upper reservoir was reported by Ameren to be leaking water at a small rate, the leakage water was collected in a small pond close to the UR. If the water level in that pond rises to a predefined level, it is to trigger a limit switch which causes the pump-back pump to start. The small size of the pump and the fact that it does not appear to have been running during the incident suggests that it did not contribute to the overfilling.

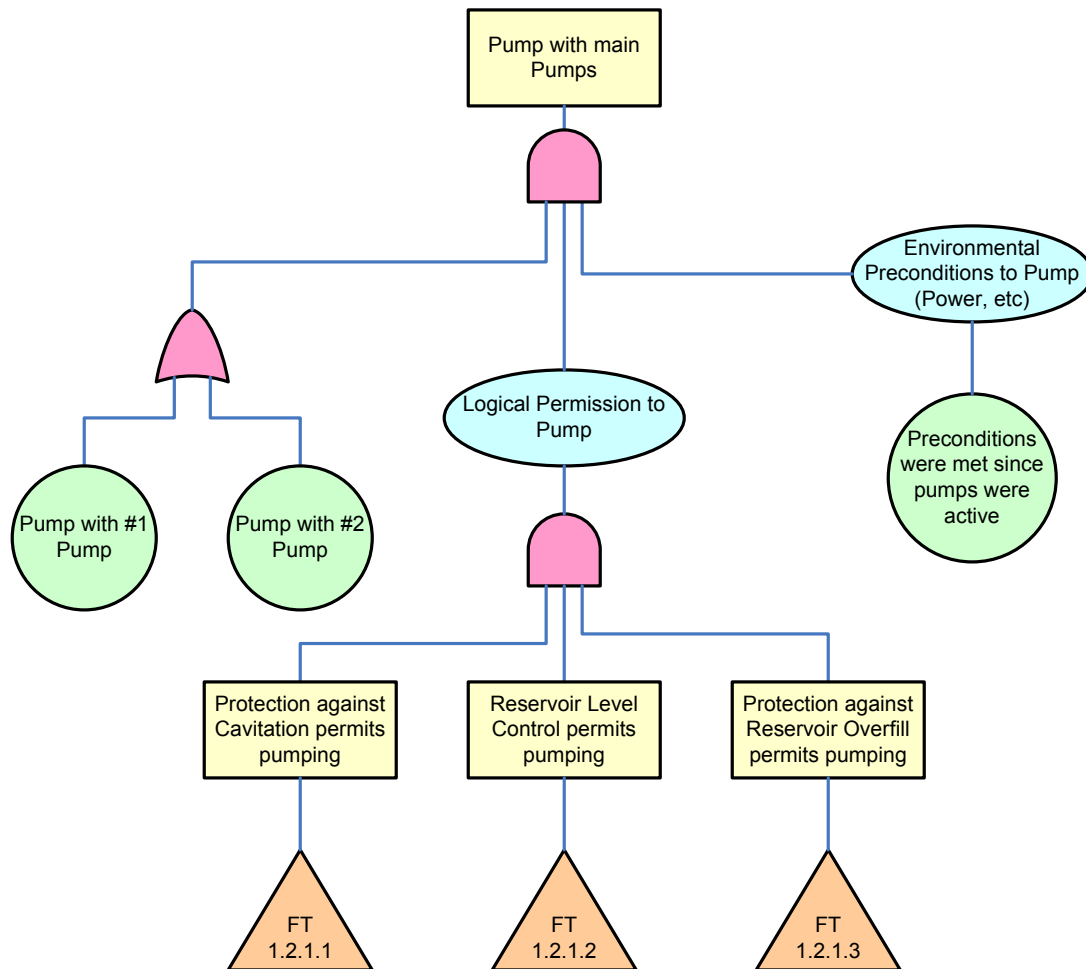
**Figure 34: Fault Tree 1.2.1: Pump with Main Pumps**

Certain environmental preconditions and permissions need to be met to enable the pumps to continue to operate. Start permissions for the pumps are not considered further since the data reviewed by Siemens suggests that the pumps were running throughout the incident.

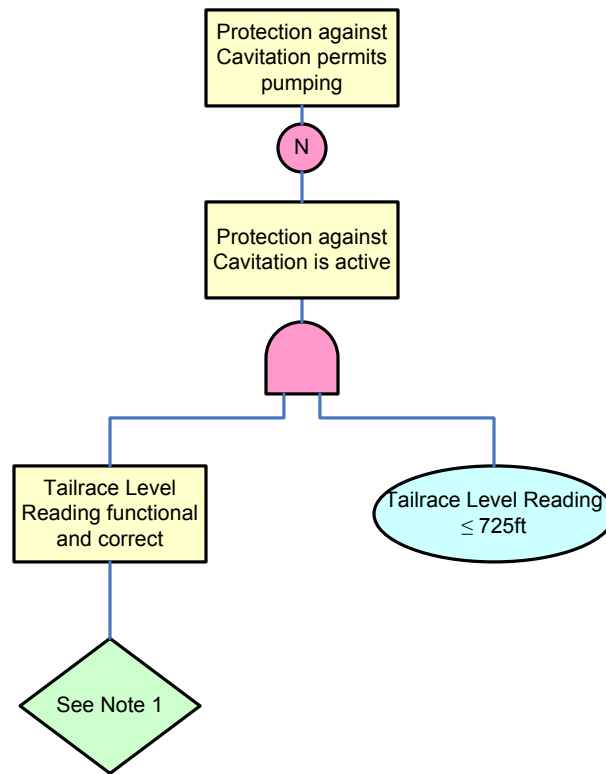
**Figure 35: Fault Tree 1.2.1.1: Protection against Cavitation**

| 1 | An incorrect tailrace reading by itself should not <i>cause</i> an overspill. An incorrect tailrace reading should only prevent an overspill if it fails low ( $\leq 725$ ). The process data archive suggests a functional transmitter during the incident. A correct tailrace reading should not prevent an overspill if there is sufficient water in the tailrace. |

Since Siemens believes that a wrong tail race reading would not be the root cause for an overspill, it is not considered any further.

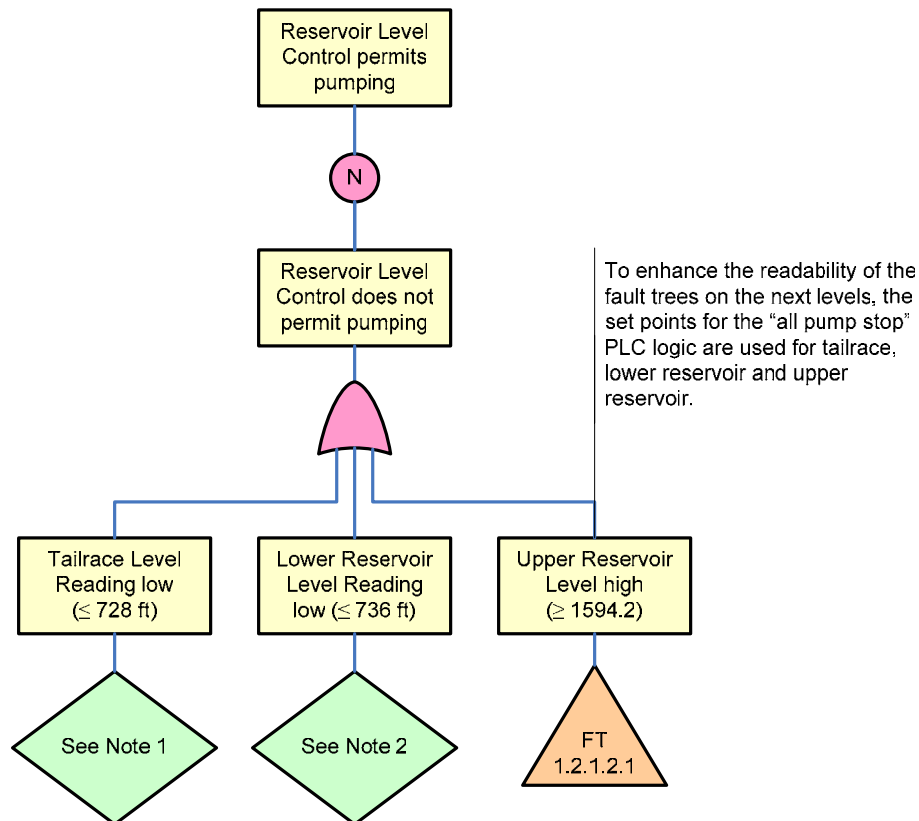
**Figure 36: Fault Tree 1.2.1.2: Level Control****Notes**

| 1 | An incorrect tailrace reading by itself should not <i>cause</i> an overflow. An incorrect tailrace reading should only prevent an overflow if it fails low ( $\leq 725$ ). The process data archive suggests a functional transmitter during the incident. A correct tailrace reading should not prevent an overflow if there is sufficient water in the tailrace |

Since Siemens believes that a wrong tail race or lower reservoir level reading would not be the root cause for an overflow, it is not considered any further.

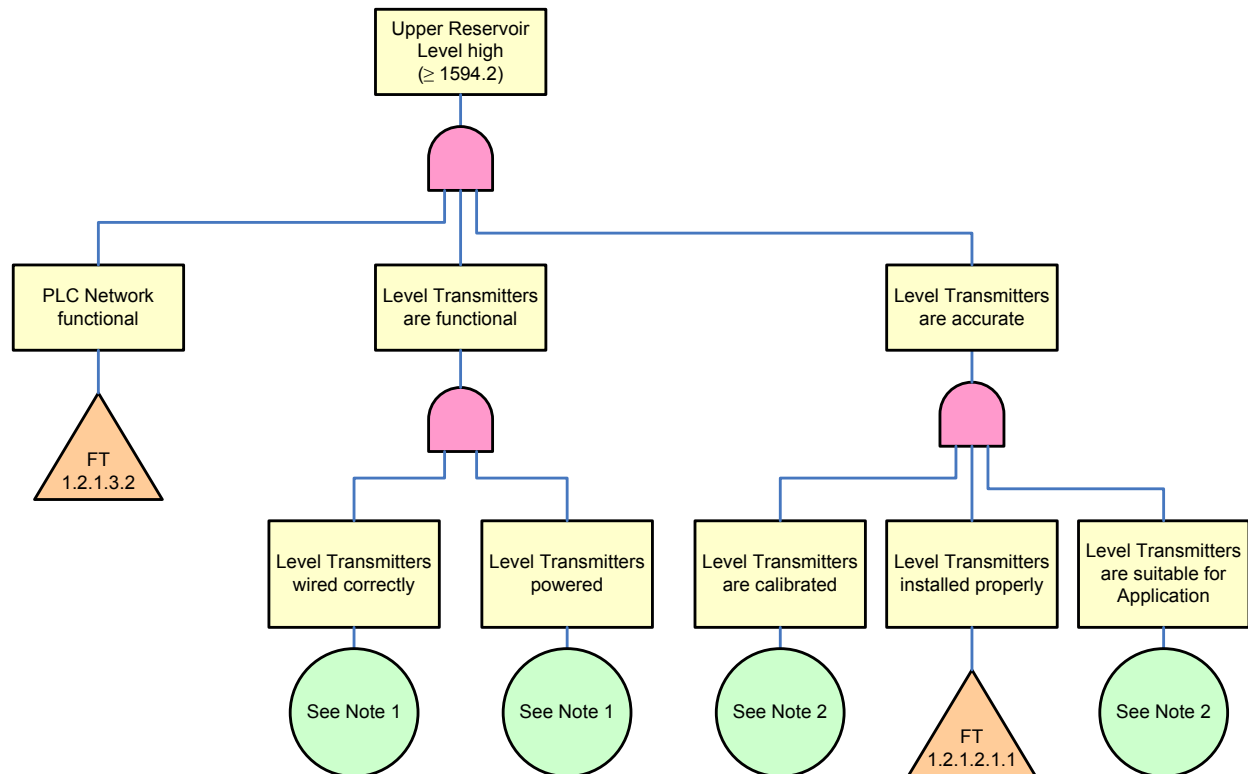
**Figure 37: Fault Tree 1.2.1.2.1: Upper Reservoir Level Control****Notes**

| 1 | The transmitters were apparently accessible from the PLC system throughout the incident and the readings correlate with the physical events observed. |
| 2 | Testing of the transmitters at the manufacturer's facility demonstrated that the transmitters were sufficiently calibrated and suitable for this application (see chapter 4.6.2.3). The temperature sensitivity of TX2 did not contribute adversely to the event. |

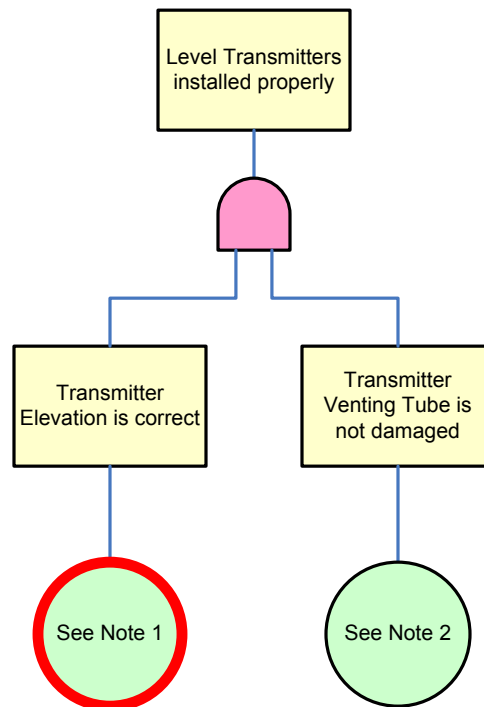
**Figure 38: Fault Tree 1.2.1.2.1.1: Level Transmitter Installation**

| 1 | The bow in the instrument pipe caused a shift in the elevation of the level transmitters. The transmitters were moved up, causing a reduction of the water level above them. Therefore the measured water level was likely too low. See also the pipe bow discussion in chapter 4.6.2.2. |
| 2 | The barometric air pressure was compared with level transmitter measurements. At stable plant conditions changes of the barometric pressure did not affect the level measurement of the upper reservoir. Therefore, Siemens assumes that the venting tube was not damaged. |

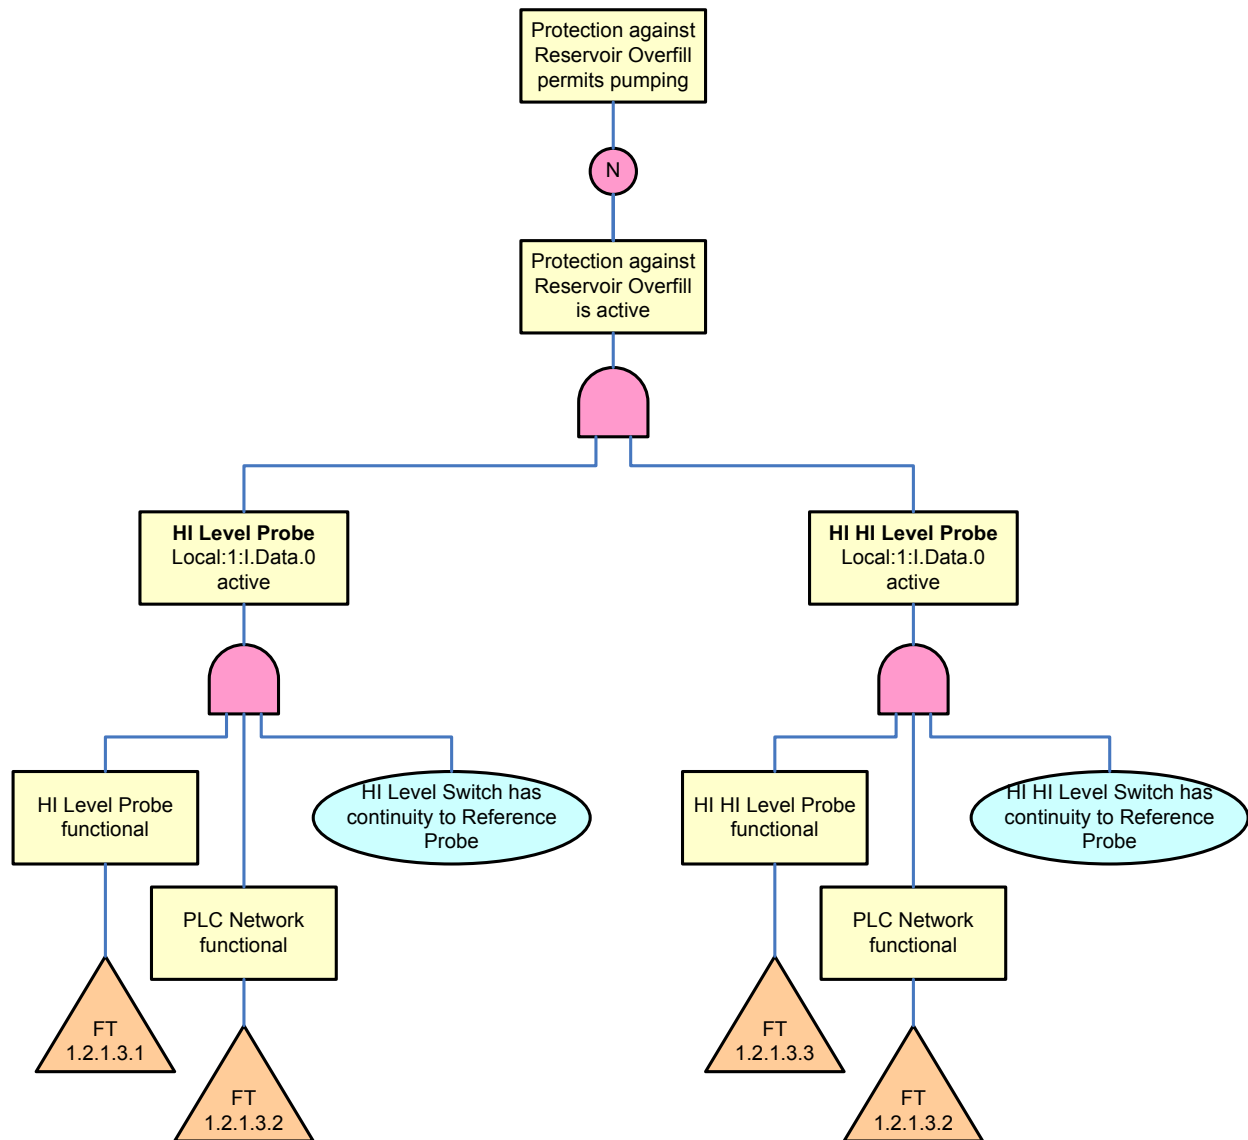
**Figure 39: Fault Tree 1.2.1.3: Level Protection**

In the as-found logic, the protection against overfill requires the HI and the HI-HI probe to become active. The probes can only become active if they are functional. In addition, the probe signals are processed properly only if the PLCs and the network are operational.

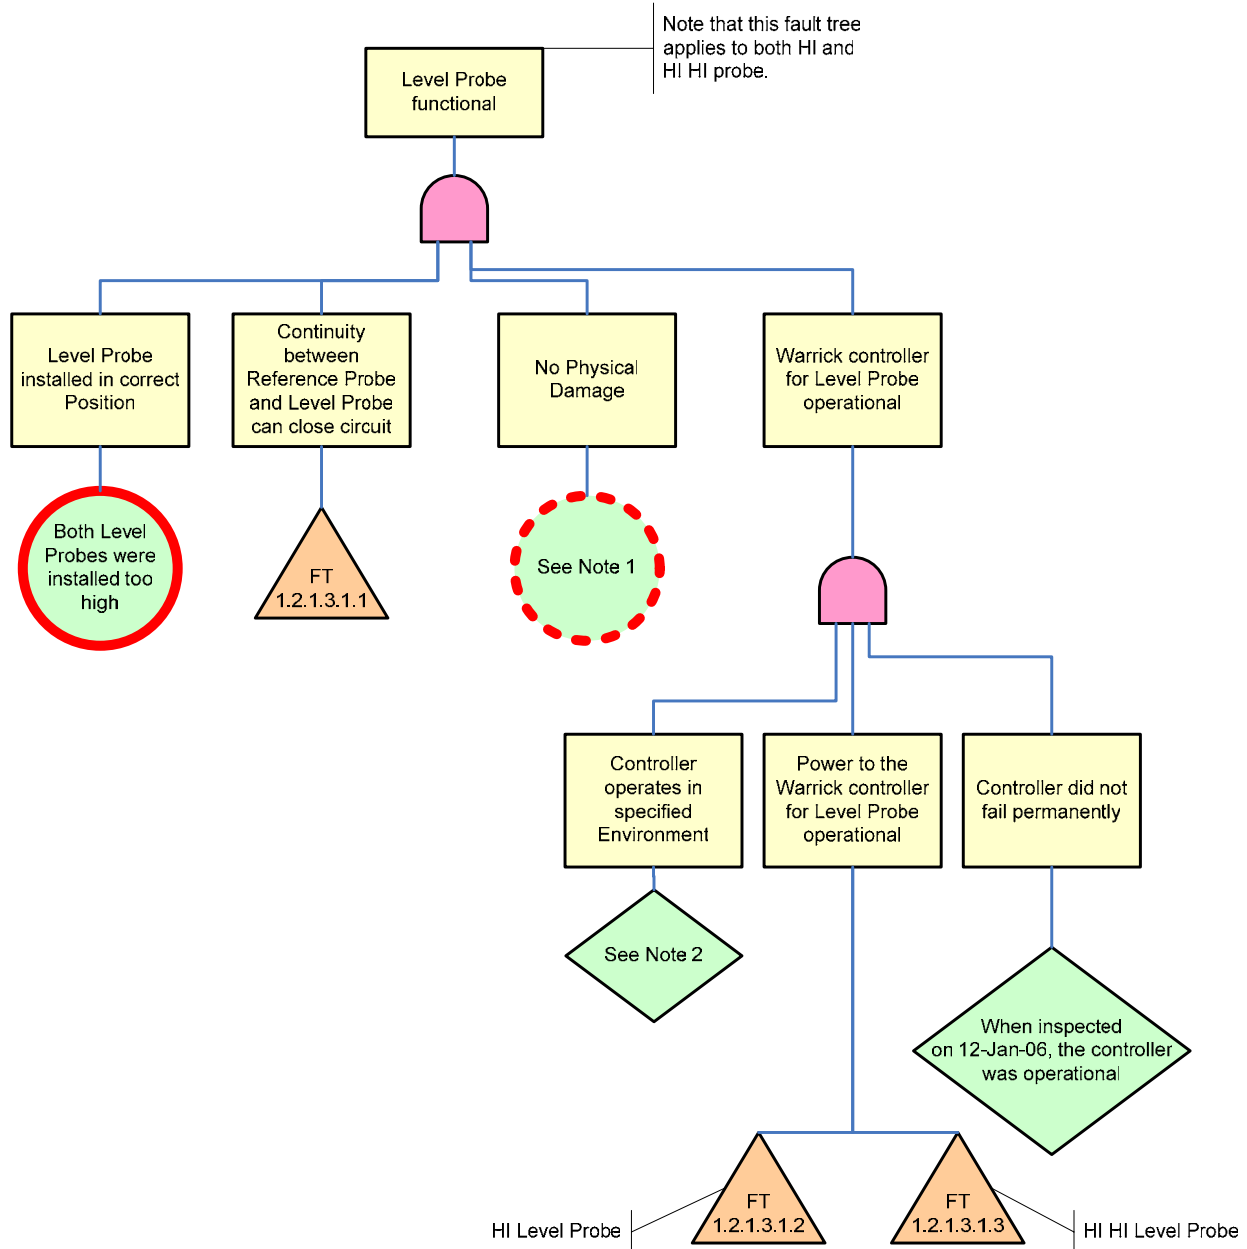
**Figure 40: Fault Tree 1.2.1.3.1-3 Level Probe functional****Notes**

| 1 | Although the probes did not show substantial physical damage when inspected on 12-Jan-06, minor rust observed on the reference probe may have affected continuity. However, when tested on 2-Feb-06, the probes were operational. |
| 2 | Controller was installed in a controlled but unmonitored environment. No PLC components were believed by Siemens to have failed in the UR gauge house during the event |

This fault tree applies to both the HI and the HI-HI level probes since they are of the same design. It is known that the level probes were installed too high which effectively disabled them.

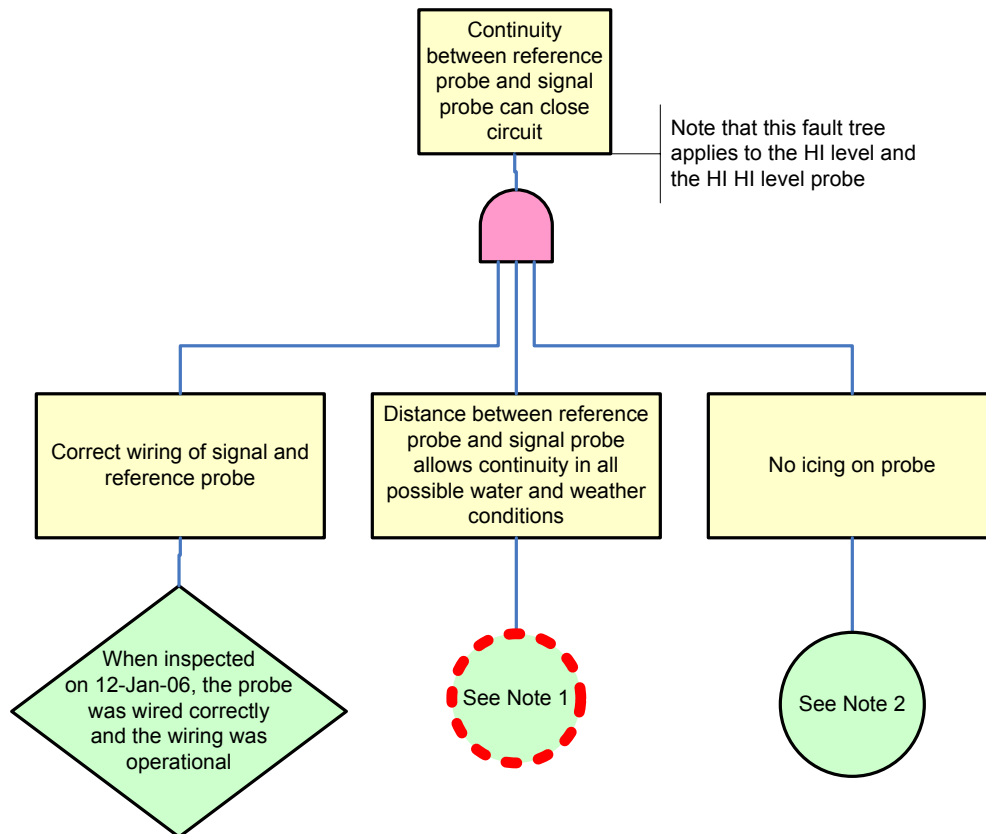
**Figure 41: Fault Tree 1.2.1.3.1.1: Continuity between the Signal Probe and the Reference Probe**

| 1 | The manufacturer (Tom James on 1/27/06) stated that the recommended maximum distance between the reference and the signal probe is 4 feet. However, when tested by Siemens and Ameren on 2-Feb-06, probes had continuity of up to 200 feet. As installed, the probes were not only depending on the continuity of the water. The stainless steel cable and the ladder provided additional continuity. |

This fault tree applies to the HI and HI-HI level probes since they are of the same design. There is a very small likelihood of icing due to weather conditions<sup>8</sup> before the event. However, it is unlikely that the icing may have built up due to pumping activity and contributed adversely to the continuity.
