**SIEMENS' REPORT**  
**MARCH 24, 2006**  
**AmerenUE**

## AmerenUE Taum Sauk Incident Instrumentation and Controls Root Cause Investigation Report

March 24, 2006

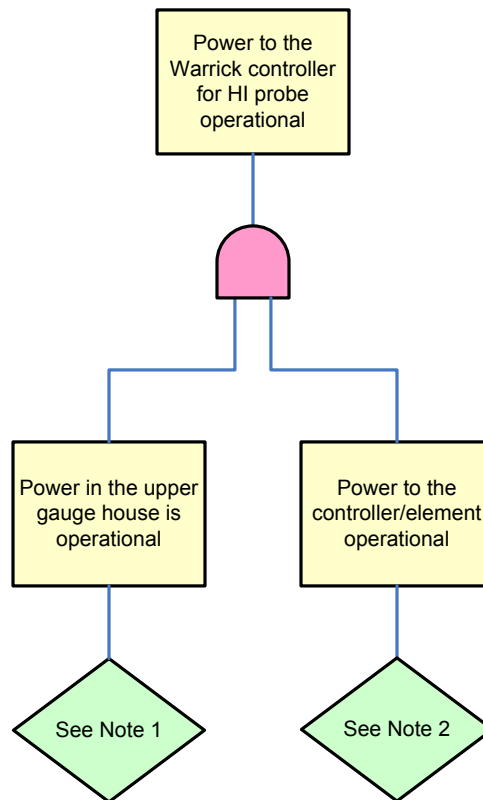
**Figure 42: Fault Tree 1.2.1.3.1.2: Power to HI Level Probe operational**

| 2 | A failure of power would not be detected by the system or the operators. However, Ameren checked the circuit after the event and determined that the circuit was operational. |

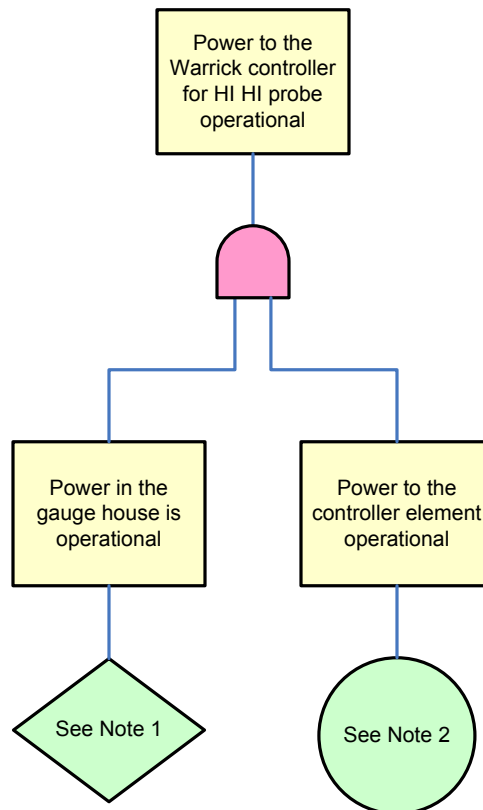
**Figure 43: Fault Tree 1.2.1.3.1.3: Power to HI-HI Level Probe operational****Notes:**

| 1 | There was no UPS alarm and the PLC was operational during the event. Therefore, Siemens assumes that the power in the upper gauge house was operational. |
| 2 | A failure of power should cause a LO-LO alarm since both contacts are supplied by the same power source. That LO-LO alarm was not observed. |

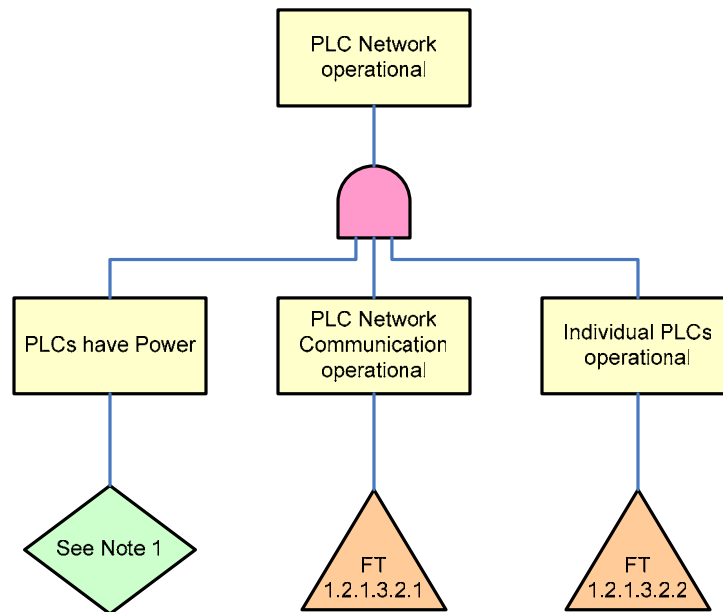
**Figure 44: Fault Tree: 1.2.1.3.2 PLC Network Functional**

The availability of power, network communication and the operational status of the individual PLCs are preconditions for the PLC network operation.

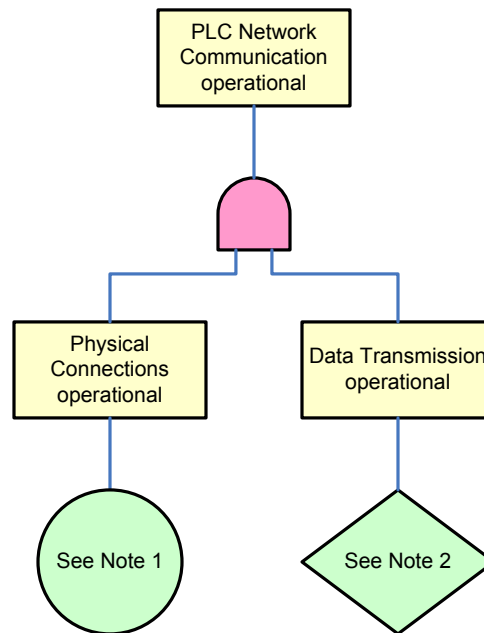
**Figure 45: Fault Tree 1.2.1.3.2.1: PLC Network Communication**

| 2 | According to Ameren, the last PLC program change before the incident was performed on 7-Dec-05. Since that date, several auto pump stops were performed by the system. This suggests that the PLCs were transmitting data between each other. Since there were no active physical network alarms reported on the data historian at the day of the incident, Siemens assumes that the PLCs were transmitting data throughout the incident. The communication with the Wonderware data process archive also appears to have been operational throughout the day of the incident. |

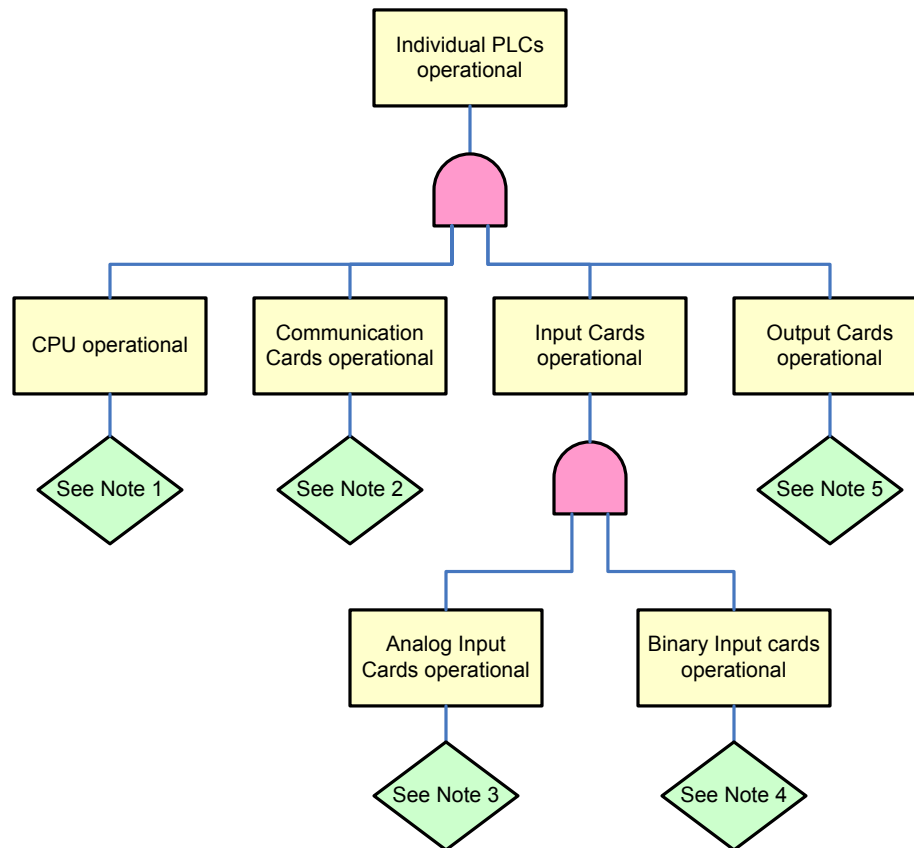
**Figure 46: Fault tree 1.2.1.3.2.2: Individual PLC Status****Notes**

| 1 | The PLCs appear to have been in communication with the Wonderware process data archive throughout the event. Therefore, Siemens assumes that the CPUs were functional. |
| 3 | There is small likelihood that the analog input cards may have contributed to the level transmitter inaccuracy. However, according to the manufacturer's documentation and the fact that the building was thermostatically heated, and calculations performed by Siemens based upon the information reviewed, analog input inaccuracy may cause a variation of 1"-3" of water level. |

Analyzing the output cards would not contribute to this root cause analysis since the PLC logic would not have attempted to activate the necessary outputs to stop the pumps. Testing performed after the event suggests that the cards were operational on 2-Feb-06.
