3.0 SUMMARY DESCRIPTION OF THE SITE GEOLOGY

3.3 GEOLOGIC MAPPING OF THE BREACH AREA

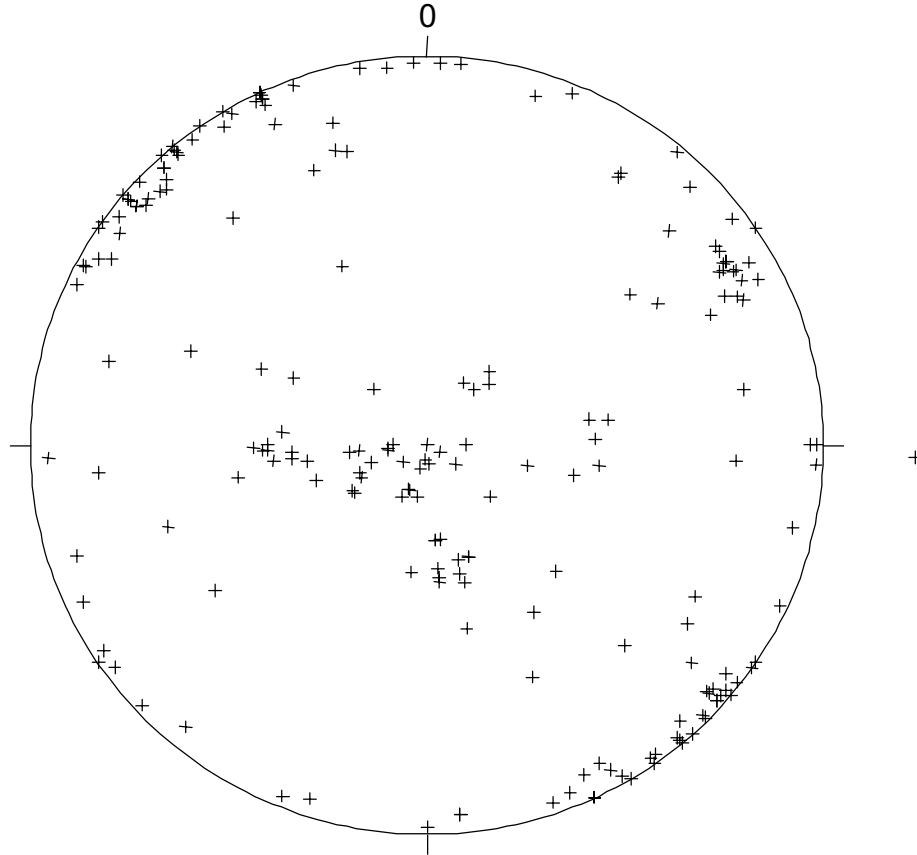
FIGURE 3-2

Table 3-1. The dominant fracture sets are FS-1, FS-2, FS-12, and FS-14. Stereonet analysis of these data lead to the conclusion that fracture sets FS-2, FS-12, and FS-14 are likely the same set that strikes N40-60E and dips 85-90 NW and SE. These fractures are very continuous (greater than 100 feet in length) and are the dominant structural feature in the rock mass. Most of the fracture sets are too steeply dipping to present planar failure potential given the geometry of the slope of Proffit Mountain. However, less dominant, shallow dipping sets such as FS-7 may present the potential for localized planar failure.

STEREONET OF FRACTURES: LOWER HEMISPHERE, POLE TO PLANE, N=193

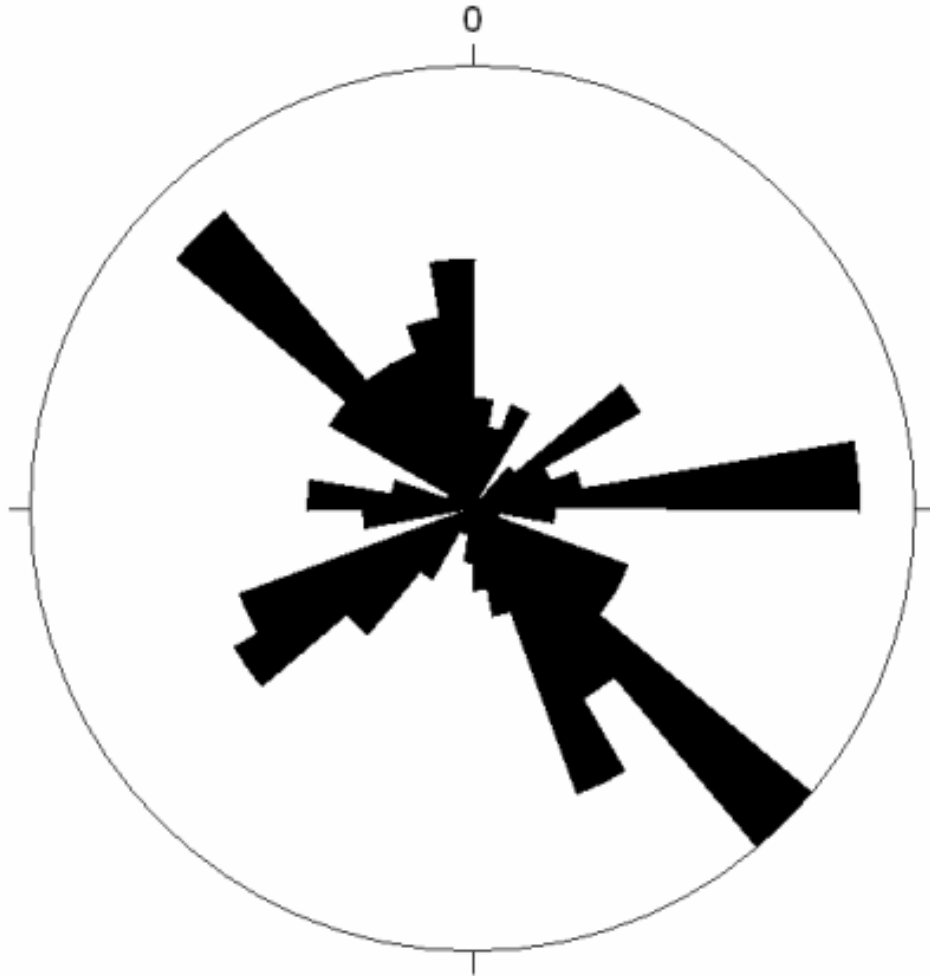
FIGURE 3-3

ROSE DIAGRAM OF FRACTURES, N=193
